## Arboricultural Impact Assessment

**Client Name:** Peter Kelly  
**Site Address:** 46a York Terrace Bilgola Plateau NSW  
**Authors Details:** Hugh Millington  
**Email:** [hugh@hughtheArborist.com.au](mailto:hugh@hughtheArborist.com.au)  
**Phone:** 0426836701  
**Date Prepared:** 20<sup>th</sup> March 2025

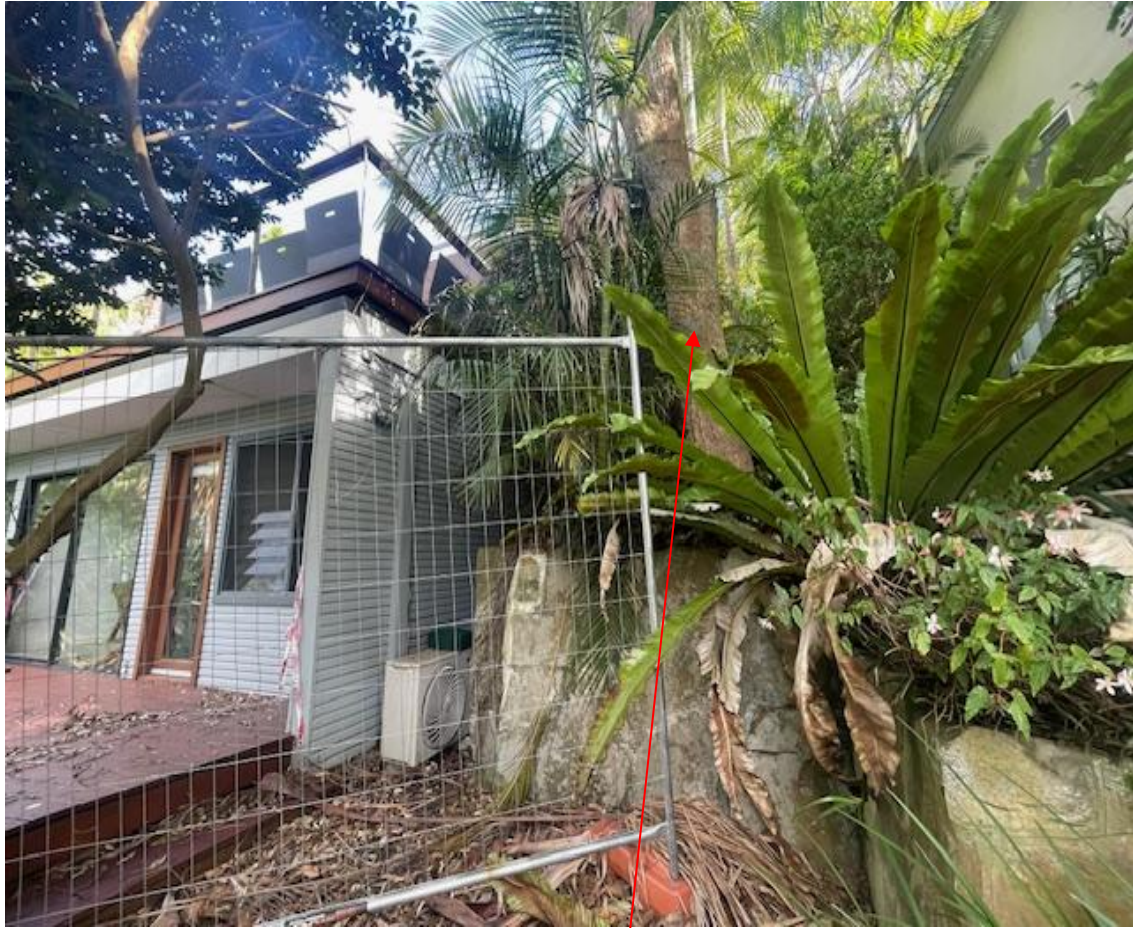
**Photo A:** The Looking from the lower ground floor at Tree 3 which is contained within a stone planter and will not be impacted by the associated encroachment of the deck.
