# Arboricultural Impact Assessment

**Client Name:** Luke & Julie Preston  
**Site Address:** 1 Harewood Place Warriewood NSW  
**Authors Details:** Hugh Millington  
**Email:** [hugh@hughtheArborist.com.au](mailto:hugh@hughtheArborist.com.au)  
**Phone:** 0426836701  
**Date Prepared:** 29<sup>th</sup> November 2023  
**Revision:** A

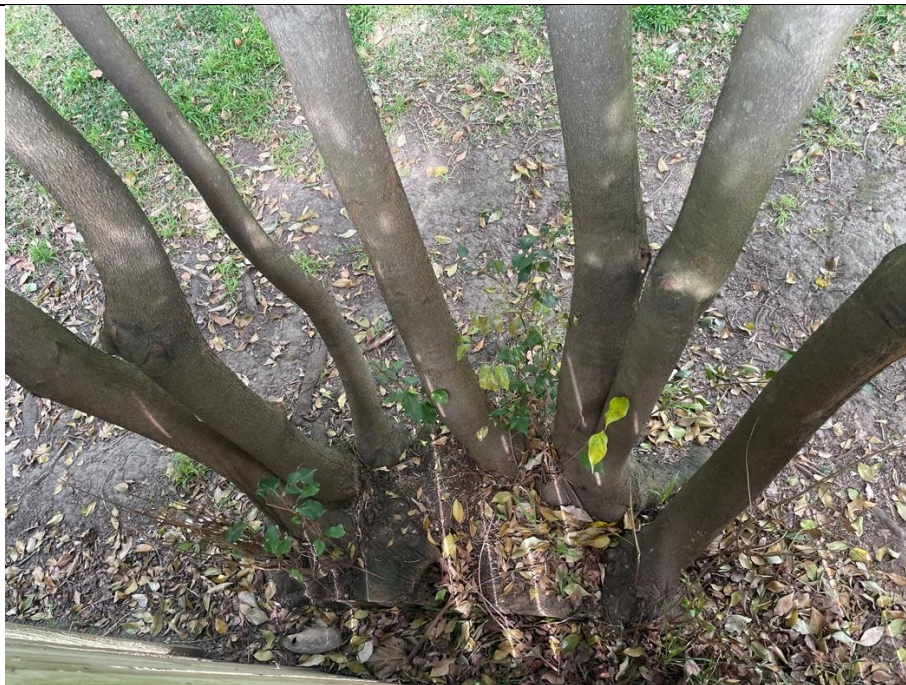
| Tree ID | Botanical Name | Retention value | TPZ radius (m) | TPZ area (m <sup>2</sup> ) | SRZ radius (m) | TPZ encroachment | Discussion/ Conclusion | Recommendation |
|---|---|---|---|---|---|---|---|---|
| 1 | <i>Acmena smithii</i> | Z10 | 3.0 | 28.3 | 2.5 | Major | The tree is located within the adjoining property. The proposed stone retaining wall and excavations for the turf area (cut of up to 1m below existing grades) will encroach into the TPZ by 16% (4.5m <sup>2</sup> ) and into the SRZ. This is considered to be a major TPZ encroachment, indicating the proposed works could potentially impact the condition and stability of the tree. However, the tree consists of epicormic regrowth from a previously lopped and partially ground stump. The Northern portion of the trunk (adjacent to the subject site) has a visible cut line, indicating no significant root growth is located within the subject site (see Photo 1). Therefore, the proposed works will not significantly impact the tree. | Retain and protect |

**Photo 1:** Looking over the boundary fence towards the base of tree 1. Showing epicormic regrowth from stump and the cut line within the trunk parallel to the fence, indicating no significant root growth remains within the subject site.

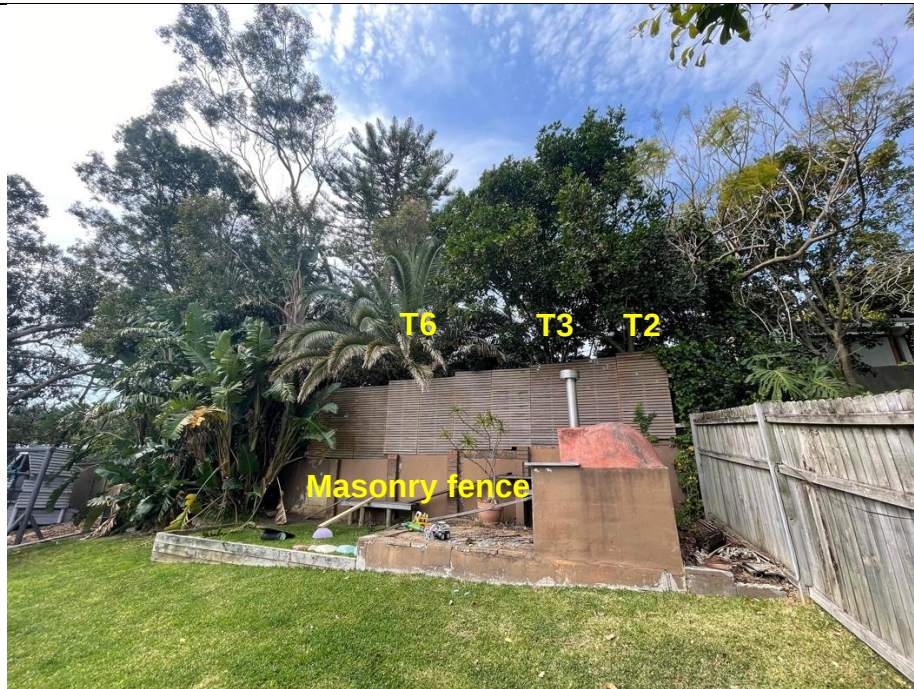
**Photo 2:** Looking East from within the site towards tree 2, 3 and 6 (located within the adjoining property). The existing boundary masonry fence appears to be restricting root growth into the subject site.

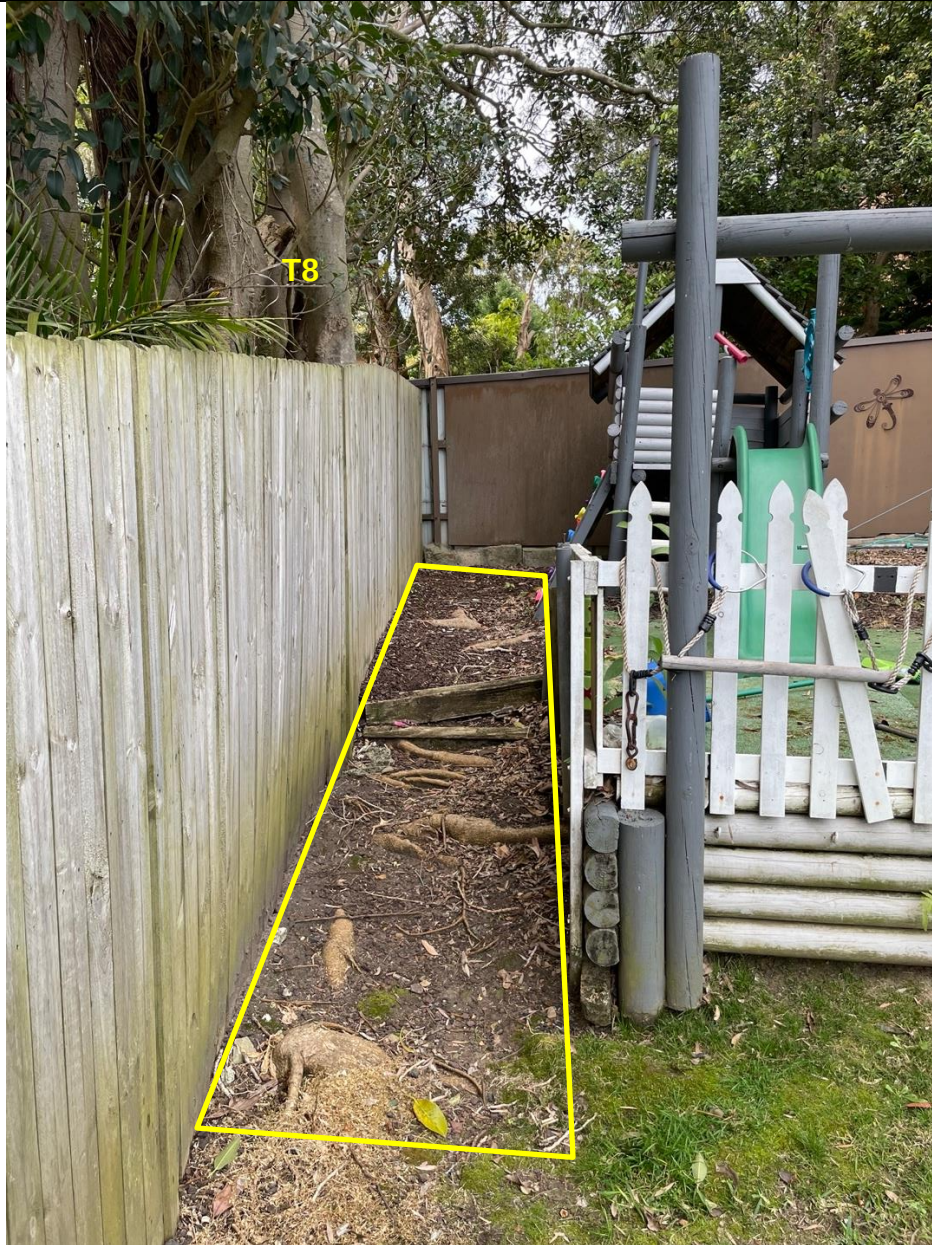
| Tree ID | Botanical Name | Retention value | TPZ radius (m) | TPZ area (m <sup>2</sup> ) | SRZ radius (m) | TPZ encroachment | Discussion/ Conclusion | Recommendation |
|---|---|---|---|---|---|---|---|---|
| 8 | <i>Ficus rubiginosa</i> | A2 | 10.5 | 346.4 | 3.9 | Major | The tree is located within the adjoining property. The proposed works include the construction of the swimming pool, the installation of a retaining wall along the rear boundary and the demolition and replacement of a retaining wall to the rear of the existing dwelling. The combined encroachment from the proposed works will be up to 10% (33m <sup>2</sup> ) with no encroachment into the SRZ. This is considered to be a minor encroachment and providing none of the large surface roots close to the northern boundary are damaged the tree will not significantly affect the condition of the tree. | Retain and protect |

**Photo 4:** Looking East from within the site towards tree 8 (located within the adjoining property). Showing the surface roots emanating from tree 8 (within the yellow rectangle) that must remain undamaged.

| Tree ID | Common Name | Botanical Name | Age Class | Height (m) | Canopy Spread Radius (m) | Stem 1 | Stem 2 | Stem 3 | Stem 4 | Stem 5 | DBH (mm) | DAB (mm) | Health | Structure | Amenity Value | SULE | Retention Value | TPZ Radius (m) | SRZ Radius (m) | Notes |
|---|---|---|---|---|---|---|---|---|---|---|---|---|---|---|---|---|---|---|---|---|
| 8 | Port Jackson Fig | <i>Ficus rubiginosa</i> | Mature | 12 | 10 | 408 | 300 | 300 | 420 | 500 | 879 | 1500 | Good | Fair | Medium | 2. Medium | A2 | 10.5 | 3.9 | The tree is located within the adjoining property. Decay in stems and surface roots within site. |
