## ***Construction Impact & Management Statement & Preliminary Plan of Management***

**October 2023**

**24 Hilma Street Collaroy Plateau NSW 2097**

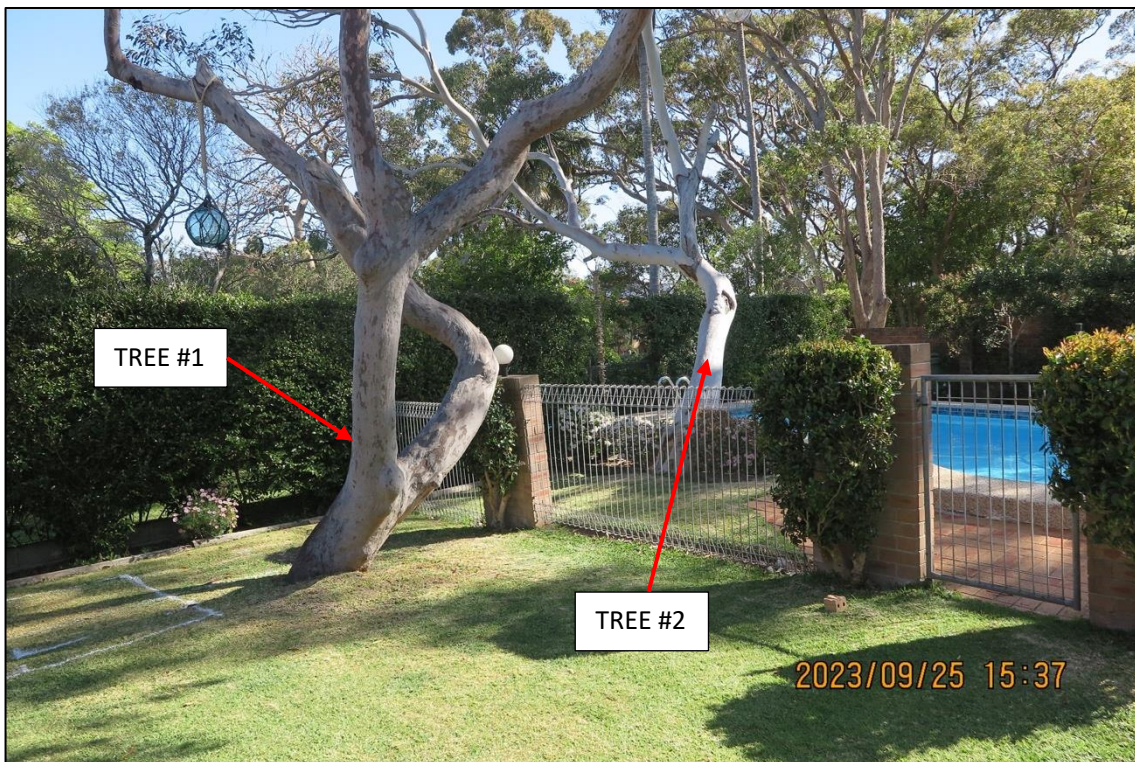
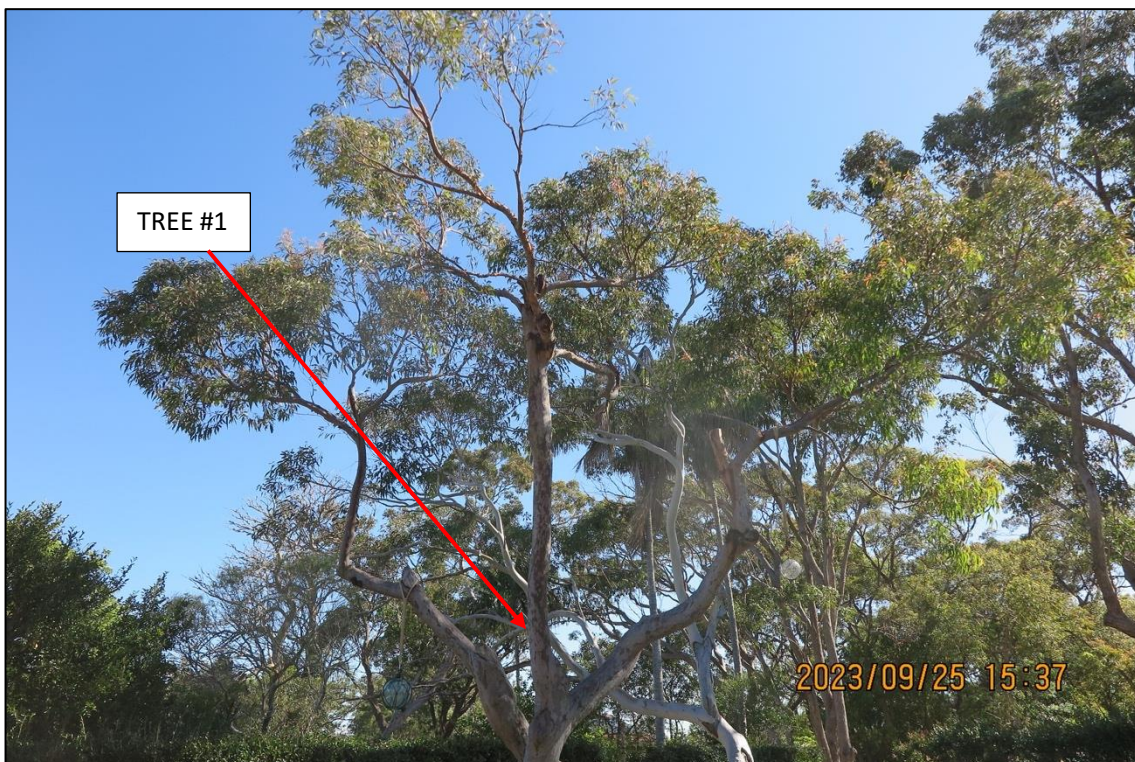
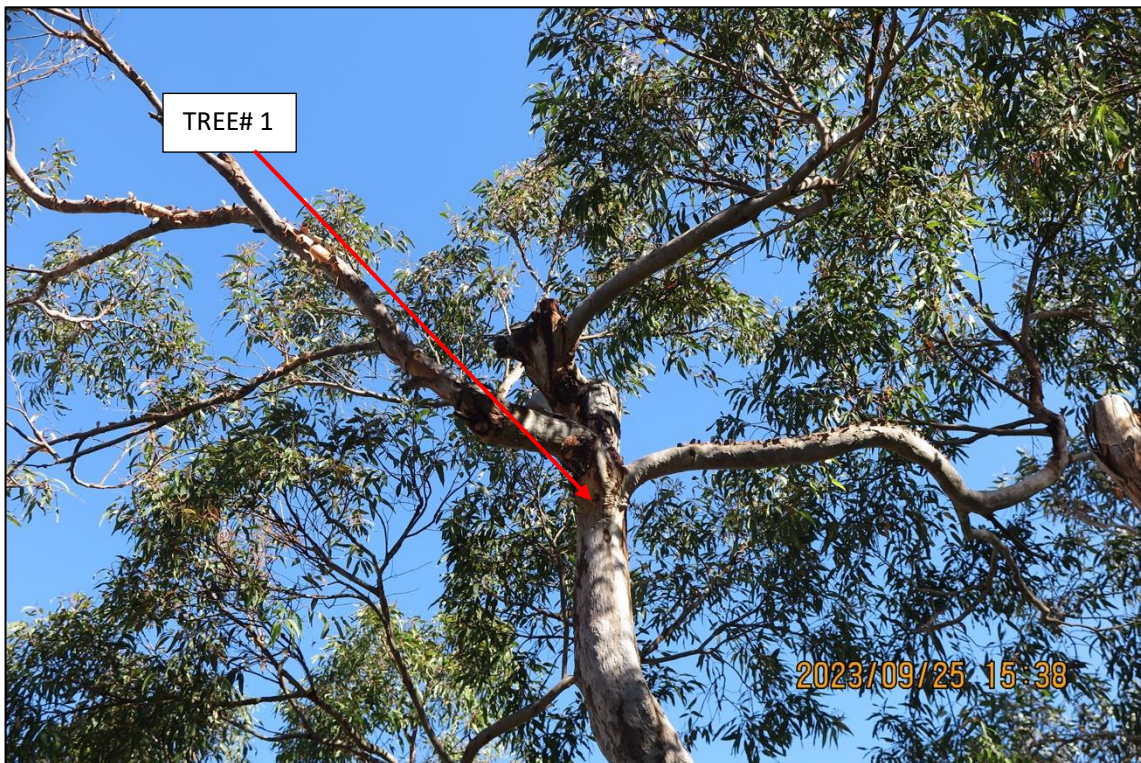
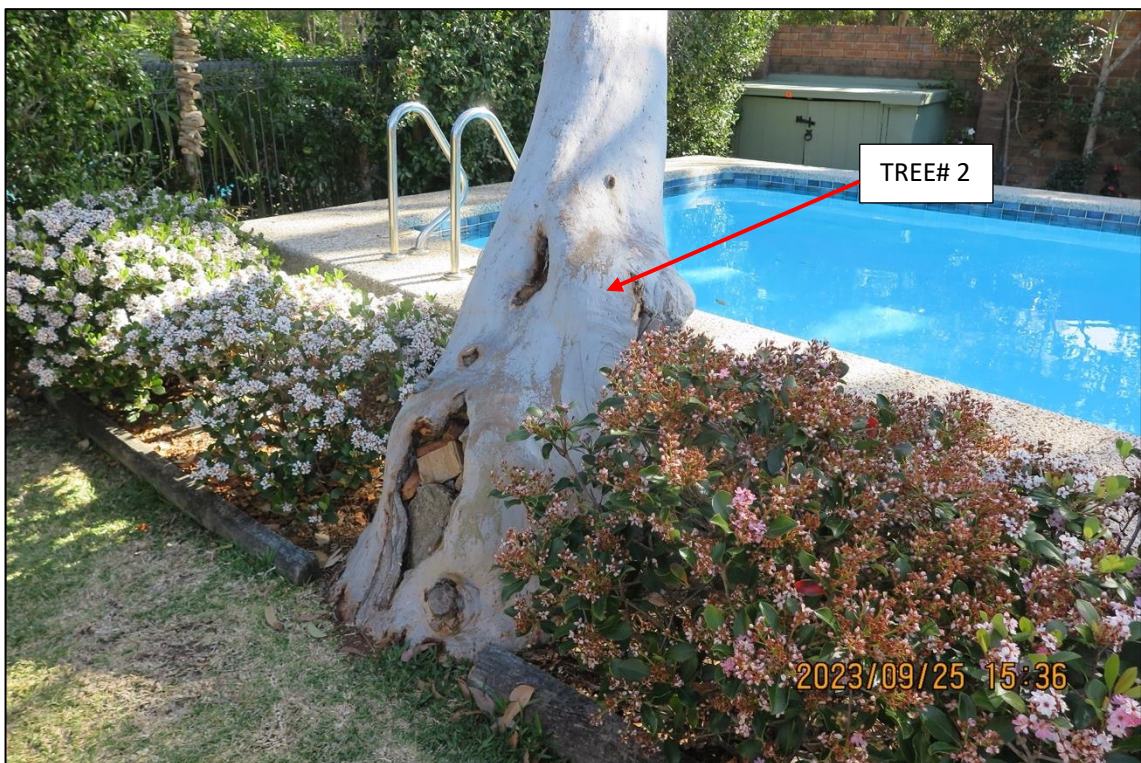
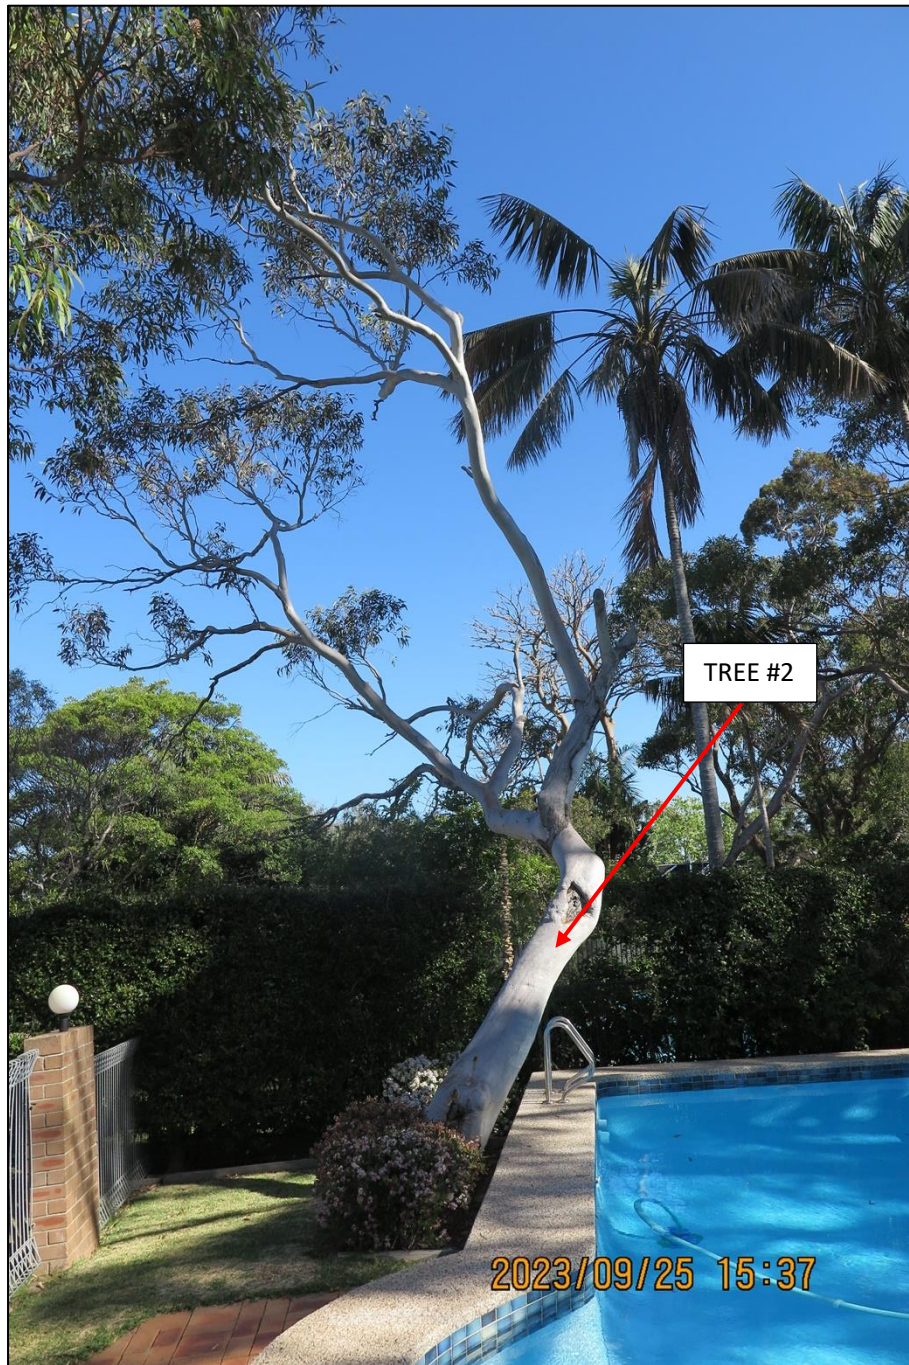
### 4.3 Tree & Site Images

We believe both trees are long term compromised with respect to their individual Useful Life Expectancy because of altered ground levels. This most likely occurred when the inground swimming pool & pool surrounds were built with the soil (or at least part) of the soil excavated spread over parts of the rear yard to create a level yard.

TREE#1 whilst not being good example of its species we conclude at the time of our assessment it should have a Medium term Useful Life Expectancy. (Medium term being defined in this situation as fifteen to twenty-five years (15 to 25).

TREE #2 having been assessed as being of Poor to Fair Health & Vigour regardless of any proposed works has only a short-term Useful Life Expectancy. (Short term being defined in this situation as being less than fifteen years (<15) .

On the basis that neither discussed tree is long term viable, defined in this situation as being greater than twenty-five years (>25) we suggest new medium size at maturity new canopy trees be included as part of the new landscape concept.

Both discussed trees are specified where TPZ total surface area to exposed soils is breached by the proposed works, the installation & continued retention of a native tree mulch at a thickness of between 50mm & 75mm is considered an essential component of AS4970-2009 compliance.

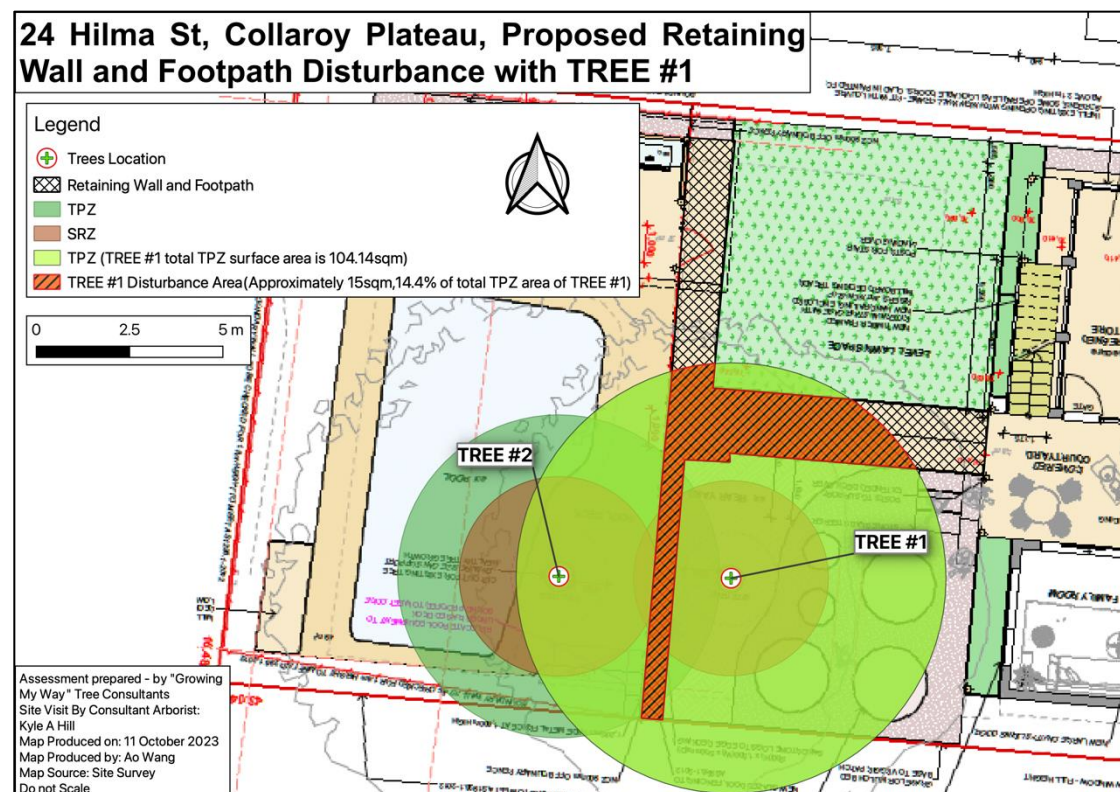
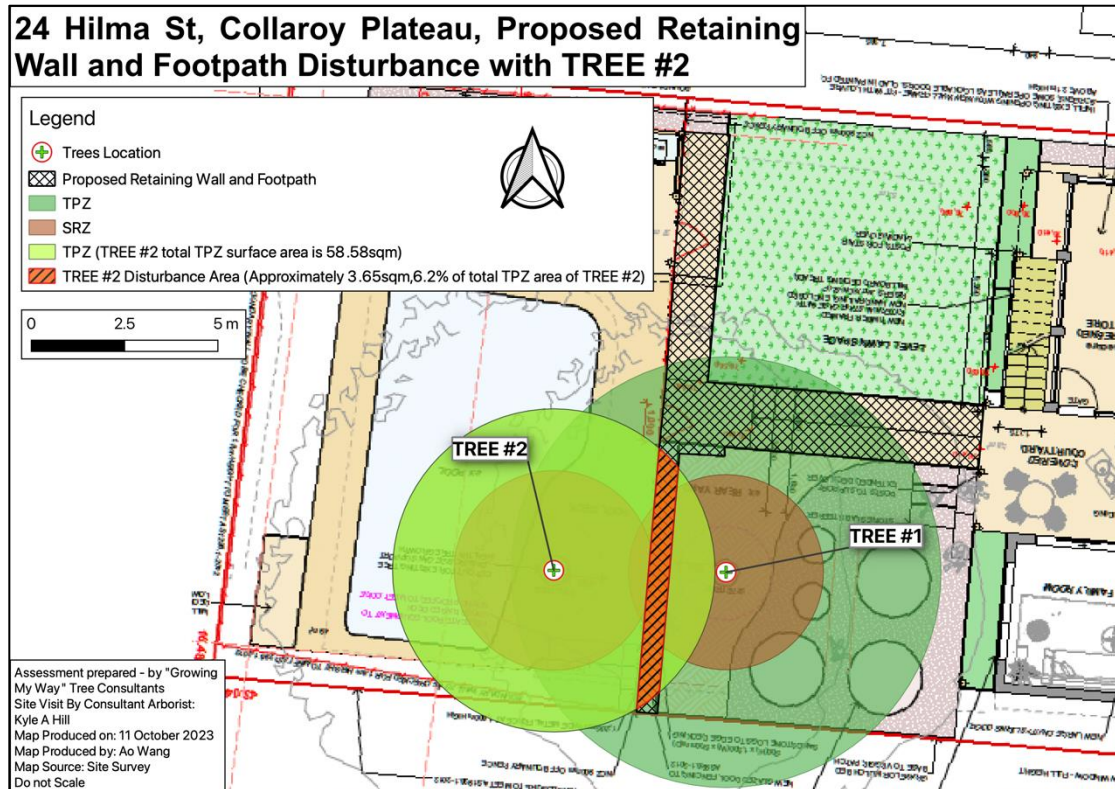
## TPZ / SRZ TREE DISTURBANCE CALCULATION DIAGRAMS

The proposed retaining wall and footpath breaches both the TREE #1 & TREE #2 TPZ total surface areas. Soil level changes within the rear yard are minimal to nil.

By calculation total TPZ surface area of TREE #1 is 104.14m<sup>2</sup>. The proposed retaining wall and footpath footprint equates to an approximately 15m<sup>2</sup> breach of total TPZ surface area for Tree# 2 to be 14.4% of total TPZ surface area. The breach as a mathematical number, (by AS4970-2009 provisions this equates to a Major encroachment. We contend, this is not a Major encroachment by virtue of soil level changes being minimal to nil. The only change to the existing environment is the demolition of the existing swimming pool surrounds fencing & a new footpath linking the dwelling to the swimming pool surrounds.

By calculation total TPZ surface area of TREE #2 is 58.58m<sup>2</sup>. The proposed retaining wall and footpath footprint equates to an approximately 3.65m<sup>2</sup> breach of total TPZ surface area for Tree #2 to be 6.20% of total TPZ surface area. The breach as a mathematical number, (by AS4970-2009 provisions this equates to a Minor encroachment. We contend, this is not a management concern as the encroachment is less than 10% & soil level changes for the proposed works as being minimal to nil. The only change to the existing environment is the demolition of the existing swimming pool surrounds fencing & a new footpath linking the dwelling to the swimming pool surrounds.
