143 Prince Alfred Parade, Newport

Comments on Updates to Plans

GEOTECHNICAL INVESTIGATION:

Alterations & Additions & New Pool at 143 Prince Alfred Parade, Newport

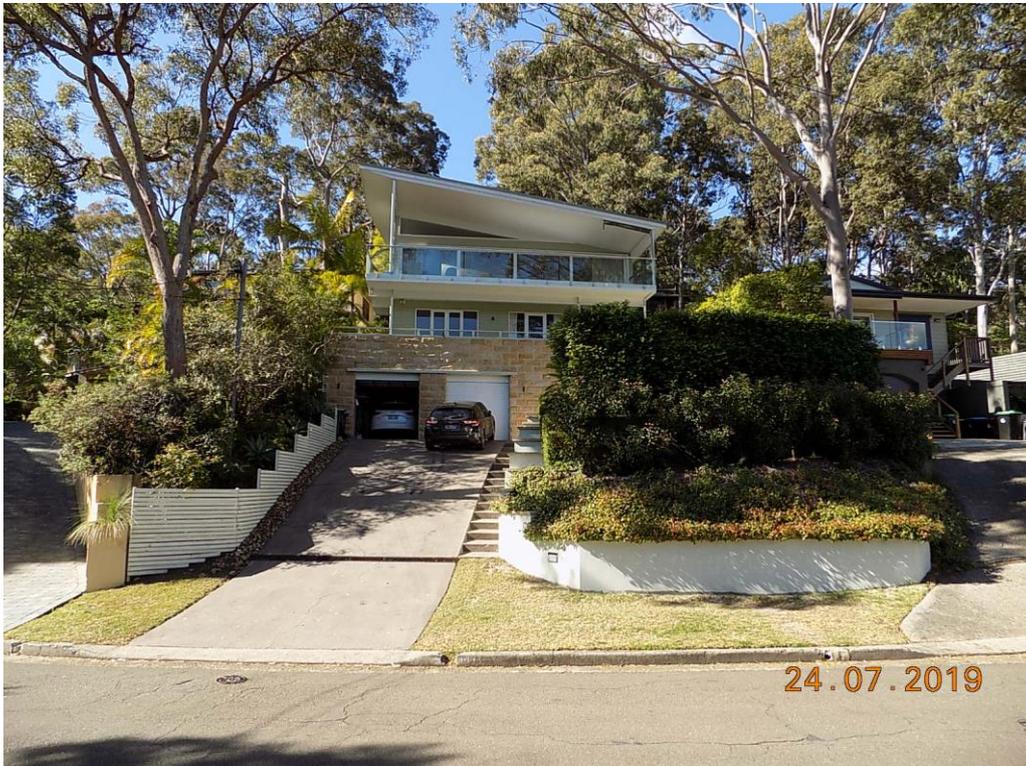
Photo 1

- 2.3 At the road frontage, a concrete driveway runs to a garage on the lower ground floor of the house (Photo 1). An excavation has been made at the rear of the garage and has been taken entirely through Extremely Low to Very Low Strength Shale (Photo 2). The slope between the road frontage and the house is terraced with two stable rendered masonry retaining walls (Photo 3). The part three-storey brick and clad house is supported on brick walls and brick piers (Photo 4). The supporting brick walls display no signs of movement and the supporting brick piers stand vertical. A

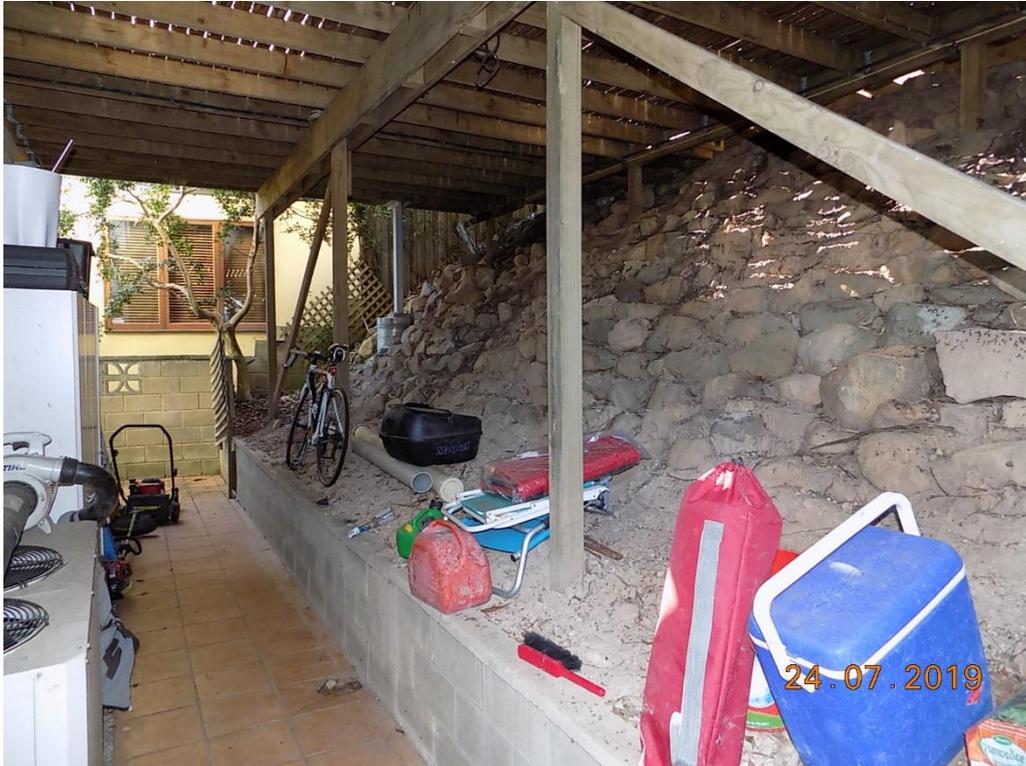
Photo 5

lawn-covered fill extends off the uphill side of the house. The fill is supported by a stable battered slope lined with large rocks (Photo 5). The slope above the lawn is terraced with two stable treated timber retaining walls (Photos 6 & 7). A well-vegetated garden area rises from the upper wall to the upper common boundary (Photo 7).

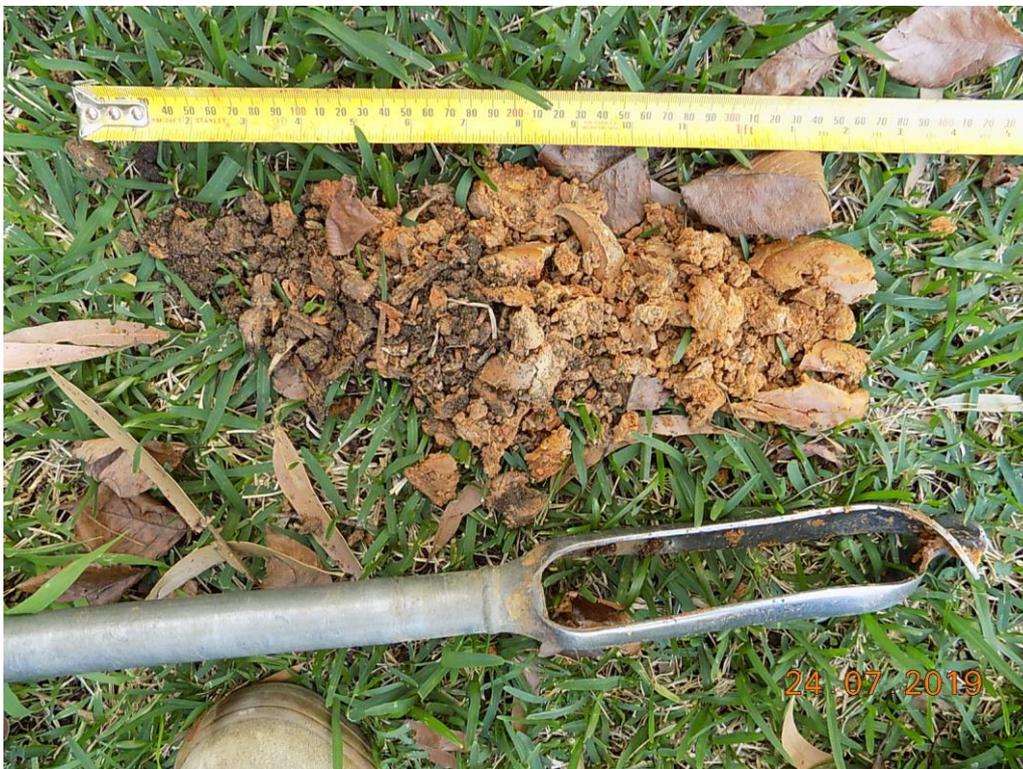
AUGER HOLE 1 (~RL32.4) – AH1 (Photo 8)

Depth (m)	Material Encountered
0.0 to 0.2	TOPSOIL , silty soil, dark brown and brown, medium dense, dry, fine to medium grained with fine trace organic matter and trace clay.
0.2 to 0.4	CLAY , weathered shale, brown and mottled orange and maroon, stiff to hard, dry, fine grained.

End of hole @ 0.4m in weathered shale. No watertable encountered.

Photo 8 – AH1: Downhole is from left to right.
