Report Title: Geotechnical Report 2131 Pittwater Road, Church Point

Report Date: 31/10/24

## **GEOTECHNICAL INVESTIGATION:**

Additions and Alterations and New Pool at **2131 Pittwater Road, Church Point**

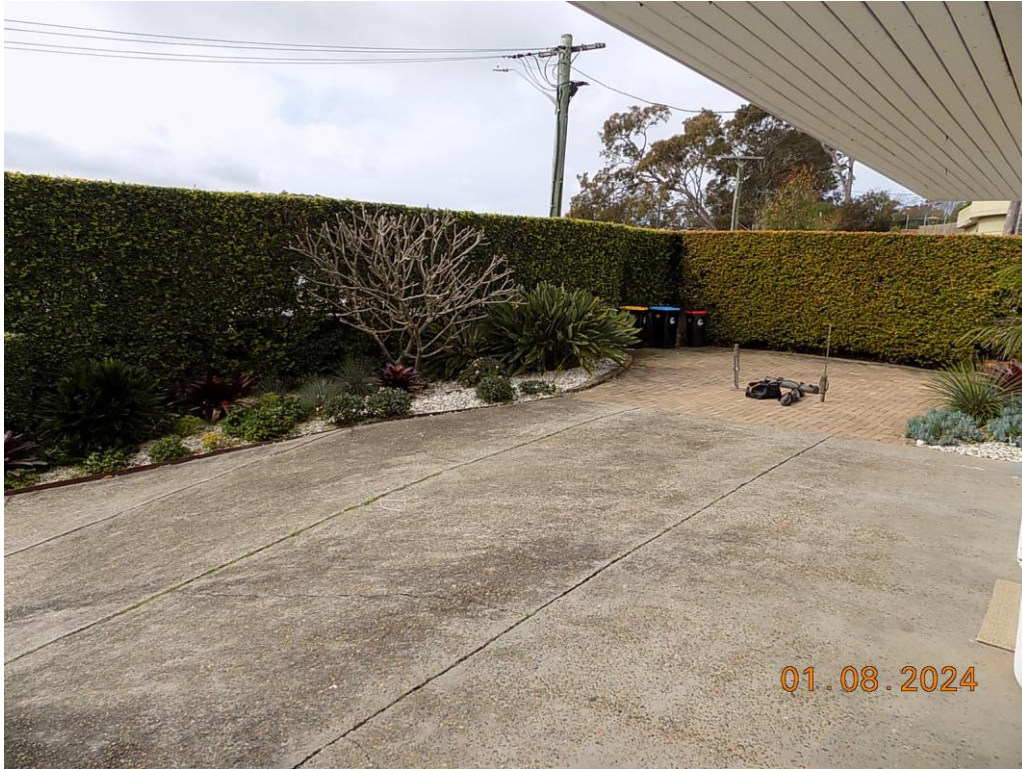
Photo 2

- 2.1** The site was inspected on the 1<sup>st</sup> August, 2024.
- 2.2** This residential property is on the high side of the road and has a NE aspect. It is located on the gentle to moderately graded lower reaches of a hillslope. The natural slope rises across the property at an average angle of ~9°. The slope above the property continues at moderate angles. The slope below the property eases to near level angles at the waterfront.
- 2.3** At the road frontage, a concrete ROW (Right of Carriageway) and driveway run to a garage under the downhill side of the house (Photo 1). Fill for the driveway and garden bedding between the road frontage (Photo 2) and the house is supported by a

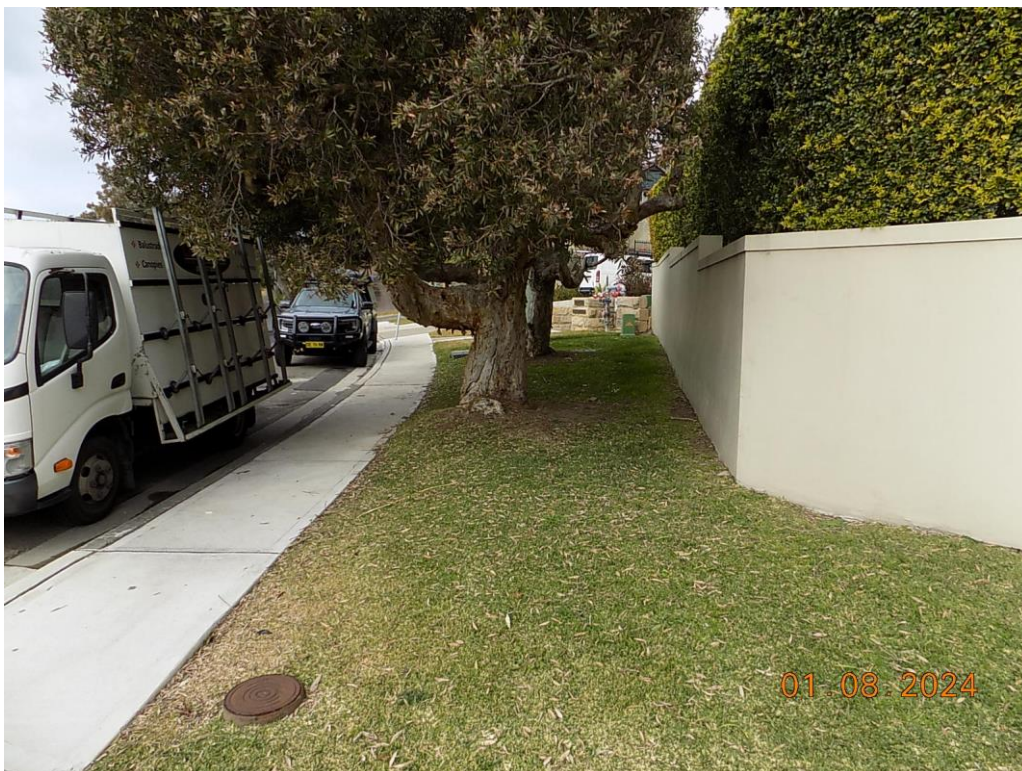
Photo 3

stable rendered masonry retaining wall (Photo 3) which approximates the downhill and SE boundaries. The part two-story house is supported on rendered masonry walls. Horizontal hairline cracking in the rendering was observed in some of the supporting walls. This minor cracking is not attributed to foundation movement. The house foundations are currently considered stable. Most of the supporting walls of the house will be demolished as part of the proposed works. A stable pool (Photo 4) and tiled patio occupies the space between the upper and lower portions of the house. The pool will also be demolished as part of the proposed works. The cut for the patio is supported by a stable rendered masonry retaining wall reaching ~1.5m high (Photo 5). Above the house a cut for level garden bedding is supported by a stable low sandstone block retaining wall which approximates the uphill common boundary (Photo 6).

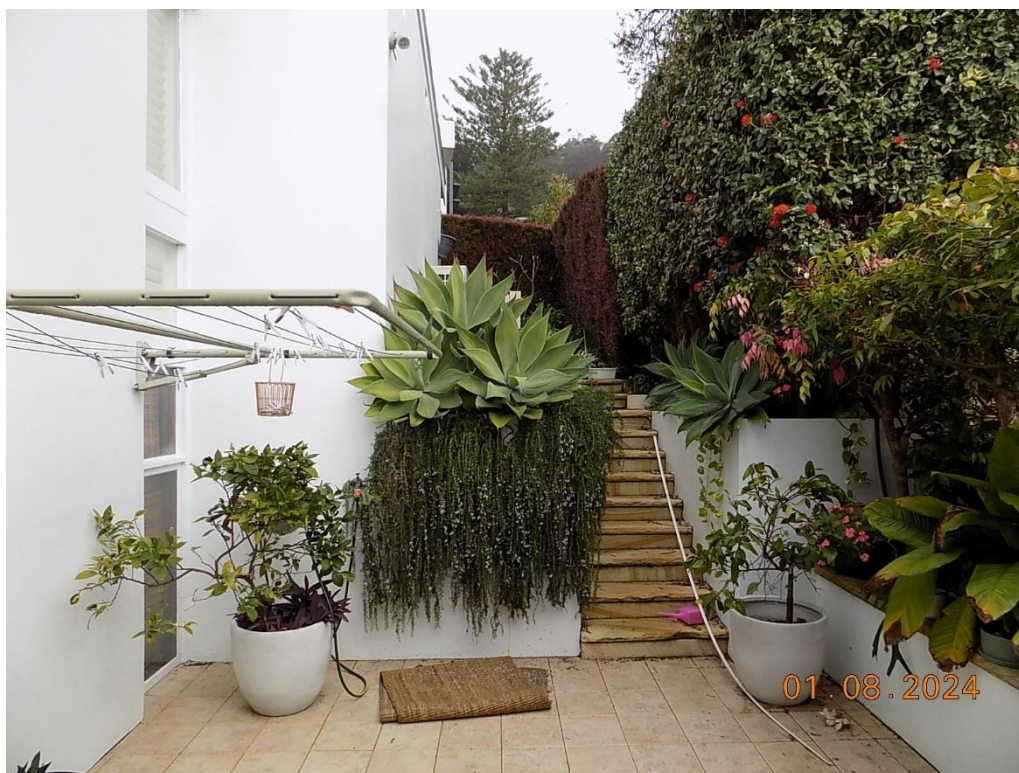
Photo 5

The excavation requires the demolition of the retaining walls supporting the cut for the lower ground floor of the house and cut for the NW patio on the uphill side (Photo 5). The walls are to be demolished from the top down in an orderly manner with the ground material behind the walls being systematically lowered at the same time. The batter slope is not to exceed 1.0 Vertical to 1.7 Horizontal (30°) as the walls are demolished.

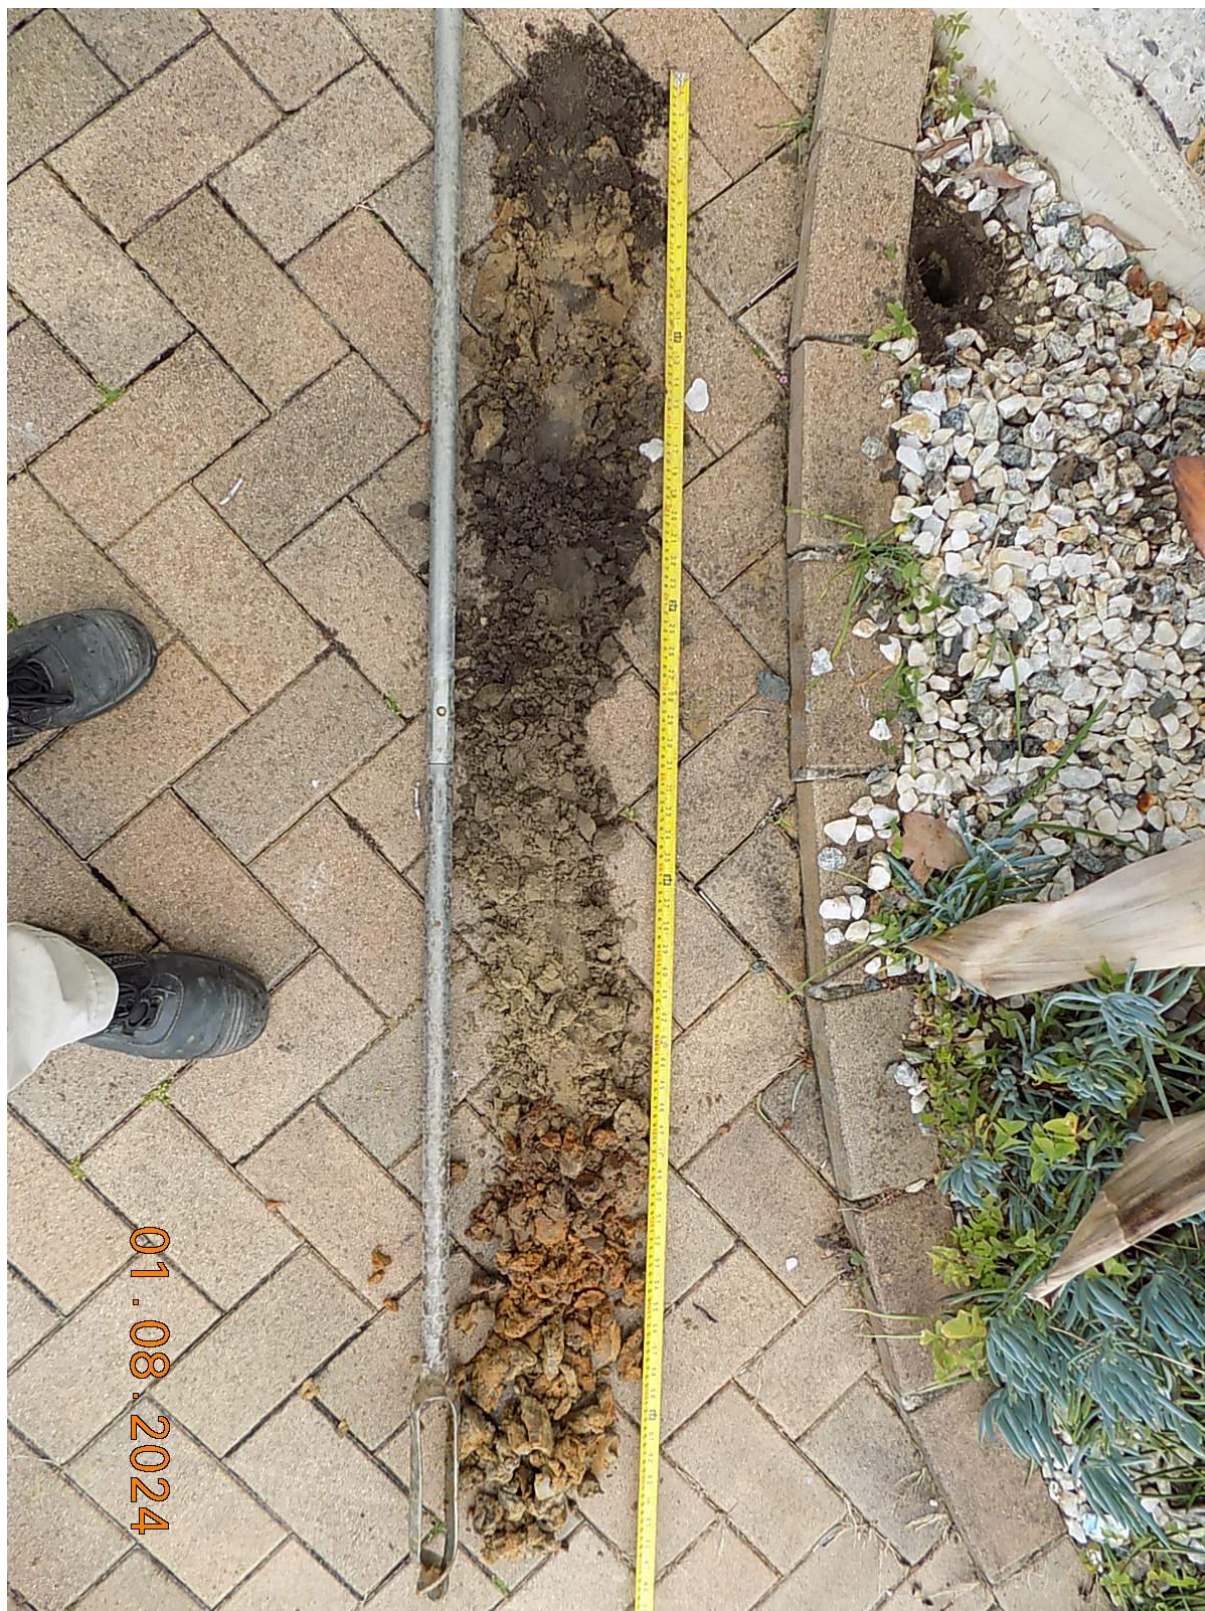
Photo 7 – AH1 – downhole is top to bottom

## **AUGER HOLE 1 (~RL3.8) – AH1 (Photo 7)**

| <b>Depth (m)</b> | <b>Material Encountered</b> |
| 0.0 to 0.1 | <b>FILL</b> , dark brown, Medium Dense, damp, medium grained |
| 0.1 to 0.4 | <b>CLAYEY FILL</b> , brown, Soft, damp, fine to medium grained, clay fragments included. |
| 0.4 to 0.7 | <b>CLAYEY SANDY SOIL</b> , dark brown, Soft, damp, fine to medium grained. |
| 0.7 to 1.2 | <b>CLAYEY SAND</b> , brown to light brown, Medium Dense to Dense, damp, fine to medium grained. |
| 1.2 to 1.5 | <b>CLAY</b> , mottled maroon, orange, yellow, grey, Very Stiff, damp, charcoal inclusions. |
| 1.5 to 1.7 | <b>CLAY</b> , derived from weathered shale, mottled orange and grey, Stiff, damp. |

End of test @ 1.7m in clay derived from weathered shale. No water table encountered.

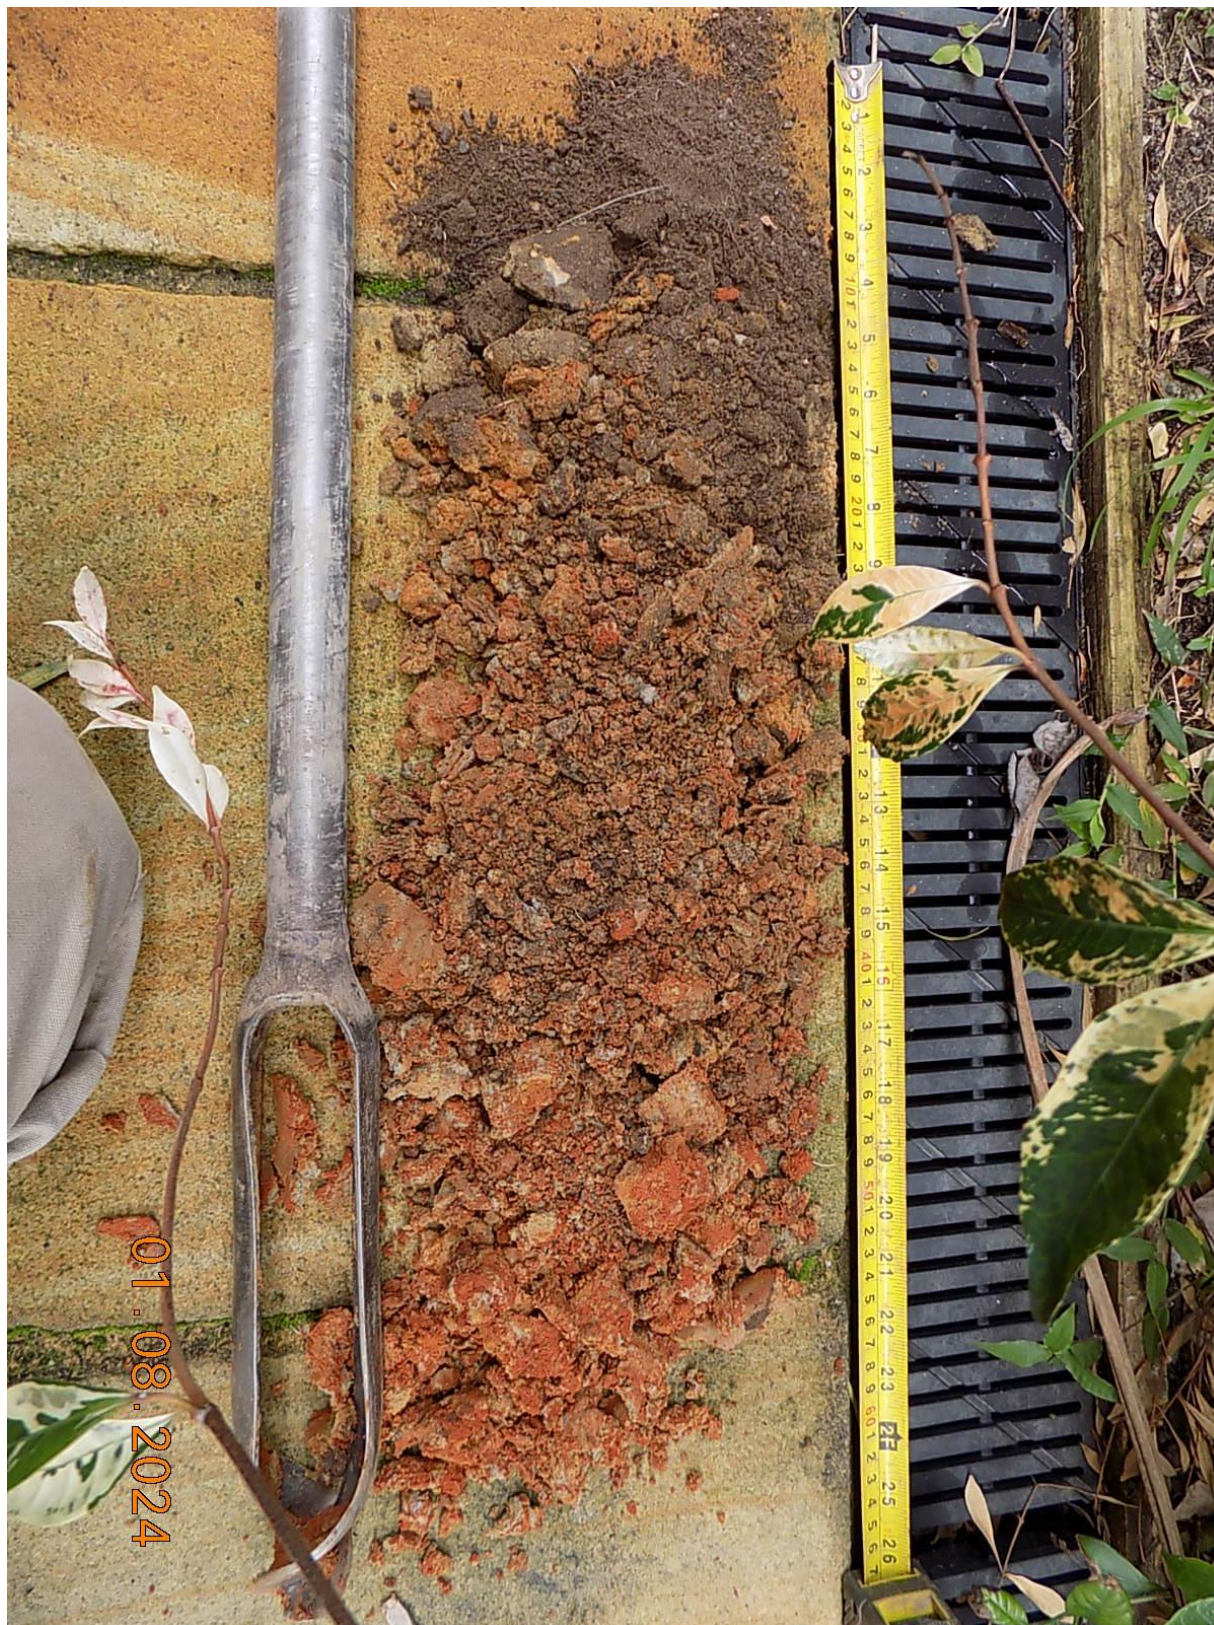
Photo 8– AH2 – downhole is top to bottom

## **AUGER HOLE 2 (~RL8.5) – AH2 (Photo 8)**

| <b>Depth (m)</b> | <b>Material Encountered</b> |
| 0.0 to 0.2 | <b>FILL</b> , brown, Dense, dry, fine to medium grained. |
| 0.2 to 0.4 | <b>CLAY</b> , mottled orange and grey, Hard, dry, fine to medium grained, soil lenses present. |
| 0.4 to 0.6 | <b>SANDY CLAY</b> , derived from weathered shale, mottled maroon, orange, and grey, Hard, dry, fine to medium grained. |

End of test @ 0.6m in clay derived from weathered shale. No water table encountered.

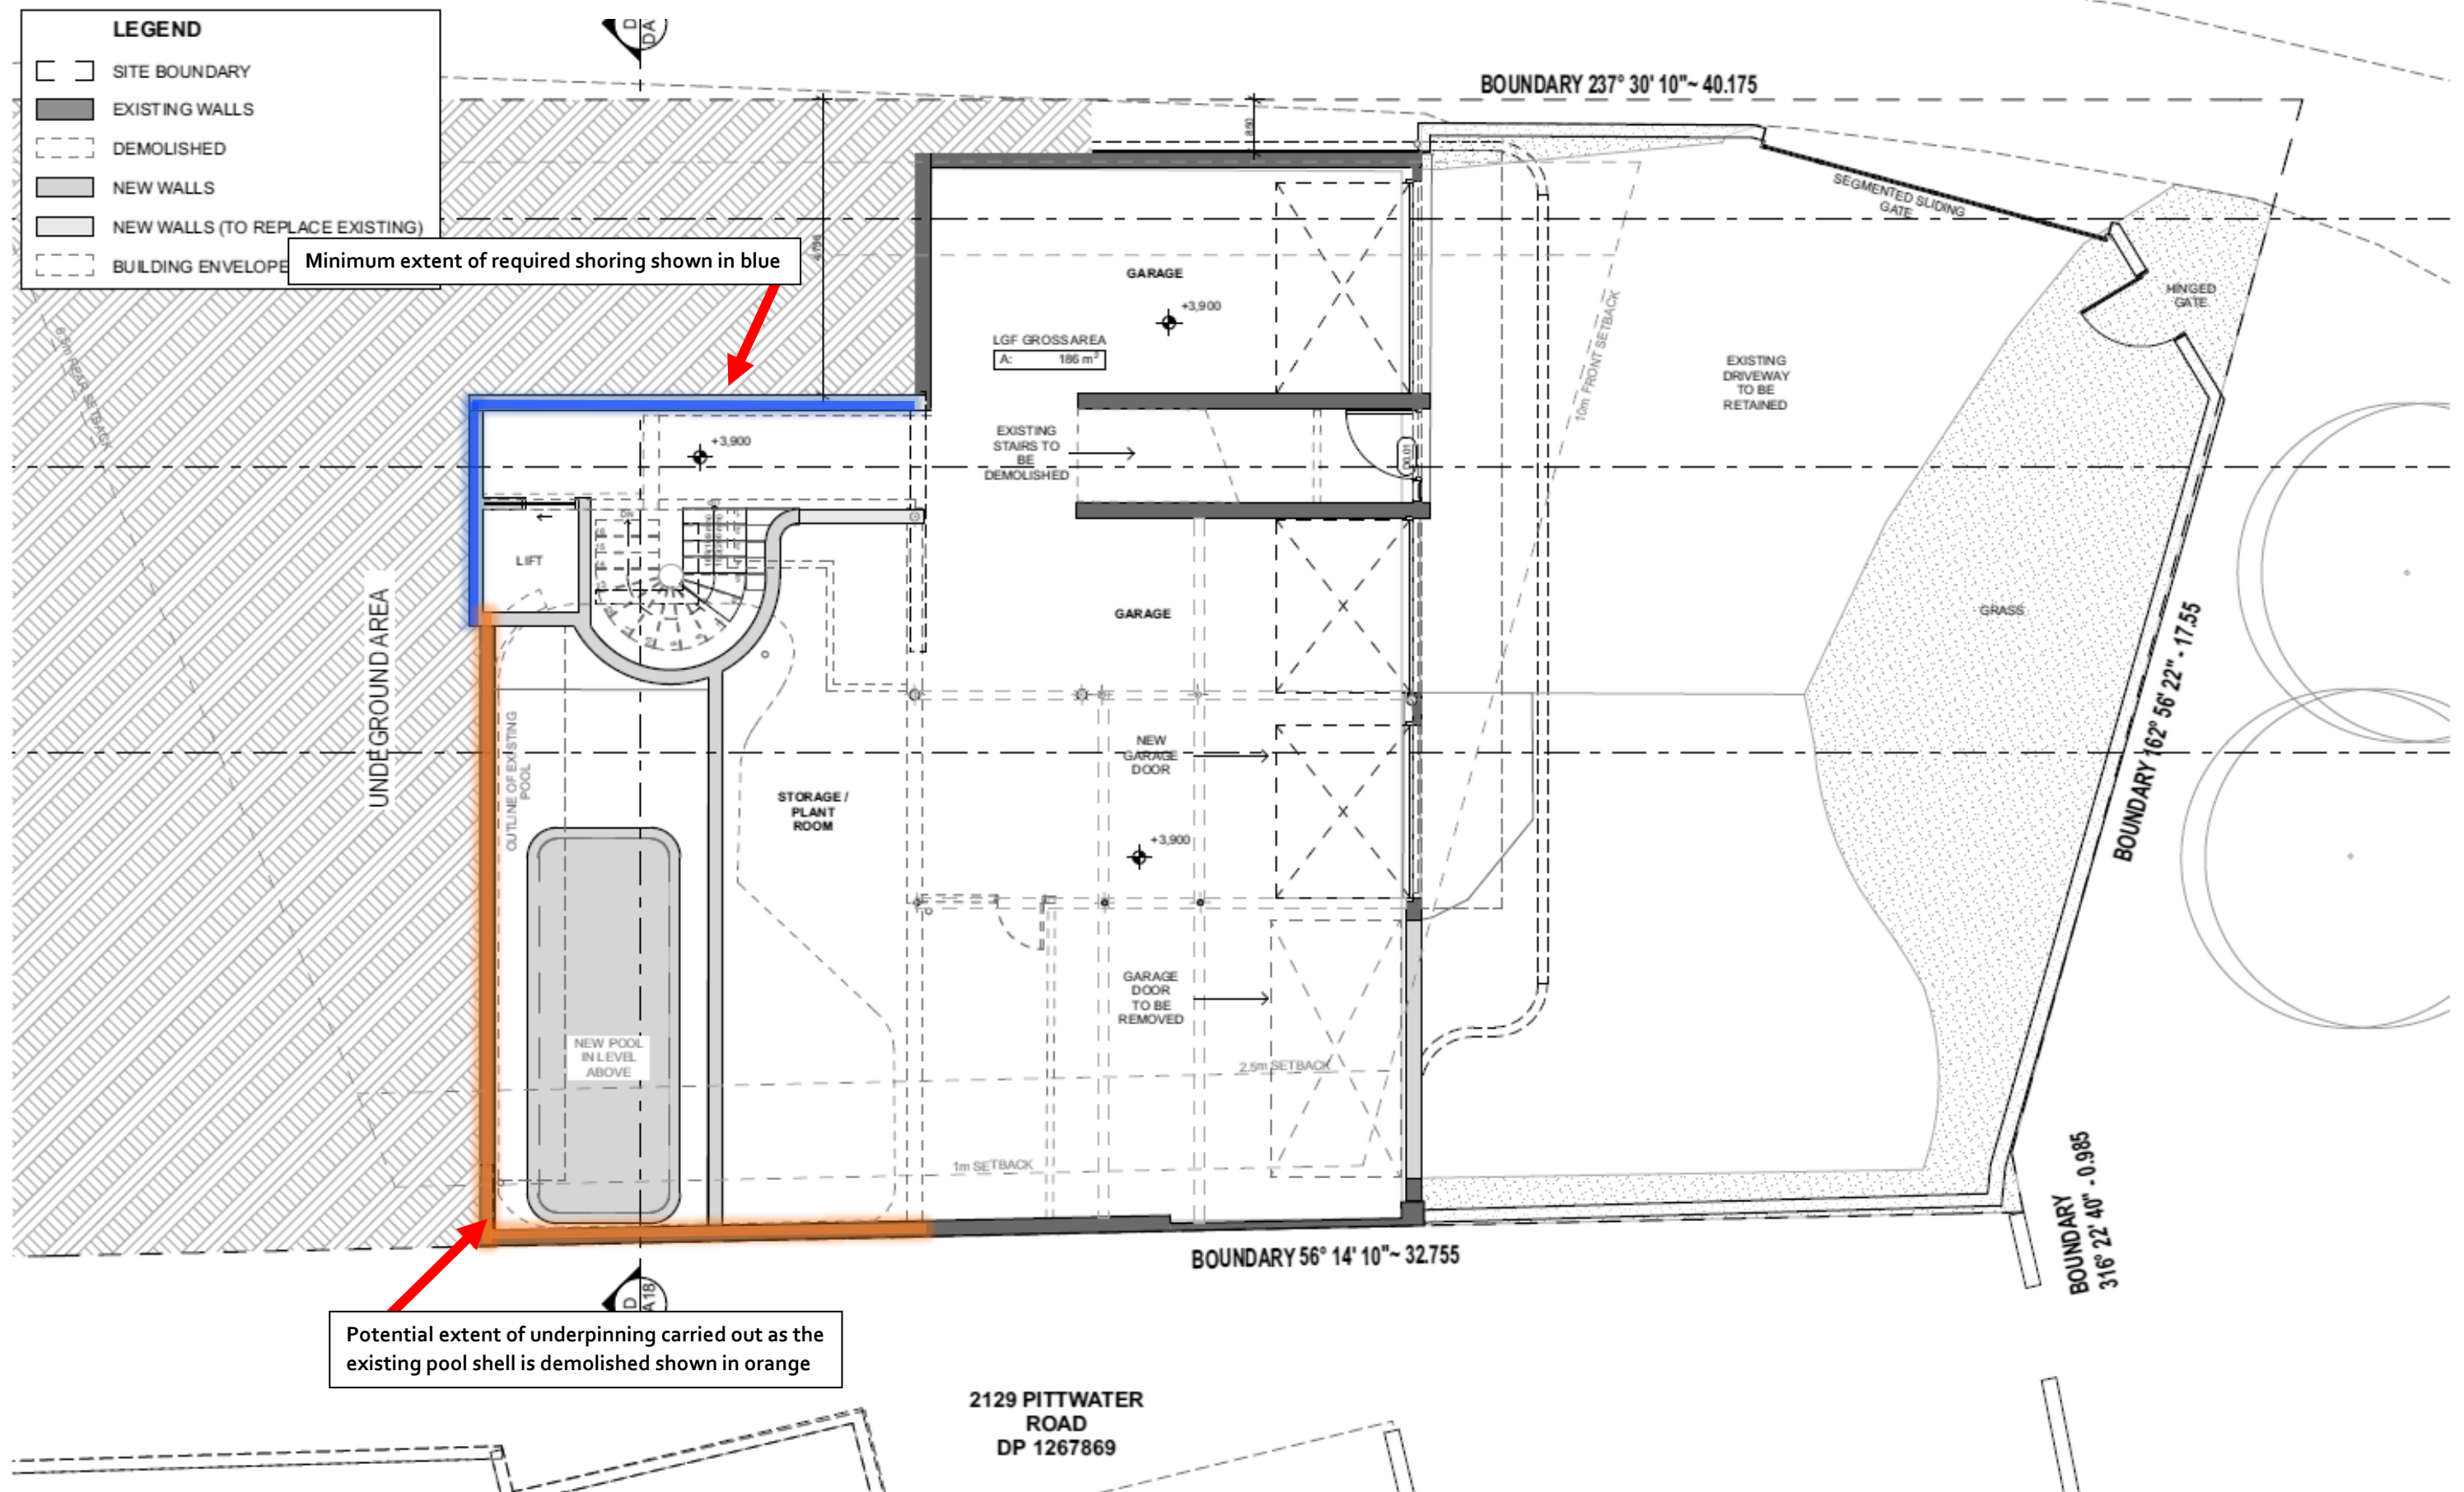
# LOWER GROUND FLOOR PLAN – showing minimum extent of required shoring / potential underpinning

unsupported. The support will need to be designed / approved by the structural engineer. See the site plan attached for the minimum extent of the required shoring shown in blue.

If the foundations are confirmed to extend below the zone of influence of the proposed excavation, the excavation may commence. If they are not, the walls will need to be underpinned to below the zone of influence of the cut prior to the excavation commencing. See the site plan attached for the minimum extent of the required exploration pits/underpinning.

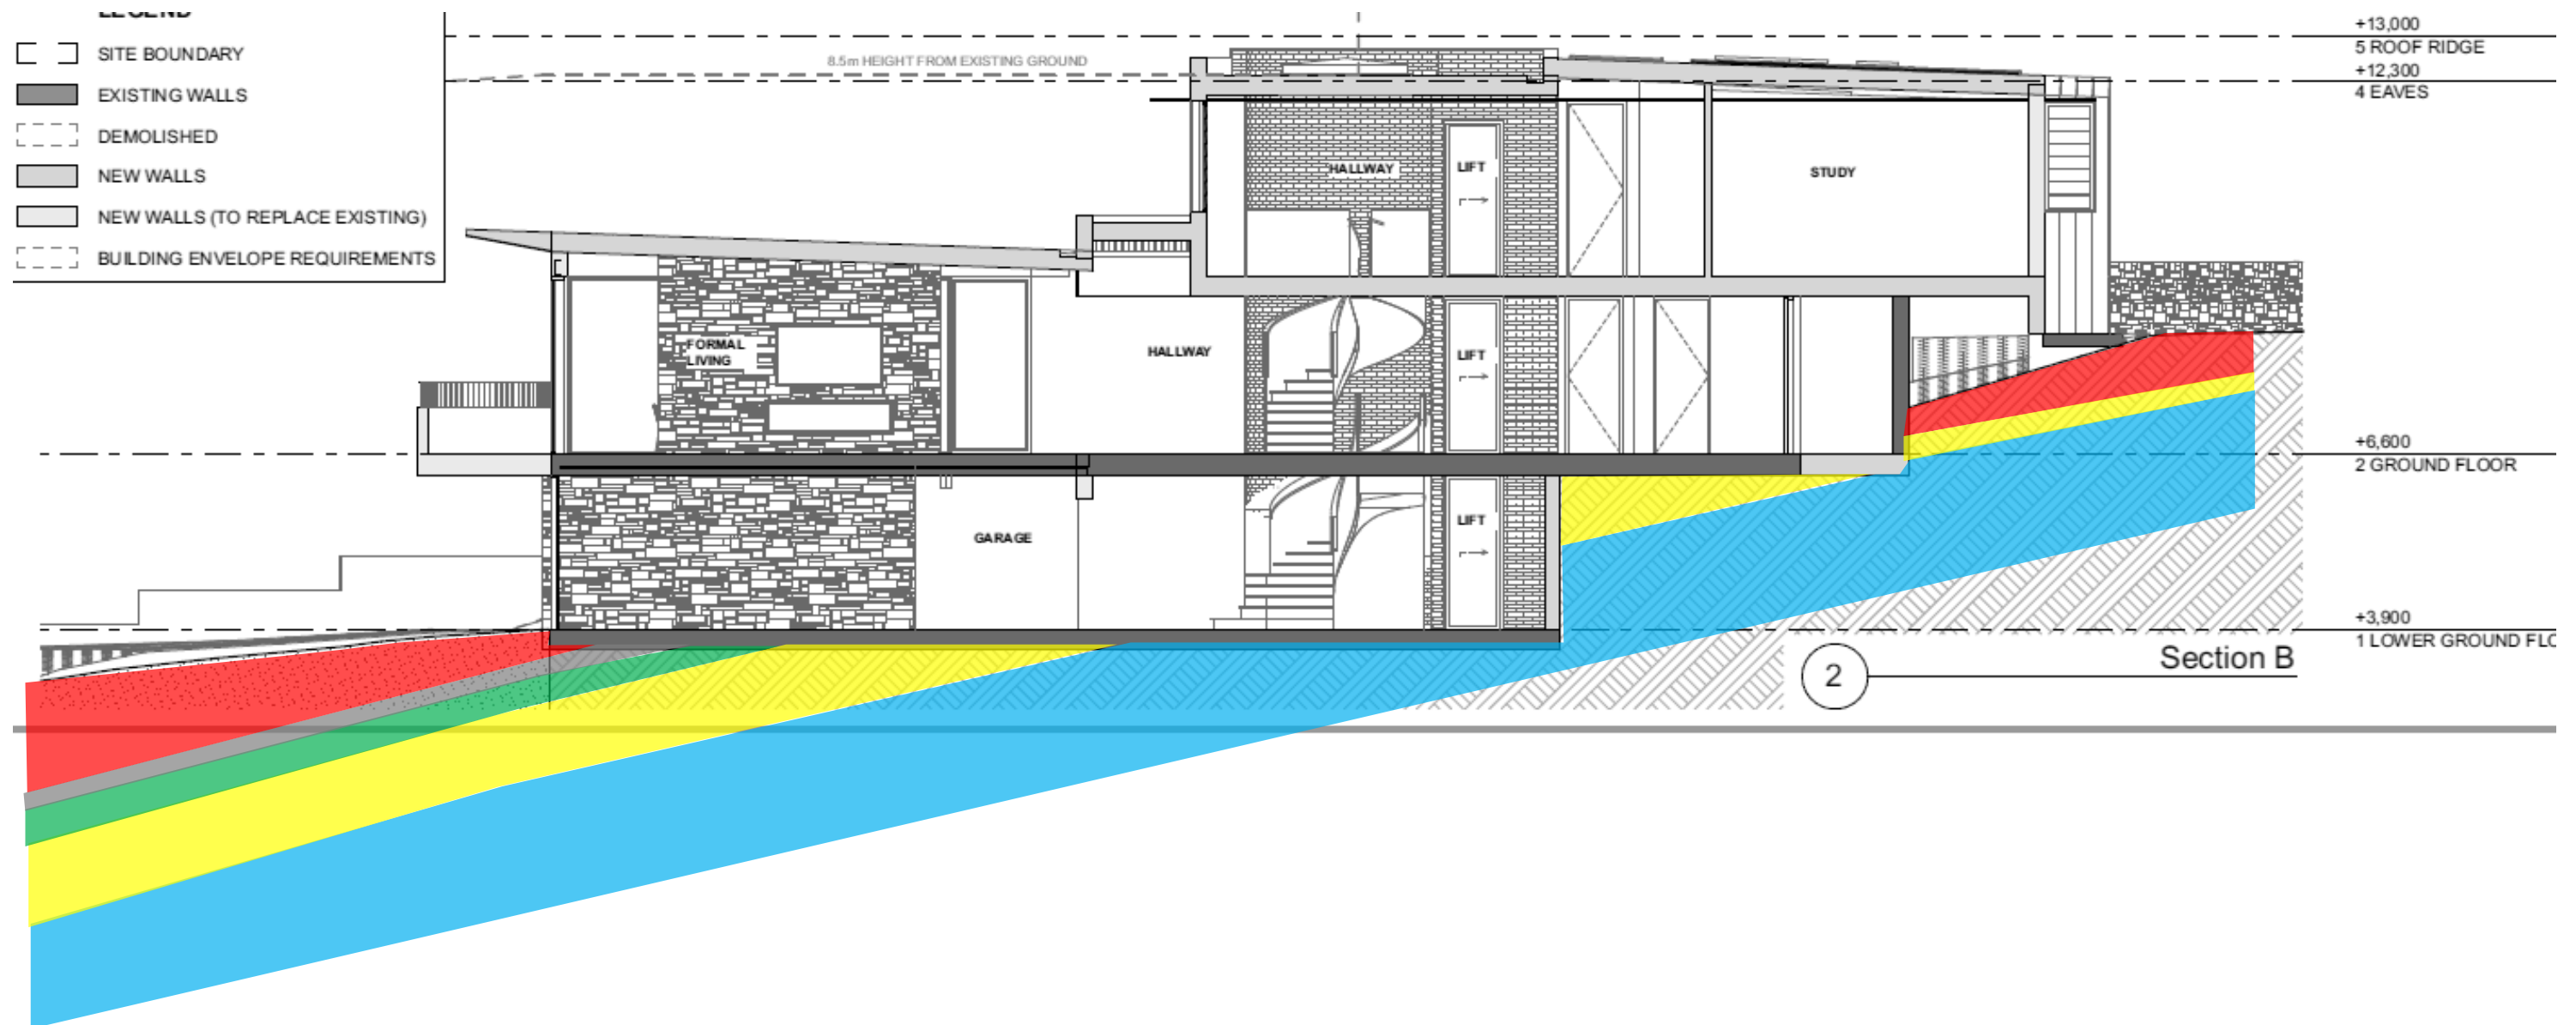
## Expected Ground Materials

- Fill
- Clayey Sandy Soil
- Clayey Sand
- Clay
- Narrabeen Group Rocks – Extremely Low to Very Low Strength Shale

The natural slope materials are colluvial at the near surface and residual at depth. In the test locations, the ground materials consist of younger sandy clay alluvial sediment at the downhill boundary which overlies deep weathered clay. Filling has been placed across the property for landscaping. The clays merge into the weathered zone of the underlying shale at depths of between 2.4m to 3.9m below the current surface on the downhill side of the house, and depths of 0.3m to 1.2m on the uphill side of the house. This variation in depth is due to the fills and sediment on the downhill side of the property, and cuts on the uphill side, as well as a variable weathering profile. The weathered zone is interpreted as Extremely Low to Very Low Strength Shale. It is to be noted that this material can appear as a mottled stiff clay when it is cut up by excavation equipment. See Type Section attached for a diagrammatical representation of the expected ground materials.
