# 1 Neridah Avenue Belrose NSW 2085

## Arboricultural Impact Assessment

Prepared for Artisan Build

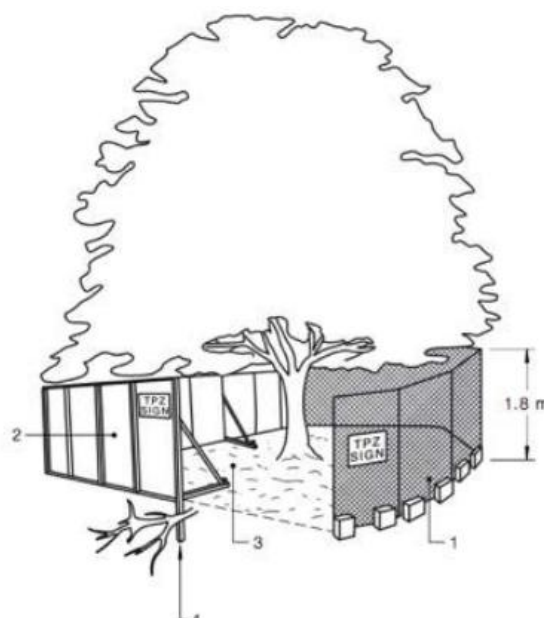
- 4) Set up protective fencing as depicted in the accompanying image. Adhere to the relevant fencing requirements outlined in AS 4687 for temporary fencing and hoardings. Additionally, affix shade cloth or a similar material to mitigate the transfer of dust, particulate matter, and liquids into the protected area.

1. Chain wire mesh panels with shade cloth (if required) attached, held in place with concrete feet.
2. Alternative plywood or wooden palling fence panels. This fencing material also prevents building materials or soil entering the TPZ.
3. Mulch installation across surface of TPZ (at the discretion of the Project Arborist). No excavation construction activity, grade changes, surface treatment or storage of materials of any kind is permitted within the TPZ.
4. Bracing is permissible within the TPZ. Installation of supports should avoid damaging roots.

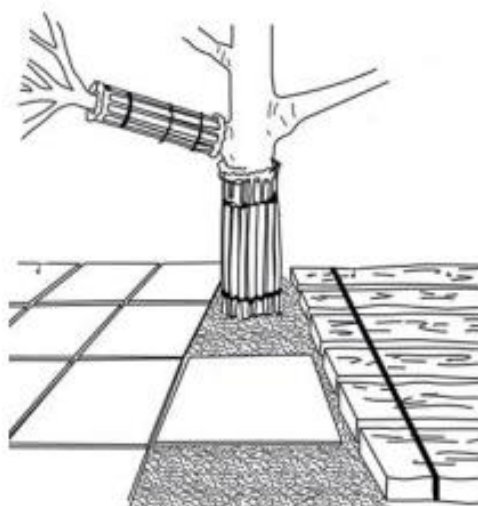
Trunk protection will include protection to the trunk and branches of trees as shown below. A minimum height of 2m is recommended.

- 1) Install breathable padding or hessian around the trunk of the tree.
- 2) Install closely spaced timber battens around the trunk, with the top edge protecting the trunk/bark by the padding/hessian. Secure with strapping

1. For trunk and branch protection use boards and padding that will prevent damage to bark. Boards are to be strapped to trees, not nailed or screwed.
2. Rumble boards should be of a suitable thickness to prevent soil compaction and root damage.
