Geotechnical Investigation Report

Sydney Extensions & Designs Pty Ltd

16 Noorong Avenue,

Report G11624-1

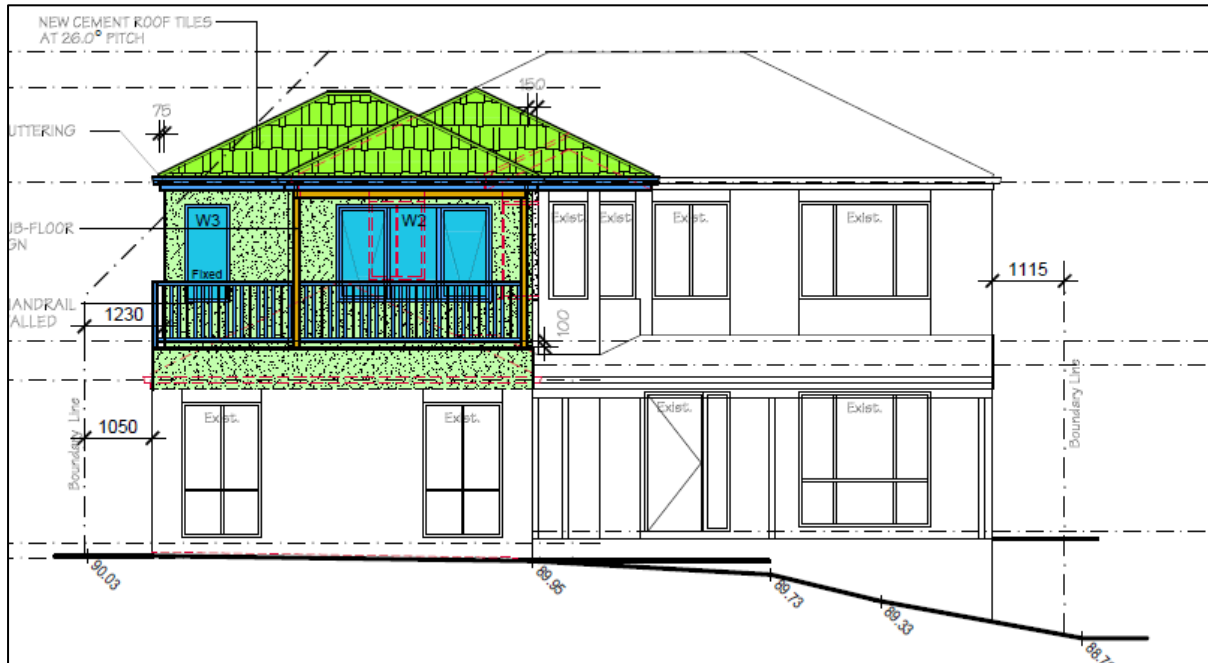
Image 2 – Proposed Construction Area

It is understood that the proposed first floor is to be constructed above the existing car garage, found at the southwestern portion of the existing residential dwelling footprint. The indicated residential developments concept was extrapolated from the aforementioned supplied documentation (Image 2).

AGS understands that the following construction has been proposed, with respect to Image 2:

- Demolition of the existing garage roofing;
- Redevelopment of the first floor and garage of the existing structure; and
- Construction of the proposed first floor, including redevelopment of the garage parking space, an additional bedroom, ensuite, staircase and balcony, within the bounds of the proposed works.

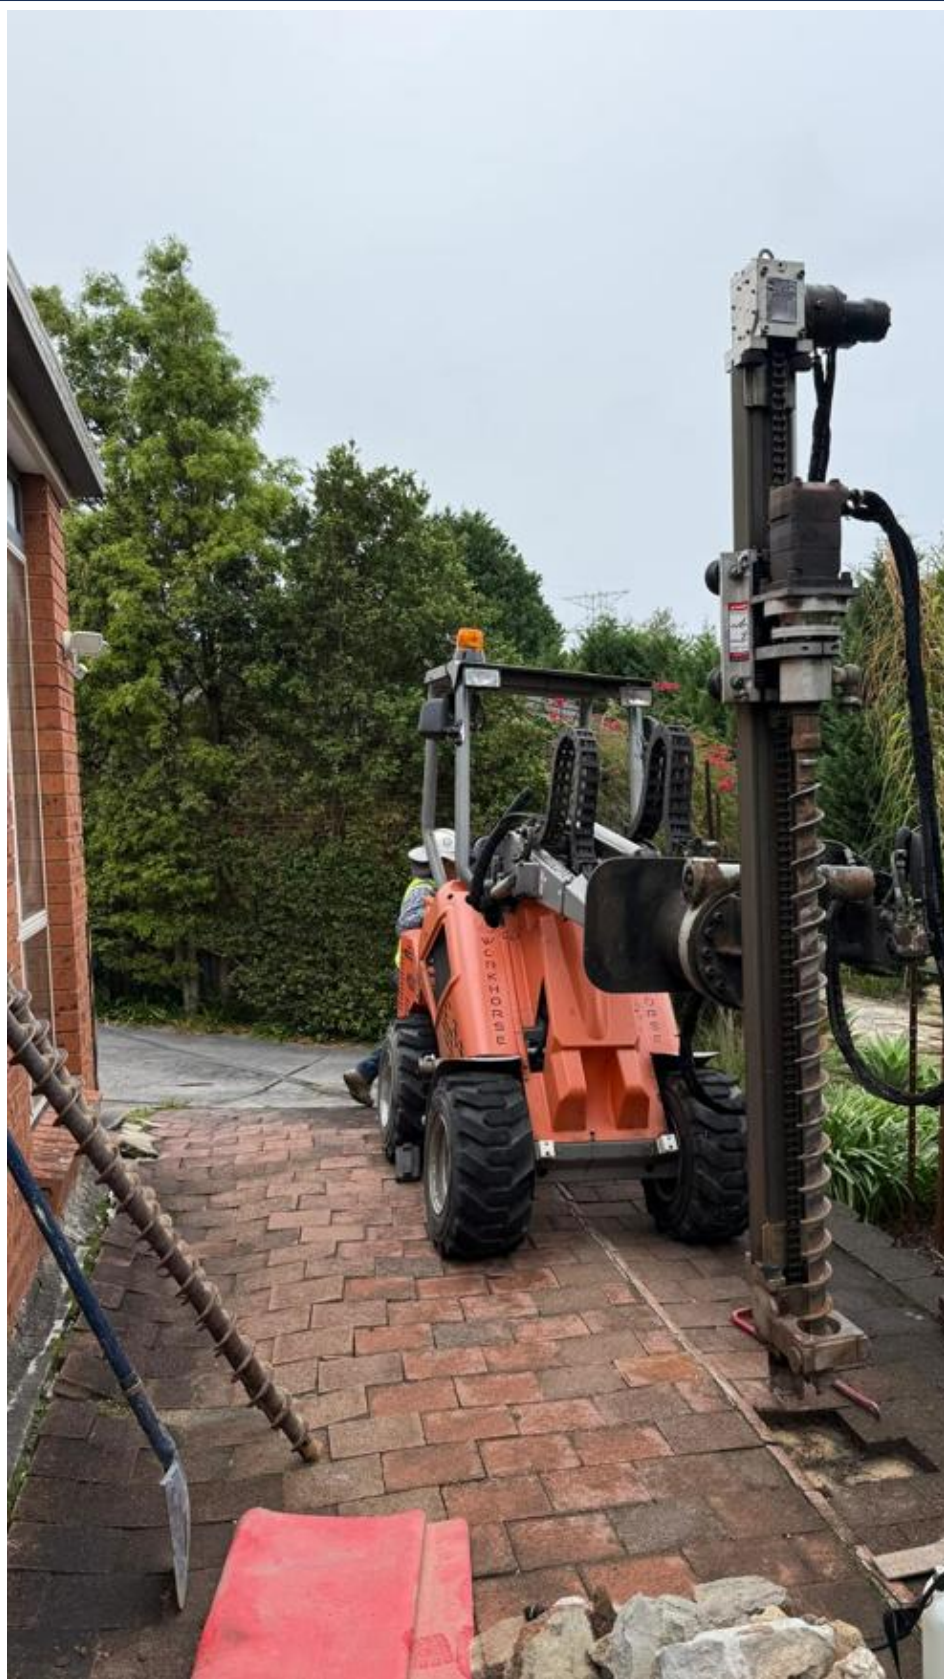
Figure 2.1 – General View of Drilling Rig (BH01)

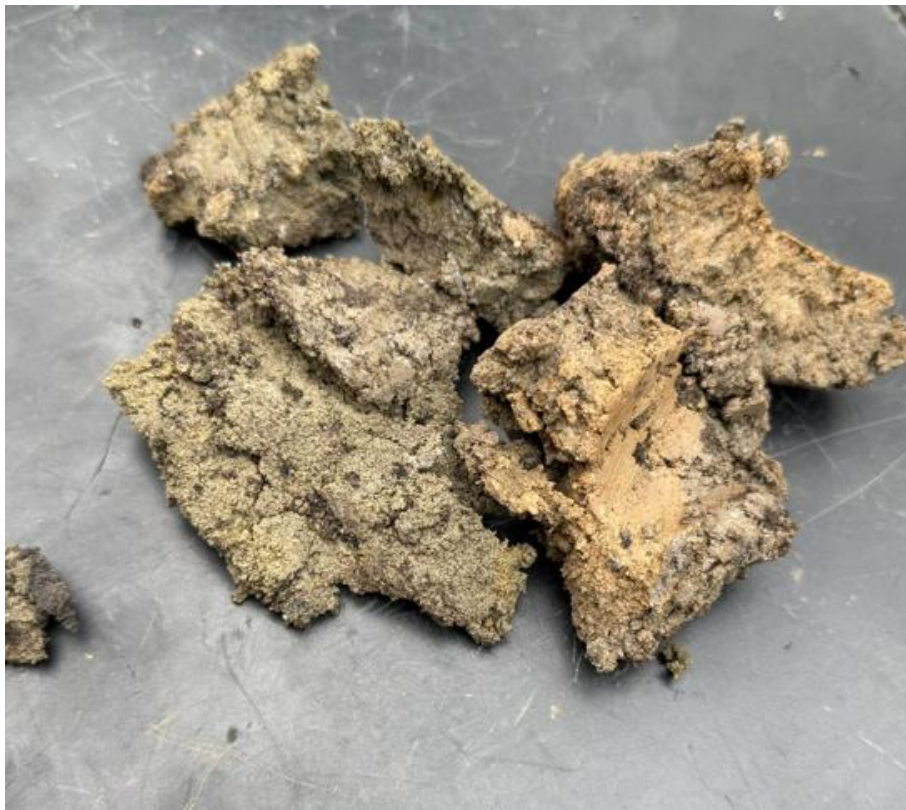
Figure 2.2 – General View of Subsurface Material (BH01)

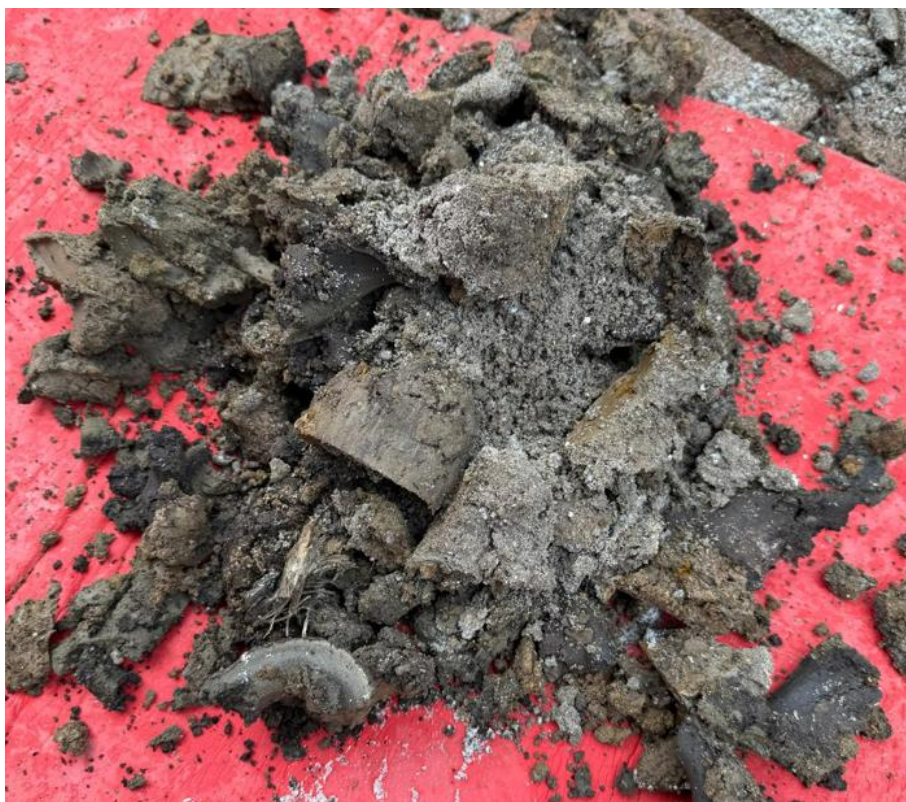
Figure 2.3 – General View of Subsurface Material (BH01)

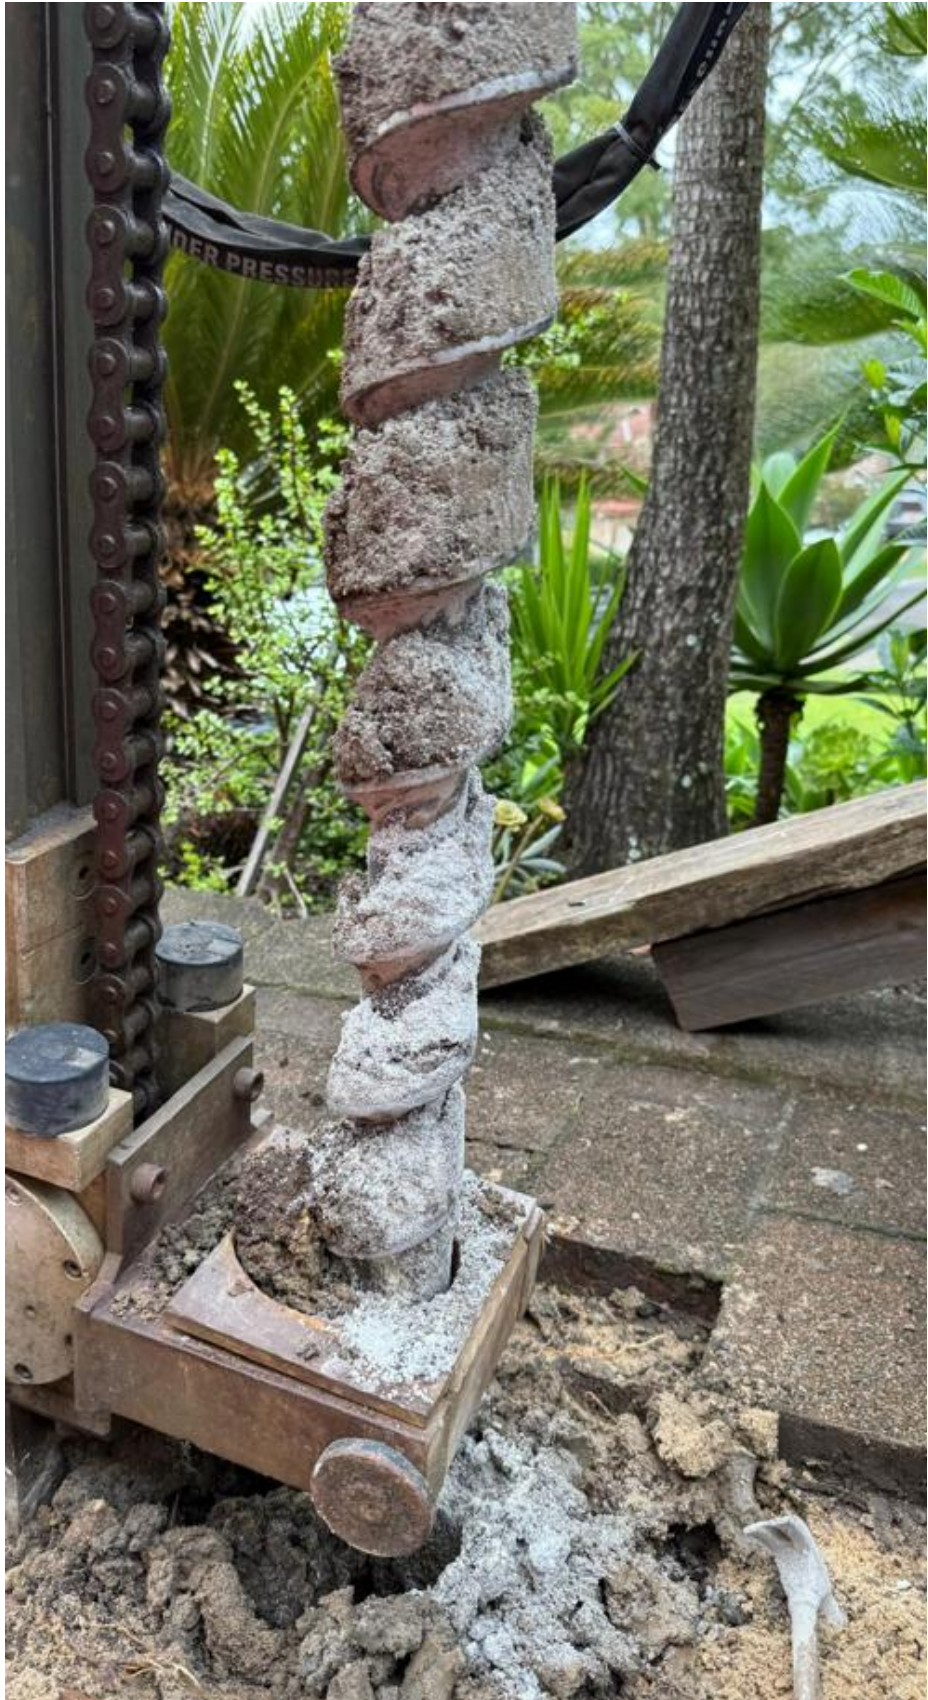
Figure 2.4 – General View of Encountered Bedrock Material at BH01

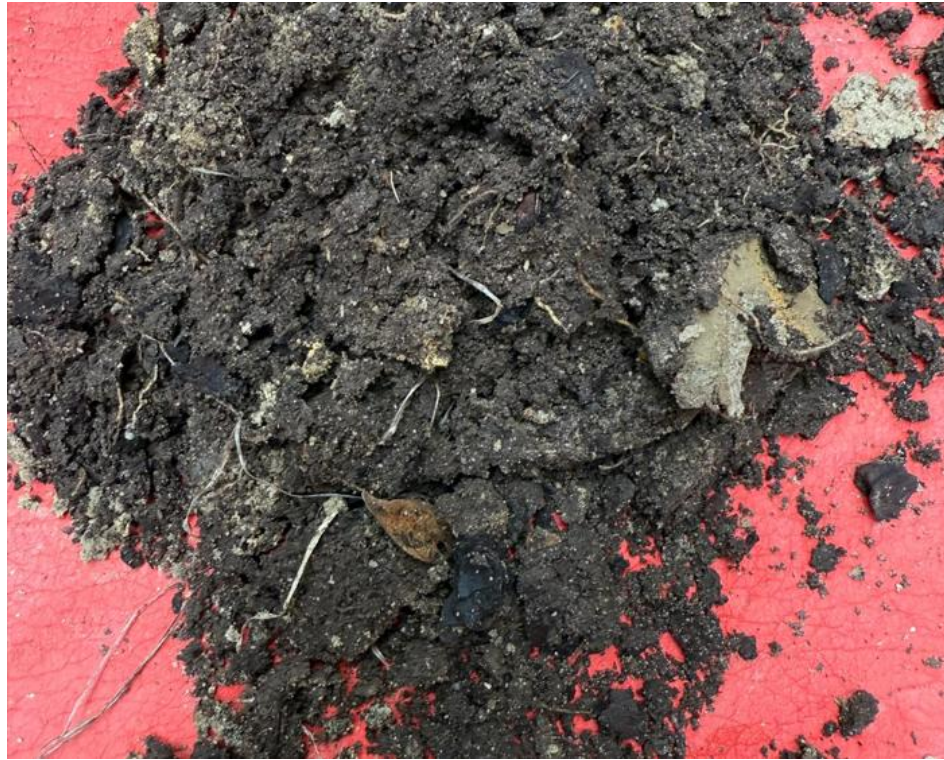
Figure 3.1 – View of Encountered Topsoil Material (BH02)

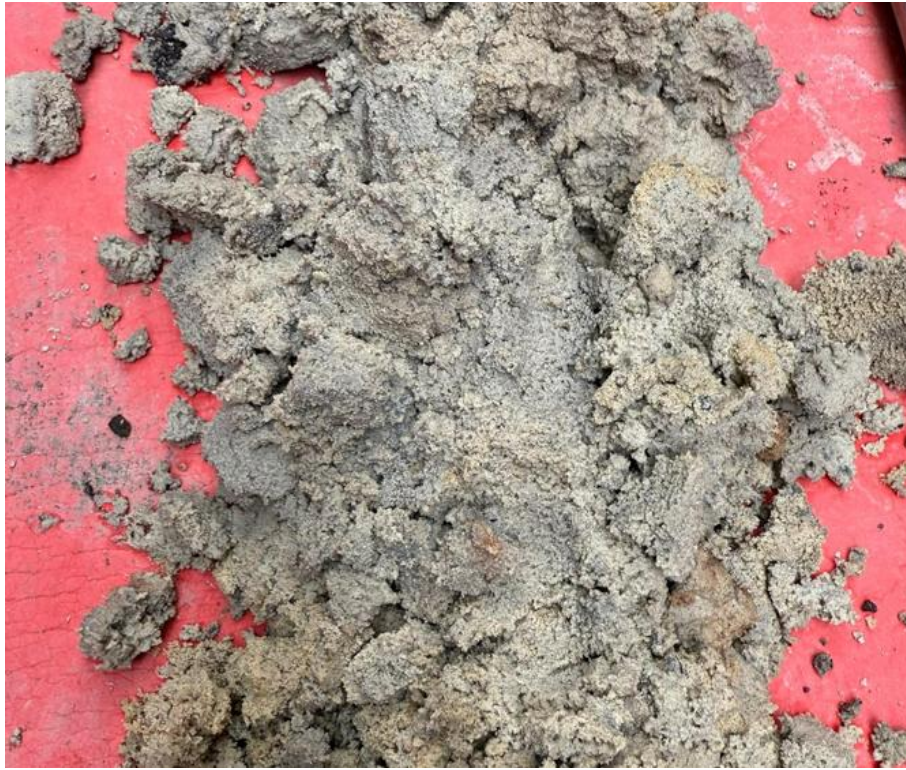
Figure 3.3 – View of Colluvial Clayey Sand (BH02)

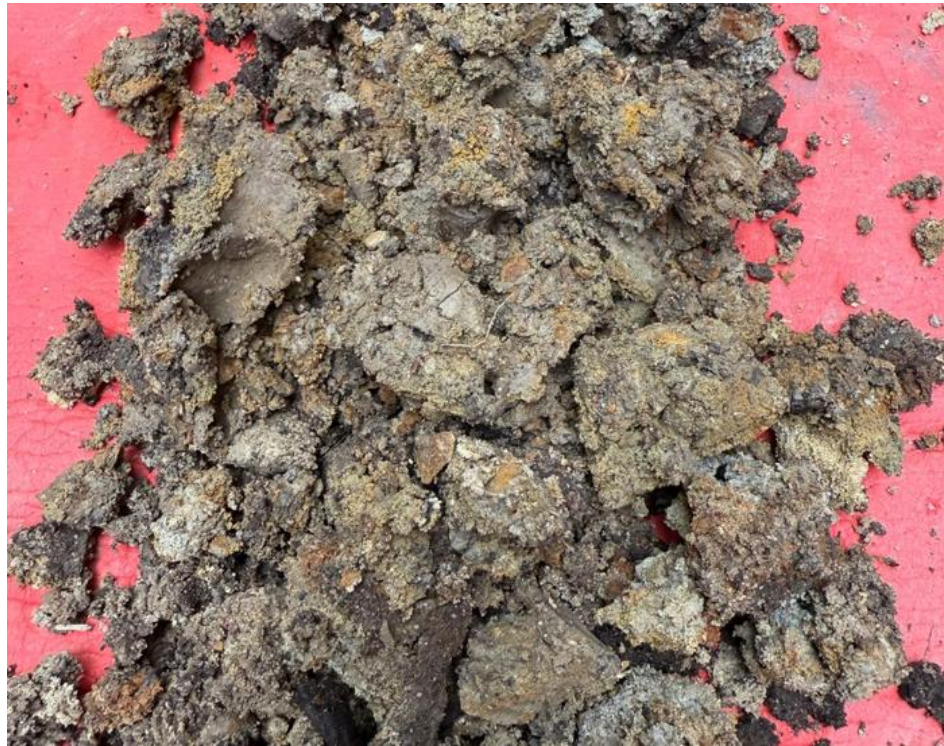
Figure 3.2 – View of Encountered Silty Clay Fill Material (BH02)

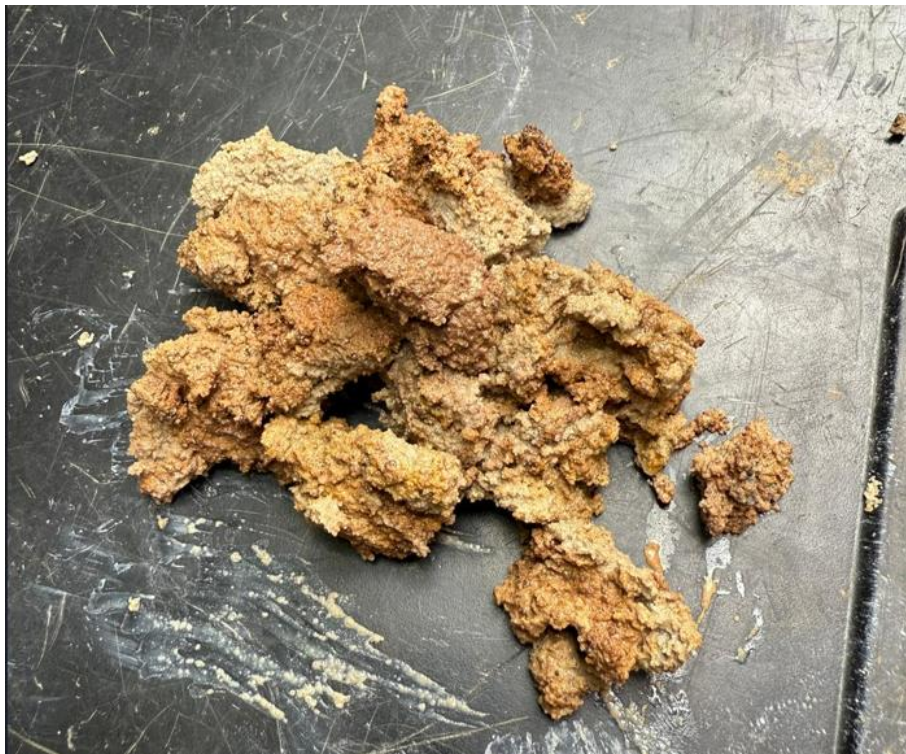
Figure 3.4 –View of In-situ Bedrock Material (BH02)

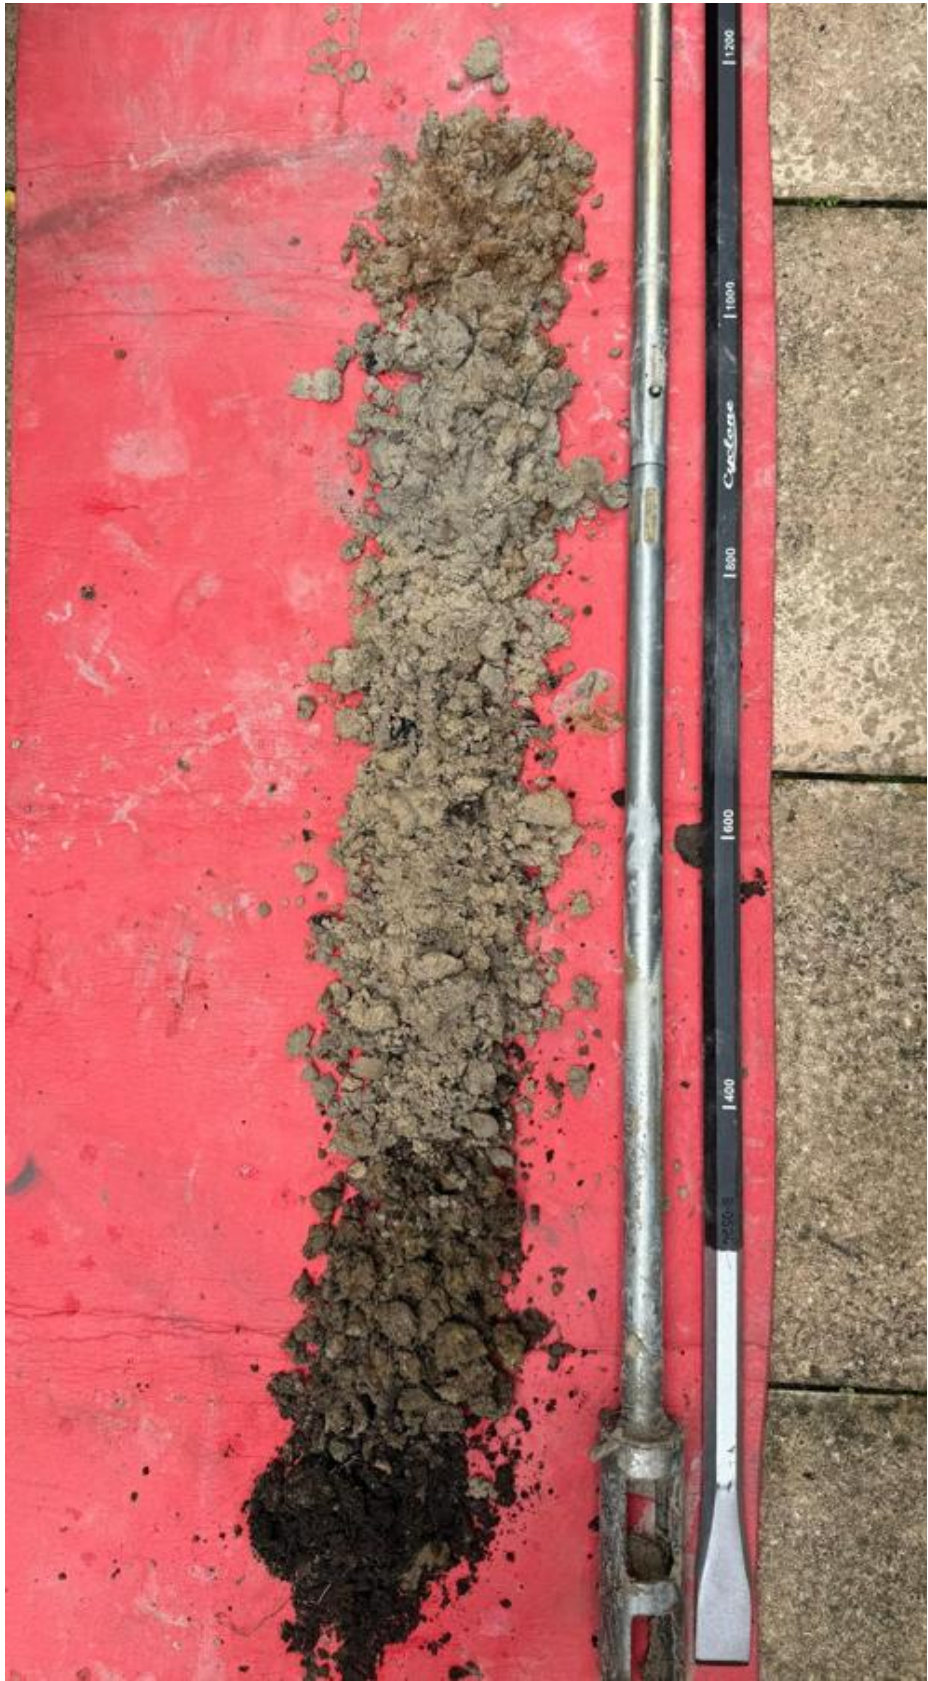
Figure 3.5 – Closeup View of Augered Material at BH02 Location
