Report Title: Geotechnical Report 1056 Barrenjoey Road, Palm Beach
Report Date: 8/12/21

GEOTECHNICAL INVESTIGATION:

Alterations and Additions at **1056 Barrenjoey Road, Palm Beach**

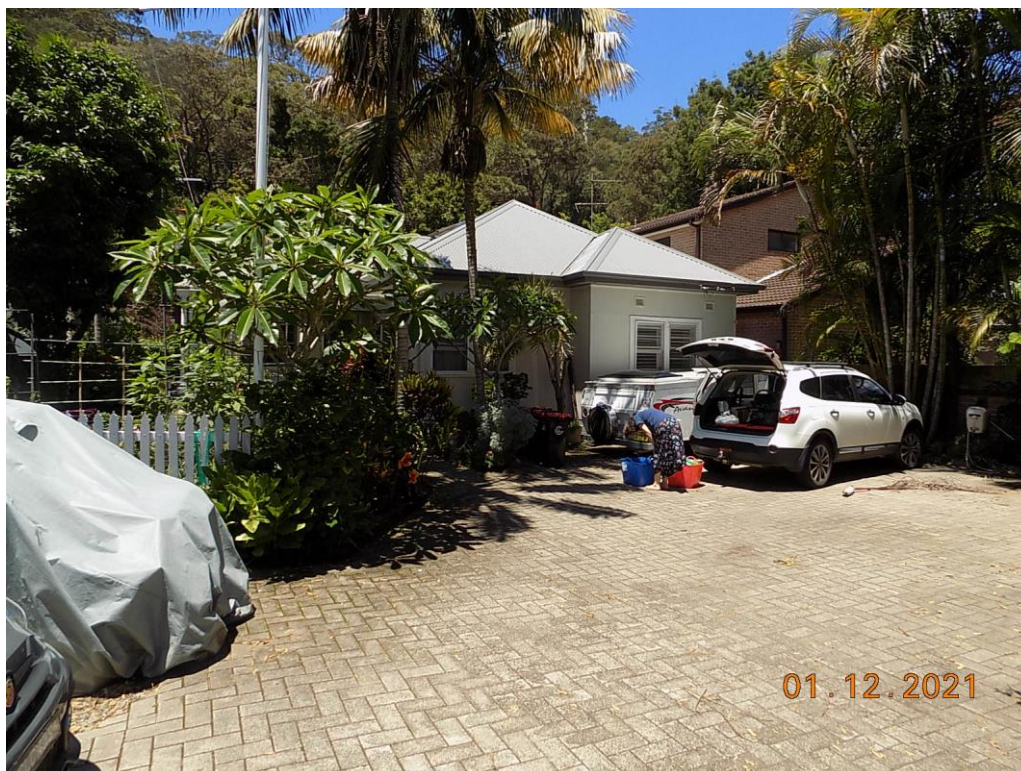
Photo 1

- 2.3** At the road frontage, a paved driveway runs to a parking area on the downhill side of the property (Photo 1). A single-storey brick and fibro clad building is supported on dwarf brick walls. The external brick walls show no significant signs of movement. A level lawn and paved area extends from the uphill side of the house to a second dwelling (Photos 2 & 3). A stable ~1.5m high timber log retaining wall supports a cut to create a level platform for the secondary dwelling on the uphill side of the property (Photo 4). Several large sandstone joint blocks are embedded in the slope in stable positions above the property (Photo 5).

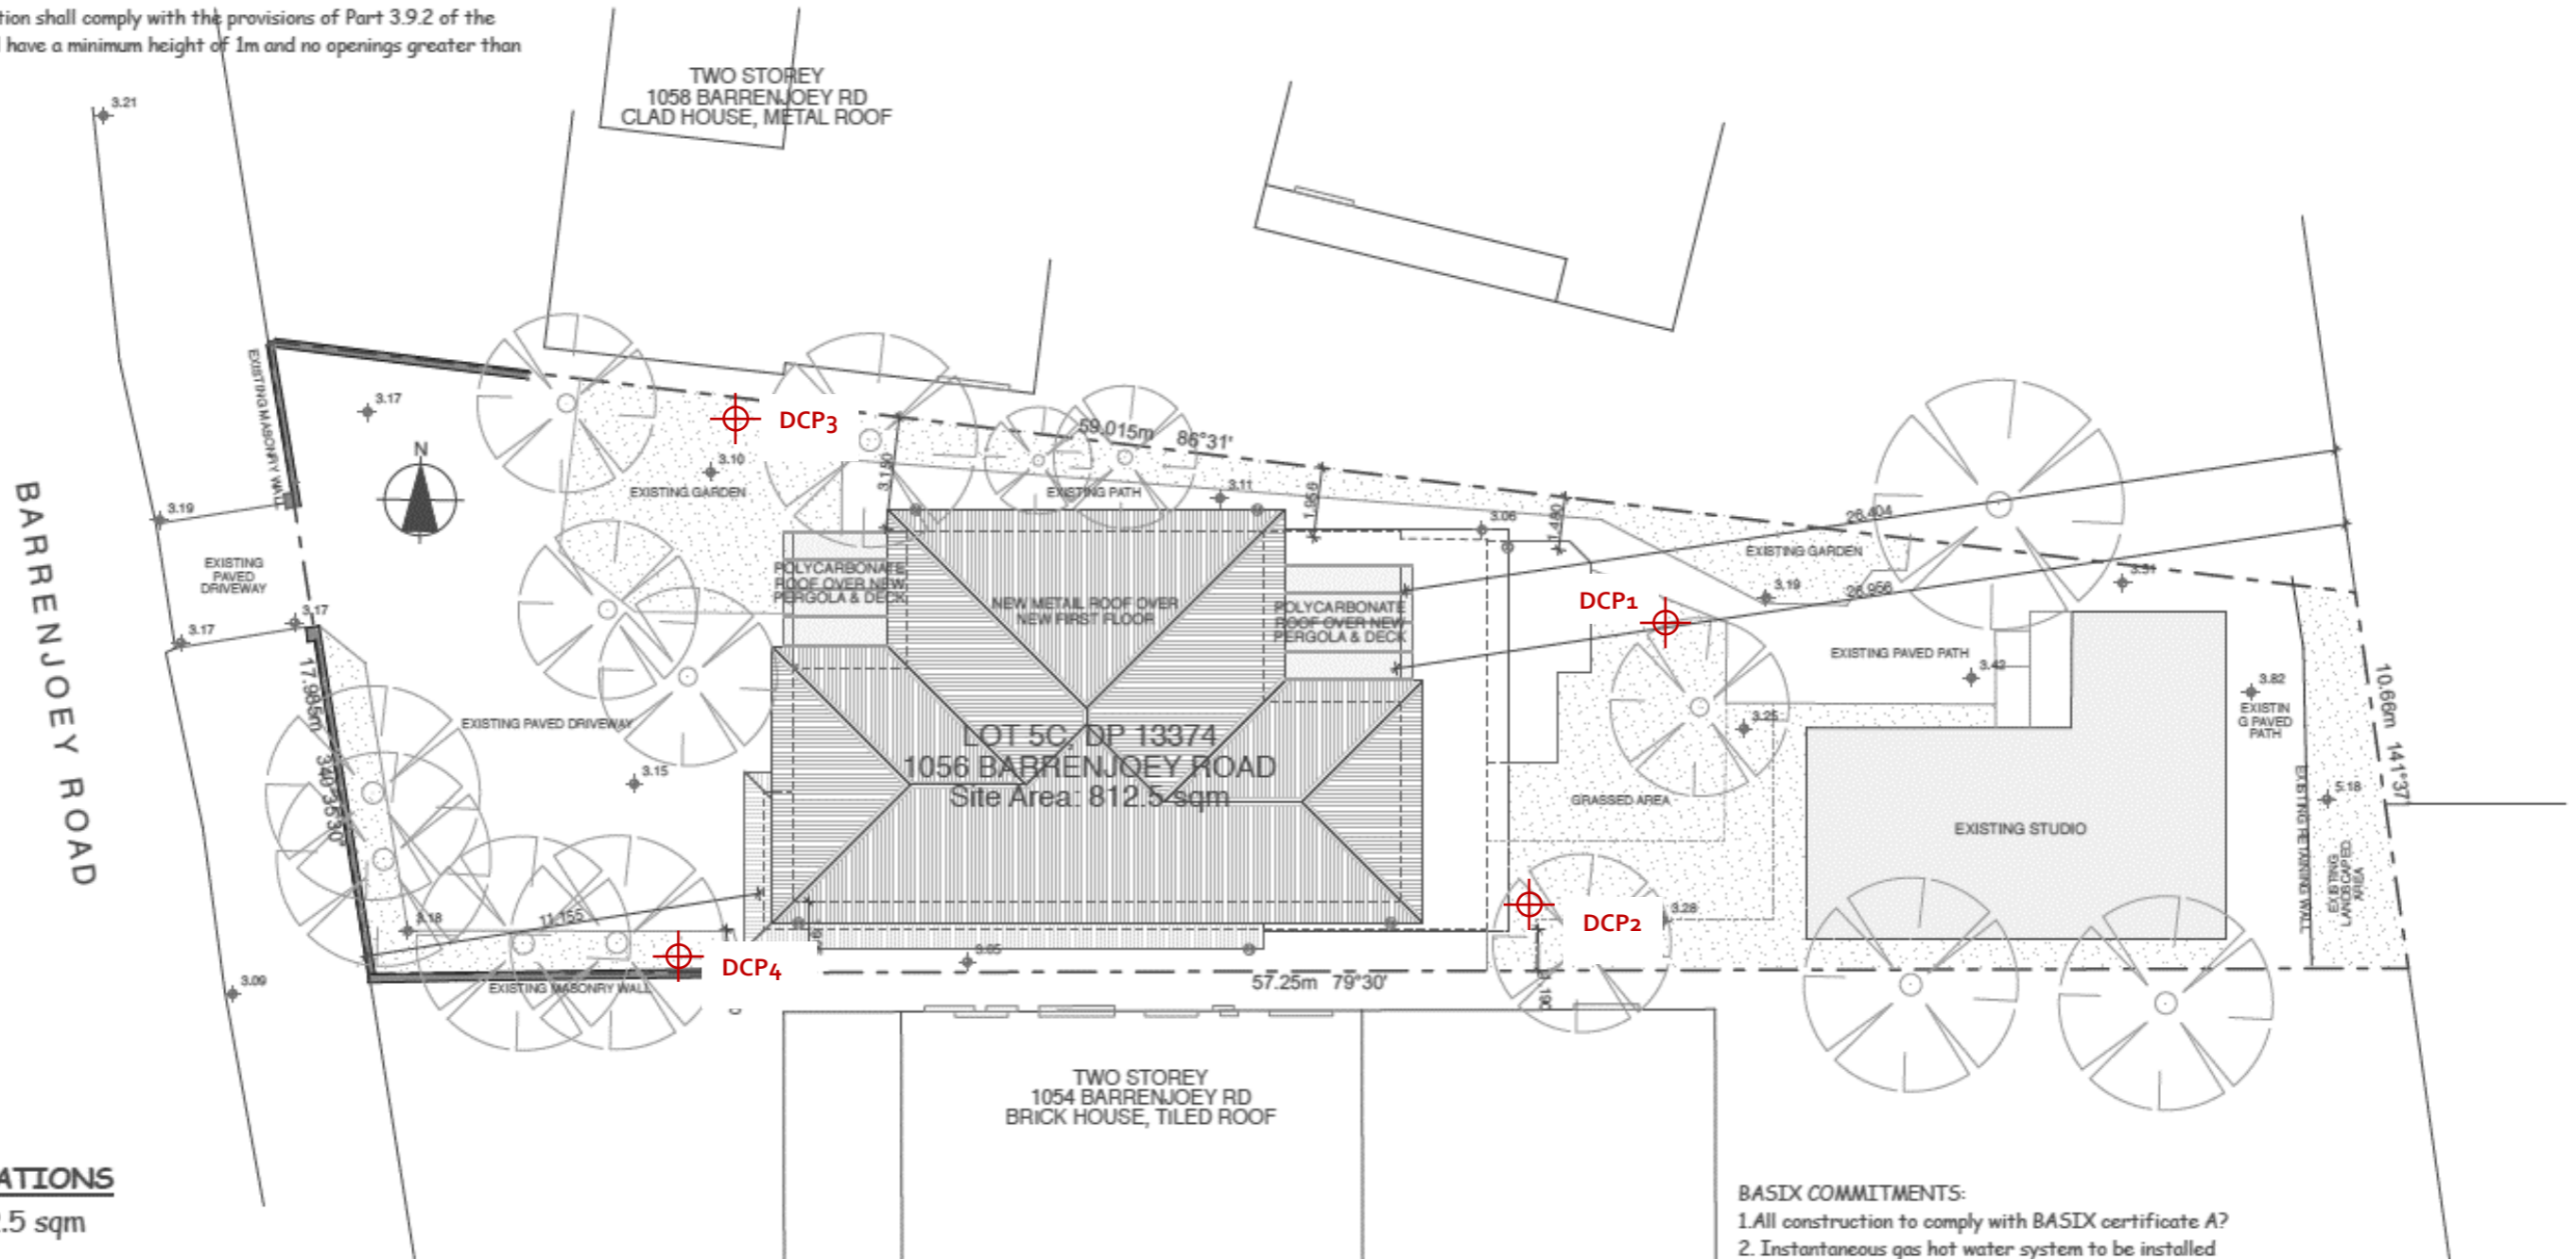
SITE PLAN – showing test locations

Four Dynamic Cone Penetrometer (DCP) tests were put down to determine the relative densities of the sands through the profile. The locations of the tests are shown on the site plan attached. It should be noted that a level of caution should be applied when interpreting DCP test results. The test will not pass through hard buried objects so in some instances it can be difficult to determine whether refusal has occurred on an obstruction in the profile or on the natural rock surface. This is not expected to be an issue for the testing on this site. However, excavation and foundation budgets should always allow for the possibility that the interpreted ground conditions in this report vary from those encountered during excavations. See the appended "Important information about your report" for a more comprehensive explanation. The results are as follows:

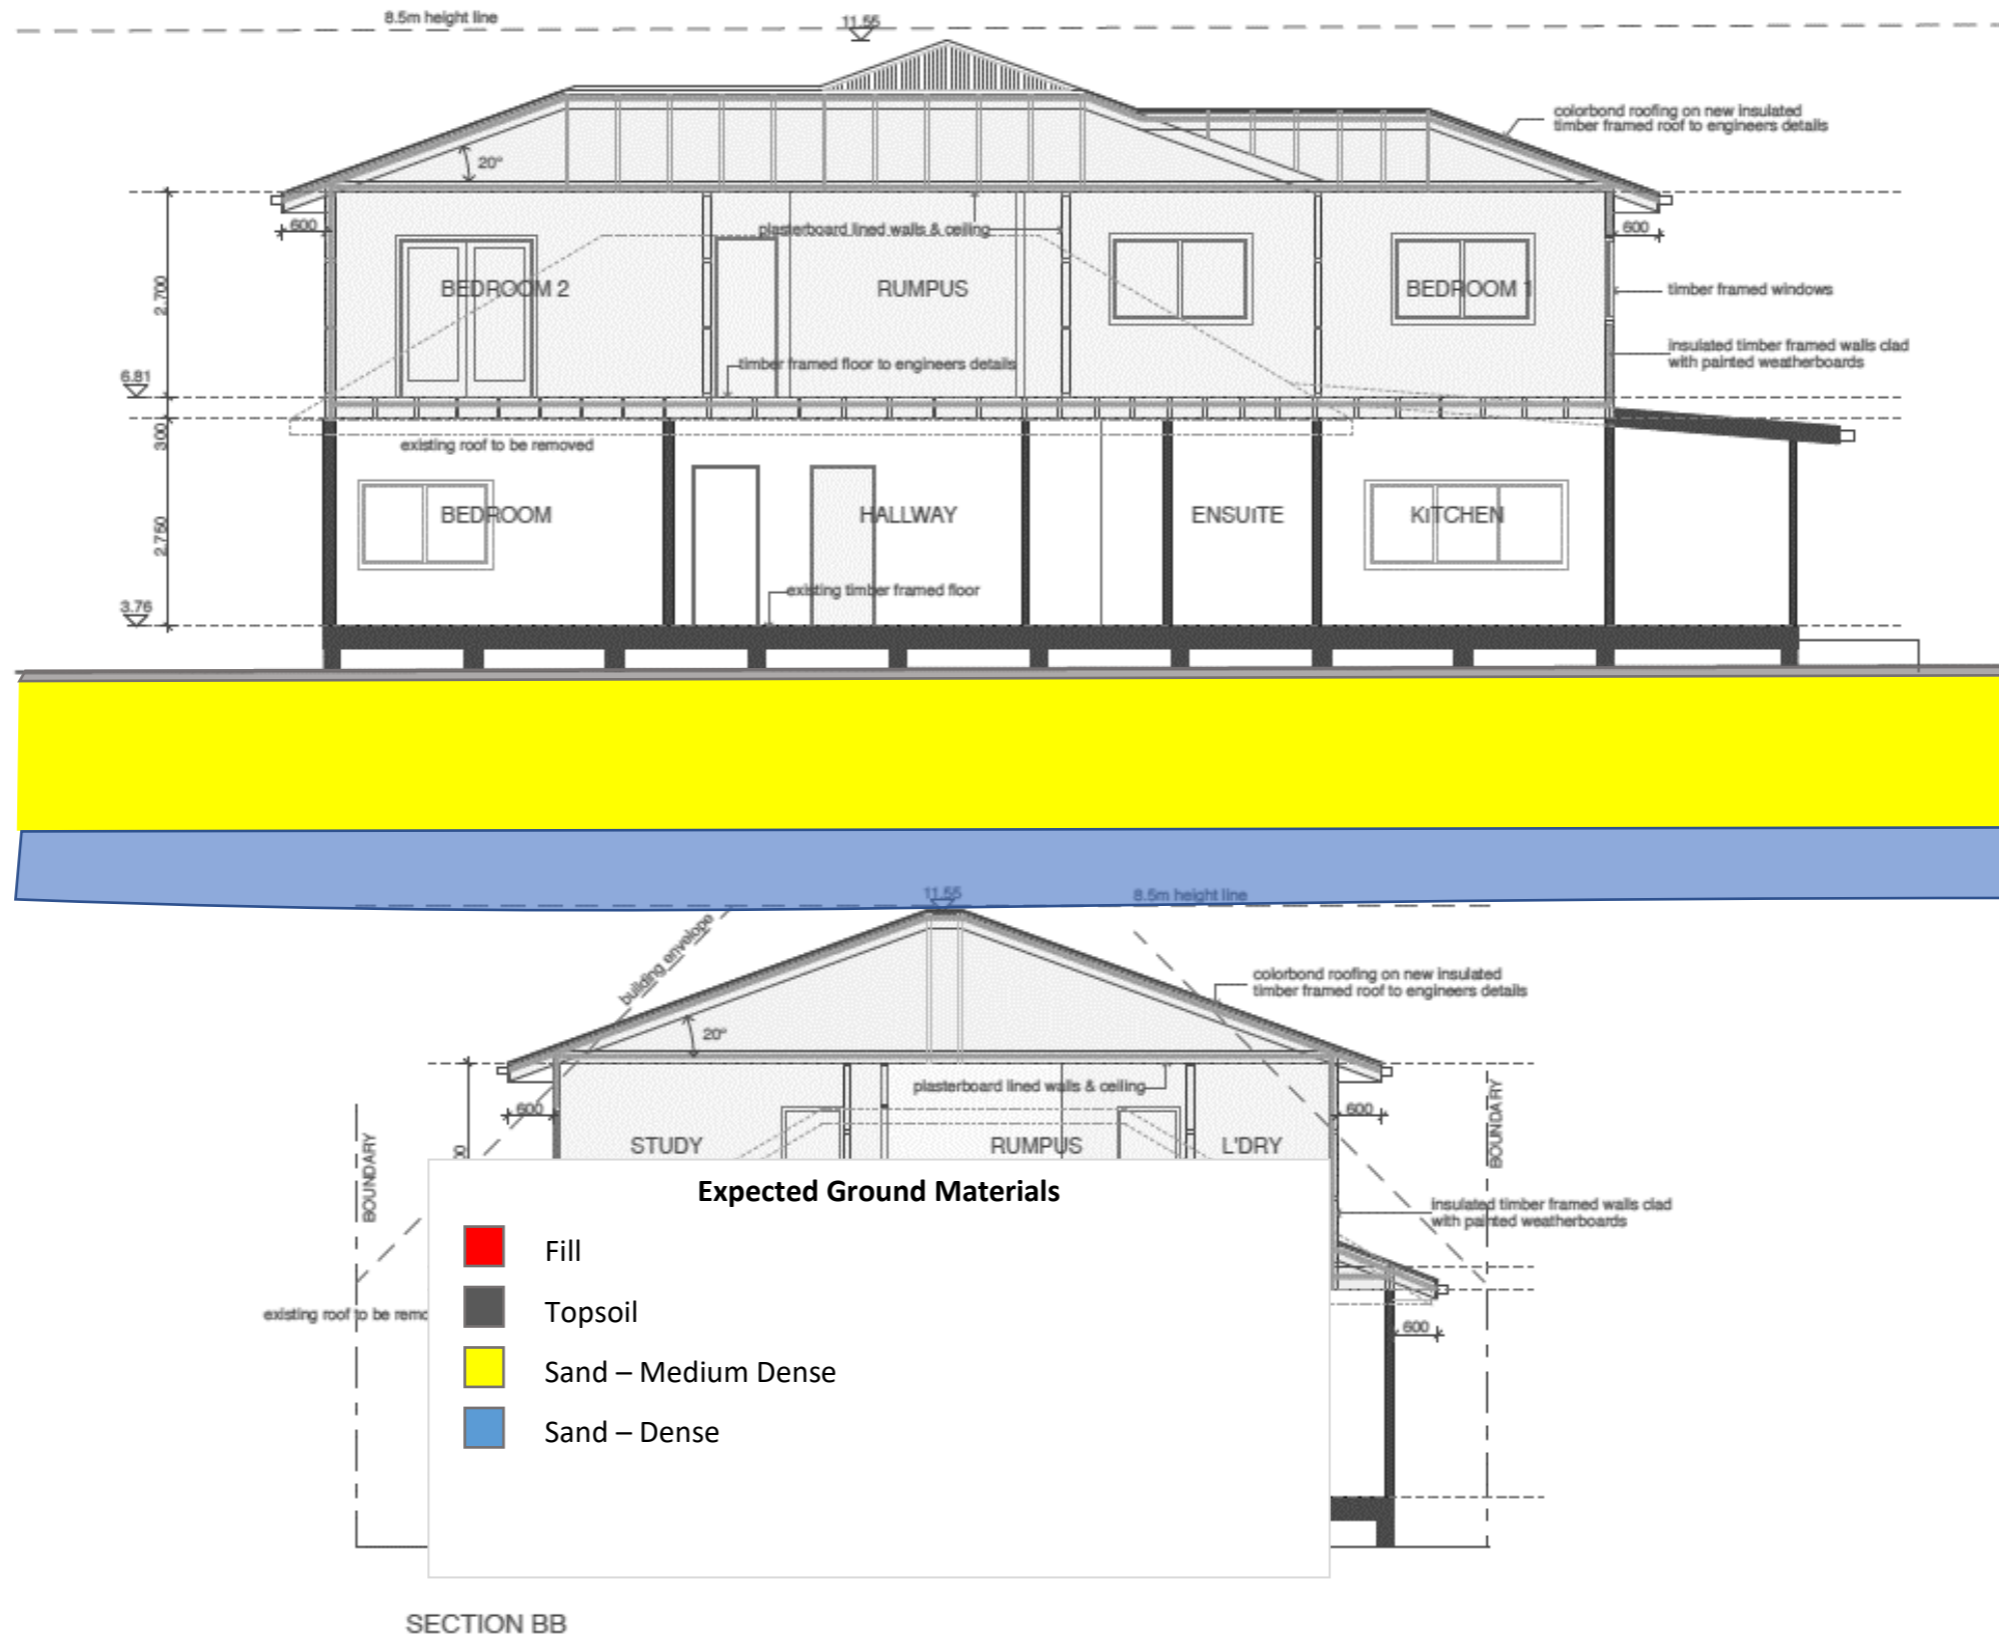
TYPE SECTION – Diagrammatical Interpretation of expected Ground Materials

The site is underlain by sand that was encountered to the extent of the testing. To summarise the test results, Medium Dense Sands occupy the top ~2.1m of the profile, these overlie Dense Sands that extend to at least the extent of the testing. Rock was not encountered to the extent of the tests at 3.0m. See the Type Section attached for a diagrammatical representation of the expected ground materials.
