## Geotechnical Investigation

27 East Esplanade, Manly, NSW

Report Title: Geotechnical Investigation, 27 East Esplanade, Manly, NSW

Report No: E26867.G03

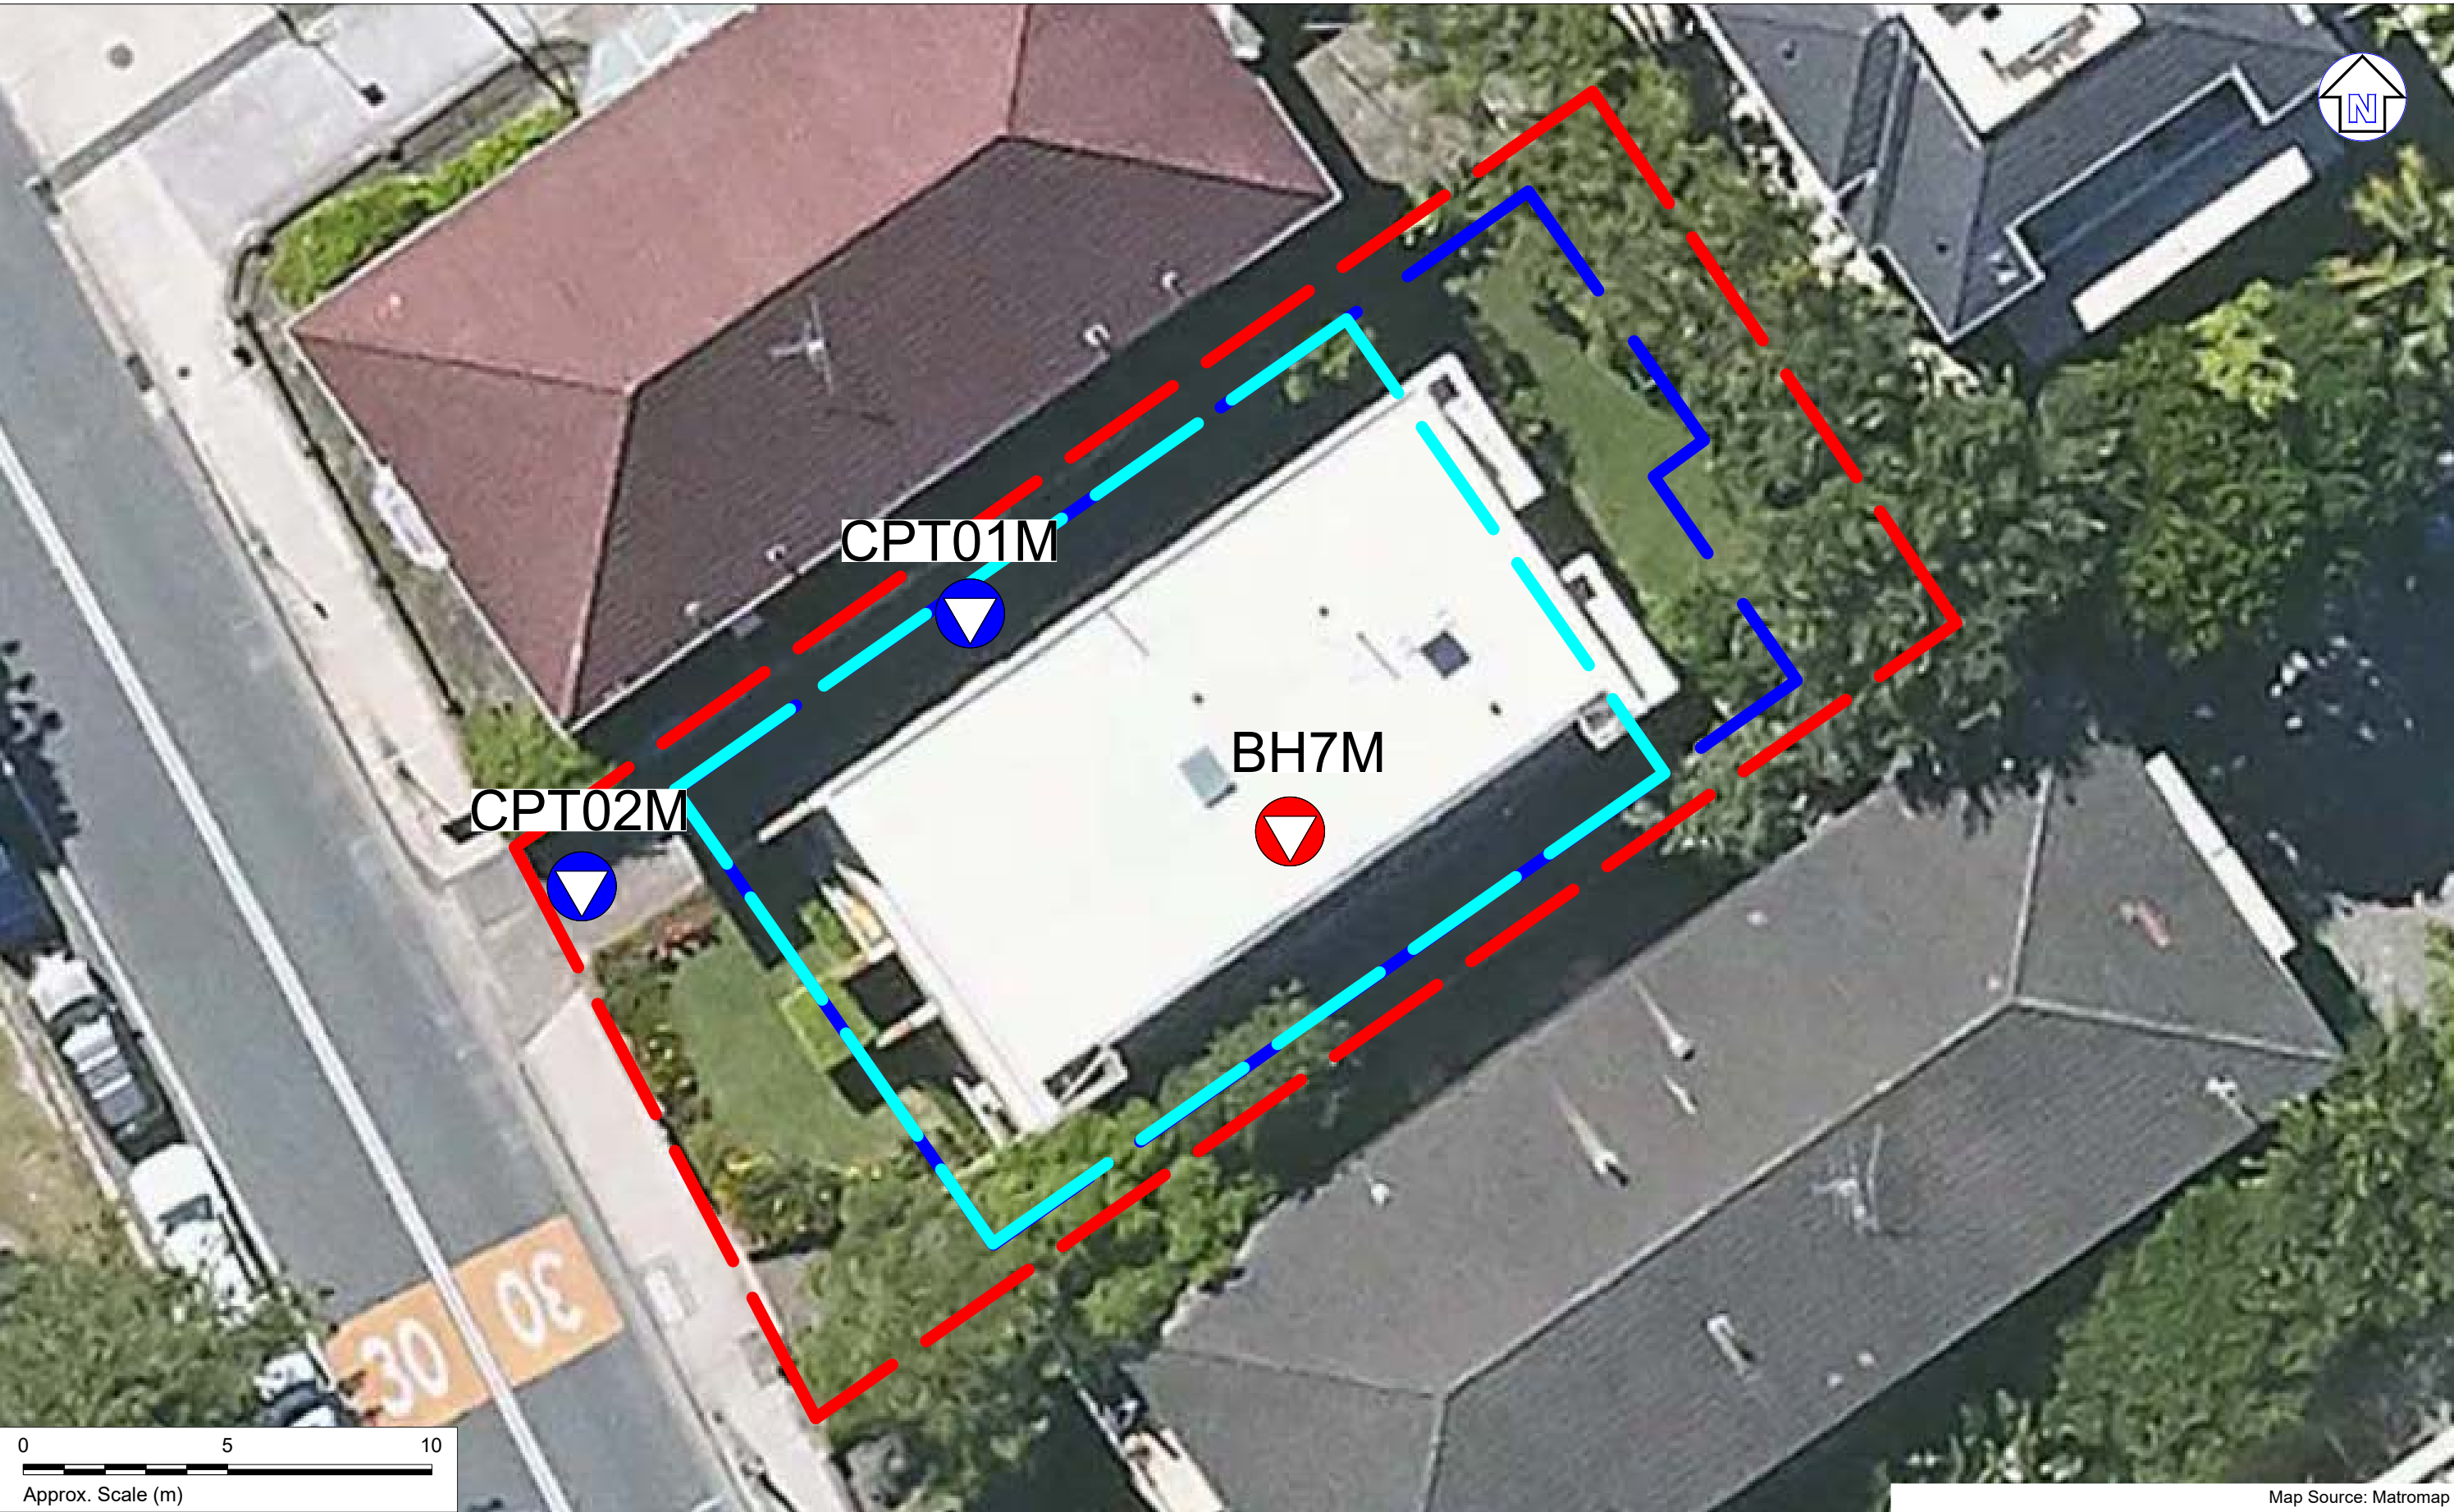
**LEGEND (All Locations are Approximate)**

- Site boundary
- Basement 1 and 2 boundary
- Basement 3 boundary
- CPT and monitoring well location
- Hand Auger Borehole/monitoring well location

- Drilling of one hand augered borehole (BH07) to a depth of 2.7m.
- The approximate geotechnical investigation locations are shown on the attached Figure 2 (Investigation Location Plan).

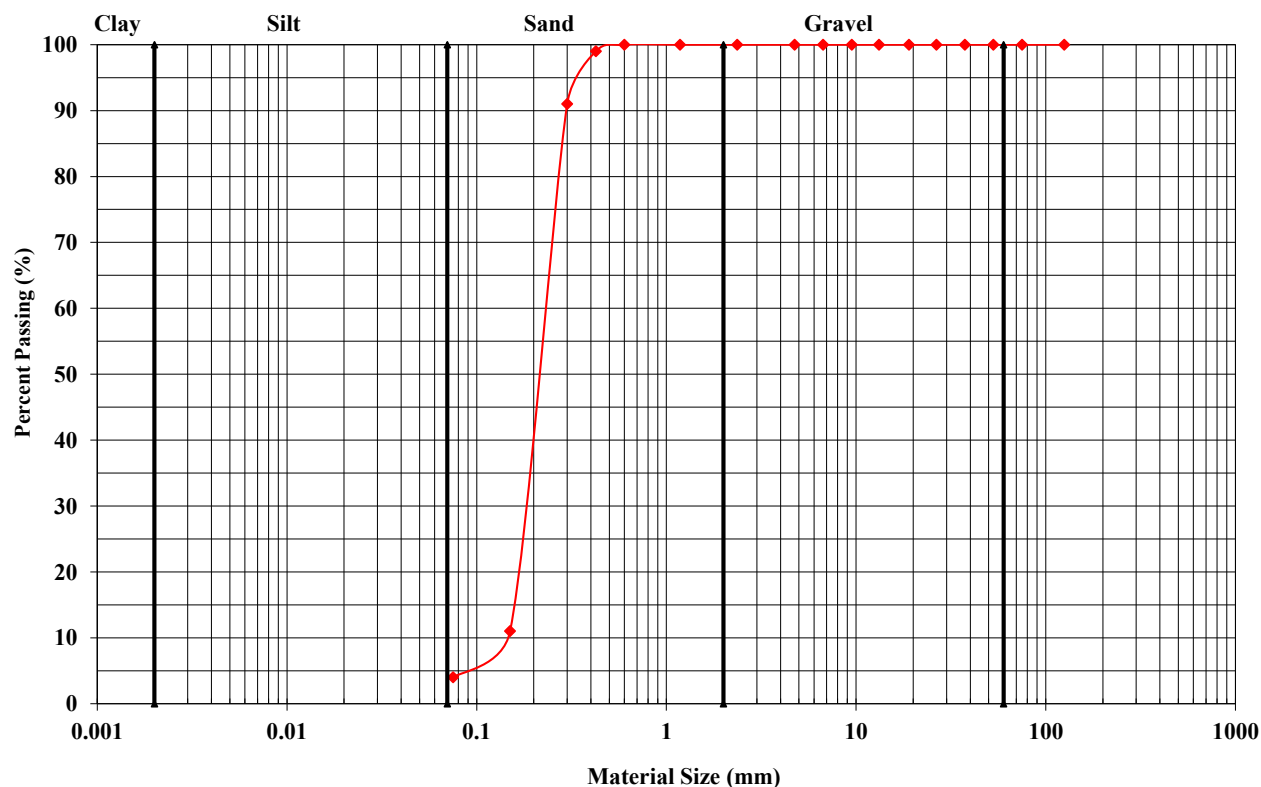
Sieve Size (mm)	Percent Passing (%)
125.0	100.0
75.0	100.0
53.0	100.0
37.5	100.0
26.5	100.0
19.0	100.0
13.2	100.0
9.5	100.0
6.7	100.0
4.75	100.0
2.36	100.0
1.18	100.0
0.60	100.0
0.425	99.0
0.30	91.0
0.15	11.0
0.075	4.0
