Solar Canopy – The Collaroy Centre

22 Homestead Ave, Collaroy NSW

GEOTECHNICAL INVESTIGATION REPORT

Job No. SYD2025-0121AB | Rev 0

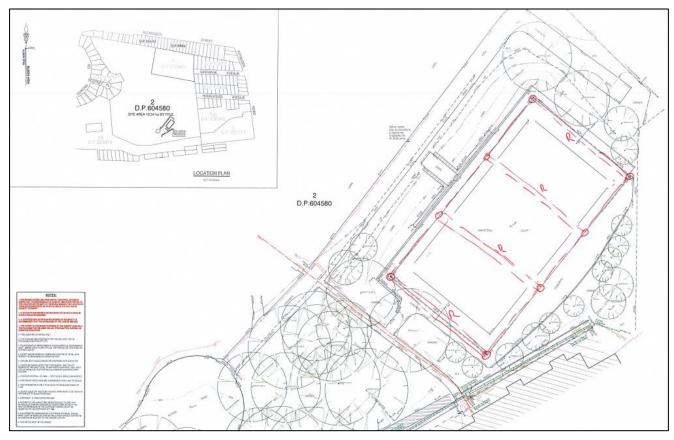
Figure 1: Proposed Collaroy Centre Solar Canopy Site Layout

CMW understands Specialised Solutions is working to construct a solar canopy at The Collaroy Centre located at 22 Homestead Ave, Collaroy NSW and owned and operated by the Salvation Army. The proposed development includes construction of the canopy over an existing tennis/basketball court located in the southern area of the Collaroy Centre premises. The proposed layout for the solar canopy can be seen in Figure 1.

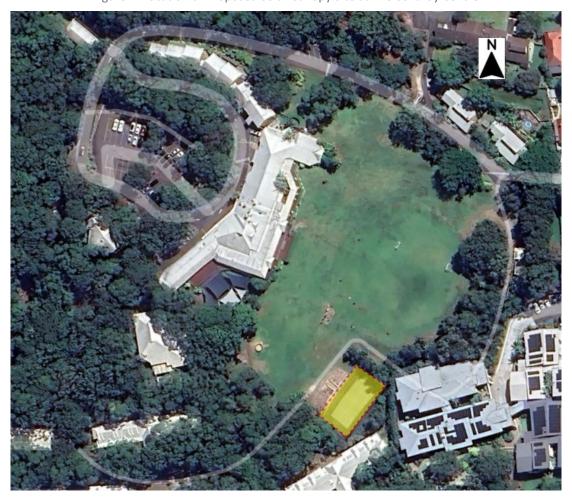
Figure 2: Location of Proposed Solar Canopy Site at The Collaroy Centre

The approximate location of the site is shown in Figure 2 below. Figure 3 presents the typical surface conditions encountered.

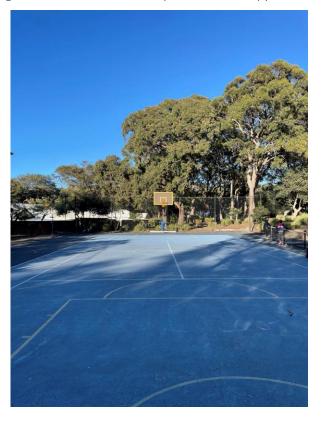
Figure 3: Site Conditions at Proposed Solar Canopy Site

The investigation location is part of the Collaroy Centre, a conference centre located in Collaroy NSW, in the Northern Beaches area of Sydney. The site is a developed parcel of land used for camps, conferences and retreats and contains accommodation, meeting/event facilities and recreation facilities including a tennis/basketball court (the investigation location). The court is bounded by the grounds of the Centre to the north and west, and Aged Care Living Residences to the south and east. A fence and trees/shrubs surround the court on three sides, with a sandstone block wall and steps providing access from the northwest. The Collaroy Centre is situated on a hillside sloping from the northwest corner to the east and south. The basketball court itself is relatively flat and consists of a concrete slab.

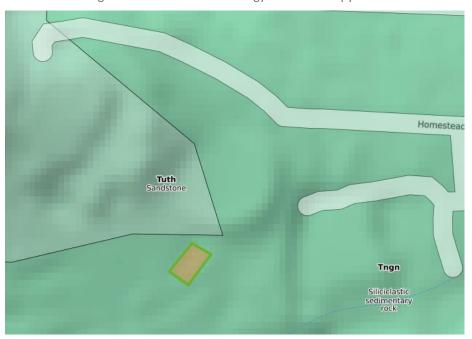
Figure 4: NSW Seamless Geology at Solar Canopy Site

A review of the NSW Government MinView Seamless Geology references for the area suggests the site is underlain by Newport Formation siliciclastic sedimentary rock, consisting of interbedded laminite, shale and sandstone white quartz to quartz-lithic, very fine to medium-grained sandstone; minor shale breccia and pebble polymictic conglomerate (at base of sandstone units); minor red clays.

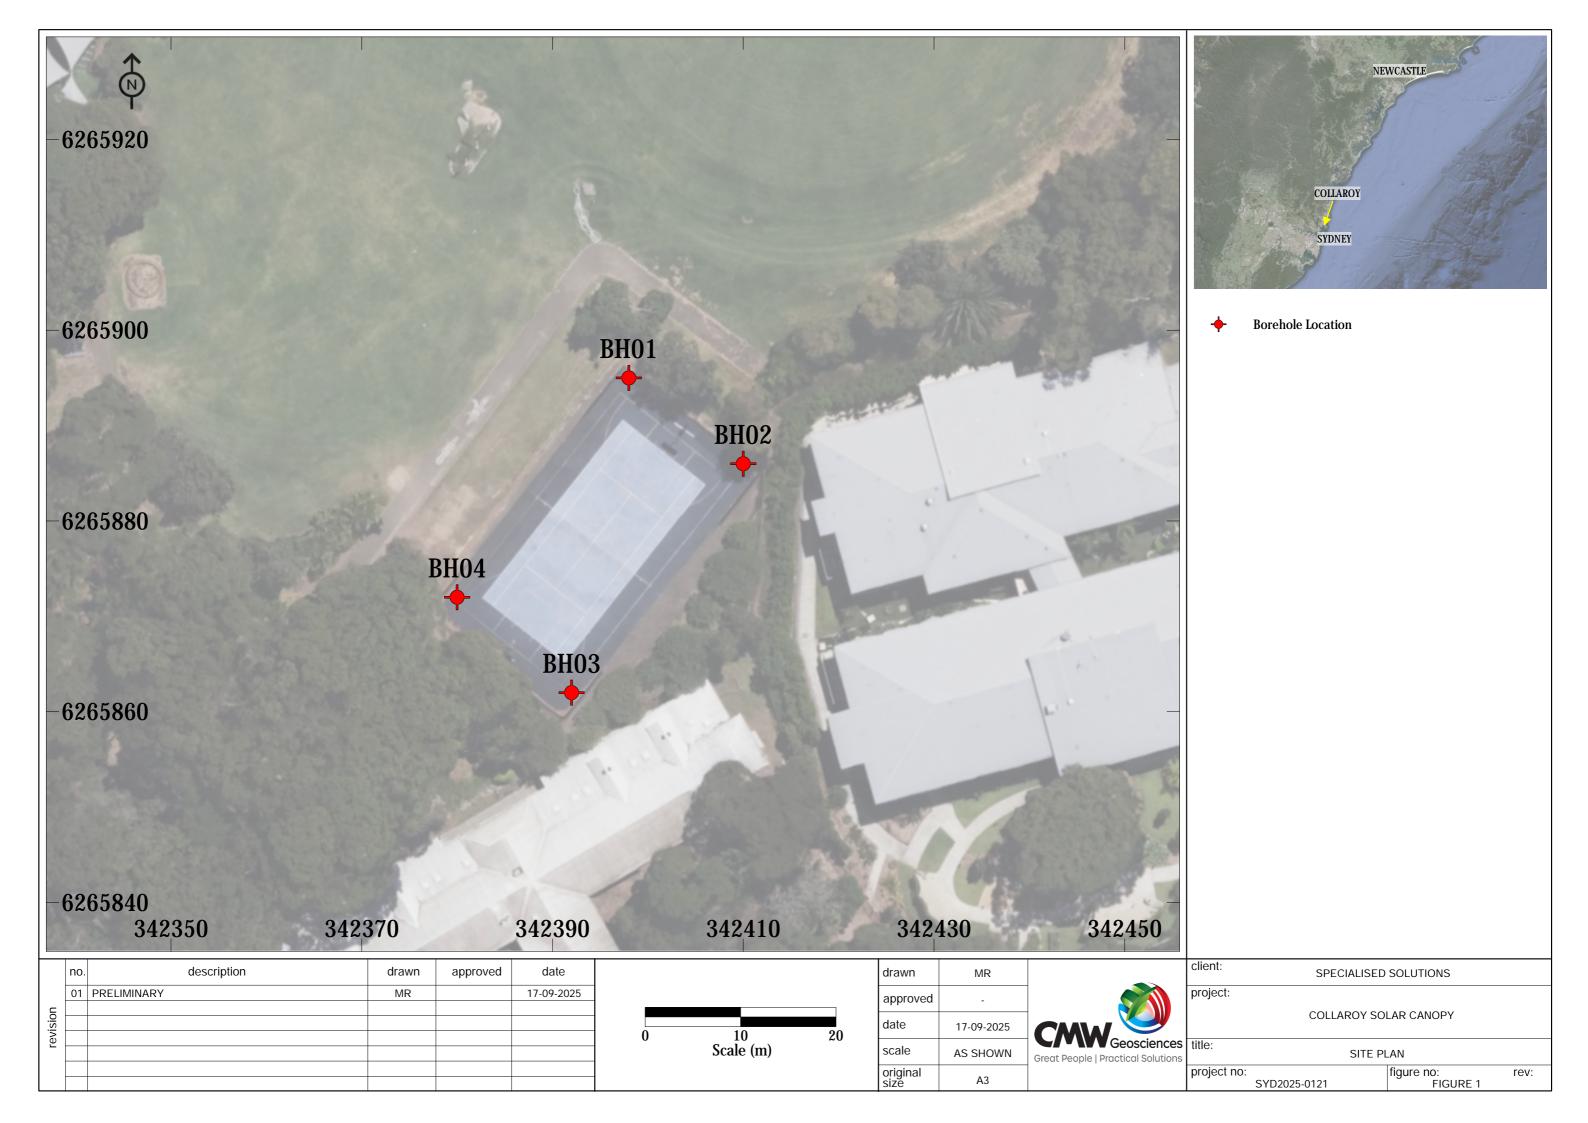
APPENDIX A Site Map

Fieldwork was carried out under the direction of a CMW Geotechnical Engineer in general accordance with AS1726 - Geotechnical Site Investigations. Investigation locations were positioned using a handheld GPS unit with an accuracy of \pm 5m. Borehole locations are presented in Appendix A.
