Acid Sulphate Assessment

20 Watergum Drive, Warriewood

73756-IDF Rev1

February 2025

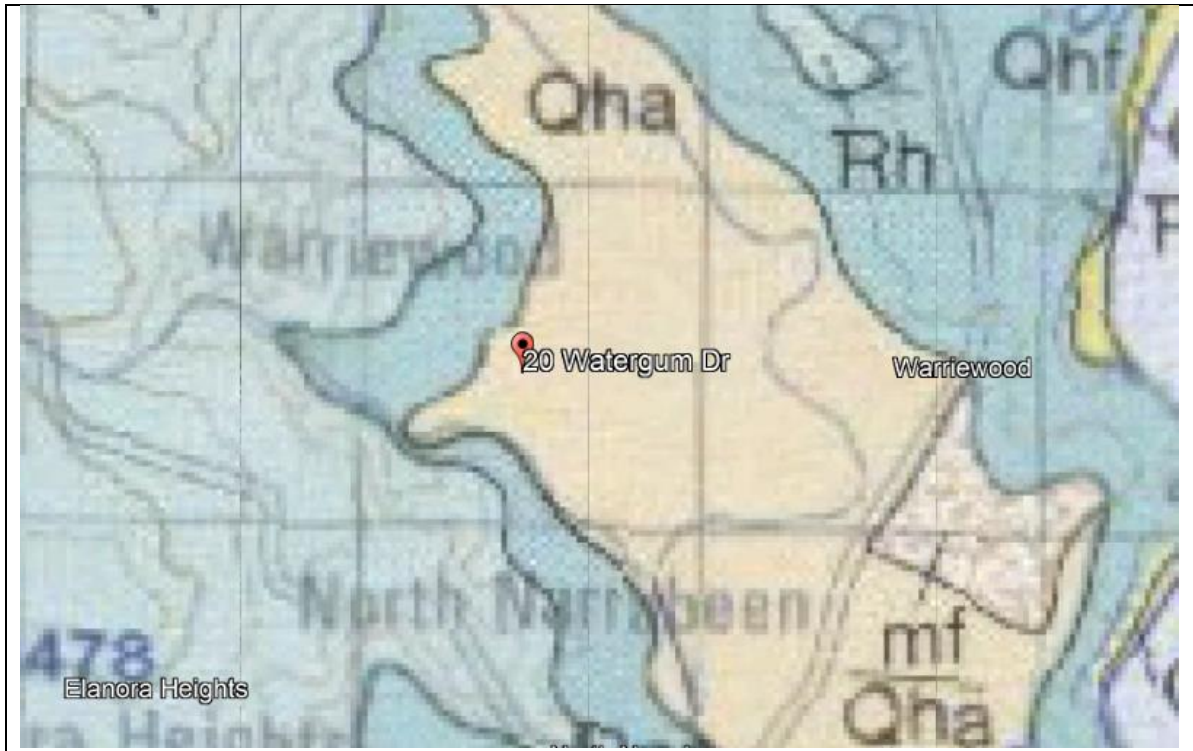
Image 1: Geological Series Map

Reference to the Sydney 1:100,000 geological map (Geological Series Sheet 9130) indicates that the site is underlain by quaternary deposits consisting of silty to peaty quartz sand, silt and clay. Ferruginous and humic cementation in places, and common shell layers.

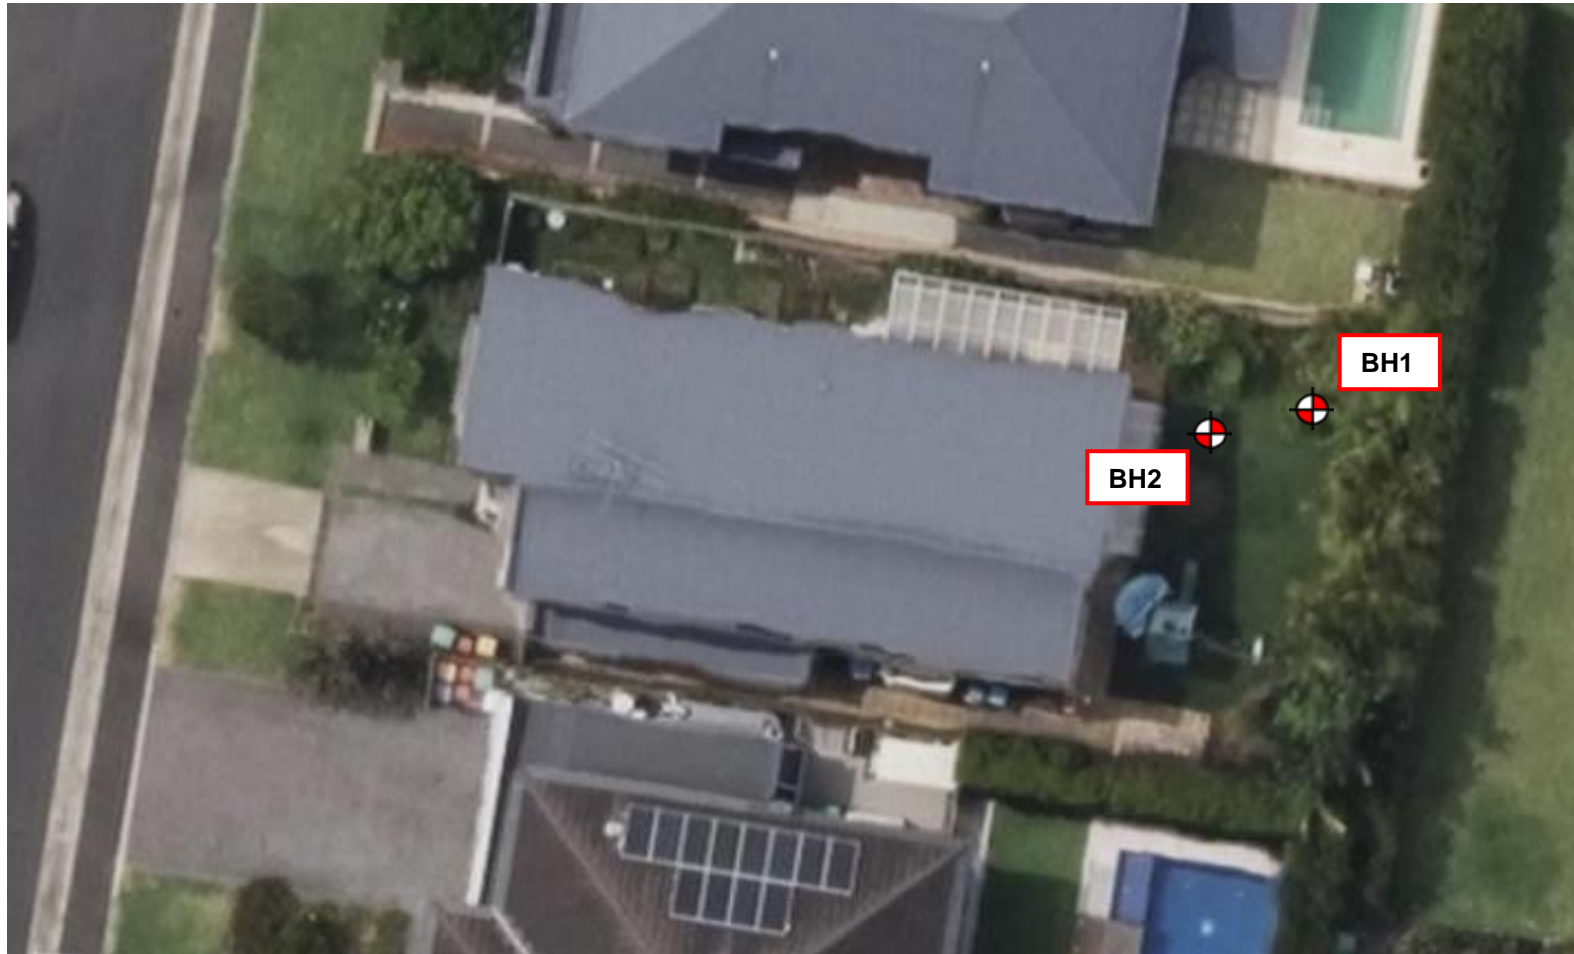
9.1 Appendix A – Borehole Location Plan

Fieldwork was undertaken on 25 October 2024 and included drilling two boreholes (BH1 & BH2) using a hand auger to a maximum depth of 1.6m at the locations shown on Figure 1, attached in Appendix A.

Title	Borehole Location Plan	Council	Warringah Council	Drawn By	Ben
Project	Acid Sulphate Soil Assessment	Job Number	73756-IDF	Checked By	Dane
Site Address	20 Watgum Drive, Warriewood	Figure Number	Figure 1	Date	Nov-24

Soil sampling was undertaken in general accordance with the Acid Sulphate Soil Guidelines (Refer to Figure 1 for the borehole locations). Test results were compared to the relevant New South Wales Environment Protection Authority (NSW EPA) criteria.
