**GEOTECHNICAL RISK MANAGEMENT POLICY FOR PITTWATER
FORM NO. 1 – To be submitted with Development Application**

Address of site 249 Barrenjoey Road, Newport

Report Date: 26 August 2025

Project No.: 2025-139

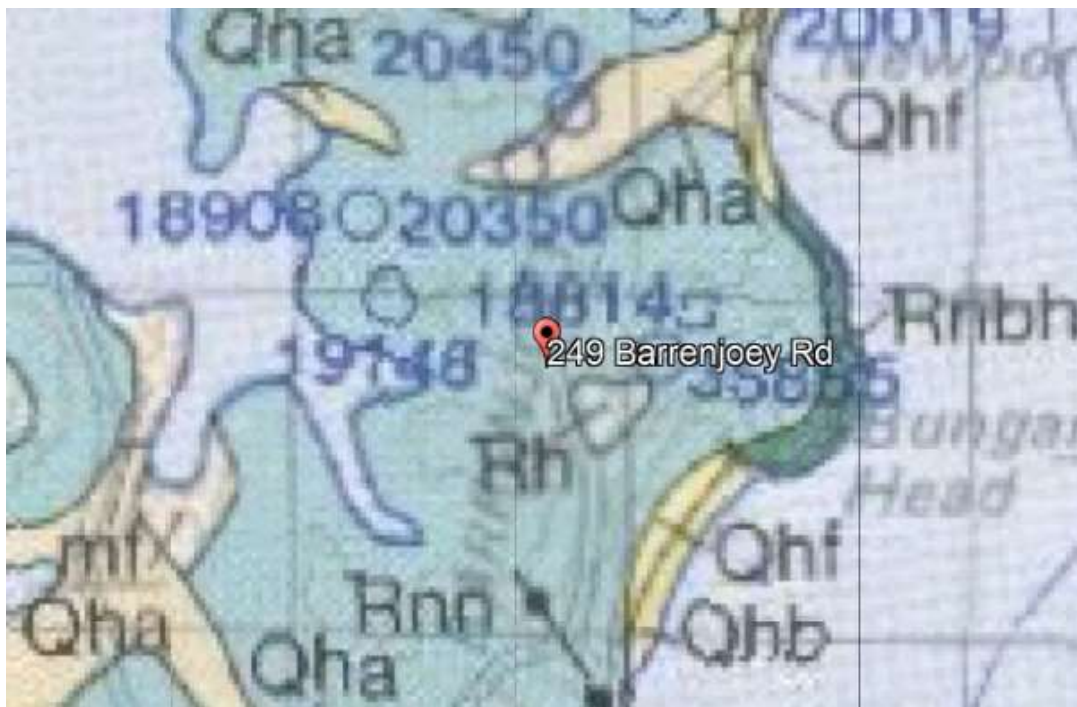
An extract from the Sydney 1:100,000 Geological Series sheet 9130 provided below (Extract 1) indicates the geology underlying the site and surrounding area.

Extract 1: Sydney (9130 Geological Series Map): 1:100,000 – Geology underlying the site

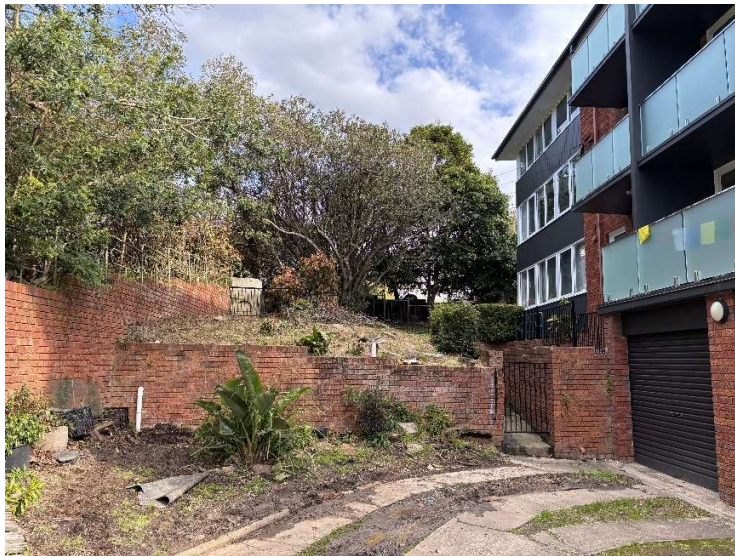
closed off. East of the ramp is an elevated grassed area retained by a brick masonry retaining wall approximately 1.40 m high. This retaining wall exhibits notable rotation and a vertical crack of approximately 85 mm in width (Photograph 5). The retaining wall south of the concrete strips shows minor cracking but no evidence of significant structural distress or excessive settlement. East of the grassed area, a boundary retaining wall supporting the Barrenjoey Road reserve extends to a maximum height of approximately 2.50 m and displays signs of ladder cracking and rotation; it also appears to have been previously bolted and underpinned (Photograph 4). Located to the rear (south) of the grassed area is a stormwater tank and several mature trees.

Photograph 2: View of existing elevated grassy area, facing southwest

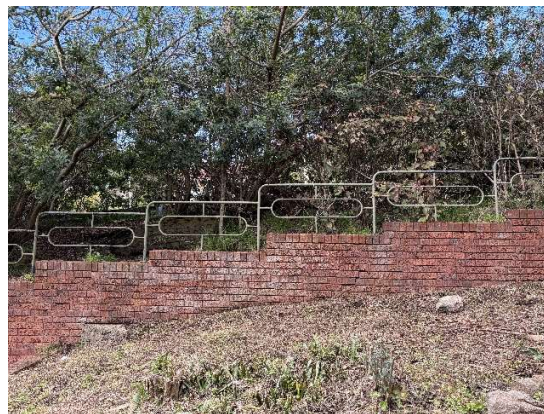
Photograph 4: View of the ladder cracks on the boundary wall, facing east
