REPORT TO  
**SYESUN PTY LTD**

ON  
**DETAILED (STAGE 2) SITE INVESTIGATION**

FOR  
**PROPOSED GARDEN CENTRE REDEVELOPMENT**

AT  
**277 MONA VALE ROAD, TERREY HILLS, NSW**

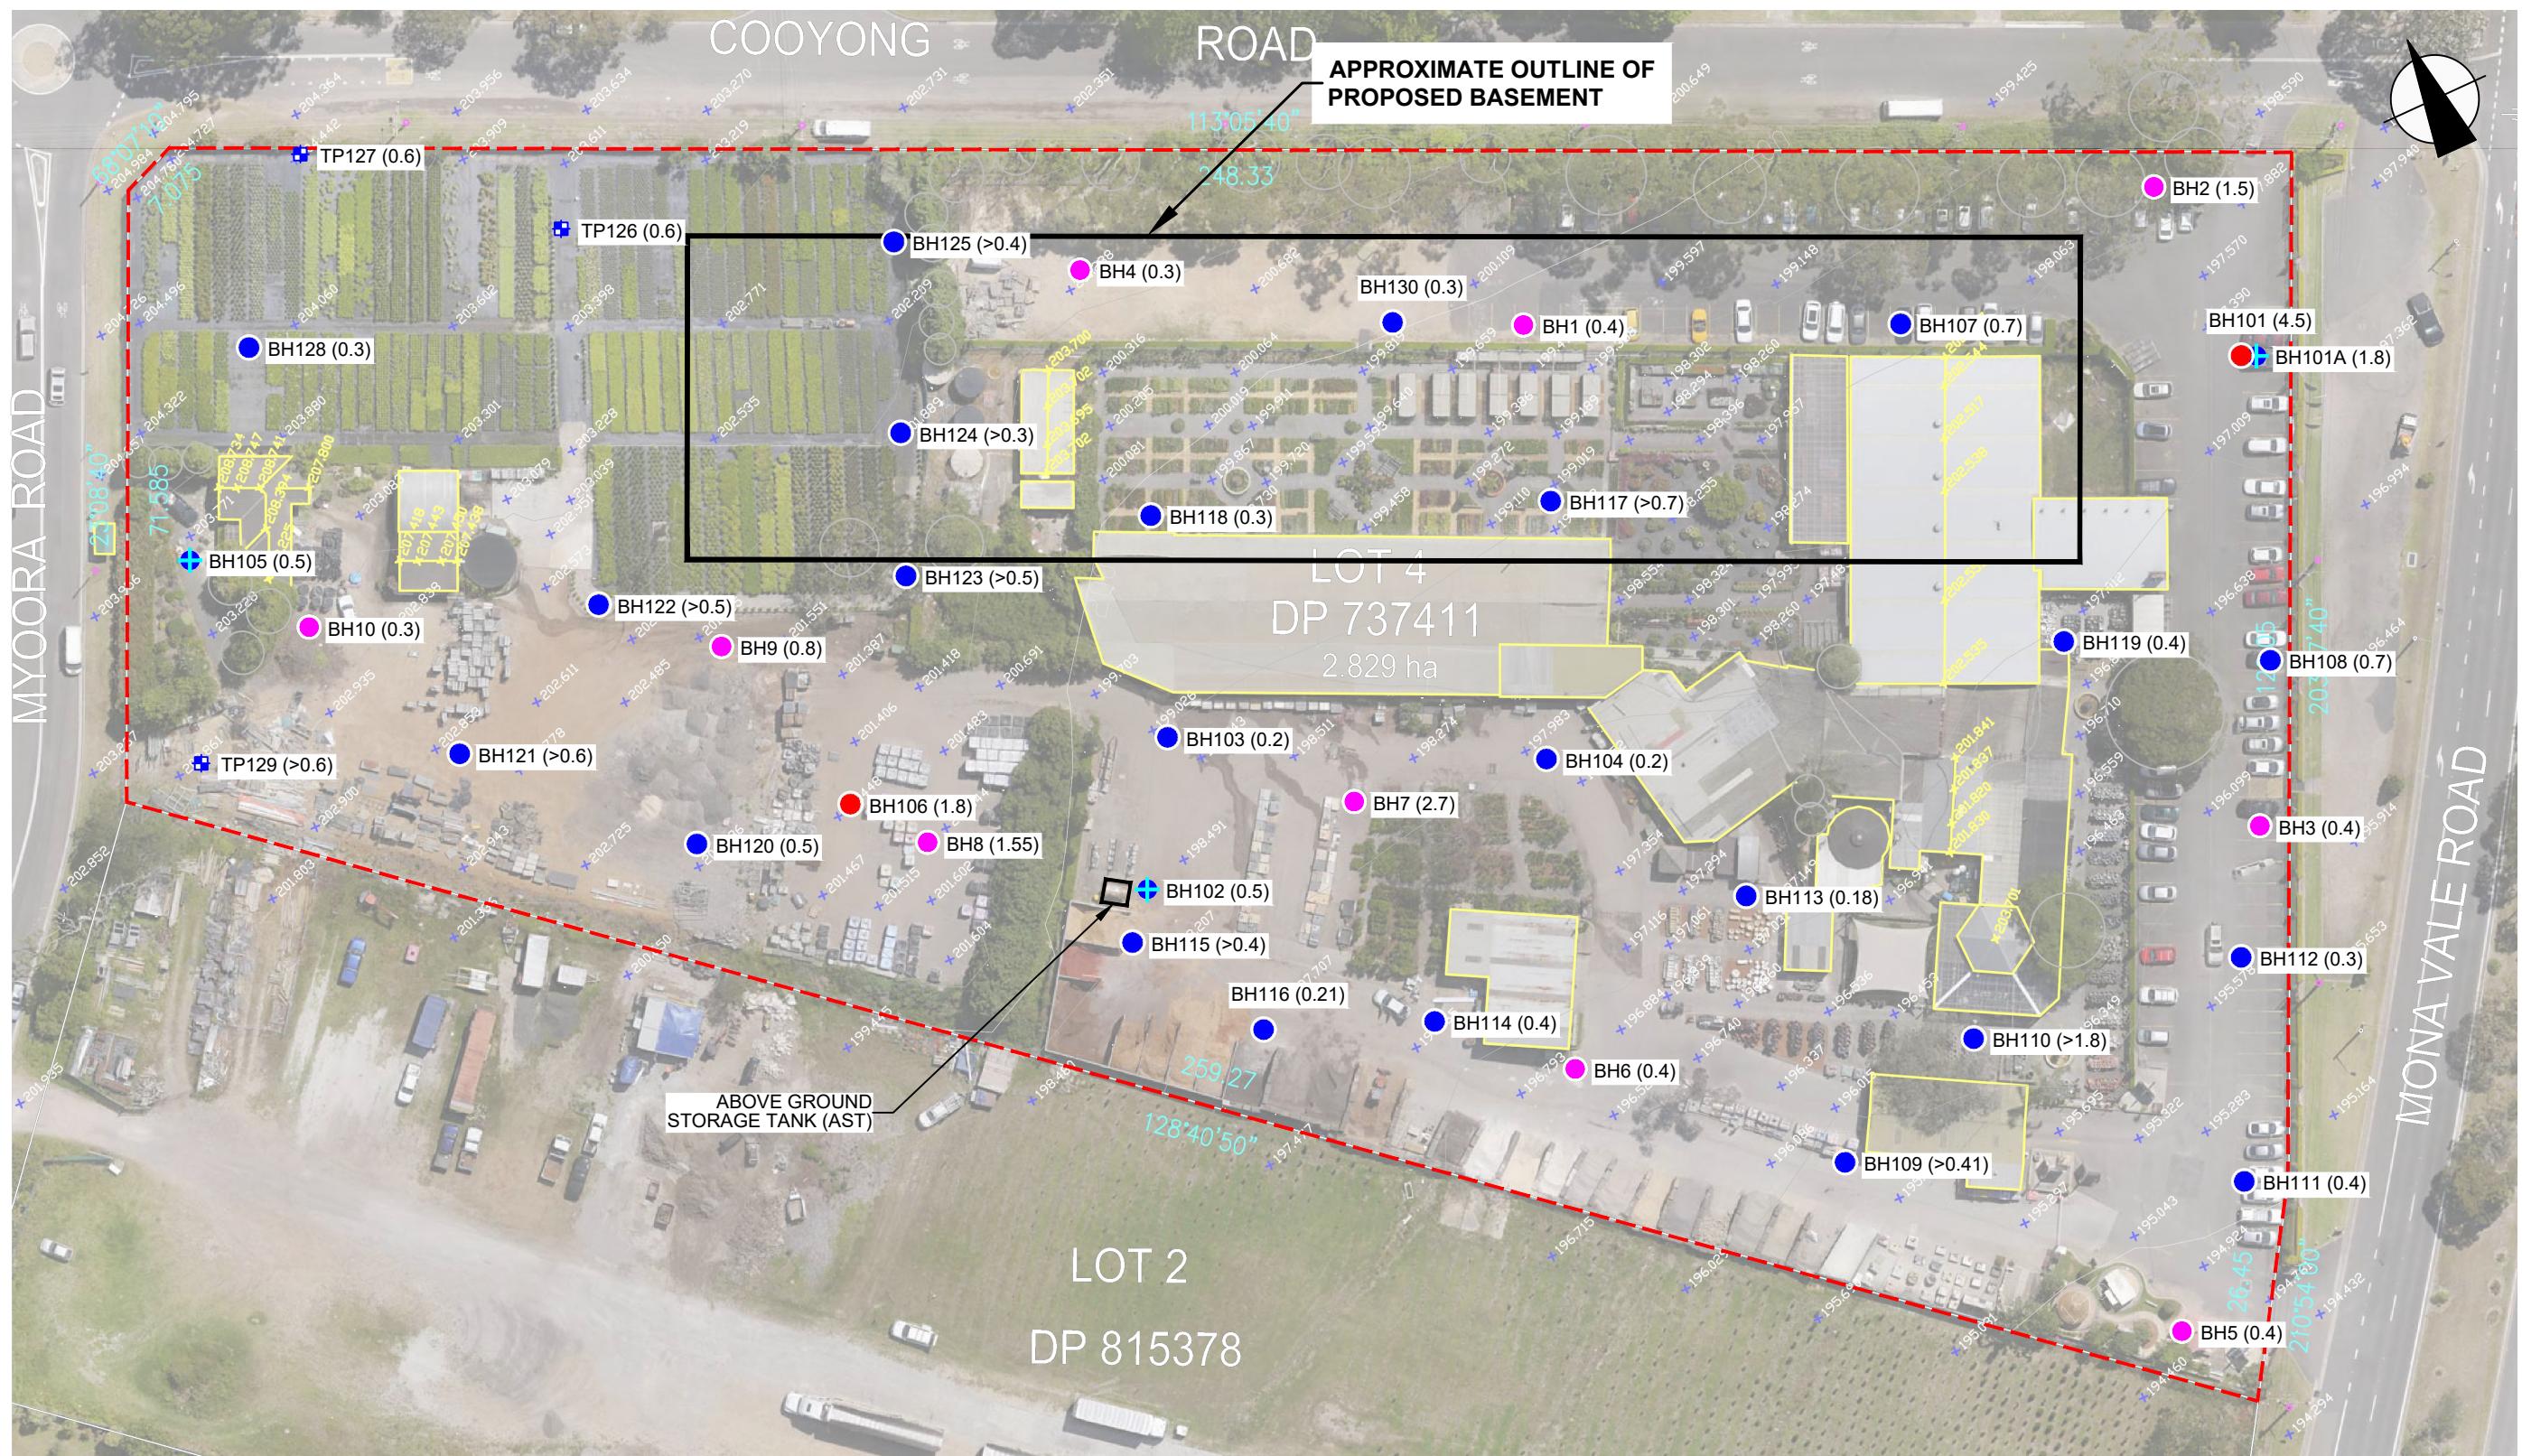
## SAMPLE LOCATION PLAN

| ● BH(Fill Depth) | BOREHOLE AND HAZARDOUS GROUND GAS WELL LOCATION, NUMBER AND DEPTH OF FILL (m) (JKE, 2022) |
