## **GROUND TESTING:**

Alterations and Additions and New Cellar at **5 Marine Parade, Avalon**

### **1.0 Scope**

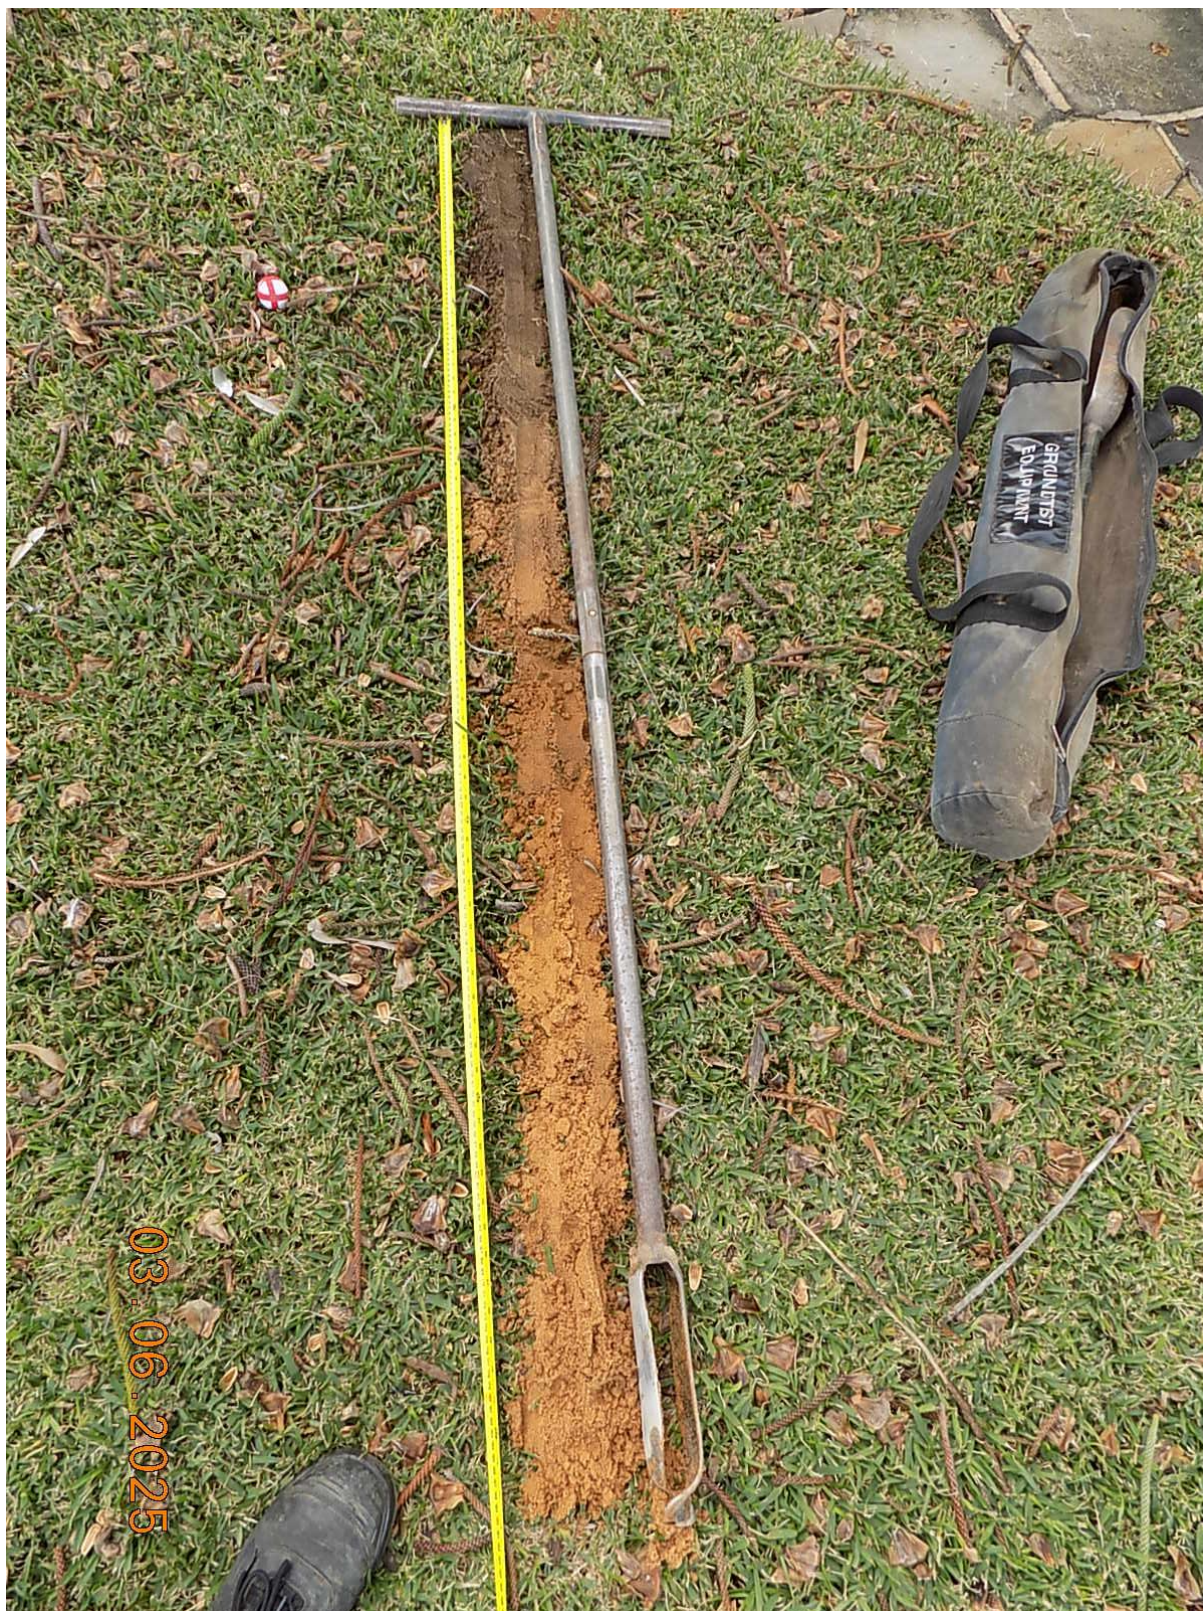
Photo 1 – AH1 - downhole is top to bottom

### AUGER HOLE 1 (~RL7.3) – AH1 (Photo 1)

Depth	Material Encountered
0.0 to 0.5	<b>TOPSOIL</b> , silty sandy soil, brown, Medium Dense, dry, fine to medium grained.
0.5 to 1.9	<b>AEOLIAN SEDIMENT</b> , clean quartz sand, shell fragments included, brown to yellow, Medium Dense, dry, coarse grained.

Refusal @ 1.9m auger grinding on inferred rock. No water table encountered.

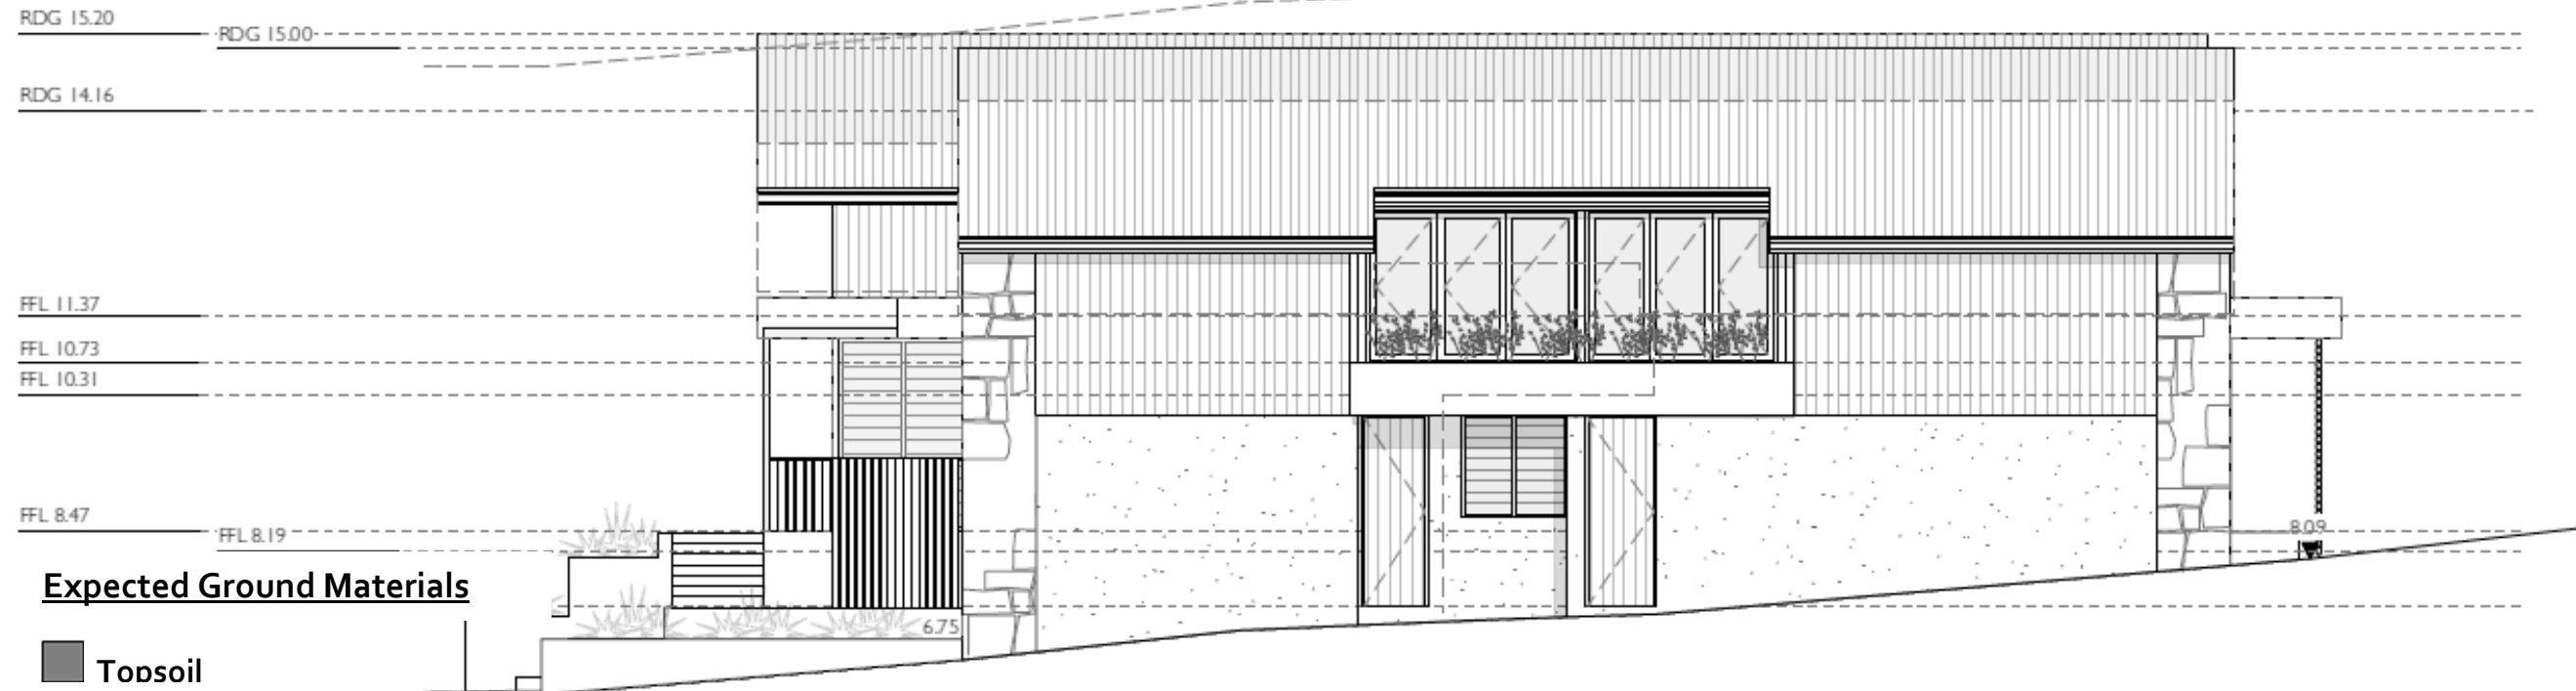
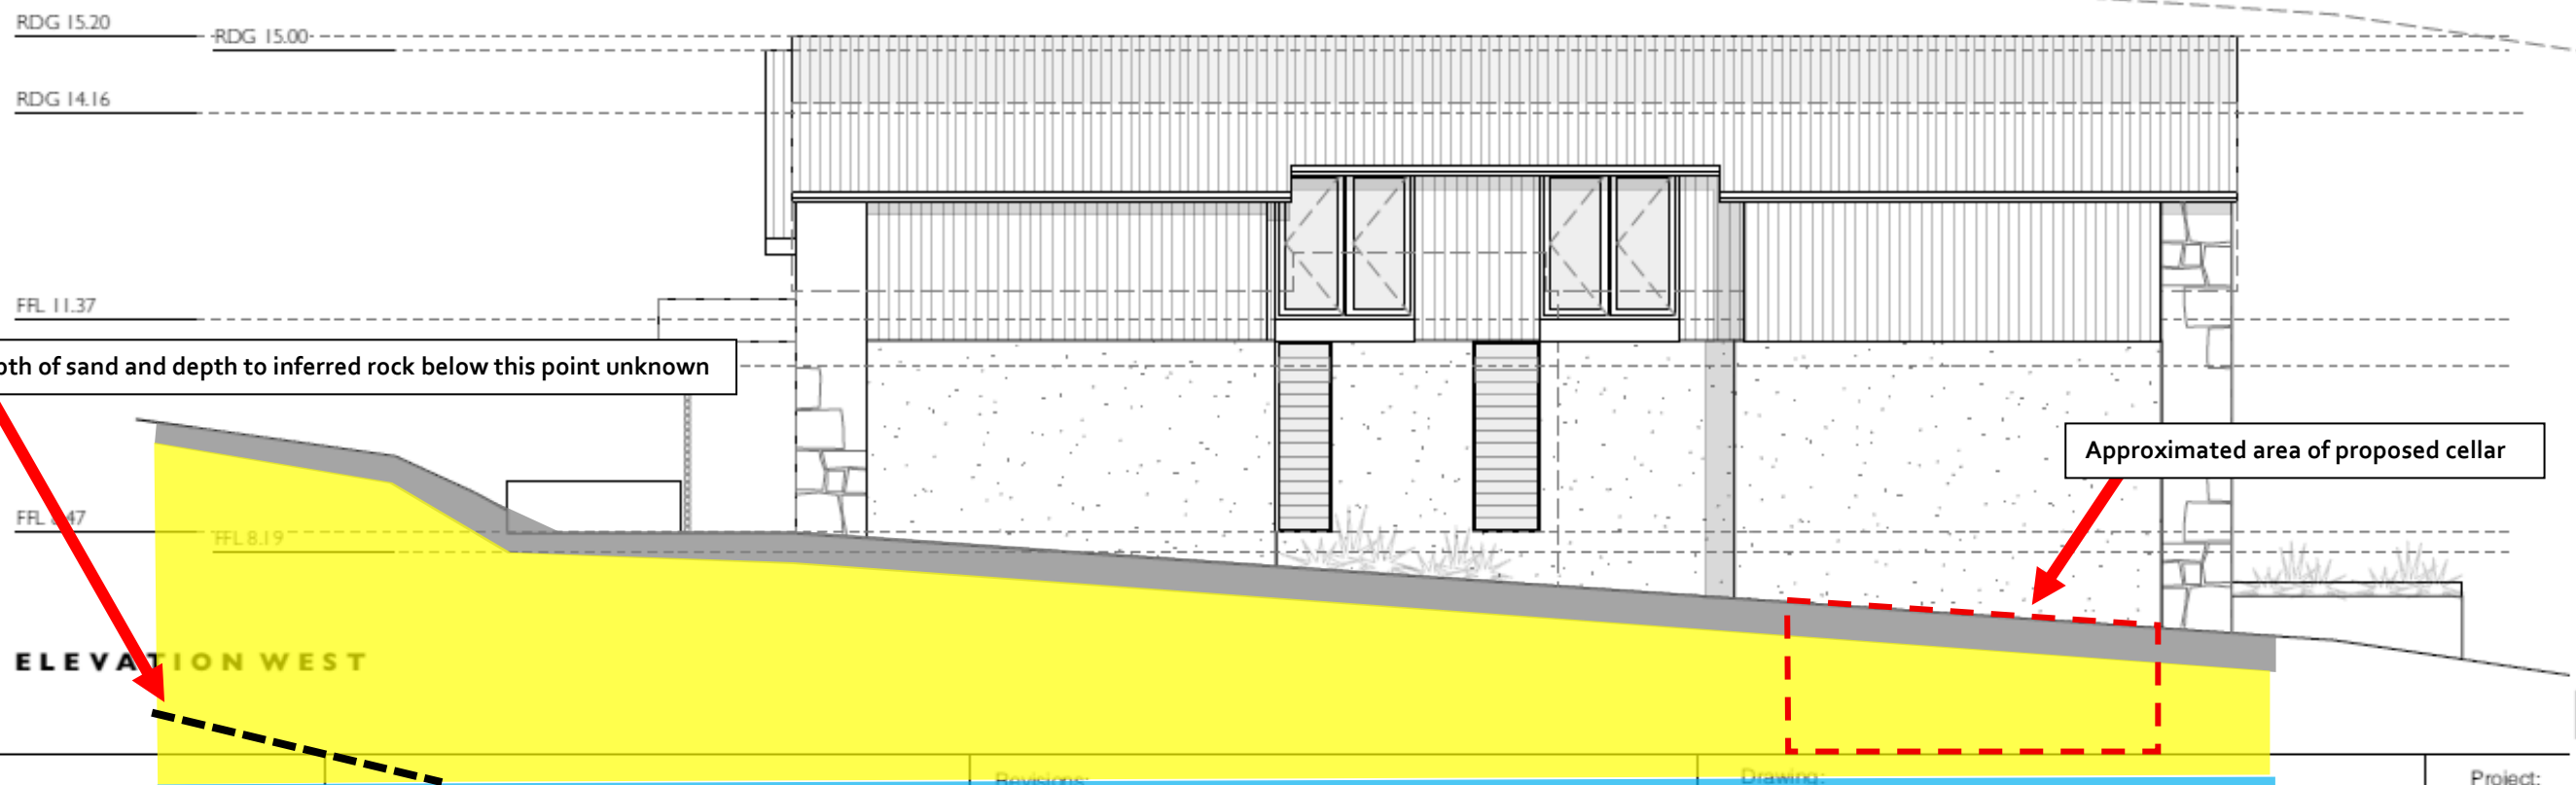
# TYPE SECTION – Diagrammatical Interpretation of expected Ground Materials

In the location of the proposed works, the site is underlain by a thin sandy topsoil and deep Aeolian sediment. To summarise the test results, a Medium Dense sandy topsoil occupies the top ~0.5m of the profile, that overlies sands of variable density that range from Loose to Dense at depths of between ~1.3m and ~4.3m. DCP test 4 was terminated at depth due to a very high blow count in inferred dense sand. DCP tests 1, 2 and 3 are interpreted to have refused on Narrabeen group bedrock. The underlying bedrock is interpreted as Very Low to Medium Strength Rock. See the Type Section attached for a diagrammatical representation of the expected ground materials.

The cellar slab can be supported off the Medium Dense Sand at base of the excavation. Where the house is not supported off the cellar structure, and for any new footings for the proposed secondary dwelling, they are to be supported on spread footings taken at least 0.4m below the current surface and into the sands of the natural profile. A maximum allowable bearing pressure of 100kPa can be assumed for footings supported on the medium dense sands of the natural profile.

Care is to be taken not to exceed this depth as Very Low to Medium Strength rock is expected to be encountered close to the base of the proposed cellar at ~RL5.4.

If Very Low to Medium Strength rock is encountered, all foundations for the cellar will need to be taken to this material.
