Marine Habitat Survey

206 McCarrs Creek Road, Church Point

Report Date 16/10/2024

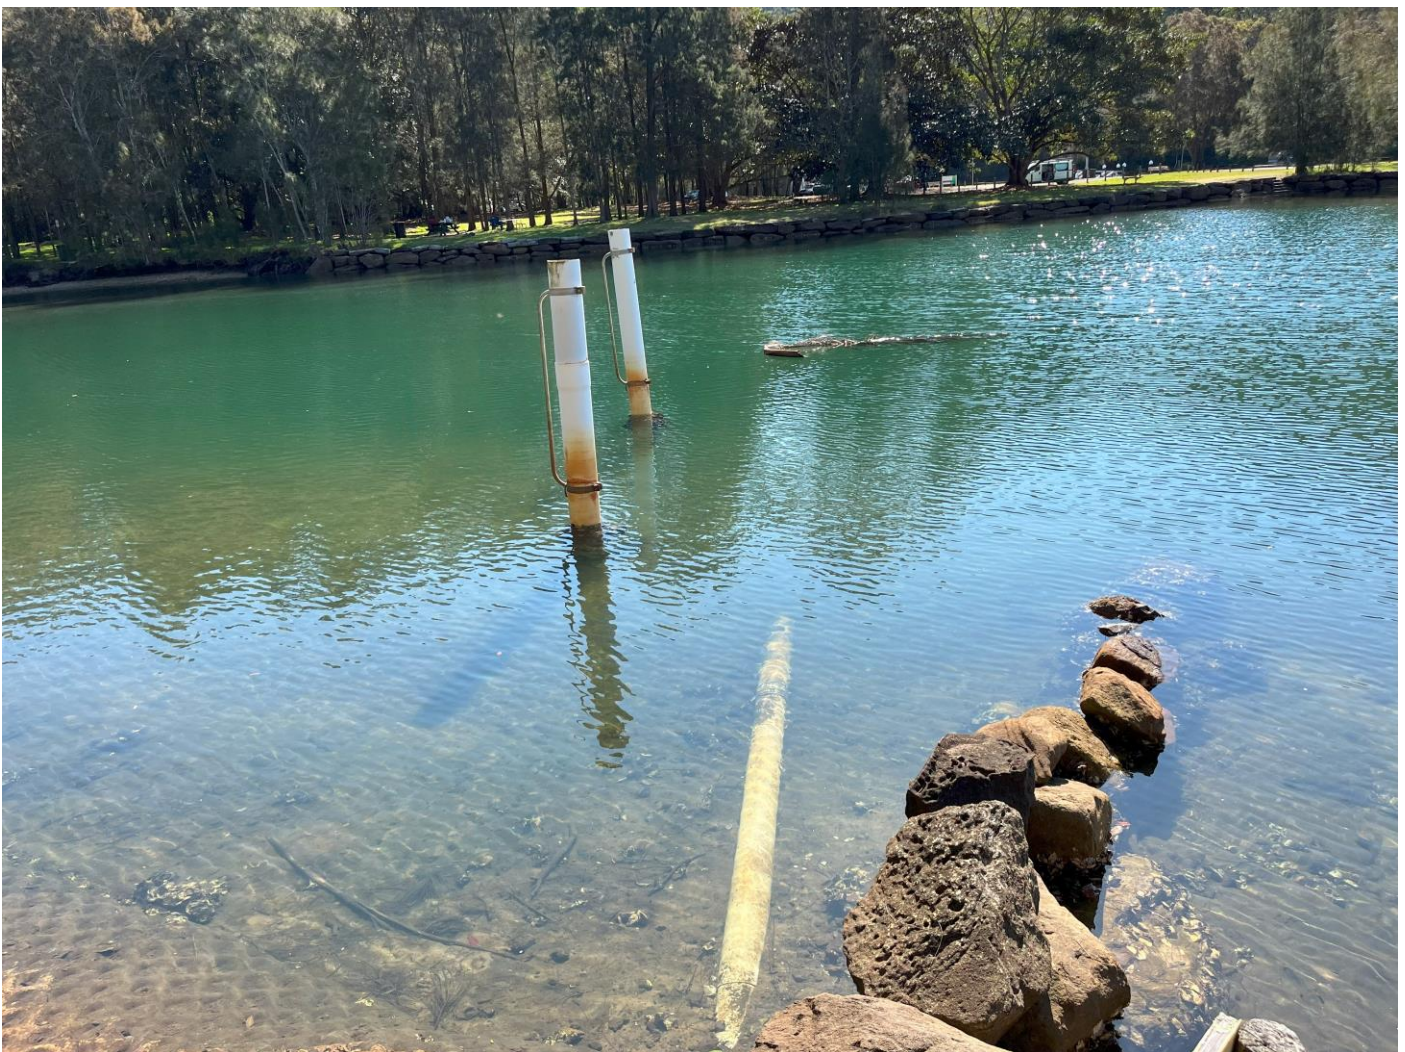
Figure 3: Existing structures at the Subject Site.

The proposed works will extend west into Cicada Glen Creek from the edge of the Subject Site (Figure 3), 15.0 m beyond the MHWL (Figure 4a,b)

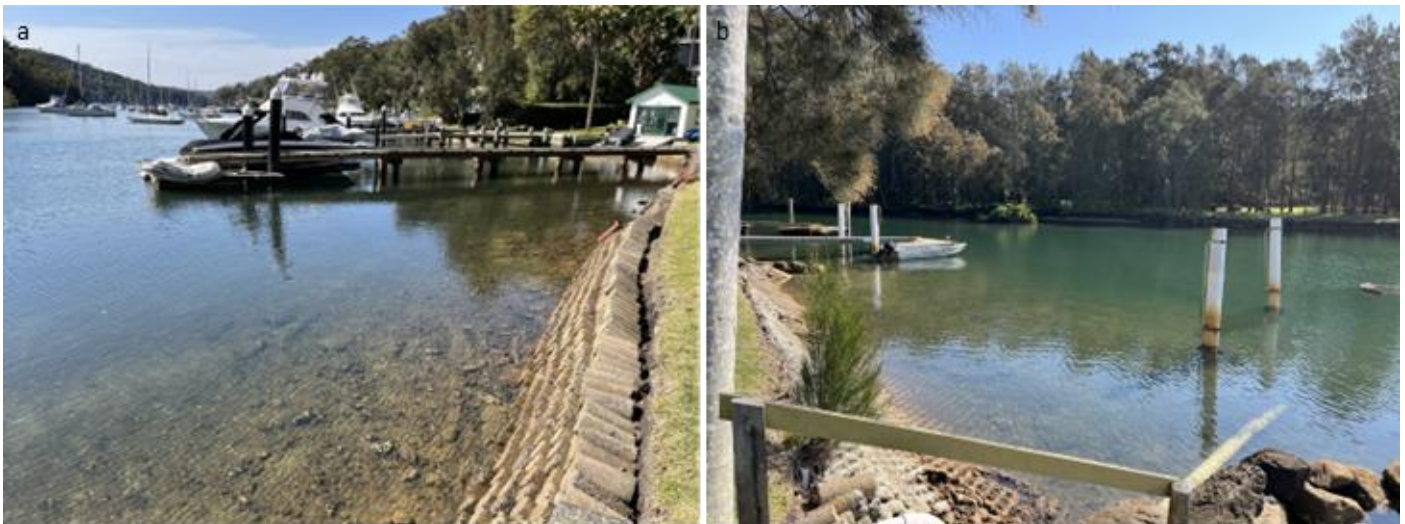
A mixed concrete core retaining wall (~0.9 m in height) and concrete erosion mat runs across the entire waterfront of the site. Active shoreline erosion slumping was observed behind the concrete core retaining wall along the northern boundary. Waterfront structures at the Subject Site consists of a man-made rock groyne (~1.0 x 5.0 m) and two existing HDPE wrapped piles. To the north, the shoreline remains moderately modified with a number of private jetties and moorings, with similar waterfront structures observed to the south (Figure 5).

Figure 5: Waterfront structures to the (a) north and (b) south of the Subject Site.

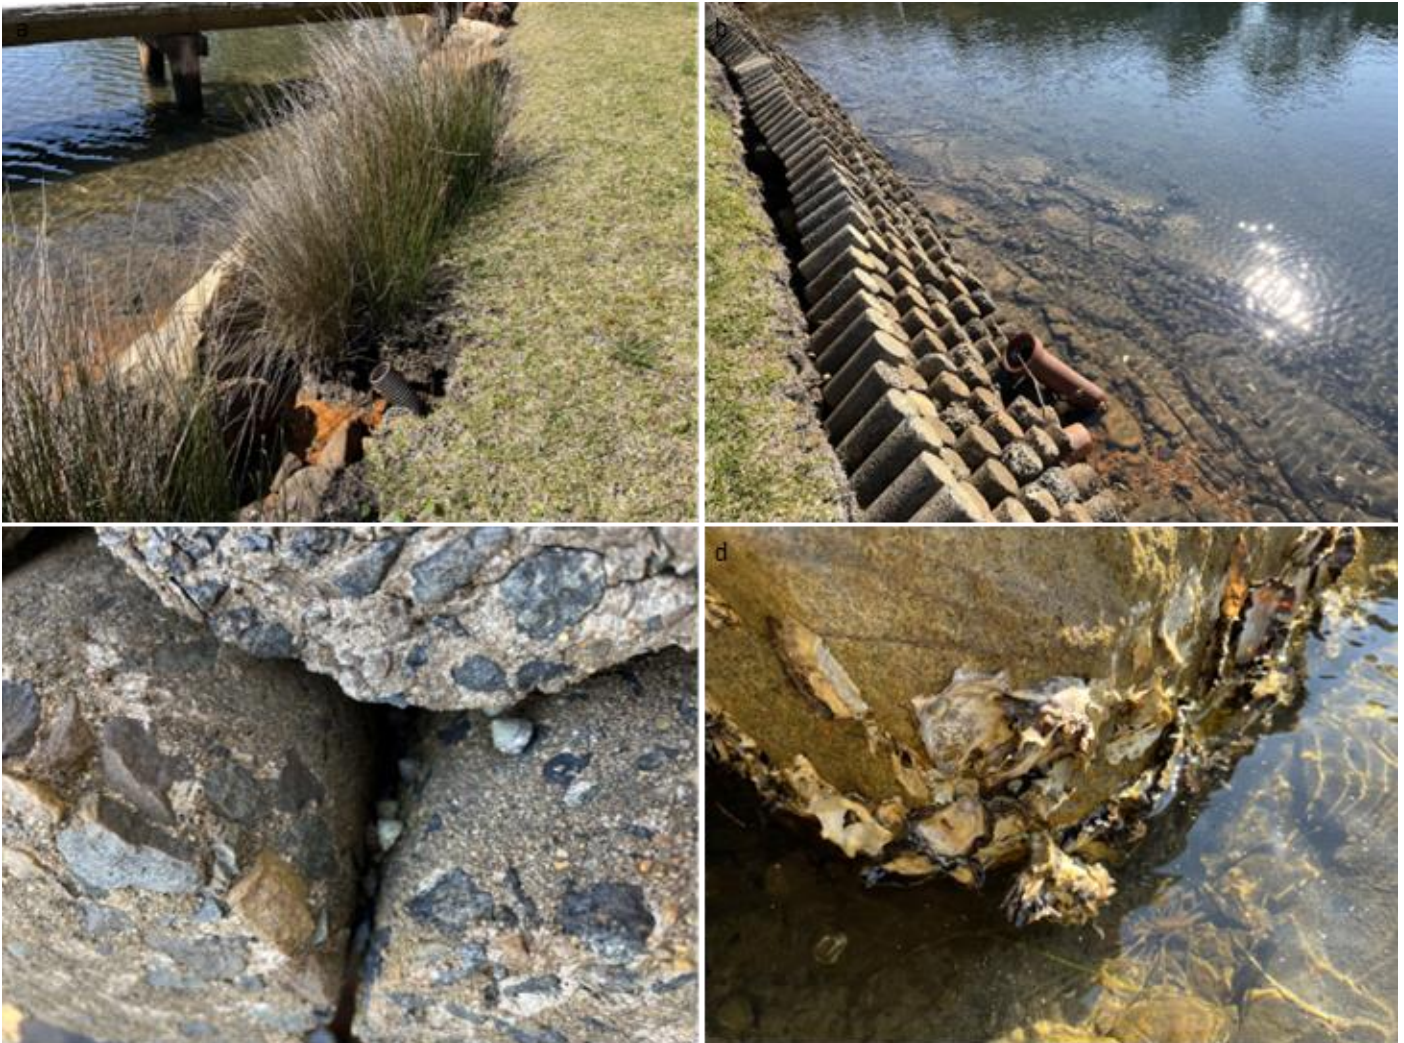
Intertidal habitat consists of broken rock shelf, rock and rubble, and fine estuarine silts and muds. Artificial intertidal habitat was provided by the man-made rock groyne, and dilapidated concrete retaining wall.

On the northern neighbouring property boundary above the Mean High-Water Mark (MHWM), a small area of Coastal Saltmarsh vegetation consisting of Sea Rush (*Juncus kraussii*) which is a characteristic species was observed (Figure 6). This saltmarsh stand is beyond the proposal footprint. No other marine vegetation, including macroalgae was recorded within the intertidal zone across the Subject Site.

Habitat in the high intertidal zones comprised of the concrete core retaining wall, retaining wall debris, broken rock platform, rubble, and as well as the rock groyne, which extended ~5 m seaward. Fauna was limited to mobile invertebrates including Variegated Shore Crab (*Cyclograpsus audouinii*) and occasional occurrences of Gold-mouth Conniwink (*Bembicium aurutum*) along the seawall. Substrate in the mid intertidal zone transitioned to silty, muddy estuarine sediment with rock and rubble, which supported similar species, and assemblages of the sessile Sydney Rock Oyster (*Saccostrea glomerata*). In the lower intertidal zone substrate predominantly consisted of muddy estuarine sediment, with high bioturbation of the sediment observed.

Figure 6: Typical intertidal habitat at the Subject Site, showing (a) Saltmarsh species *Juncus kraussii* above the MHW along northern boundary (b) concrete core retaining wall with broken rock and rubble (c) communities of *B. auratum* along the mid - lower retaining wall; and (d) lower intertidal areas with assemblages of *S. glomerata* and rubble.
