Site Location: Forestway Shopping Centre
Reference: GR23239
Report Date: 22/11/2023

RE: Geotechnical Investigation Report Review - Forestay Shopping Centre, Frenchs Forest, NSW

Forestway Shopping Centre

SYDGE217641AB

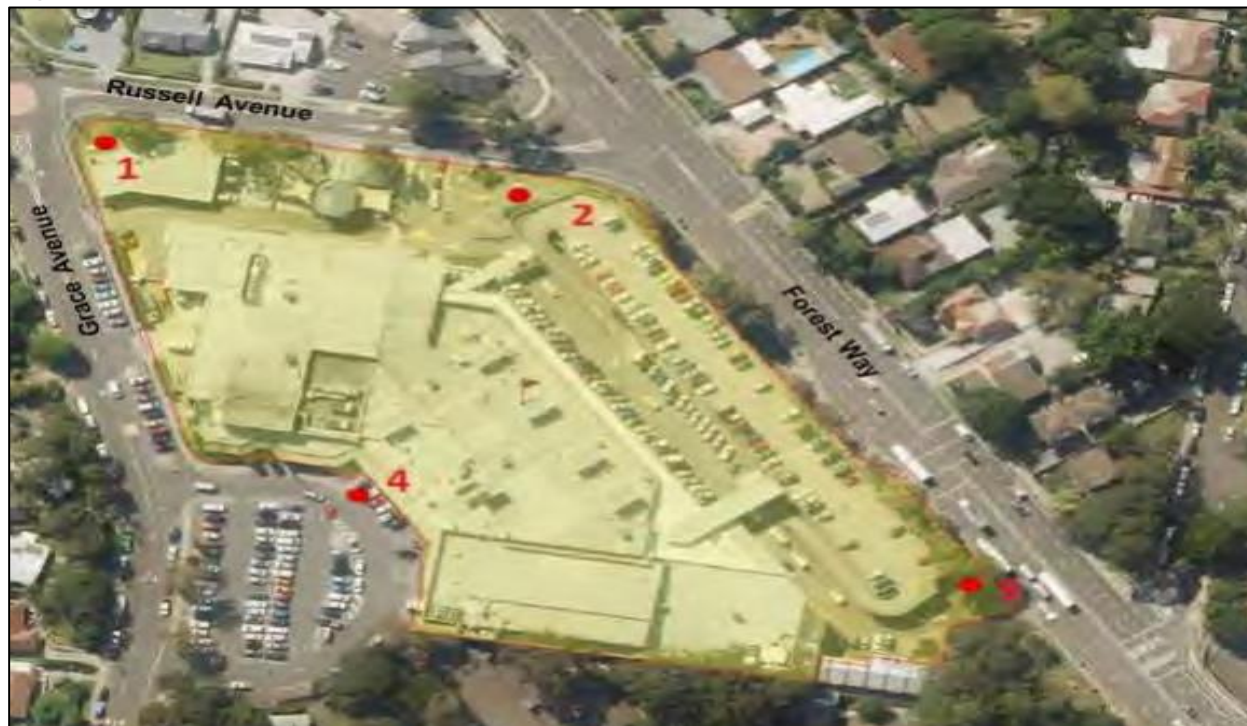
Figure 1: Site Location Plan

- Four boreholes (BH01 to BH04) were drilled as shown in Figure 1; and
- The soil and rock profiles encountered during the investigation have been characterised into the following geotechnical units as shown in Table 1.

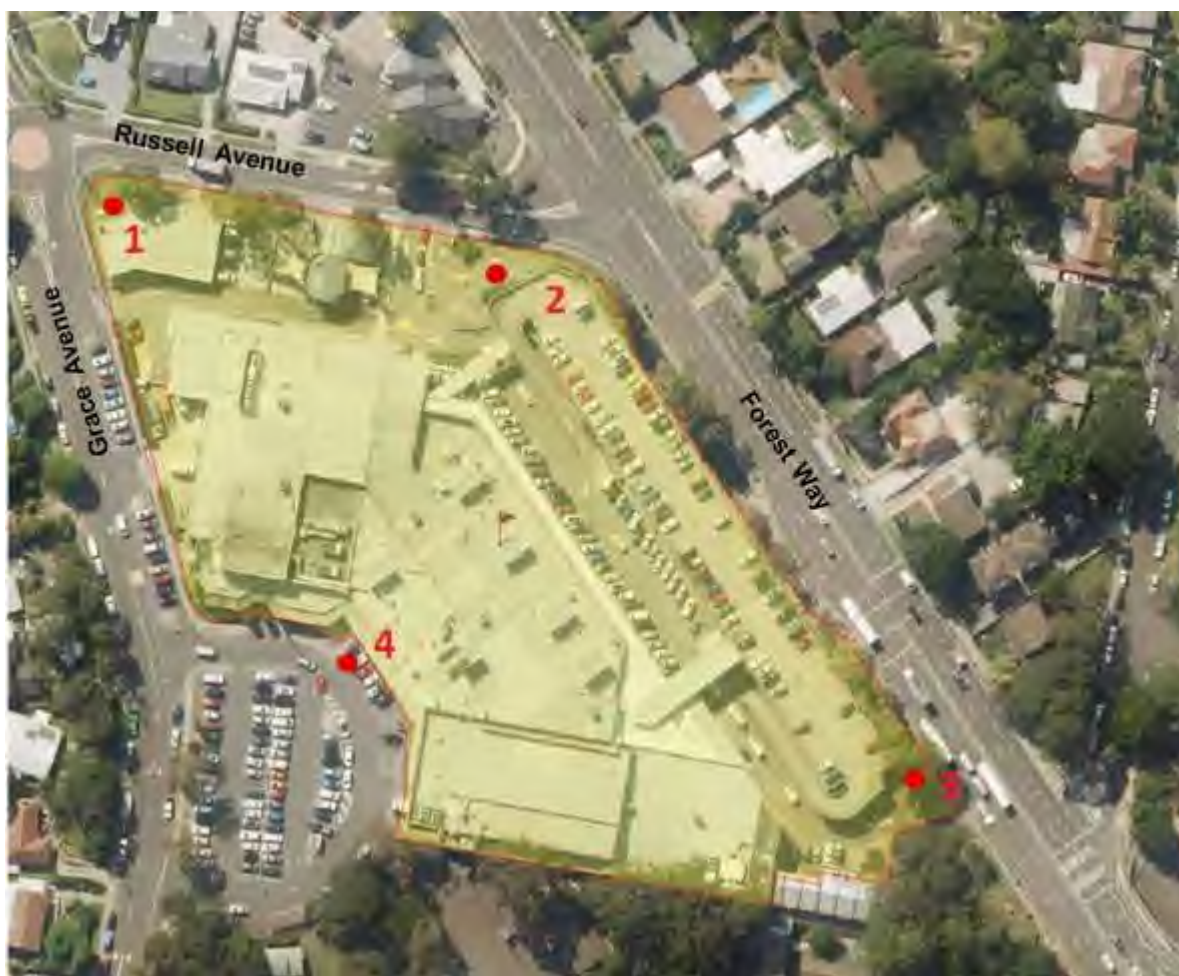
Figure 1 - Site Location Plan

The site location plan is shown in Figure 1. It is located within the existing Forestway shopping centre at the corner of Forest way and Russell avenue, Frenchs forest. The site is bounded by Forest way to the east, Grace avenue to the west and Russell avenue to the North. It is relatively flat, situated on a local high plateau. To the west of the site, beyond Grace avenue the ground slopes steeply (between 15° to 20°) west towards Lane Cove river. The southern section of the site, comprising the residential area, has a gentle (<5°) slope to the south, towards Warringah road.

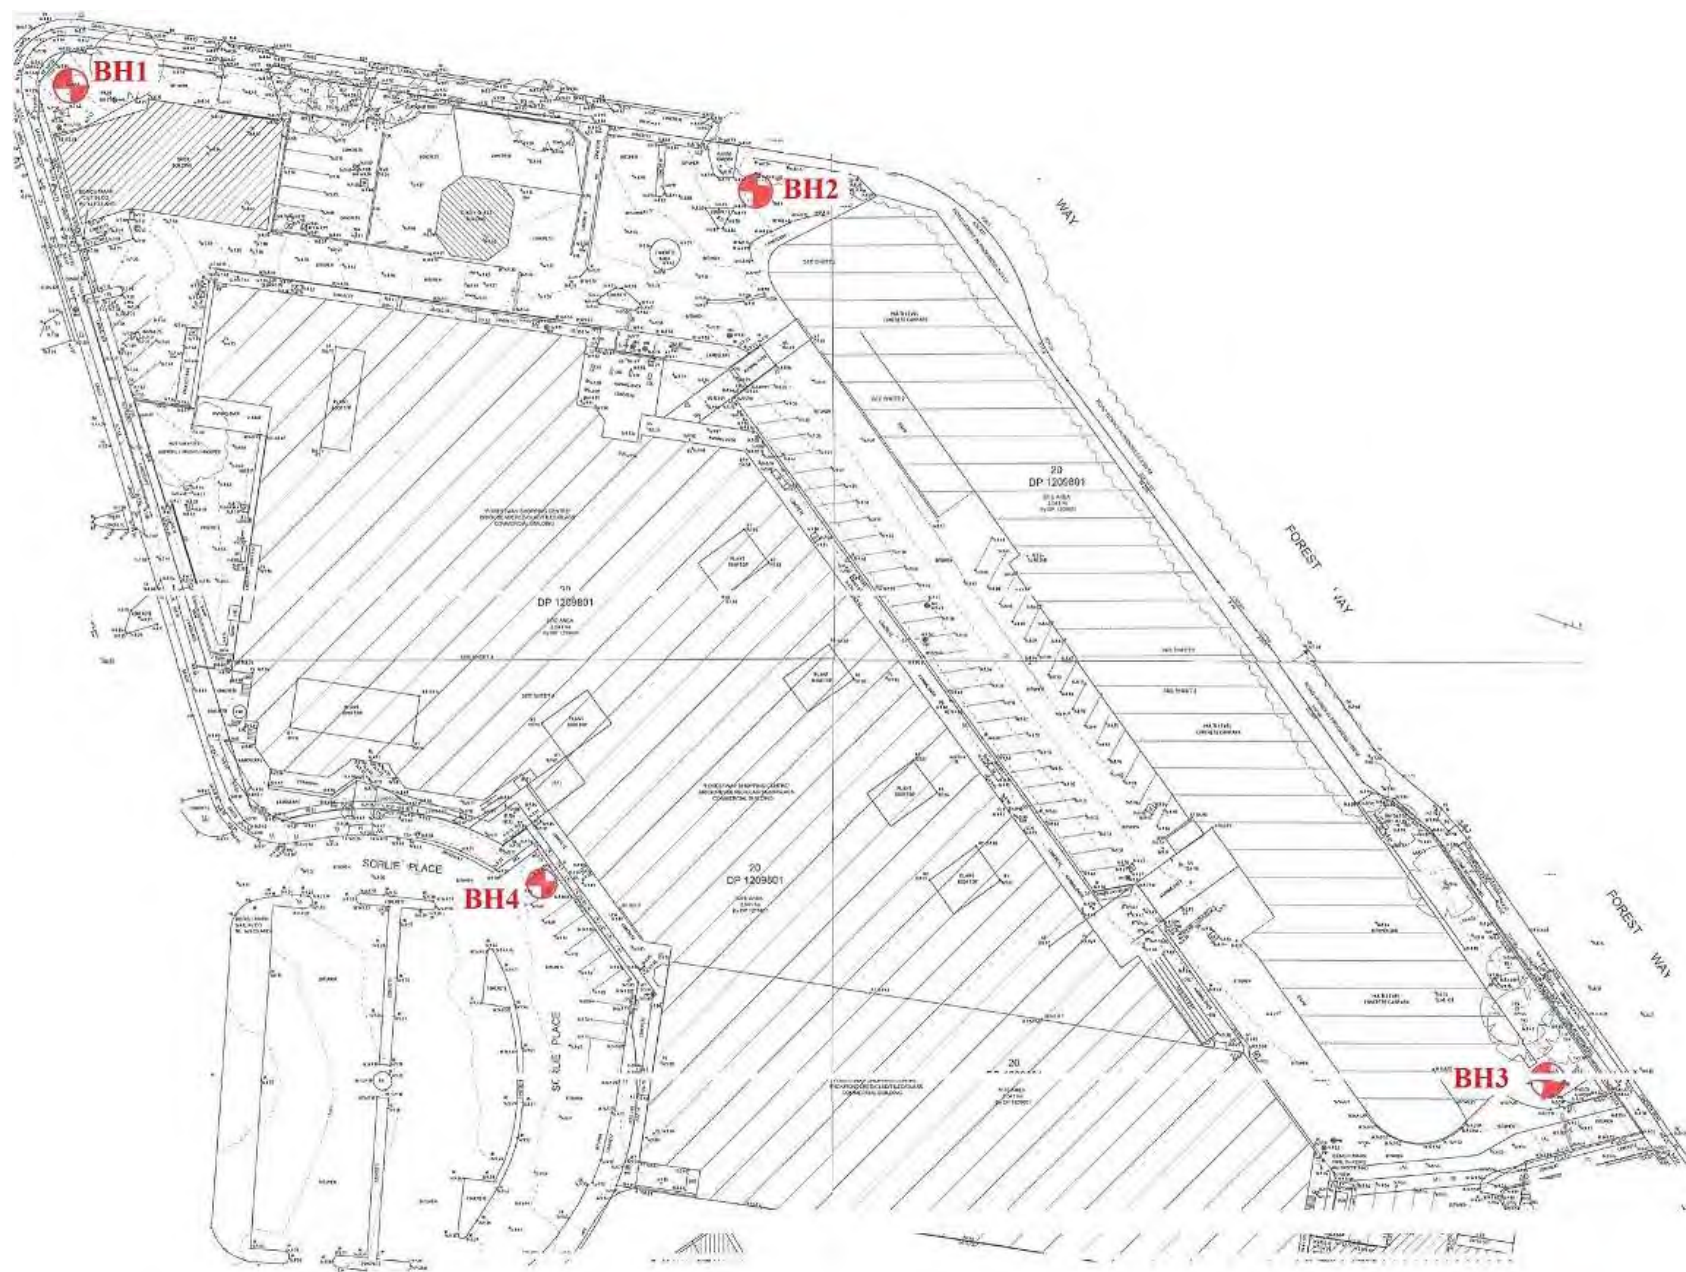
Appendix A - Borehole Location Plan

The fieldwork was carried out from 26 July to 30 July 2018 and comprised the drilling of four boreholes numbered BH1 to BH4. The borehole locations, as shown on the attached borehole location plan in Appendix A, were nominated by the client and determined on site by Coffey after the clearance of underground services at the drilling locations.

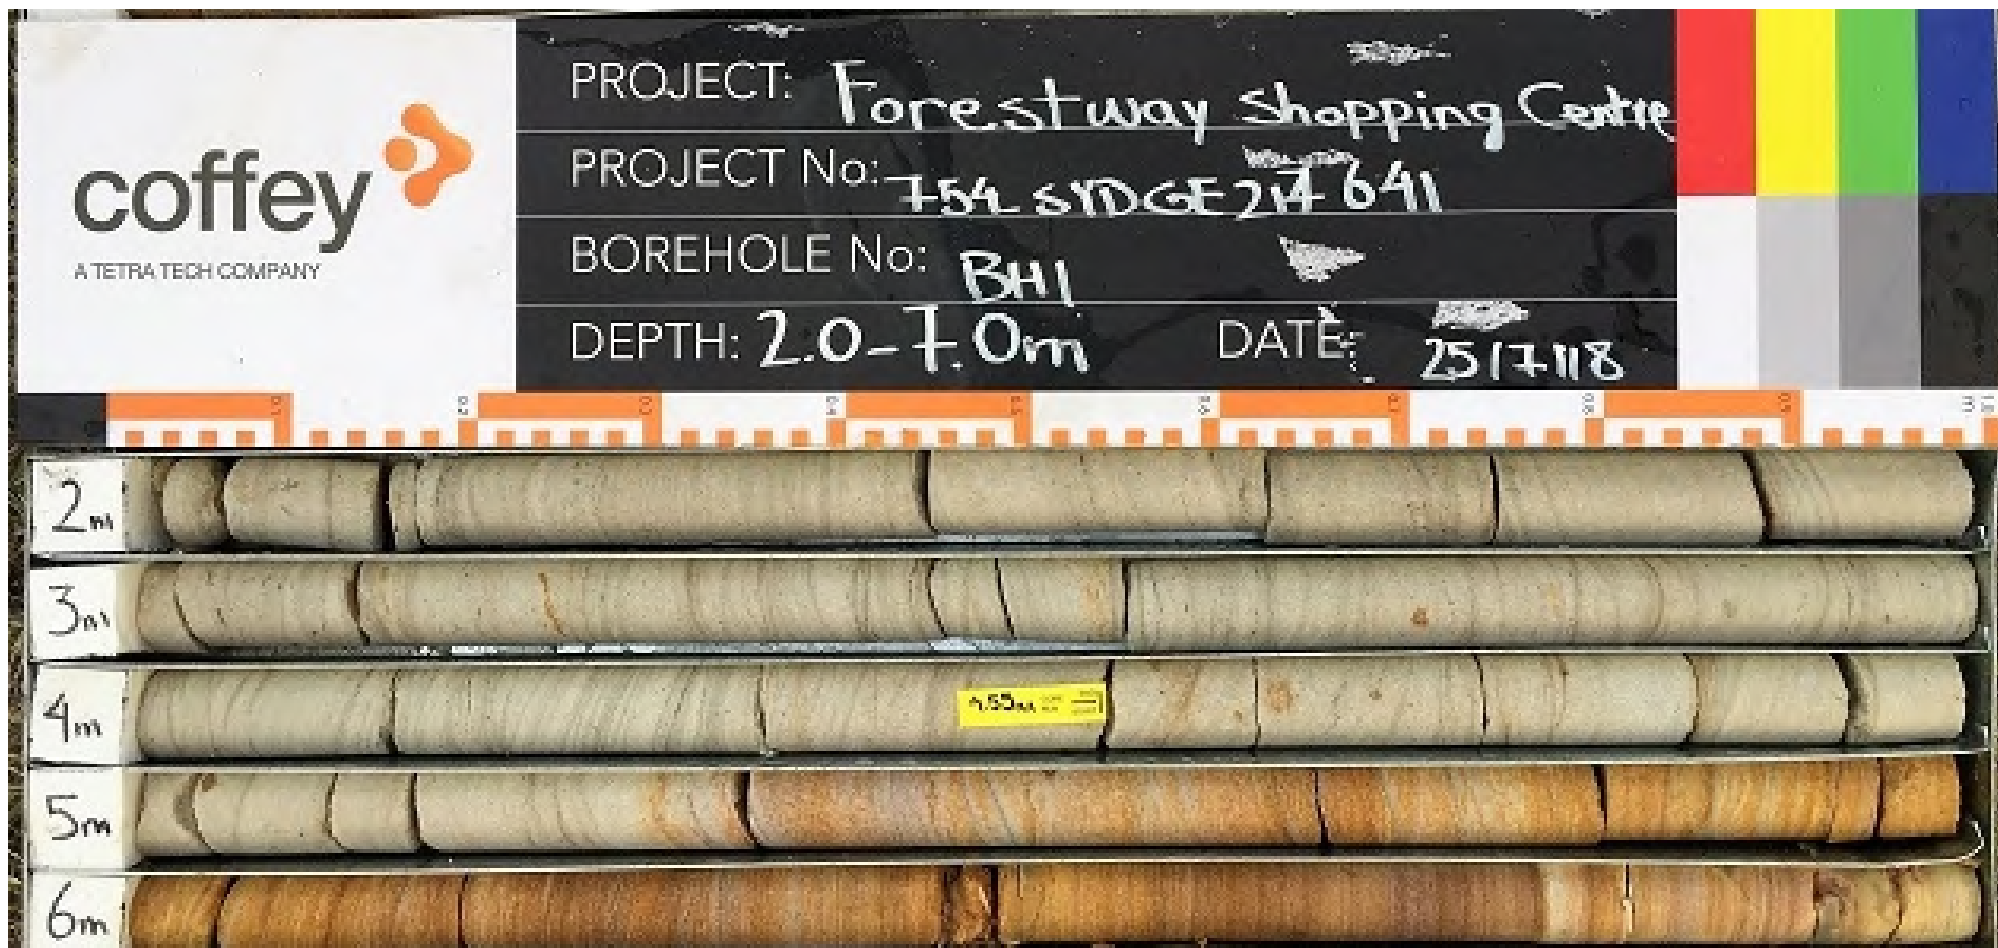
PointID : BH1 Depth Range: 2.00 - 7.00 m

drawn	LP	 	client:	Point Polaris		
approved	VN		project:	Forestway Shopping Centre Development Forestway Shopping Centre		
date	10/08/2018		title:	CORE PHOTOGRAPH BH1		
scale	N.T.S.		project no:	754-SYDGE217641	fig no:	FIGURE 1
original size	A4				rev:

Upon the refusal of augering in rock, the boreholes were then extended into the rock using NMLC sized diamond coring equipment to reach the required target depths. The recovered rock core was logged, boxed and photographed. To assist in assessing rock strength, the recovered rock core was Point Load Index tested at a nominal spacing of 1 meter.

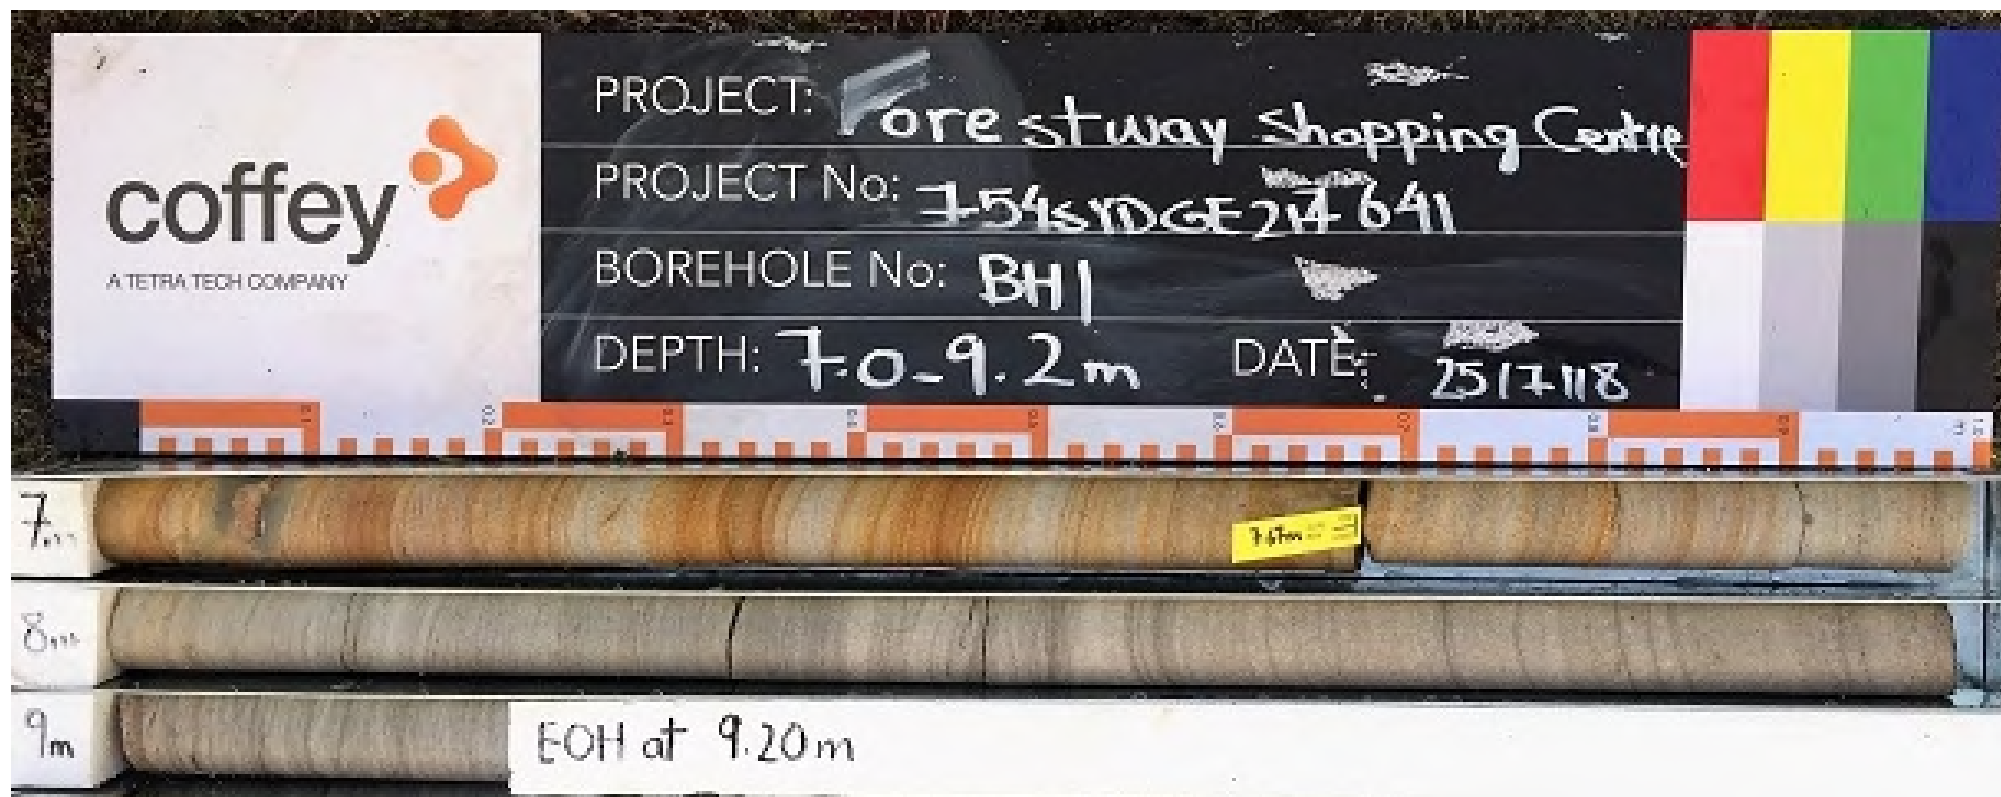
PointID : BH1 Depth Range: 7.00 - 9.20 m

drawn	LP	 	client:	Point Polaris		
approved	VN		project:	Forestway Shopping Centre Development Forestway Shopping Centre		
date	10/08/2018		title:	CORE PHOTOGRAPH BH1		
scale	N.T.S.		project no:	754-SYDGE217641	fig no:	FIGURE 2
original size	A4				rev:

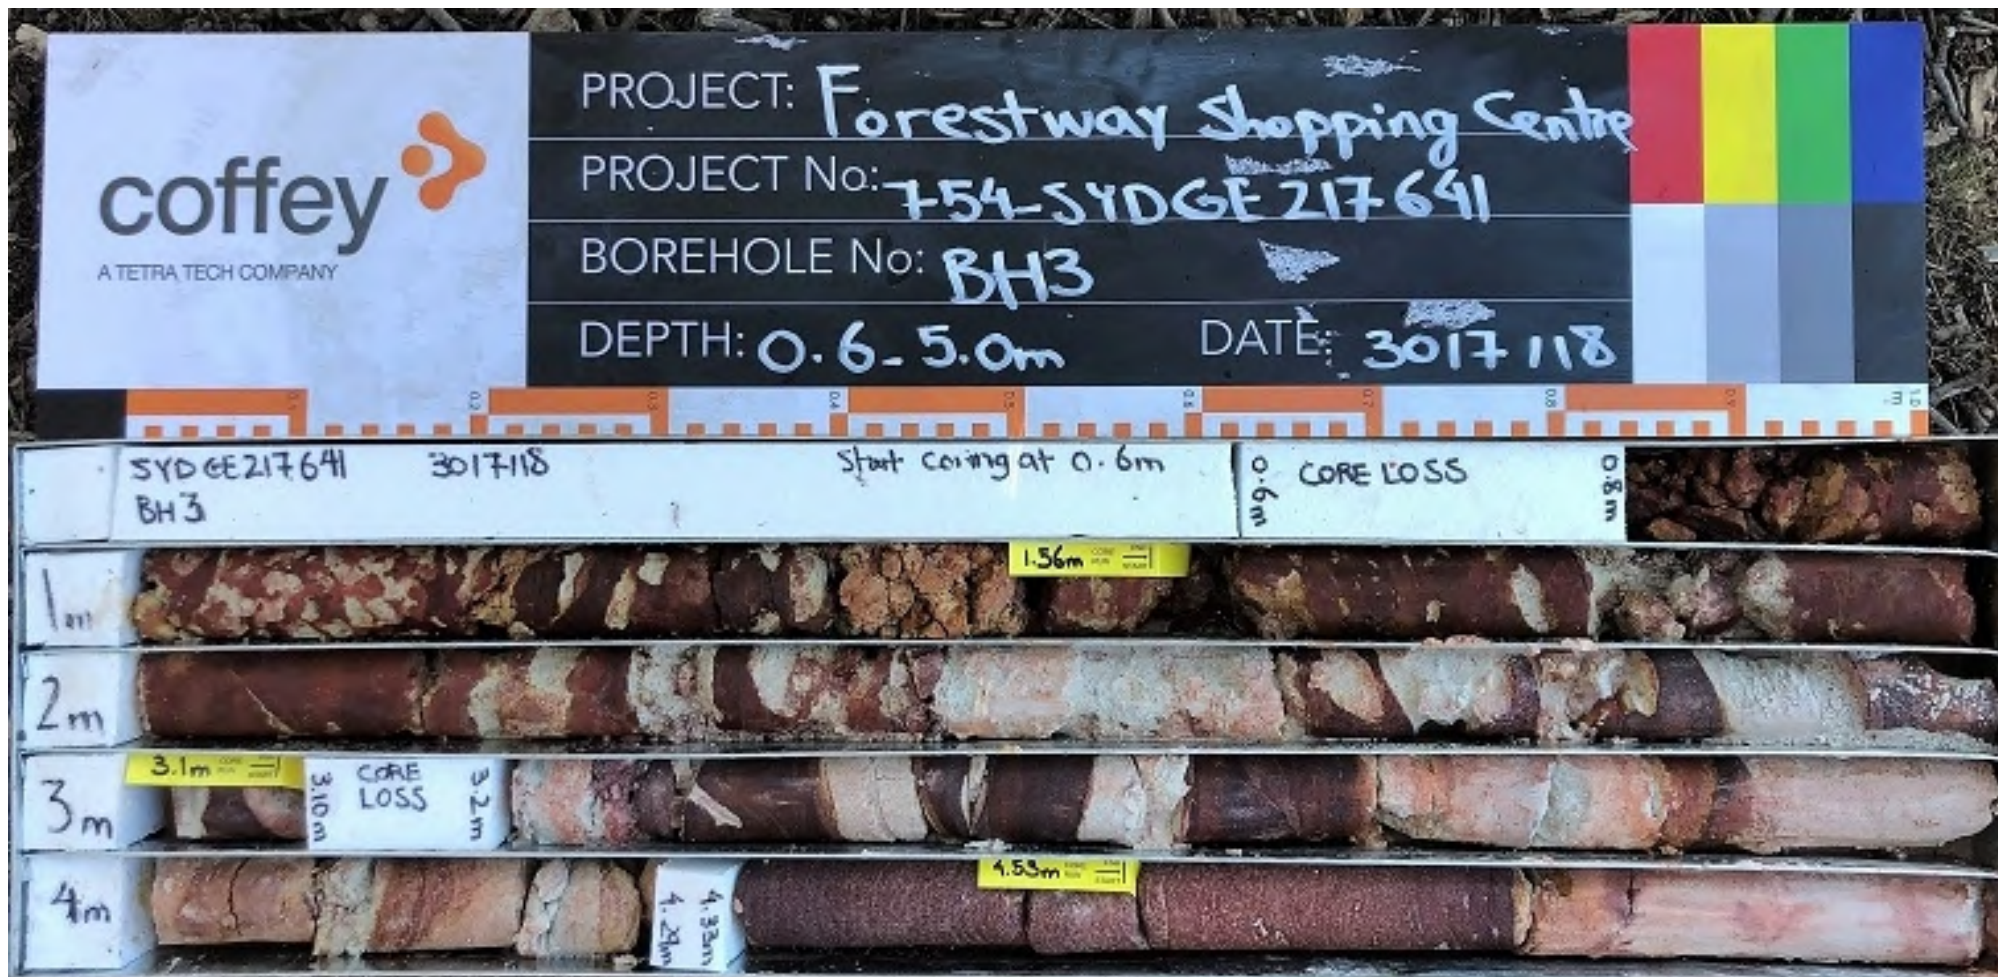
PointID : BH3 Depth Range: 0.60 - 5.00 m

drawn	LP	  A TETRA TECH COMPANY	client:	Point Polaris		
approved	VN		project:	Forestway Shopping Centre Development Forestway Shopping Centre		
date	10/08/2018		title:	CORE PHOTOGRAPH BH3		
scale	N.T.S.		project no:	754-SYDGE217641	fig no:	FIGURE 3
original size	A4				rev:

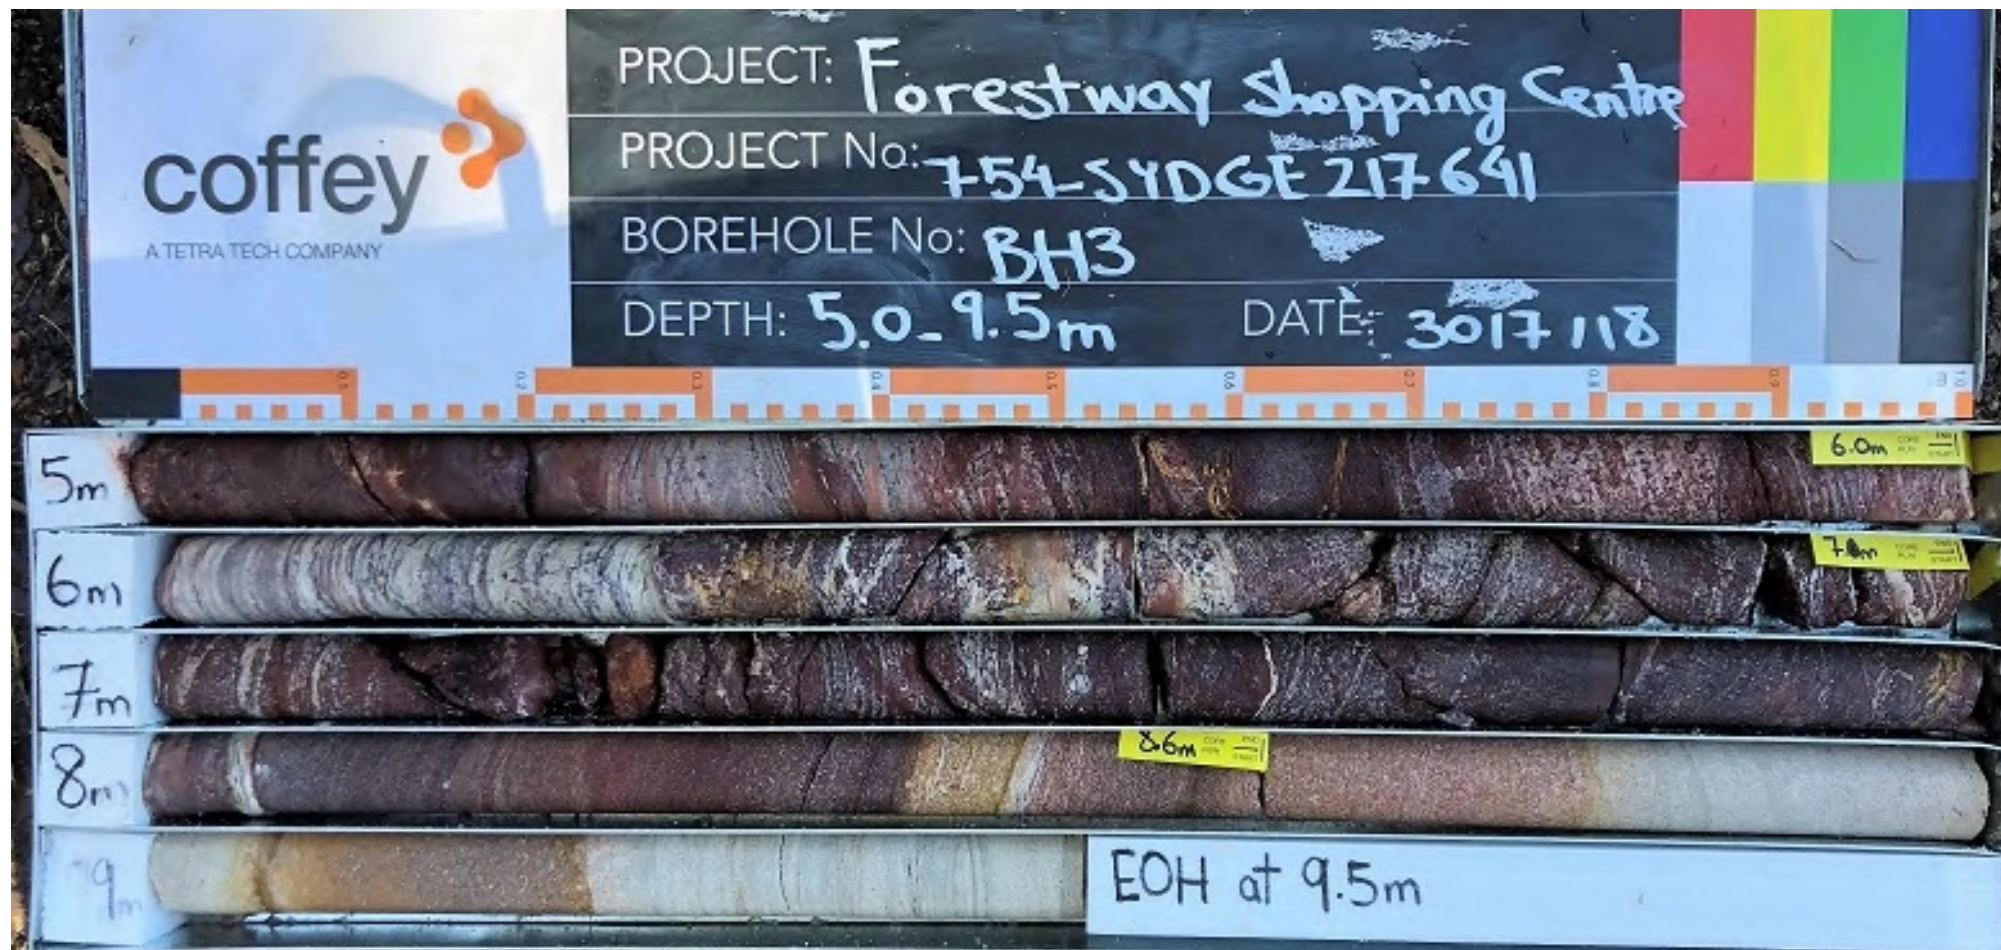
PointID : BH3 Depth Range: 5.00 - 9.50 m

drawn	LP	  A TETRA TECH COMPANY	client:	Point Polaris		
approved	VN		project:	Forestway Shopping Centre Development Forestway Shopping Centre		
date	10/08/2018		title:	CORE PHOTOGRAPH BH3		
scale	N.T.S.		project no:	754-SYDGE217641	fig no:	FIGURE 4
original size	A4				rev:
