REPORT TO
SYESUN PTY LTD

ON
DATA GAP INVESTIGATION

FOR
PROPOSED GARDEN CENTRE REDEVELOPMENT

AT
277 MONA VALE ROAD, TERREY HILLS, NSW

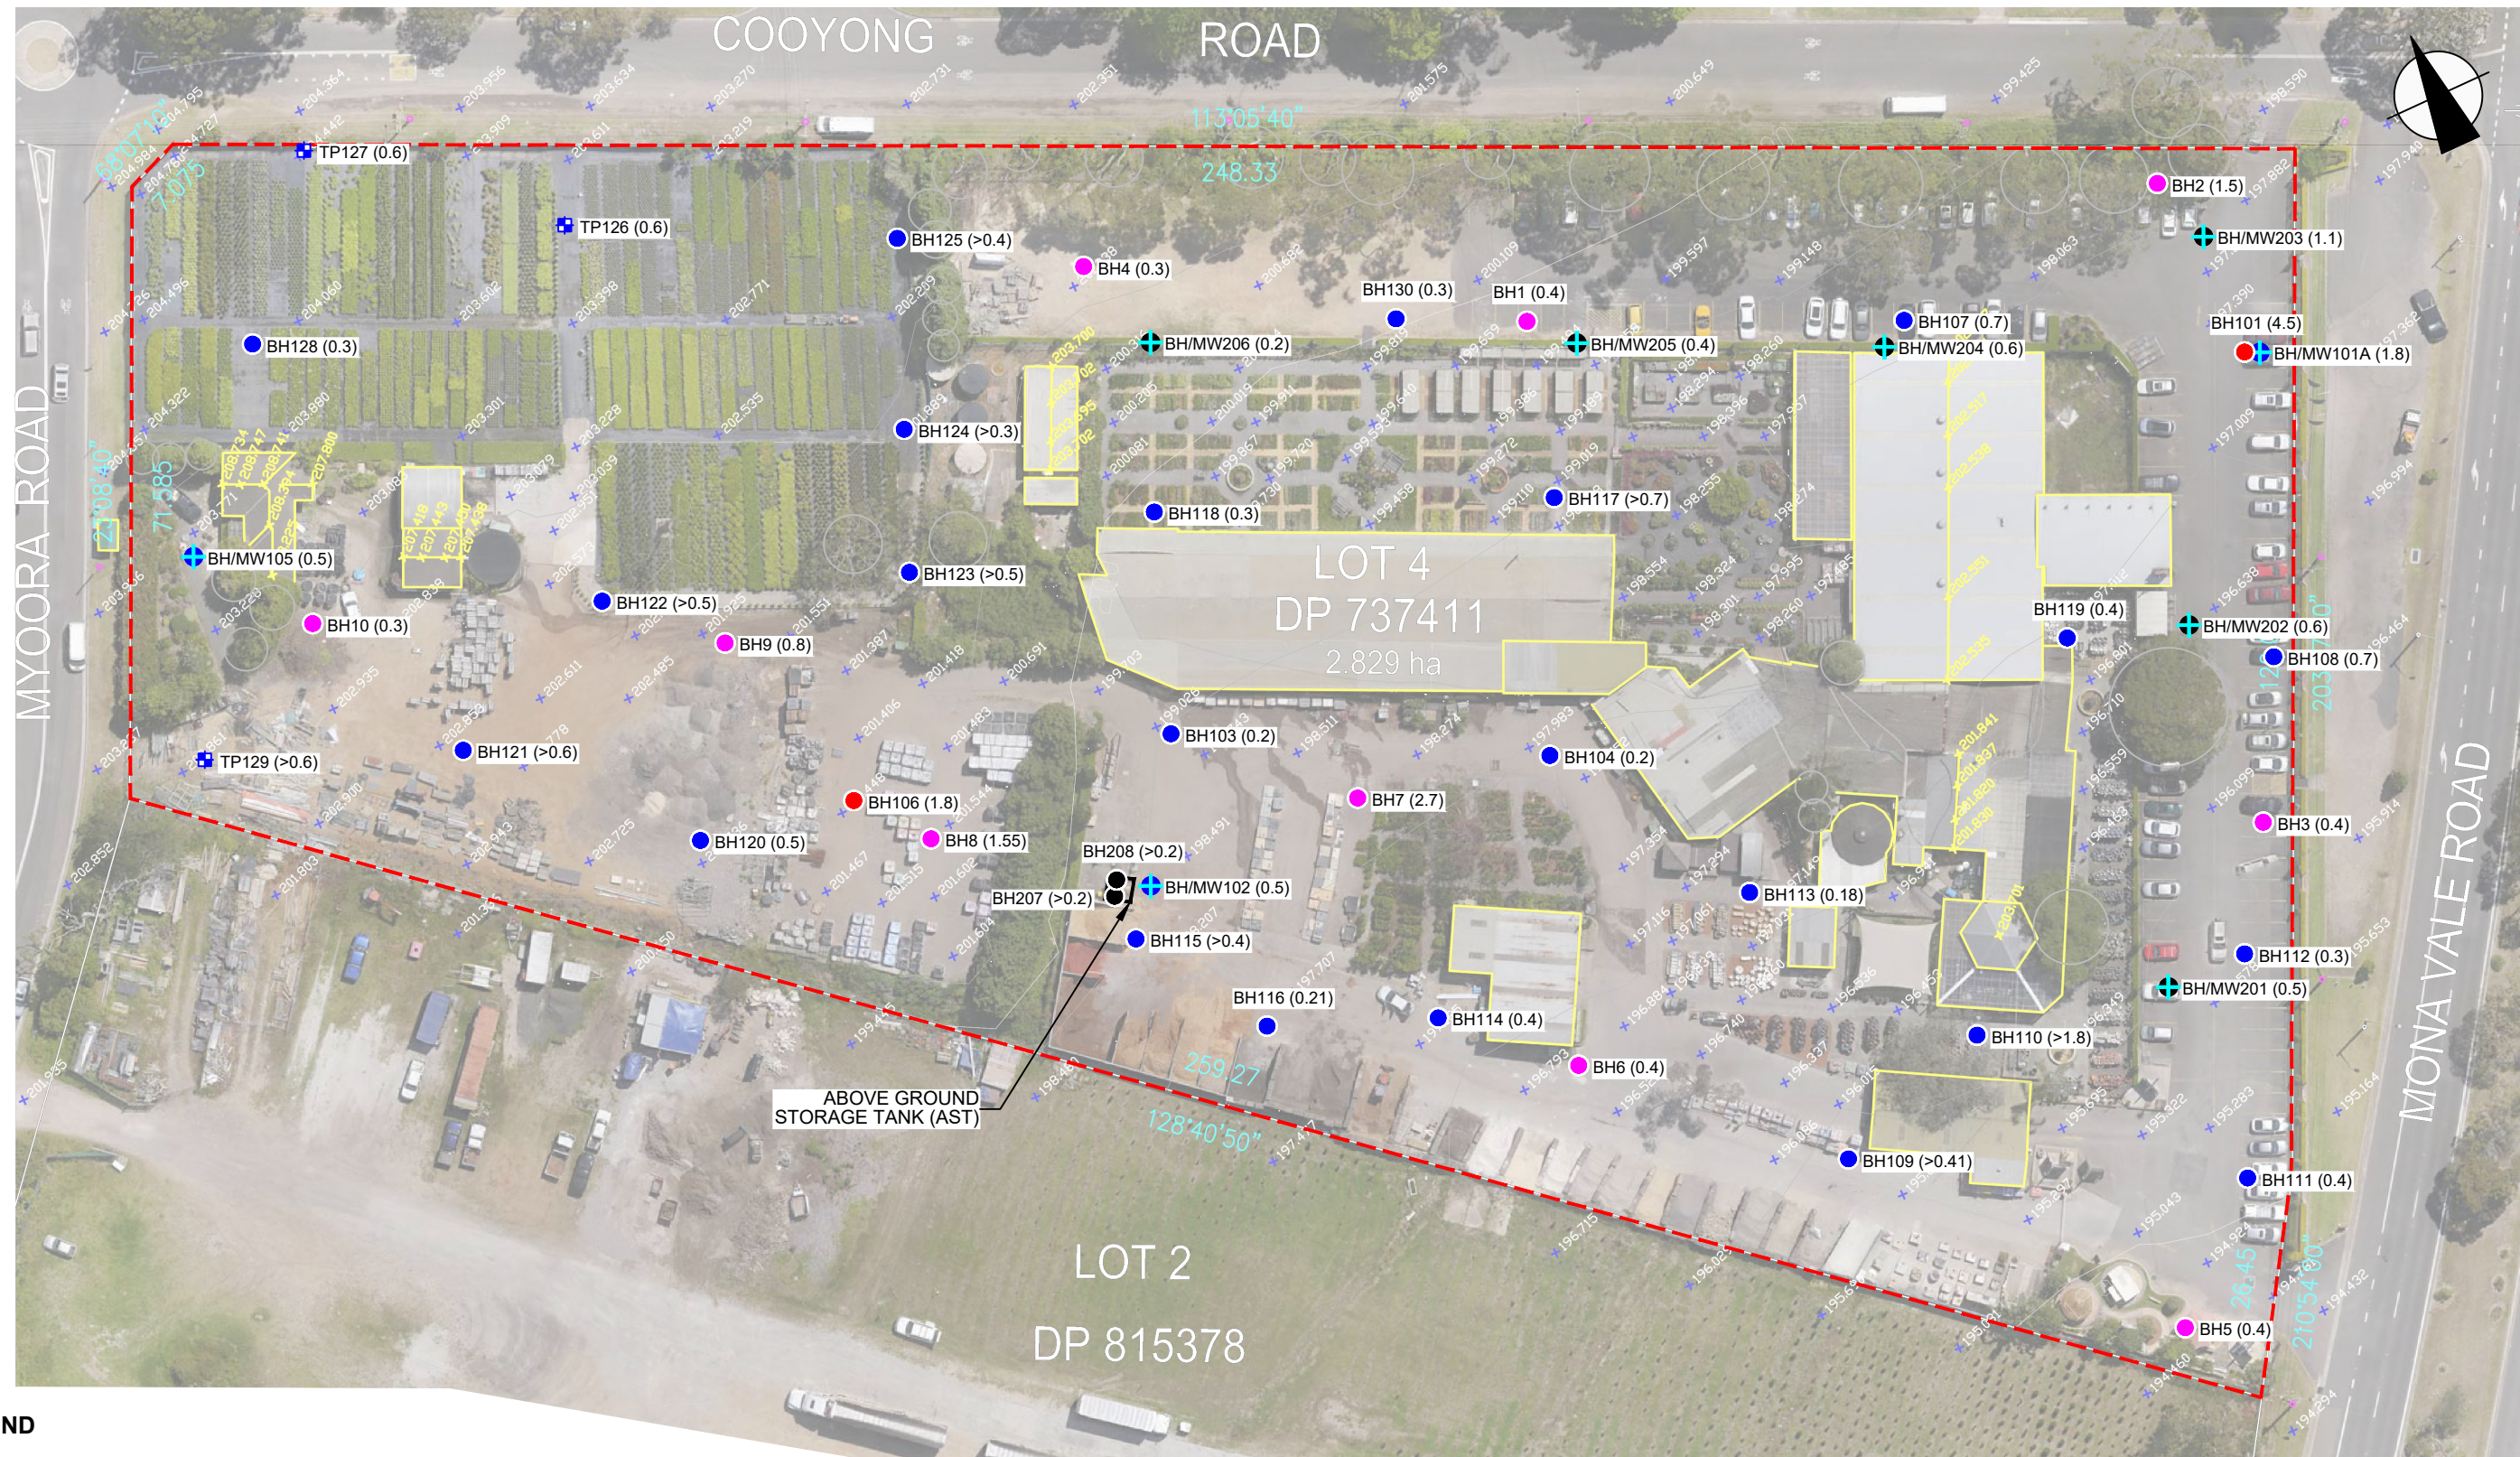
- APPROXIMATE SITE BOUNDARY
- BH(Fill Depth) BOREHOLE LOCATION, NUMBER AND DEPTH OF FILL (m) (JKE, 2021)
- BH(Fill Depth) BOREHOLE LOCATION, NUMBER AND DEPTH OF FILL (m) (JKE, 2022)
- BH/MW(Fill Depth) BOREHOLE AND GROUNDWATER MONITORING WELL LOCATION, NUMBER AND DEPTH OF FILL (m) (JKE, 2022)
- TP(Fill Depth) TEST PIT LOCATION, NUMBER AND DEPTH OF FILL (m) (JKE, 2022)
- BH(Fill Depth) BOREHOLE AND HAZARDOUS GROUND GAS WELL LOCATION, NUMBER AND DEPTH OF FILL (m) (JKE, 2022)
- BH208 BOREHOLE LOCATION, NUMBER AND DEPTH OF FILL (m)
- BH/MW201 BOREHOLE AND HAZARDOUS GROUND GAS WELL LOCATION, NUMBER AND DEPTH OF FILL (m)

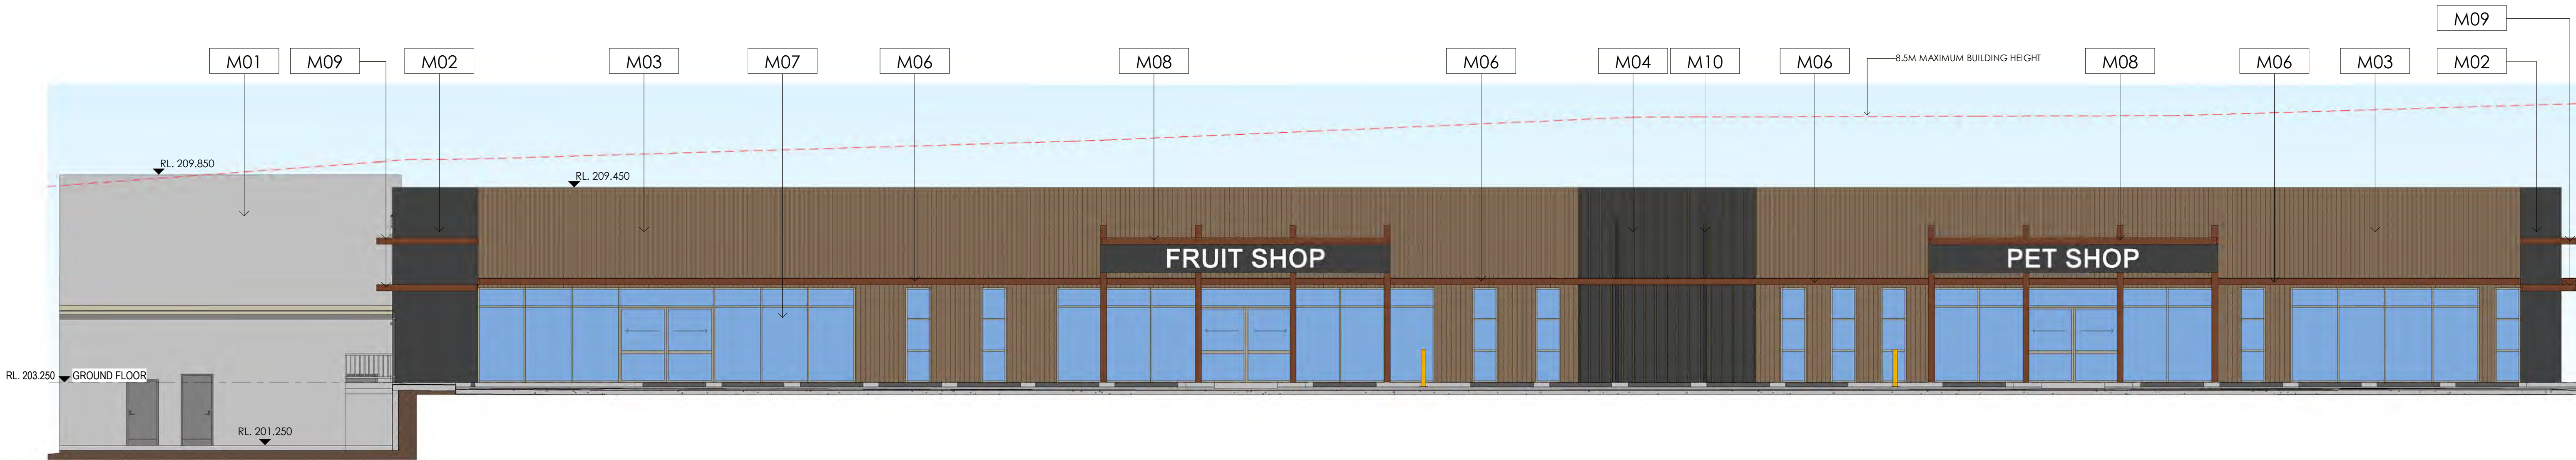
ELEVATION- SHEET 1

1 NORTH ELEVATION
Scale: 1 : 100

2 EAST ELEVATION
Scale: 1 : 100
