Marine Habitat Survey

41 Robertson Road, Scotland Island

Prepared For: Copley Marine Consulting

Report Date: 23 June 2023

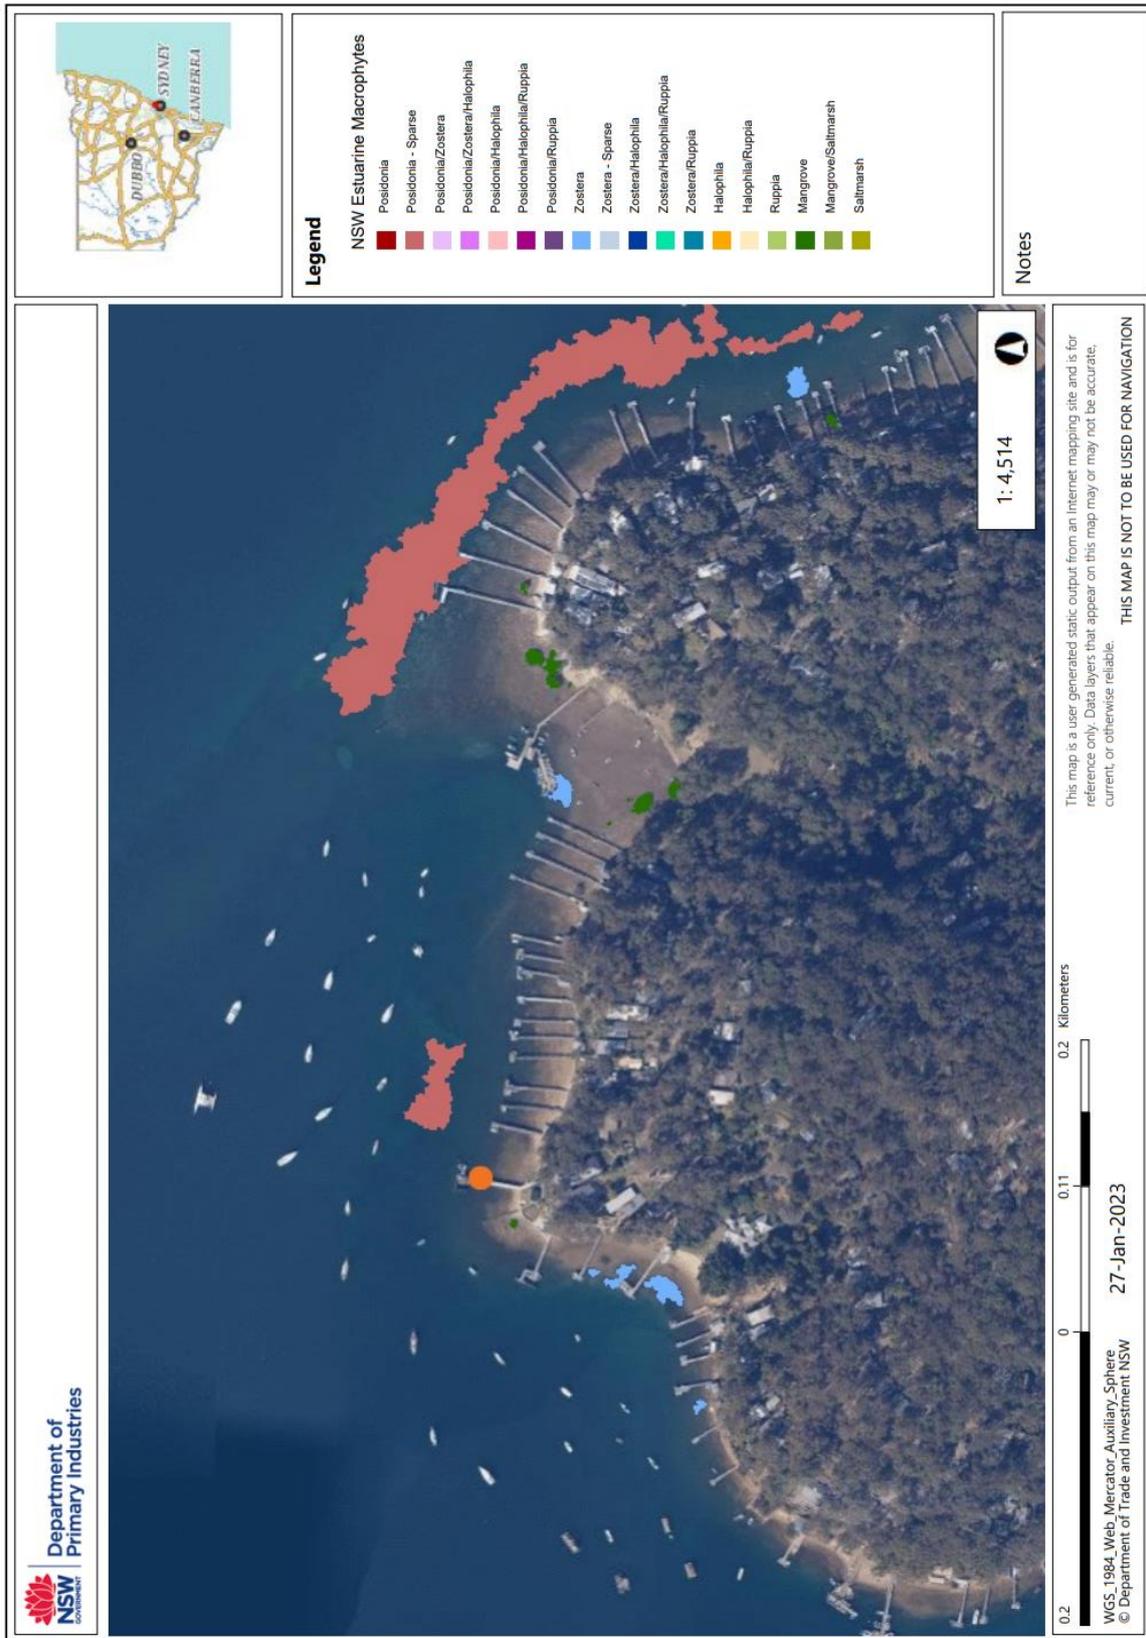
Figure 2: NSW DPI Fisheries mapping in the vicinity of the Subject Site (Source: NSW DPI 2023).

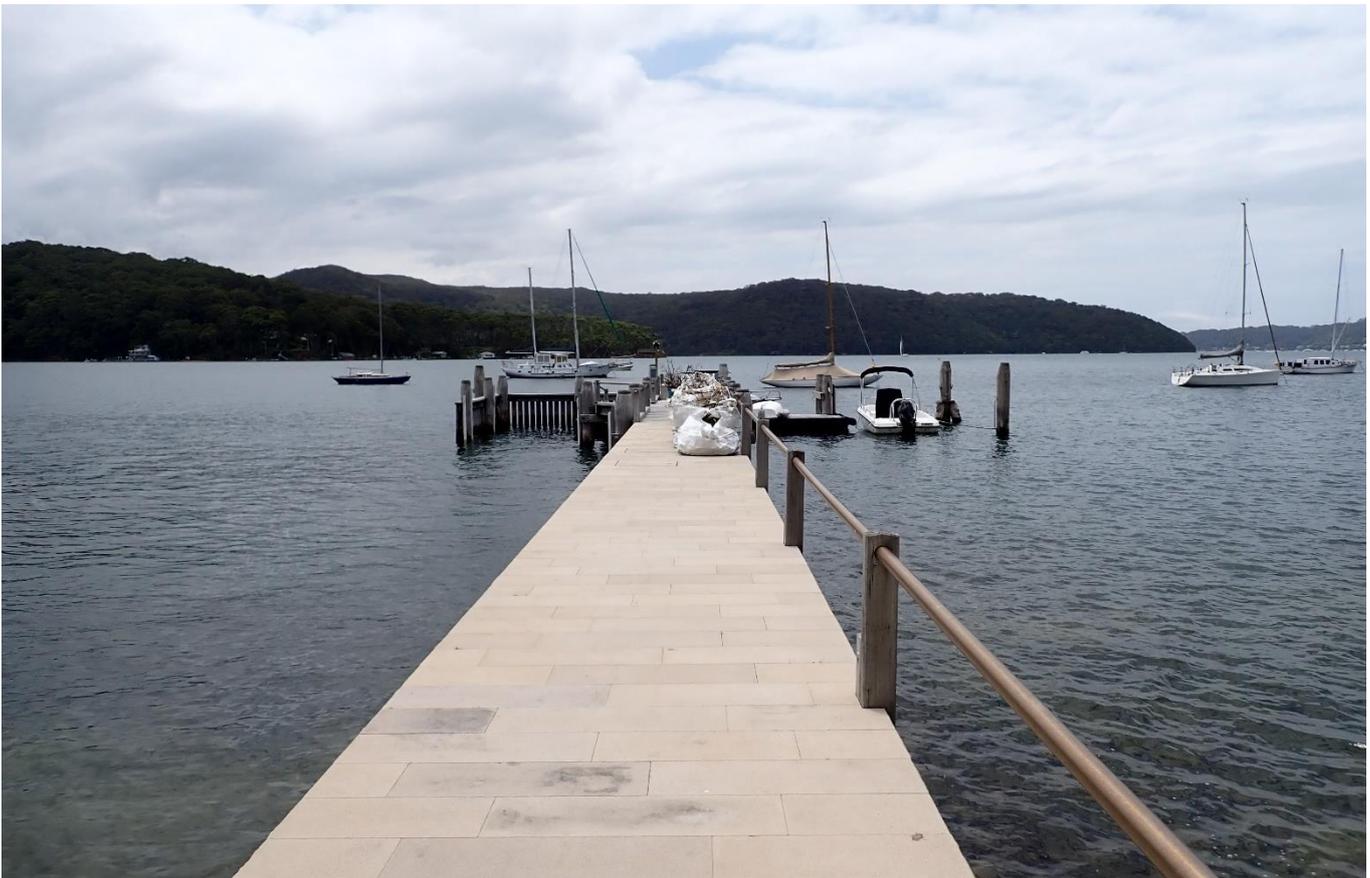
Figure 3: Existing jetty, pontoon, mooring pens and wave attenuator at the Subject Site.

The proposal utilises some of the footprint of the existing structures, including the stone jetty and part of the timber jetty, while also retaining two jetty piles and two mooring piles at the Subject Site (Figure 3 and 4).

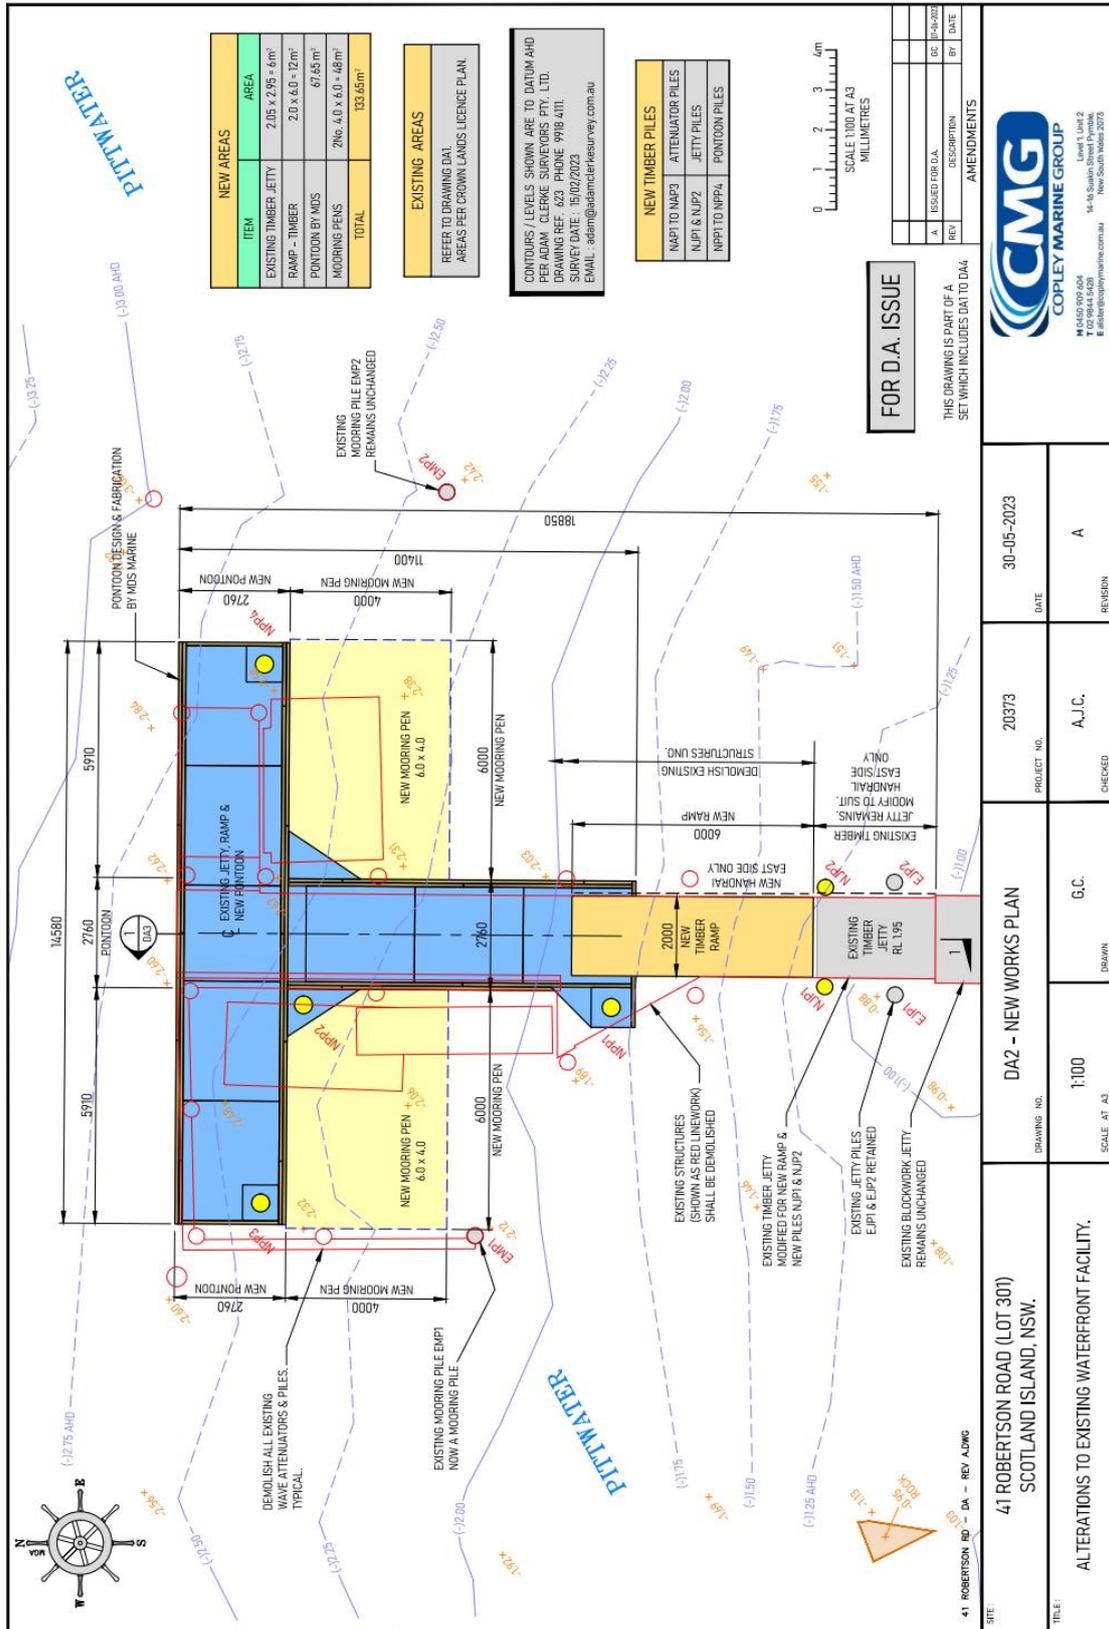
Figure 4: Proposed modifications to the waterfront structures at the Subject Site.

- Removal of all existing wave attenuators and associated piles,
- Removal of existing ramp, pontoons and stairs, and associated piles,
- Modification of by partial removal of existing timber jetty to connect to new timber ramp,
- Construction of new timber ramp (2.0 x 6.0 m) connecting existing timber jetty to new pontoon,
- Construction of new t-shaped large pontoon (67.65 m²) with four new timber piles; and
- Construction of two new mooring pens (4.0 x 6.0 m each).

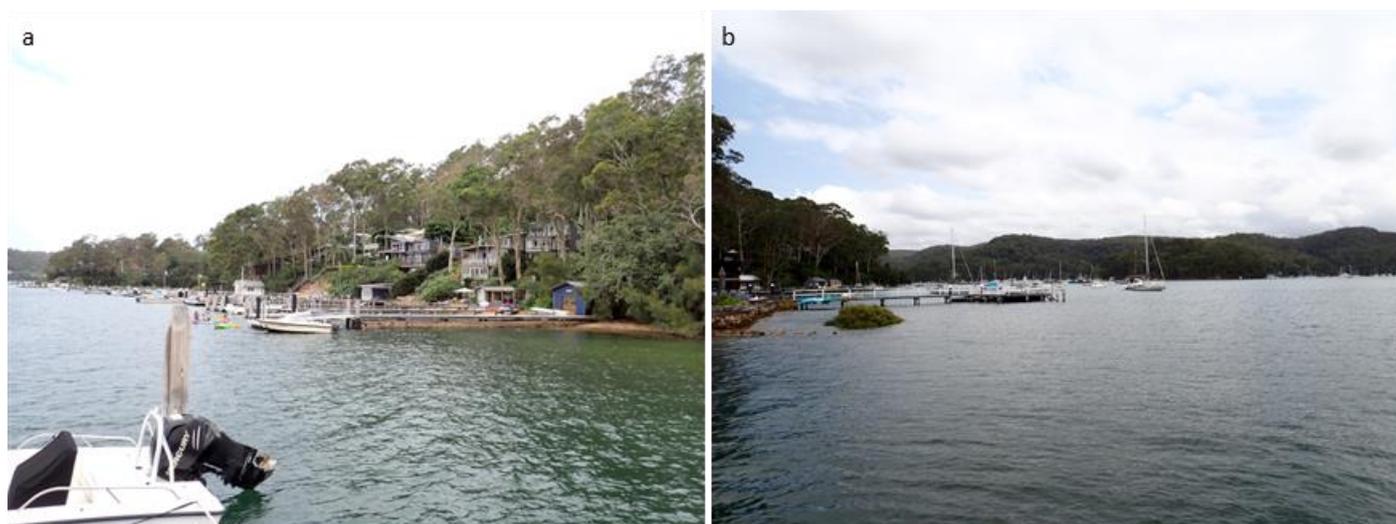
Figure 5: Waterfront structures to the (a) east and (b) west of the Subject Site.

The adjoining shoreline is a moderately sloping, modified domestic waterfront amongst dense vegetation on the northern shore of Scotland Island, with a northerly aspect across Pittwater to Morning Bay. Waterfront structures at the Subject Site include a sandstone block seawall approximately 1.5 m in height, an existing stone jetty with a timber ramp and sea stairs, two pontoons and mooring pens, and a wave attenuator on the western pontoon. To the east and west of the Subject Site, waterfront structures include a combination of natural shoreline and sandstone block seawalls, with stone jetties, pontoons, mooring pens and boatsheds (Figure 5).

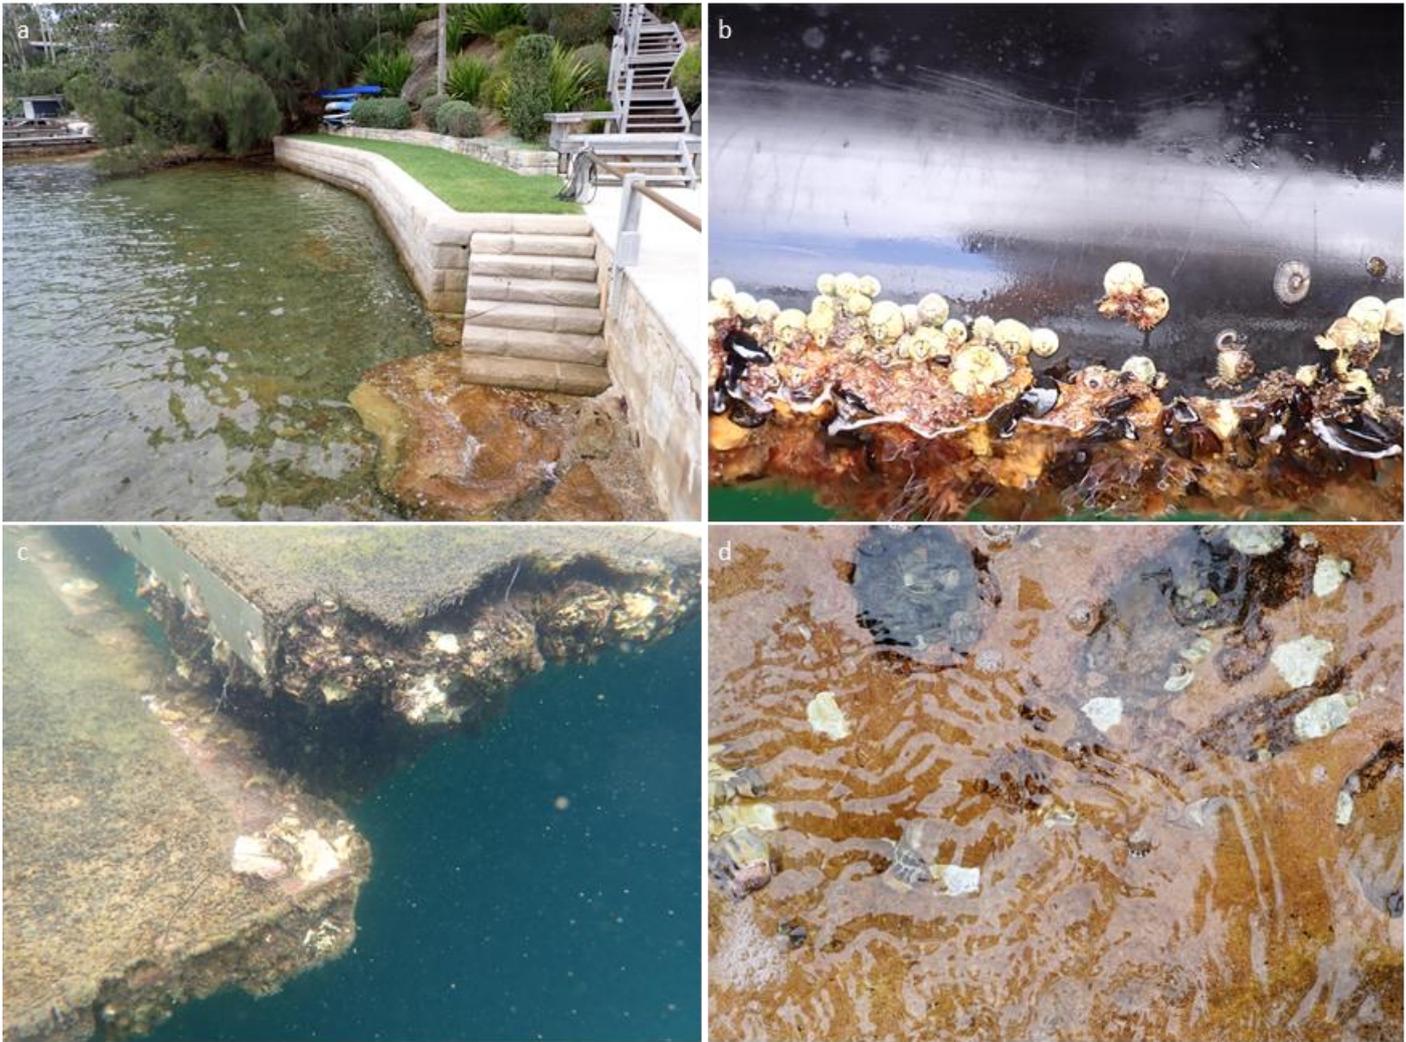
Intertidal habitat comprised of a combination of sand, rubble and shallow rock shelf, with artificial habitat provided by the existing sandstone block seawall and jetty sides, stairs and piles. In higher intertidal areas on the stone seawall, stairs and rockshelf, intertidal species were limited to Blue Periwinkles (*Nodilittorina unifasciata*), whilst upper sections of existing piles and the along the water line of existing pontoons, common intertidal organisms included Rose Barnacles (*Tesseropora rosea*) and False Limpets (*Siphonaria denticulata*). Mid and lower intertidal zones on stone walls and natural rock and rubble habitat were dominated by dense assemblages of Sydney Rock Oysters (*Saccostrea glomerata*), with other common intertidal invertebrates including Pacific Oysters (*Crassostrea gigas*), Oyster Limpets (*Patelloida mimula*), Striped-mouth Conniwinks (*Bembicium nanum*) and Mulberry Whelks (*Morula marginalba*). Lower intertidal sections existing structures were also found to support Blue Mussels (*Mytilus edulis*).

Intertidal zones near the Low Water Mark (LWM) among the sand and rubble sediment to the west of the existing jetty supported a small patch of medium-density *Zostera capricorni* seagrass, that was observed to have leaf length of approximately 5-10 cm. Areas near the LWM on both sides of the jetty also included the common macroalage, Neptune's Necklace (*Homosira banksia*). No mangroves or saltmarsh were observed on the Subject Site; however, one Grey Mangrove (*Avicennia marina*) was present on the adjacent property, approximately 15 m to the west of the proposal footprint.

Figure 6: Typical intertidal habitat at the Subject Site showing (a) sandstone block seawall and jetty, with rockshelf, sand and rubble shoreline, (b) *T. rosea*, *S. denticulata* and *M. edulis* on the pontoon sides, (c) assemblages of *C. gigas* and *T. rosea* on upper sections of stairs; and (d) *M. marginalba* and *B. nanum* on the lower intertidal rock platform with *S. glomerata* footings.

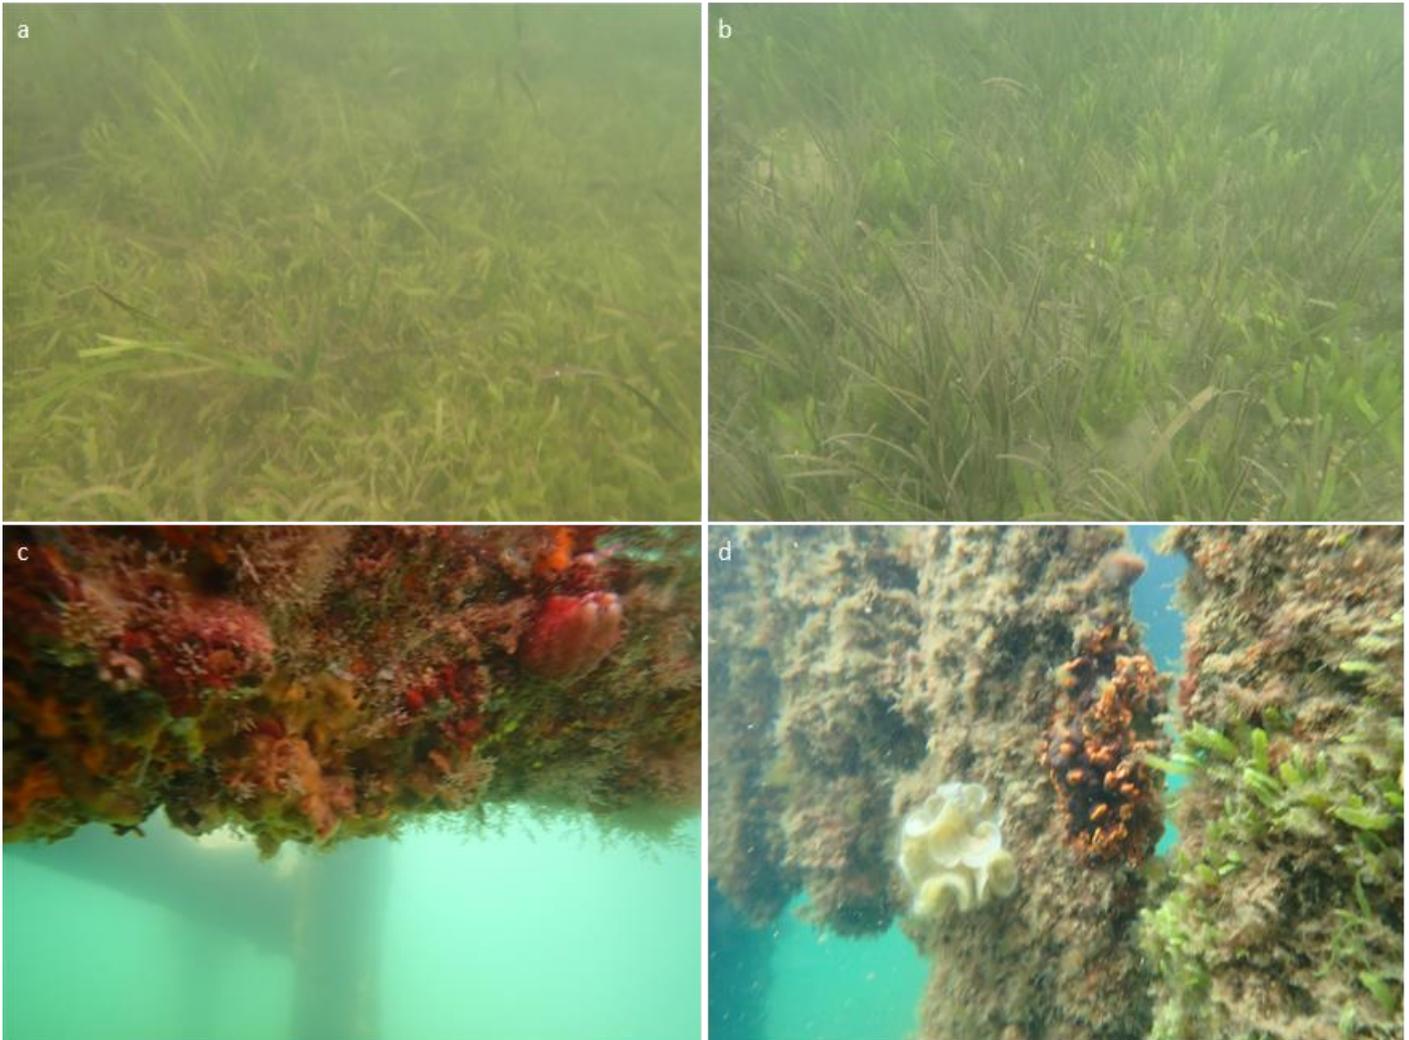
high-density beds of the invasive *Caulerpa taxifolia* seagrass species choking the available substrate (Figure 7). A fringing stretch (approximately 15.0 x 3.0 m) of very sparse *Zostera capricorni* was recorded to occur within this *C. taxifolia*, with the eastern side of the bed mixed with very sparse stands of the Endangered *Posidonia australis* seagrass (Figure 7; Figure 8). To the west of the jetty, *Z. capricorni* beds were present across much of the seabed between the shore and the inner reaches of the western mooring pen. Seagrass beds started within 2-3 m of the jetty wall and extended to the west, with a large medium-density bed closer to shore, a fringing low-density bed approximately 15 m from shore and two smaller low-density beds on the southern border of the mooring pen (Figure 8). In deeper waters, a small bed of low-density *P. australis* was recorded approximately 10 m to the north of the existing wave attenuator, while a long fringing bed of very sparse *P. australis* was recorded approximately 12 m north of the existing structures (Figure 8). A majority of the native seagrass stands were observed to have been displaced by the extensive growth of *C. taxifolia* throughout the Subject Site, which has evidently prevented high density growth for these species.

Artificial subtidal habitat provided substrata for a high diversity of marine biota. Artificial habitat was observed to have heavy fouling from turfing brown algae (likely *Ectocarpus* sp.), with growths of *P. crassa* and *C. taxifolia* common across all artificial substrata (Figure 7). The underside of pontoons, wave attenuator and piles were observed to support a rich biodiversity with varied macroalgae including *C. fragile* in addition to those aforementioned, solitary ascidians, high densities of various bryozoans including the Common Bugula (*Bugula neritina*) and Encrusting Bryozoans (*Watersipora subtorquata*) and sporadic occurrences of Purple Encrusting Sponges (*Haliclona permollis*) in deeper areas (Figure 7).

Figure 7: Typical subtidal habitat within the study area, showing (a) sparse *P. australis* stands amongst dense *C. taxifolia*, (b) medium-density bed of *Z. capricorni*, (c) high biodiversity on the underside of pontoons, including varied macroalgae and bryozoans; and (d) diverse species on the wave attenuator, showing *P. crassa*, *W. subtorquata*, *H. permollis* with turfing algae and some *C. taxifolia*.

The invasive green alga *Caulerpa taxifolia* was observed in high densities at the Subject Site. The proposed works may facilitate the further spread of this species. It is essential that care is to be taken to ensure construction equipment is clean before leaving site and does not facilitate the spread of this species to new sites. Given that *C. taxifolia* was observed to be growing on artificial structures that are proposed to be removed, it is essential that all structures removed are appropriately disposed of on land.

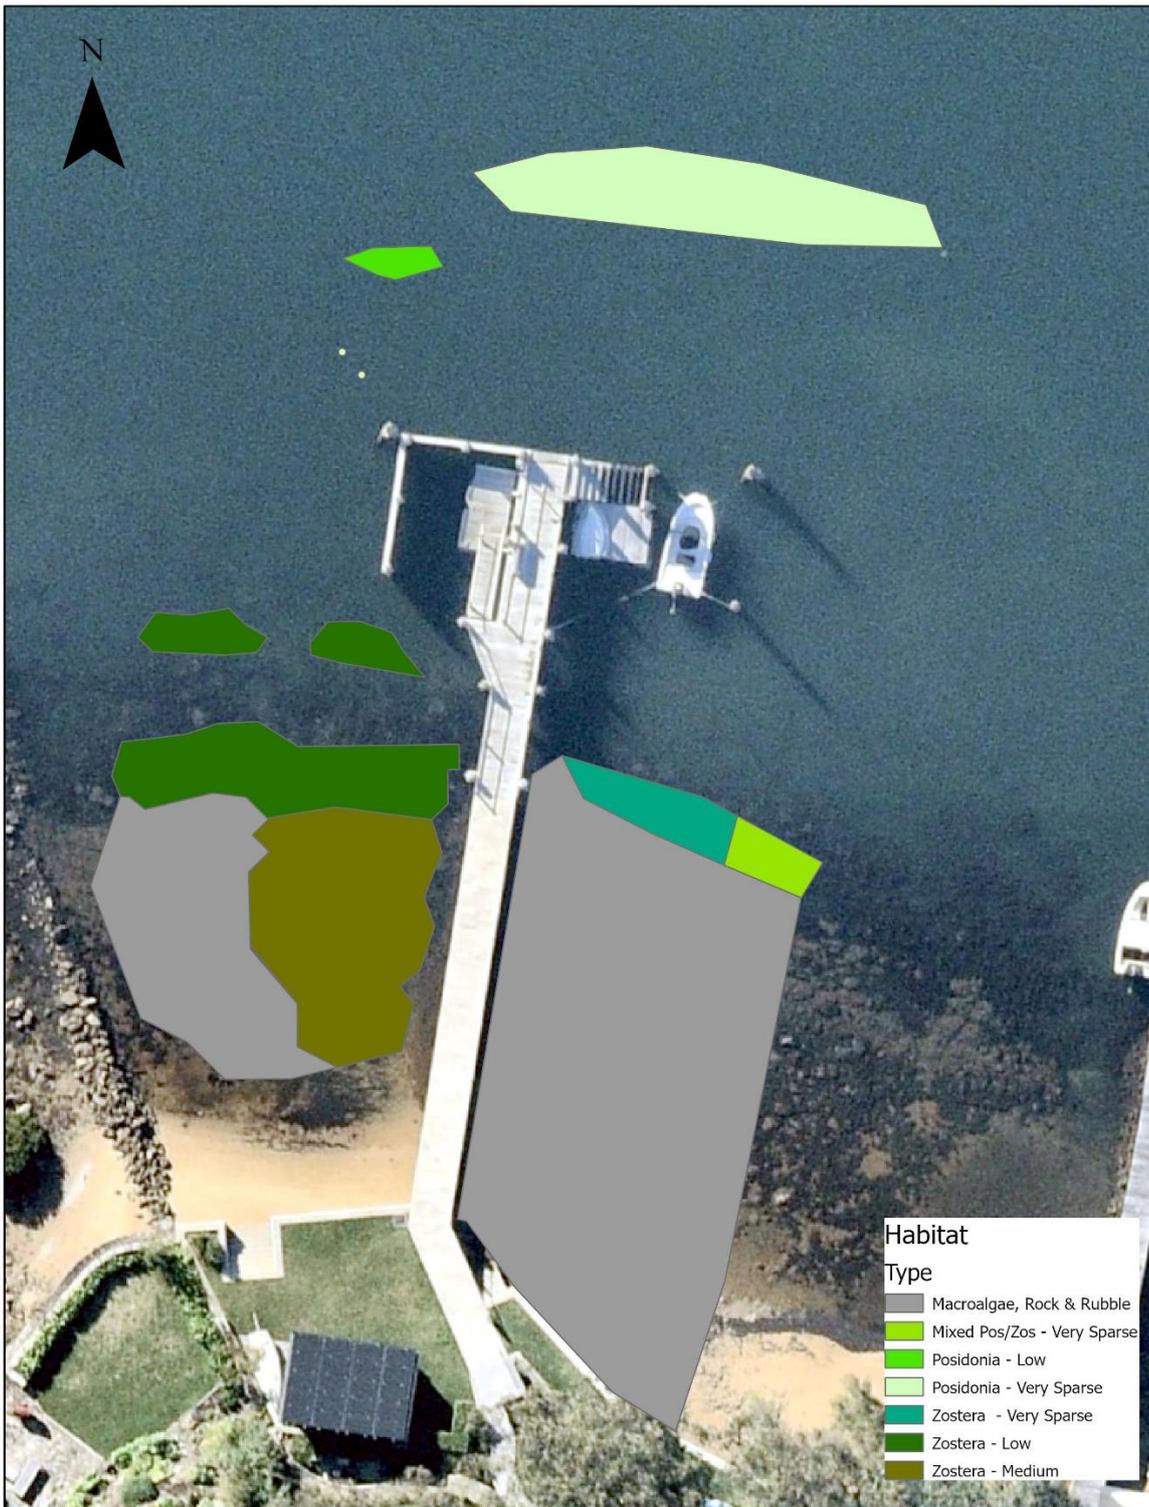
Figure 8: Habitat map showing seagrass presence within the Subject Site.
