## Demolition / Reconstruction Plan Station Beach Boat House Wharf Superstructure and Ancillary Building

Prepared by Blue Pacific Constructions P/L.

19/04/21

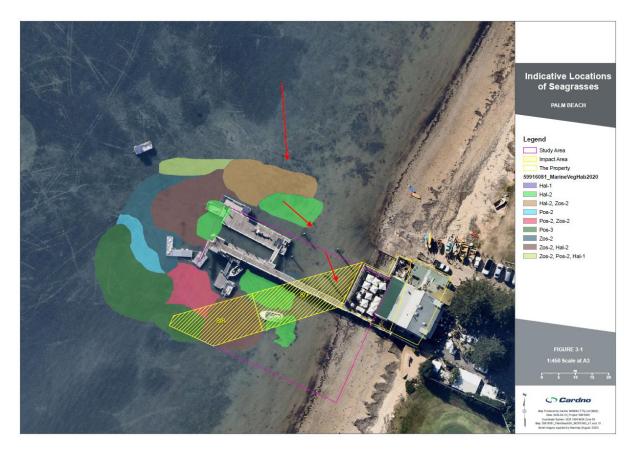
Path of barge entre

The barge is not self-propelled and will be move into position by a large tinny with an out-board motor that can be tilted to suit water depth to avoid prop scouring. Once in position the boat can be move by ropes as described below. RE moving thru the seagrass area, the Aquatic report wants Posidonia marked and the area avoid by the barge.

The Barge could easily be tided to wharf on 4 sides and over the sand and rest at low tide on the bottom as no sea grass in the immediate vicinity as per the Aquatic report.

The Aquatic report has identified a path to bring the barge in please see appendix
