PRELIMINARY ASSESSMENT: Acid Sulfate

Alterations and Additions and New Pool at **2131 Pittwater Road, Church Point**

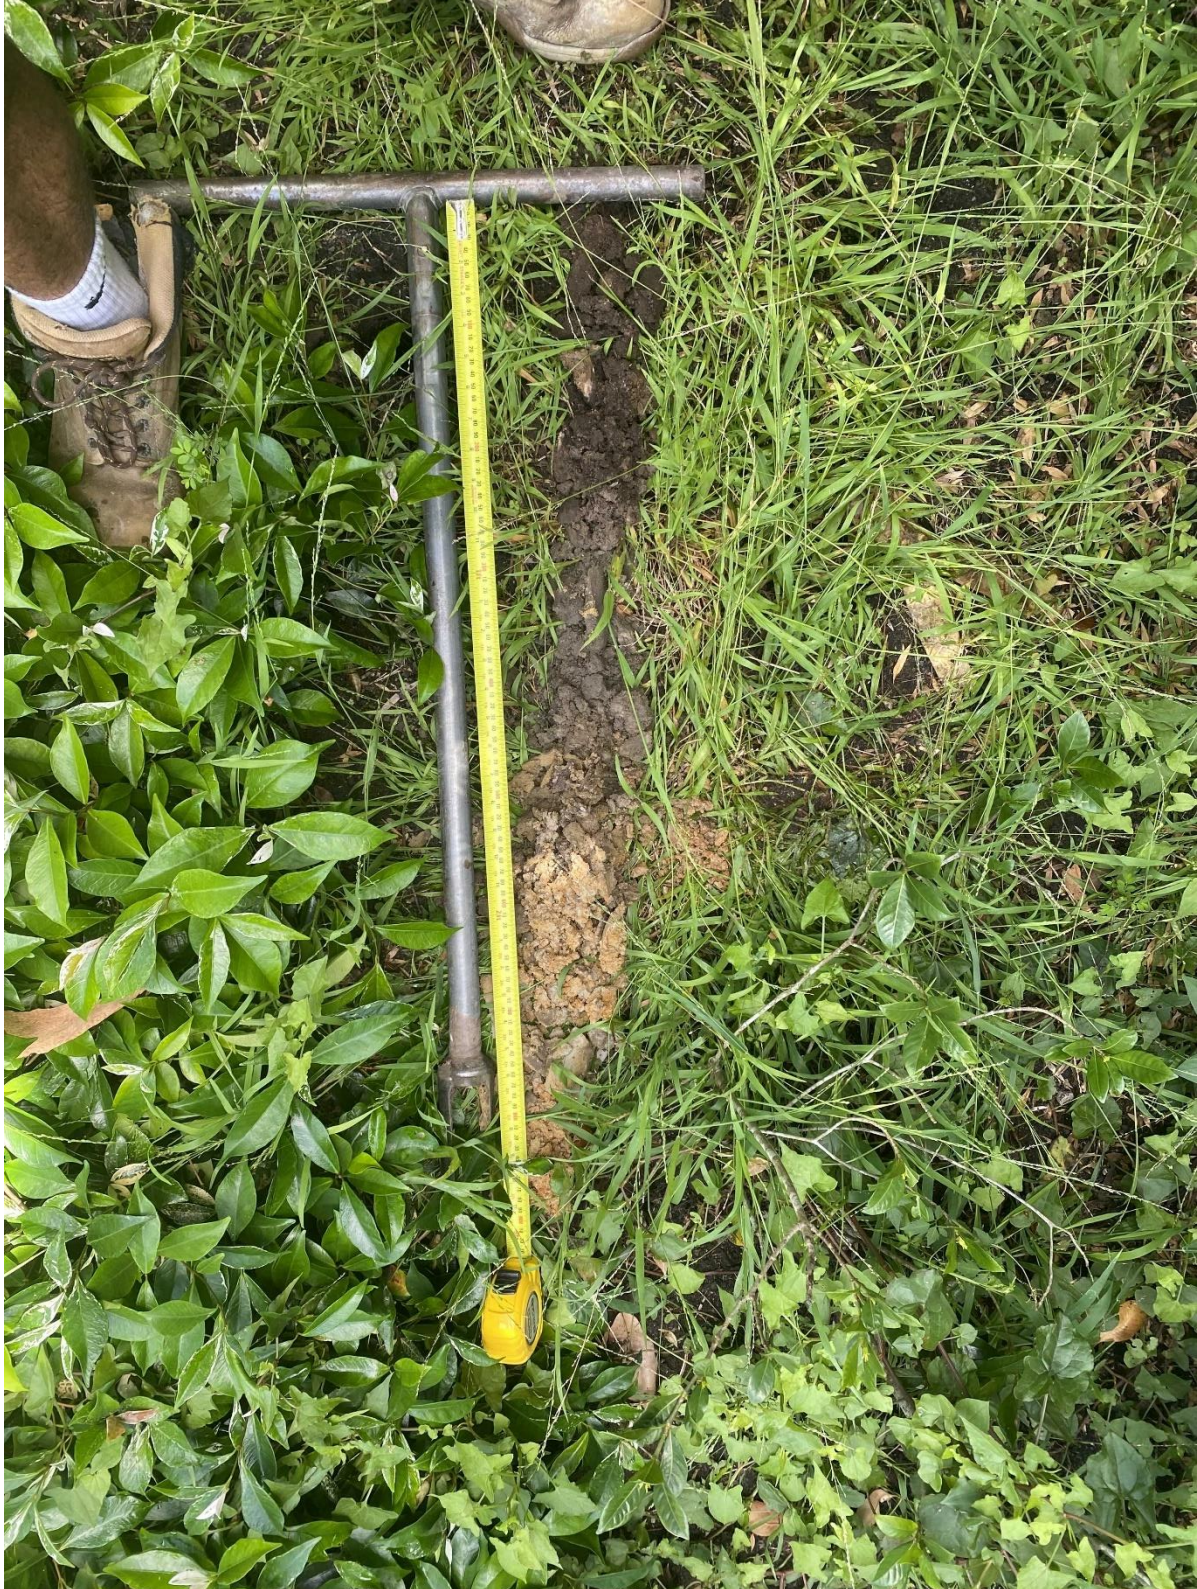
Photo 1: AH1 – Downhole is from top to bottom.

AUGER HOLE 1 (~RL8.4) – AH1 (Photo 1)

Depth (m)	Material Encountered
0.0 to 0.1	FILL , brown, Dense, dry, fine to medium grained.
0.1 to 0.3	FILL , mottled grey clay, dry, fine to medium grained.
0.3 to 0.7	SANDY CLAY , derived from weathered shale, mottled maroon, orange, and grey, Hard, dry, fine to medium grained.

End of test @ 0.7m in clay derived from weathered shale. No water table encountered.

TEST: AH1	FIELD pH & PEROXIDE RESULTS				
Sample depth (m)	pH _F	30% Peroxide reaction	pH _{FOX}	pH _F - pH _{FOX}	SS=Shell J=Jarosite R=Roots
0.2	5.6	L	5.2	-0.4	-
0.5	6.0	M	6.0	0.0	-

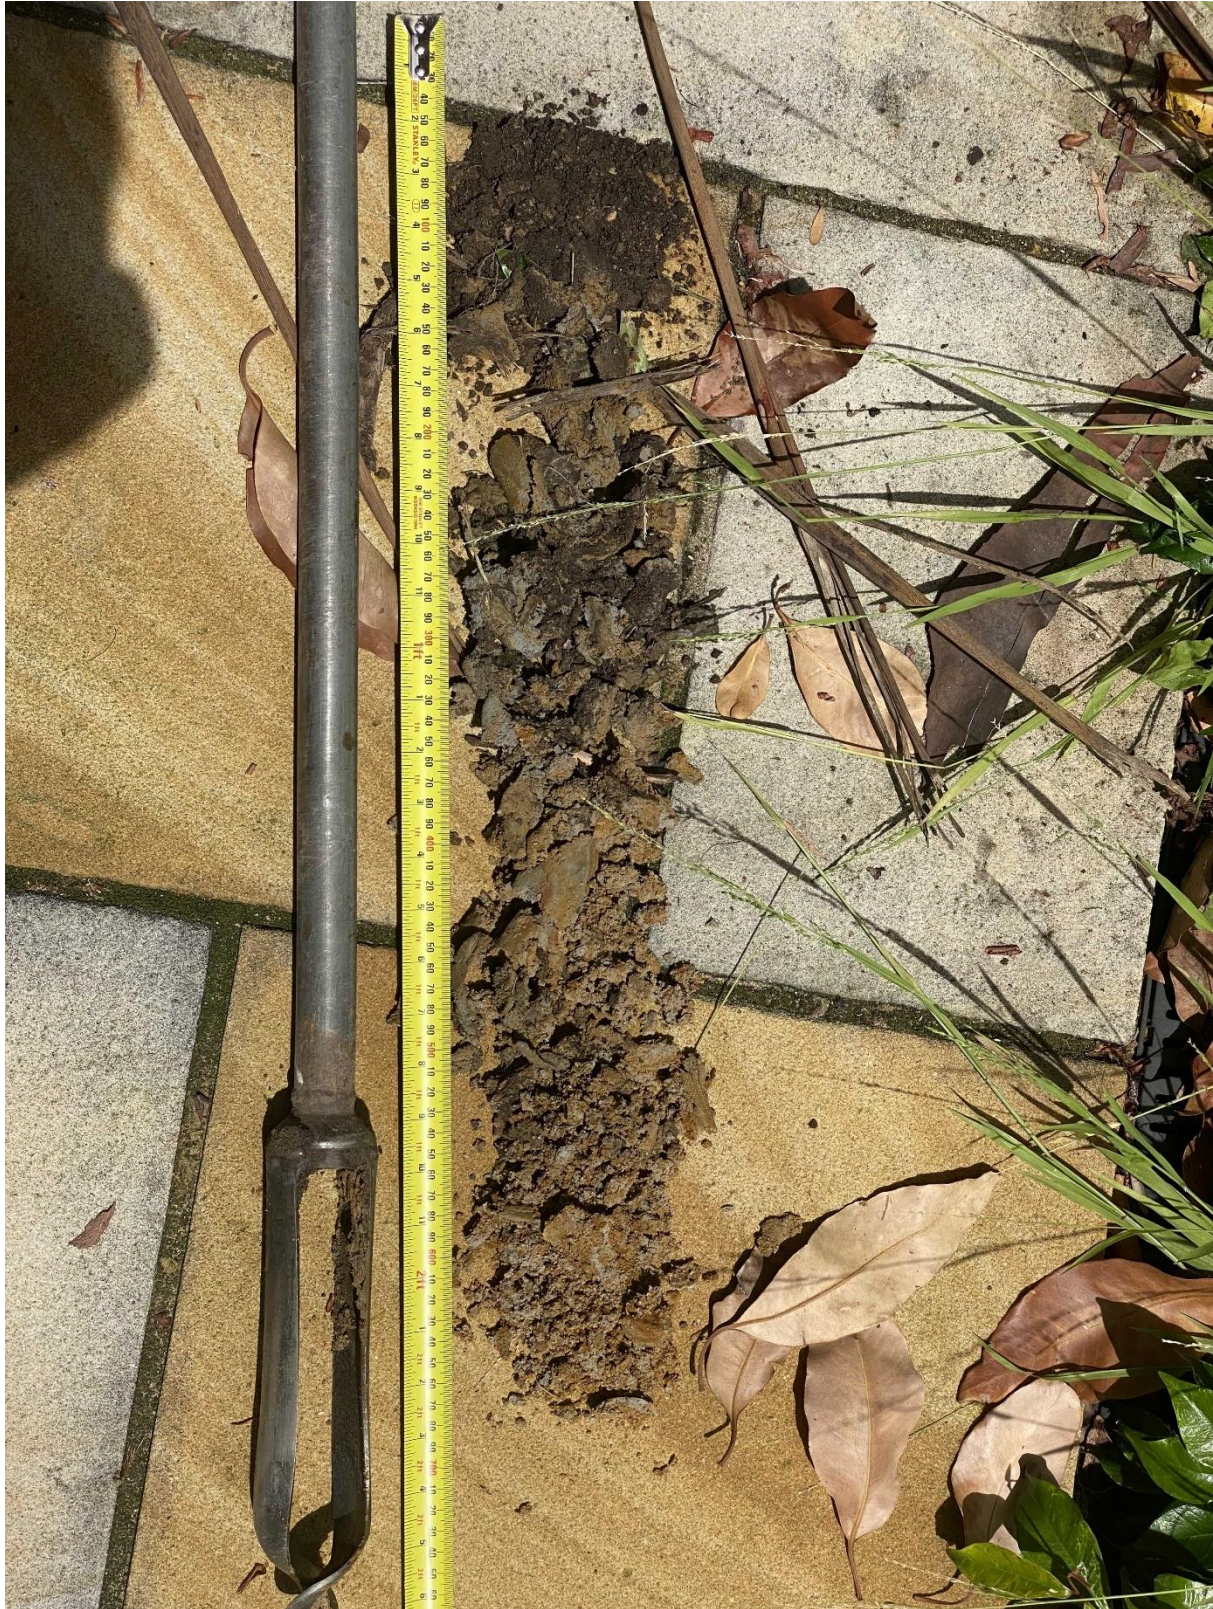
Photo 1: AH2 – Downhole is from top to bottom.

AUGER HOLE 2 (~RL8.4) – AH2 (Photo 2)

Depth (m)	Material Encountered
0.0 to 0.1	FILL , brown, Dense, dry, fine to medium grained.
0.1 to 0.3	FILL , mottled grey clay, dry, fine to medium grained.
0.3 to 0.7	SANDY CLAY , derived from weathered shale, mottled maroon, orange, and grey, Hard, dry, fine to medium grained.

End of test @ 0.7m in clay derived from weathered shale. No water table encountered.

TEST: AH2	FIELD pH & PEROXIDE RESULTS				
Sample depth (m)	pH _F	30% Peroxide reaction	pH _{FOX}	pH _F - pH _{FOX}	SS=Shell J=Jarosite R=Roots
0.2	5.7	M	5.6	0.1	-
0.5	4.6	M	4.7	-0.1	-

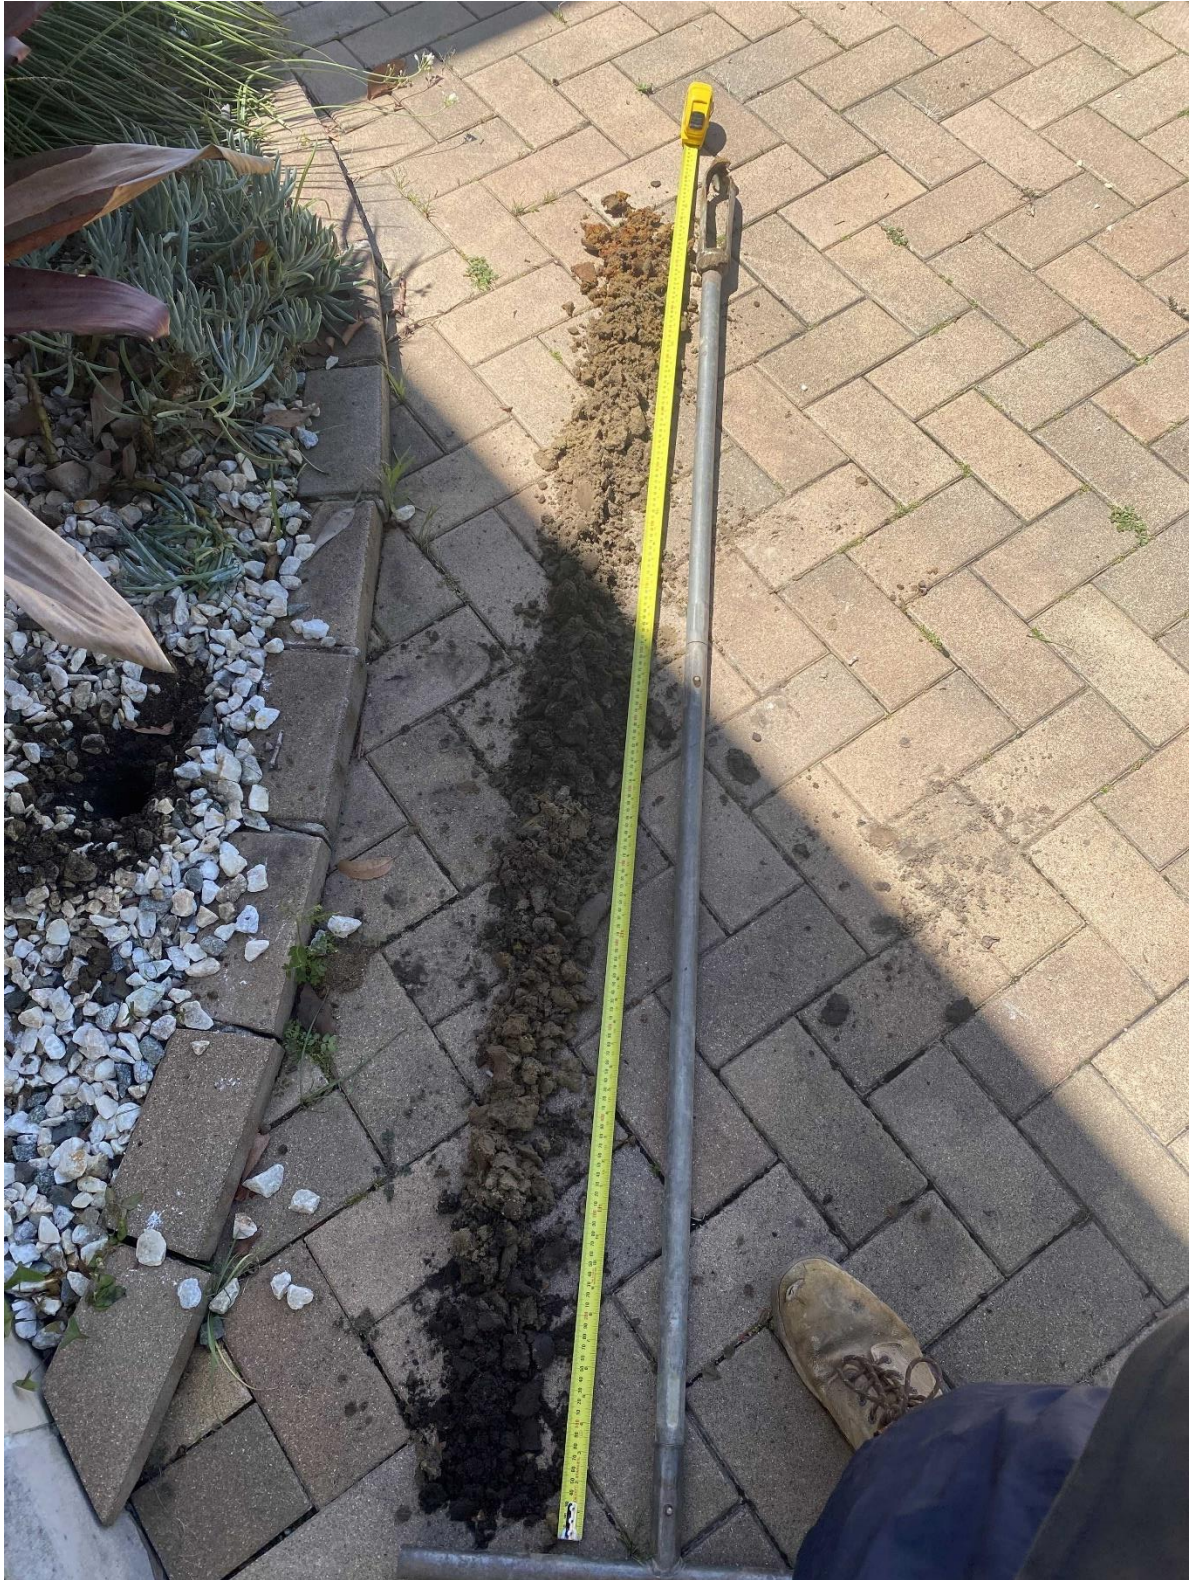
Photo 3: AH3 – Downhole is from bottom to top.

AUGER HOLE 3 (~RL3.7) – AH3 (Photo 3)

Depth (m)	Material Encountered
0.0 to 0.2	FILL , dark brown, Medium Dense, damp, medium grained
0.2 to 0.8	CLAYEY FILL , brown, Soft, damp, fine to medium grained, clay fragments included.
0.8 to 0.9	CLAYEY SANDY SOIL , dark brown, Soft, damp, fine to medium grained.
0.9 to 1.6	CLAYEY SAND , brown to light brown, Medium Dense to Dense, damp, fine to medium grained.
1.6 to 1.8	CLAY , mottled maroon, orange, yellow, grey, Very Stiff, damp, charcoal inclusions.

End of test @ 1.8m in clay derived from weathered shale. No water table encountered.

TEST: AH3	FIELD pH & PEROXIDE RESULTS				
Sample depth (m)	pH _F	30% Peroxide reaction	pH _{FOX}	pH _F - pH _{FOX}	SS=Shell J=Jarosite R=Roots
0.3	5.7	M	5.7	0.0	-
0.7	6.1	M	5.8	0.3	-
1.3	7.1	M	6.7	0.4	-

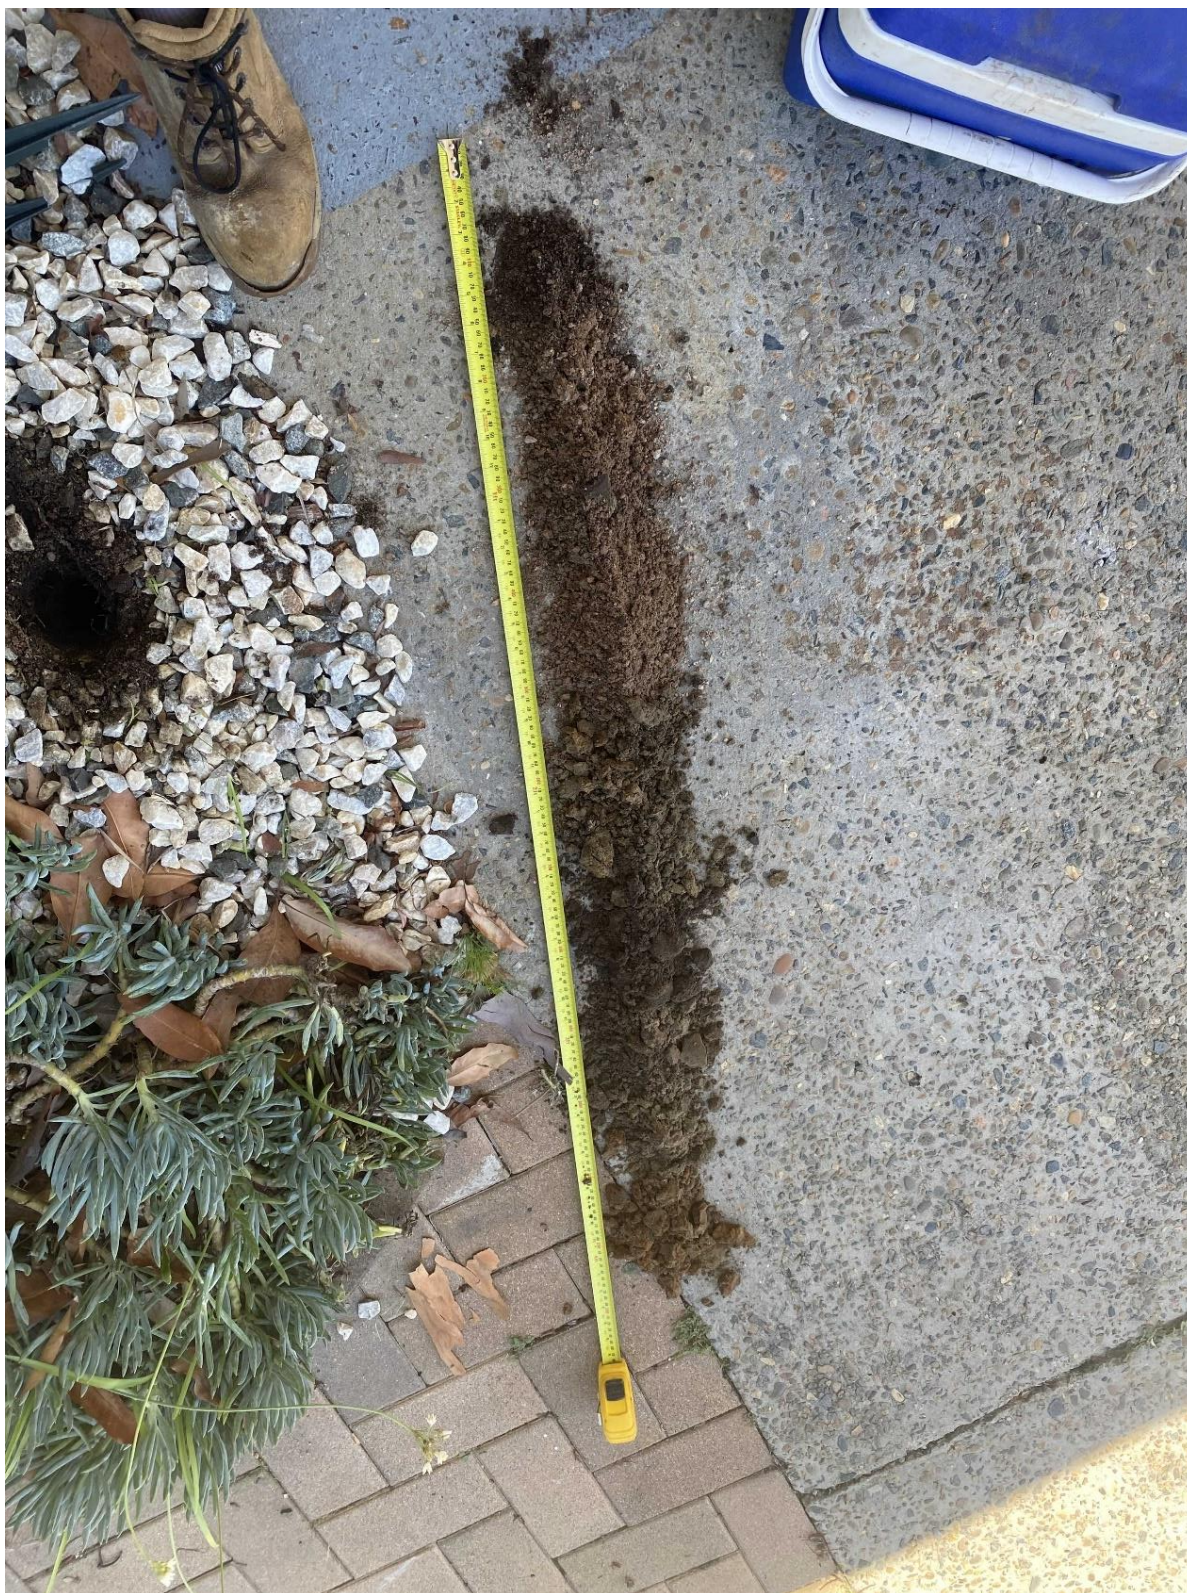
Photo 4: AH4 – Downhole is from top to bottom.

AUGER HOLE 4 (~RL3.7) – AH4 (Photo 4)

Depth (m)	Material Encountered
0.0 to 0.1	FILL , dark brown soil, Medium Dense, damp, medium grained
0.1 to 0.7	FILL , clay, and gravel, dry, fine to medium grained.
0.7 to 0.9	CLAYEY SANDY SOIL , dark brown, Soft, damp, fine to medium grained.

0.9 to 1.1 **SAND**, brown to light brown, Medium Dense to Dense, damp, fine to medium grained.

1.1 to 1.3 **CLAY**, derived from weathered shale, mottled orange, Stiff, damp.

End of test @ 1.3m in clay. No water table encountered.

TEST: AH4	FIELD pH & PEROXIDE RESULTS				
Sample depth (m)	pH _F	30% Peroxide reaction	pH _{FOX}	pH _F - pH _{FOX}	SS=Shell J=Jarosite R=Roots
0.3	6.7	M	6.1	0.6	-
0.7	6.3	M	5.8	0.5	-
1.1	6.9	M	6.9	0.0	-
