RE: TREE REMOVAL APPLICATION

ROCHE PRODUCTS PTY LIMITED
SITE: 4 - 10 INMAN ROAD, DEE WHY
REMEDICATION WORKS - ASBESTOS FILL AREA

Heritage Listed Trees
Statement of Heritage Impact

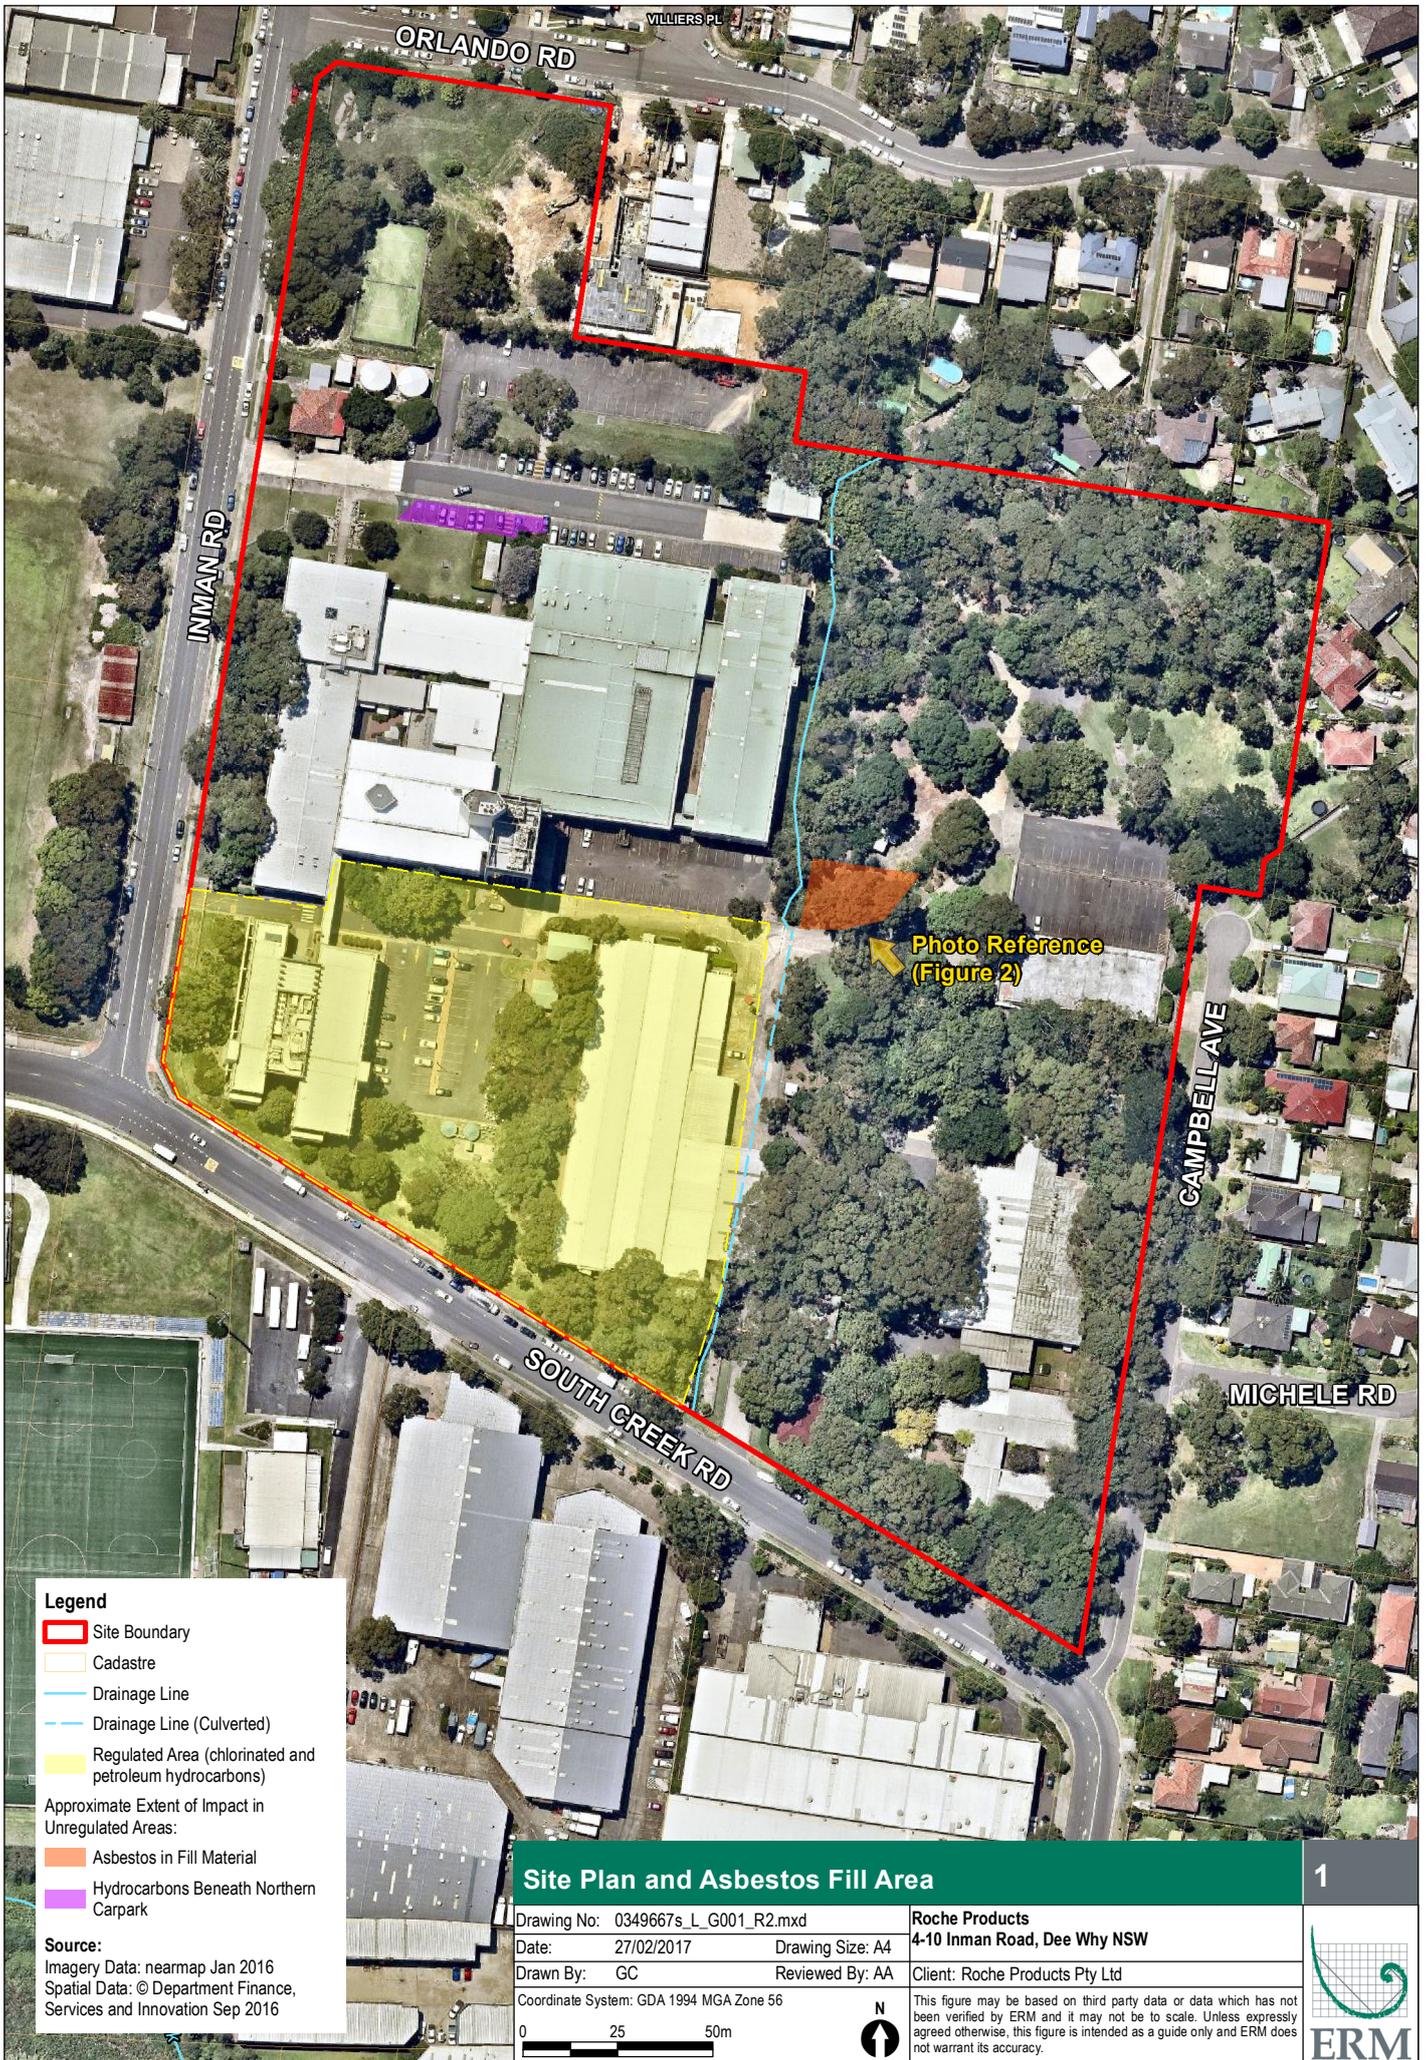
Site Plan and Asbestos Fill Area

In preparation for potential divestment of the Site, Roche has undertaken a number of environmental investigations across the Site in order to understand current site conditions and any potential contamination issues as a result of historical activities, including the completion of a Phase 1 and 2 Environmental Site Assessment. These investigations included soil, soil vapour, indoor air, groundwater and surface water sampling and subsequent laboratory analysis to assess the extent of contamination across the Site. The investigations have been undertaken in consultation with the NSW Environment Protection Authority (EPA). The key outcome of the investigations completed has been the identification of three areas of contamination as summarised below and shown on *Figure 1* within *Annex A*:

- Part A Unregulated Area on eastern side of the site impacted by asbestos in fill material (**the subject of this tree removal application**);
- Part B Unregulated Area to the north of the site impacted by petroleum hydrocarbons beneath a portion of the northern carpark area; and
- Regulated Area in southwest corner of the site impacted by chlorinated and petroleum hydrocarbons. Note: This portion of the Site is subject to regulation as significantly contaminated land (No. 20161101) by the NSW EPA as a result of a Section 60 notification under the *Contaminated Land Management Act 1997* (CLM Act, 1997). This portion of the Site has been regulated under the CLM Act (1997) and is currently managed under a Voluntary Management Proposal.

The environmental investigations undertaken across the Site have identified the following contamination with the Asbestos Fill Area identified in *Figure 1*:

- an area of asbestos impacted fill material on the Unregulated Area of the Site within a non-operational portion of the Site;
- there is evidence to suggest that the source of the asbestos is demolition waste associated with a small cottage like structure that existed on the north eastern portion of the Site or with the previous removal of the upper floors of Building 10;
- bonded fragments have been identified primarily below ground within soils and are considered unlikely to generate airborne fibres; and
- this area is not regulated under the CLM Act and based on the current location and form of the bonded asbestos, it was not considered to represent an unacceptable risk to human health or the environment.

The preferred remedial works will require the removal of the following trees within the asbestos fill area (refer Figure 1 in Annex A for location of the proposed tree removal on the Site):

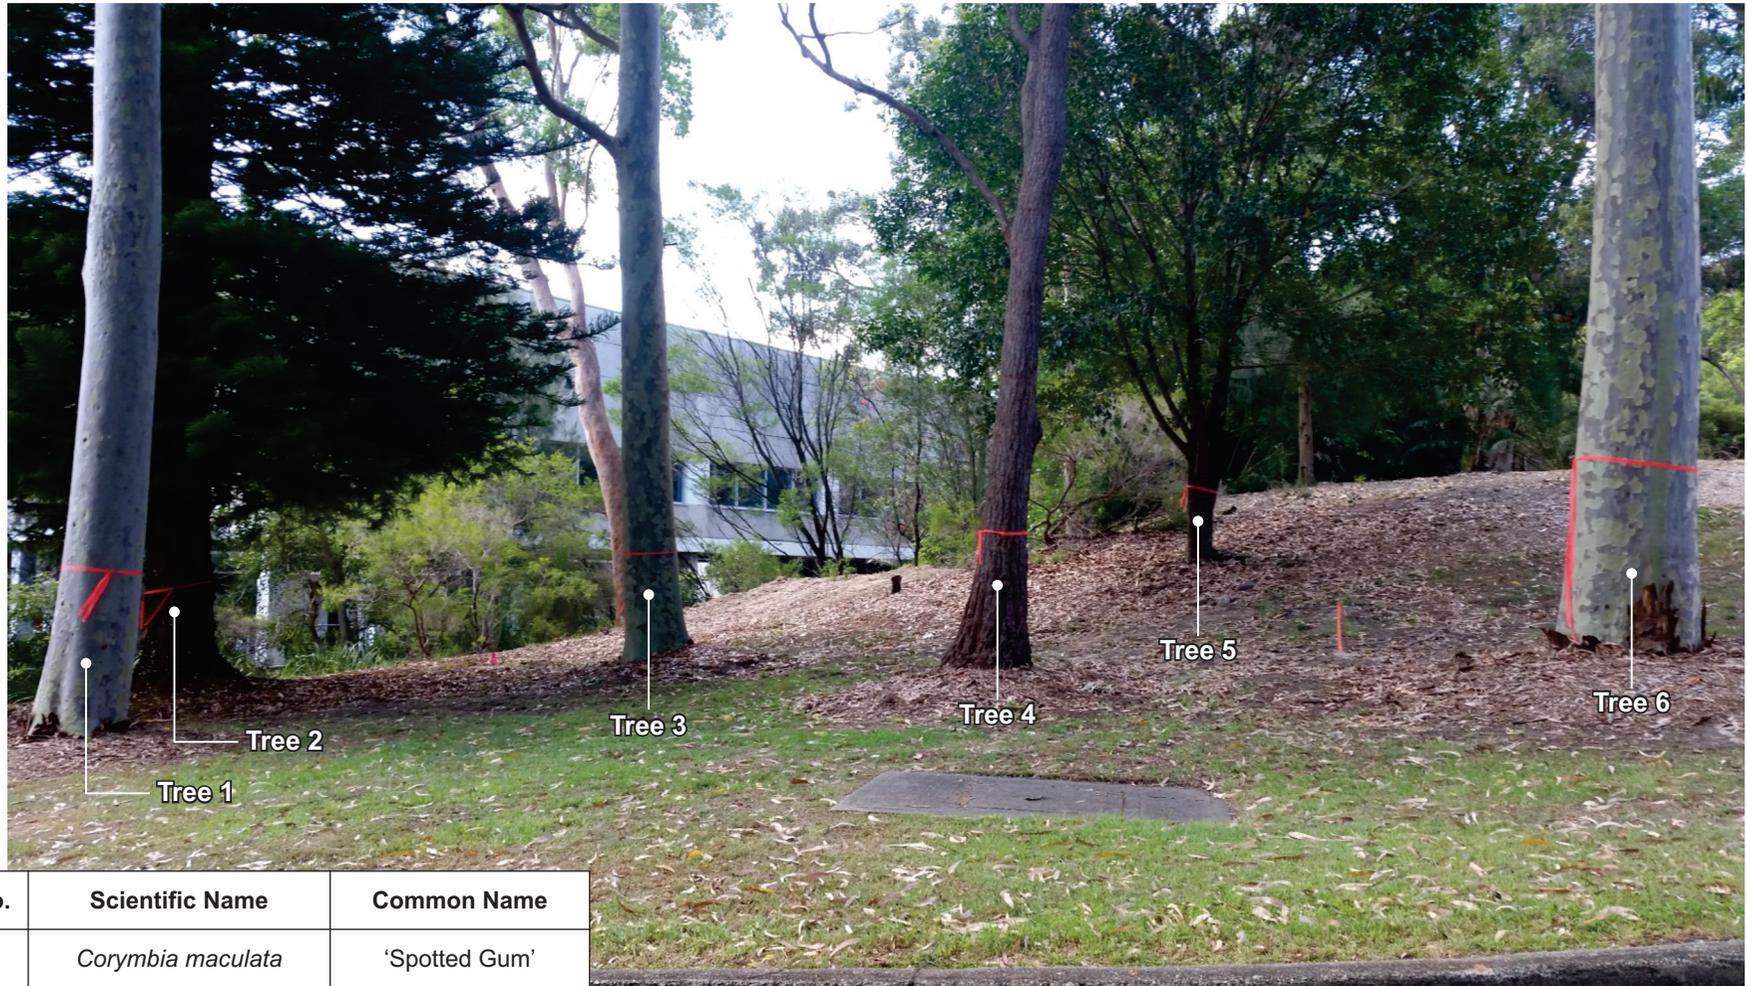
Trees Requiring Removal - Asbestos Fill Area		2
Drawing No: 0349667s_L_C002_R0.cdr	Roche Products

Figure 2 of Annex A provides an annotated photograph of the trees to be removed. A report from a qualified ecologist confirming the species of the trees to be removed is provided in Annex B.

Tree No.	Scientific Name	Common Name
1	<i>Corymbia maculata</i>	'Spotted Gum'
2	<i>Araucaria heterophylla</i>	'Norfolk Island Pine'
3	<i>Corymbia maculata</i>	'Spotted Gum'
4	<i>Eucalyptus robusta</i>	'Swamp Mahogany'
5	<i>Glochidion ferdinandi</i>	'Cheese Tree'
6	<i>Corymbia maculata</i>	'Spotted Gum'

- *Corymbia maculata* - Spotted Gum - three trees;
- *Araucaria heterophylla* - Norfolk Island Pine - one tree;
- *Eucalyptus robusta* - Swamp Mahogany - one tree; and
- *Glochidion ferdinandi* - Cheese Tree - one tree.

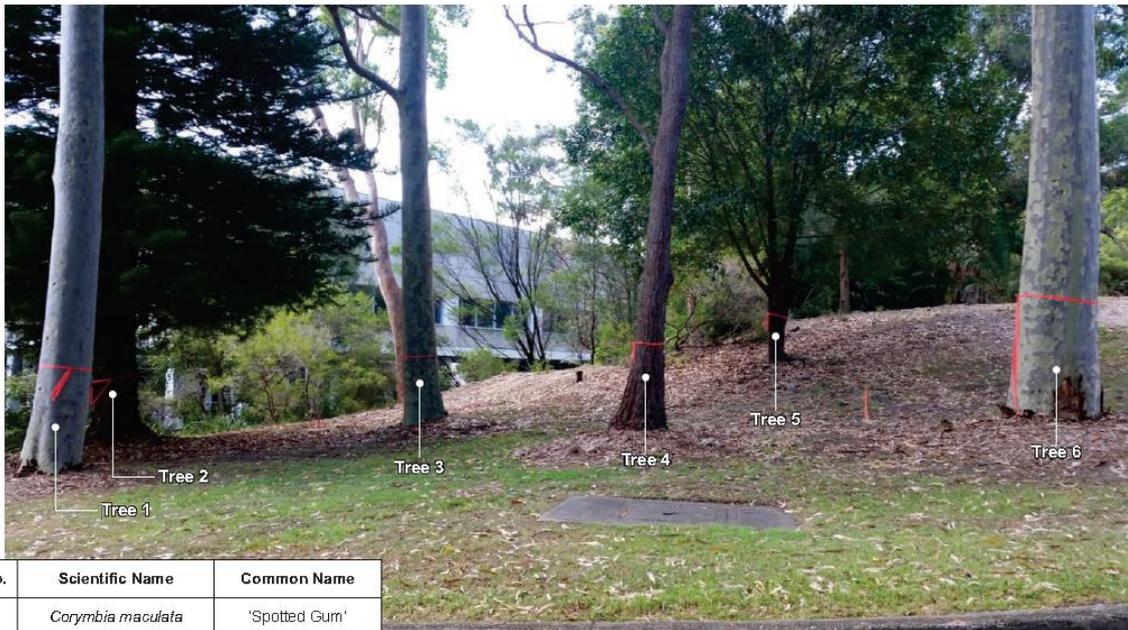
Six (6) trees are identified/confirmed as being required to be removed. (See below)

Tree No.	Scientific Name	Common Name
1	<i>Corymbia maculata</i>	'Spotted Gum'
2	<i>Araucaria heterophylla</i>	'Norfolk Island Pine'
3	<i>Corymbia maculata</i>	'Spotted Gum'
4	<i>Eucalyptus robusta</i>	'Swamp Mahogany'
5 ^(*)	<i>Glochidion ferdinandi</i>	'Cheese Tree'
6	<i>Corymbia maculata</i>	'Spotted Gum'

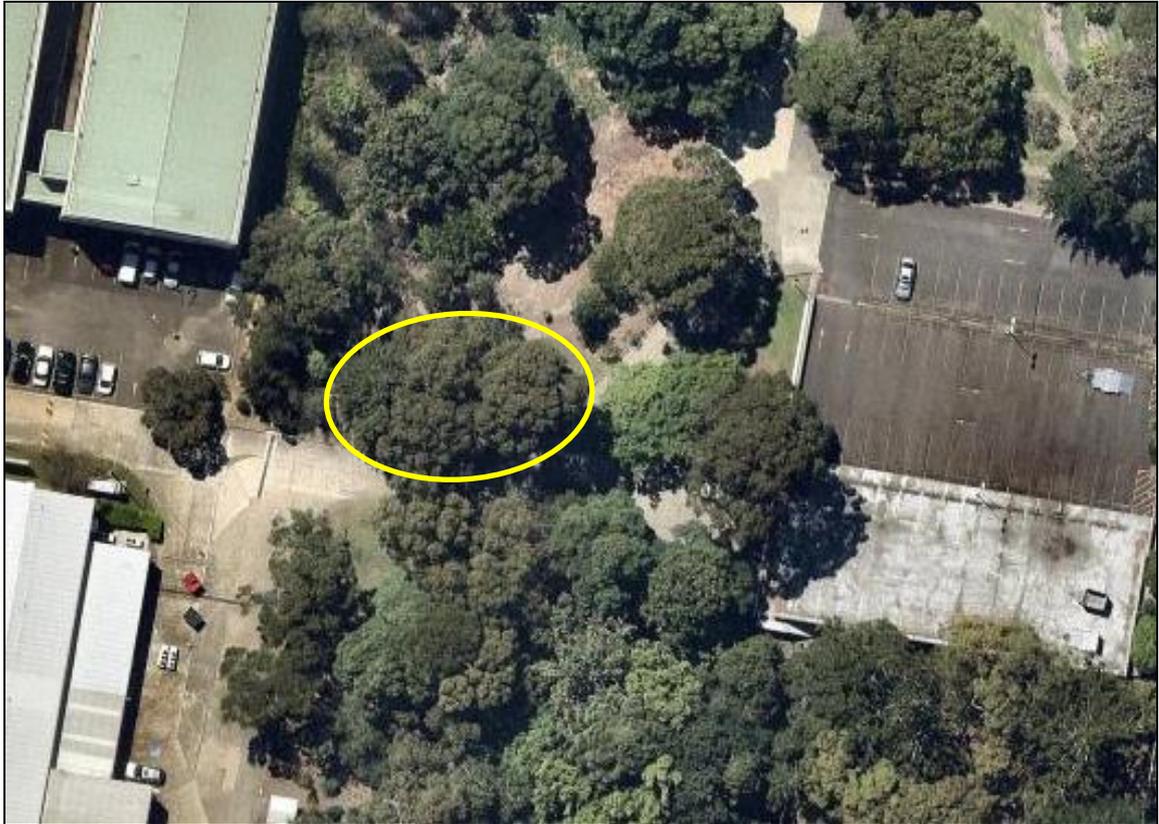
Figure 1: Previous page confirms trees (by Number, Tree #1 thru Tree #6) required to be removed. Above illustrates location (yellow circle) of trees required to be removed.

On the basis, these trees are located relatively close to each other (i.e. tree trunk bases) it is considered impossible to remove contaminated soils/materials in a manner that was viably able to preserve any individual tree root system. This is additionally reinforced on the basis same species trees, [three (3) trees are *Corymbia maculata*, Spotted Gums] often have shared root systems as a consequence of below ground root grafting.

It is presumed that all six (6) required to be removed trees will be replaced post soil remediation process with at least an equal number of preferably “locally indigenous” trees.

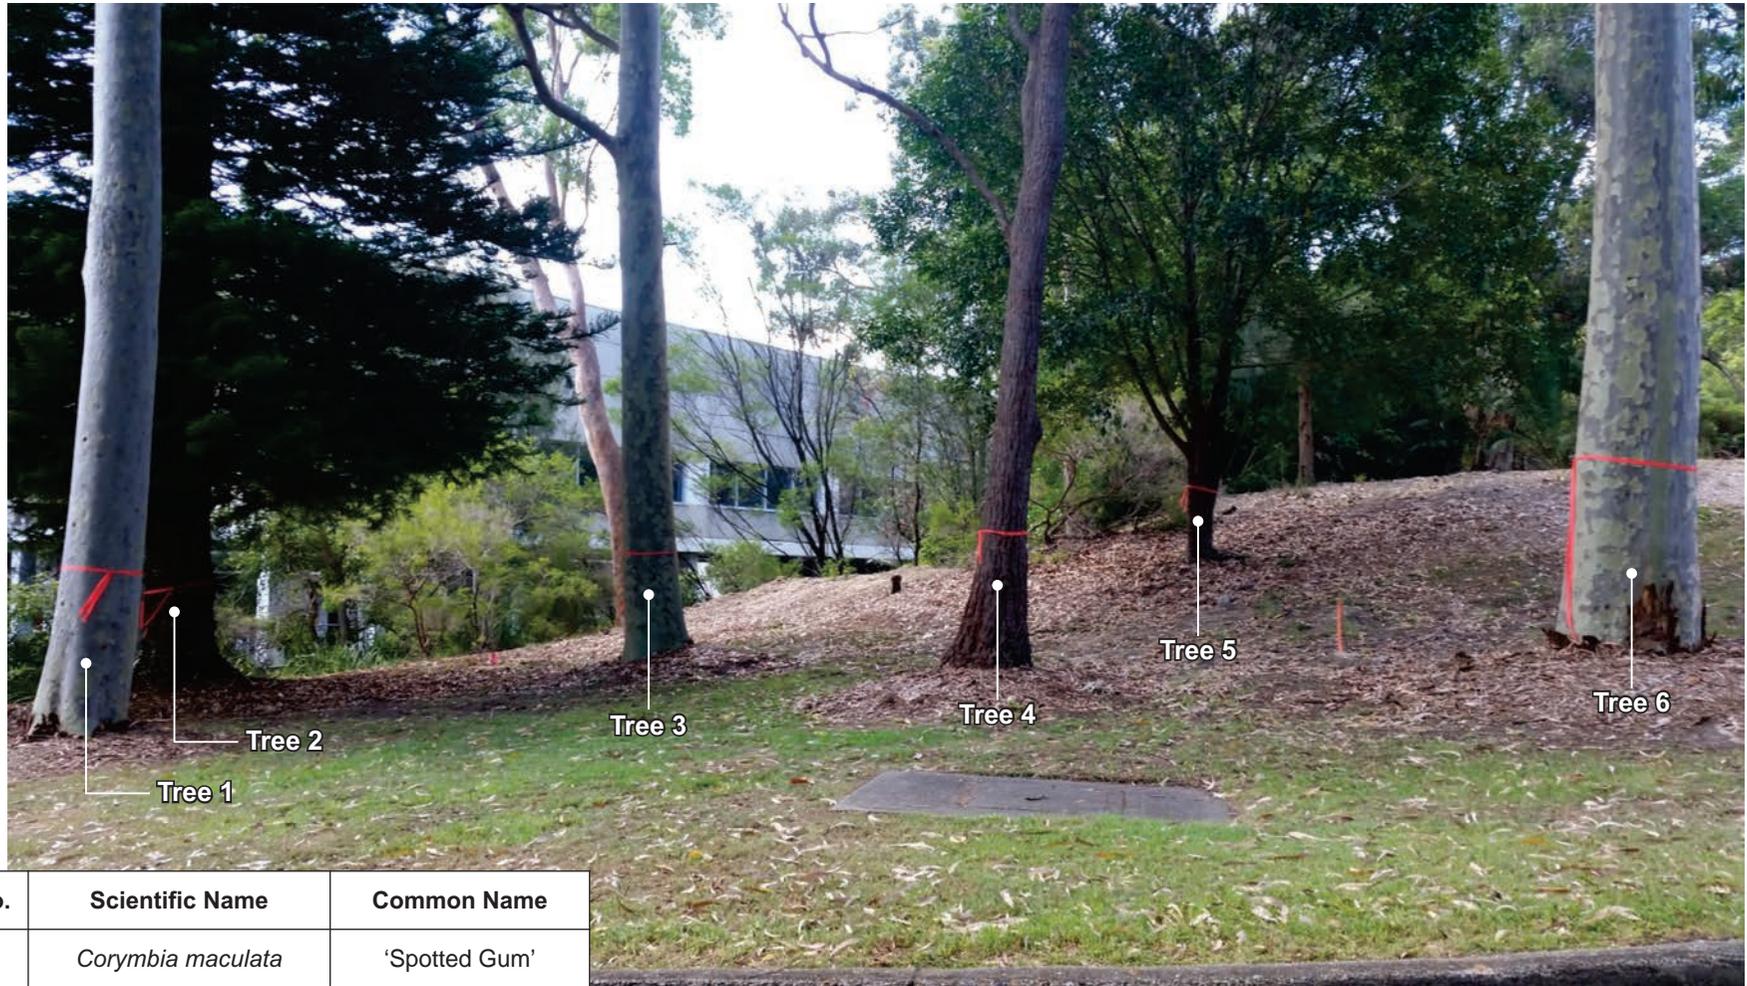
Road, carpark and footpath surfaces are capped with bitumen and/or concrete. The remaining areas of the Project Area, notably to the east of and screening the Roche Building and setting the Givaudan-Roure Building is formally and informally landscaped with remnant natural vegetation and sandstone outcropping observed elsewhere. The cluster of trees proposed for removal is identified *Figure 3 (Annex A)* and described in *Table 3* below.

Tree No.	Scientific Name	Common Name
1	<i>Corymbia maculata</i>	'Spotted Gum'
2	<i>Araucaria heterophylla</i>	'Norfolk Island Pine'
3	<i>Corymbia maculata</i>	'Spotted Gum'
4	<i>Eucalyptus robusta</i>	'Swamp Mahogany'
5 ⁽¹⁾	<i>Glochidion ferdinandi</i>	'Cheese Tree'
6	<i>Corymbia maculata</i>	'Spotted Gum'

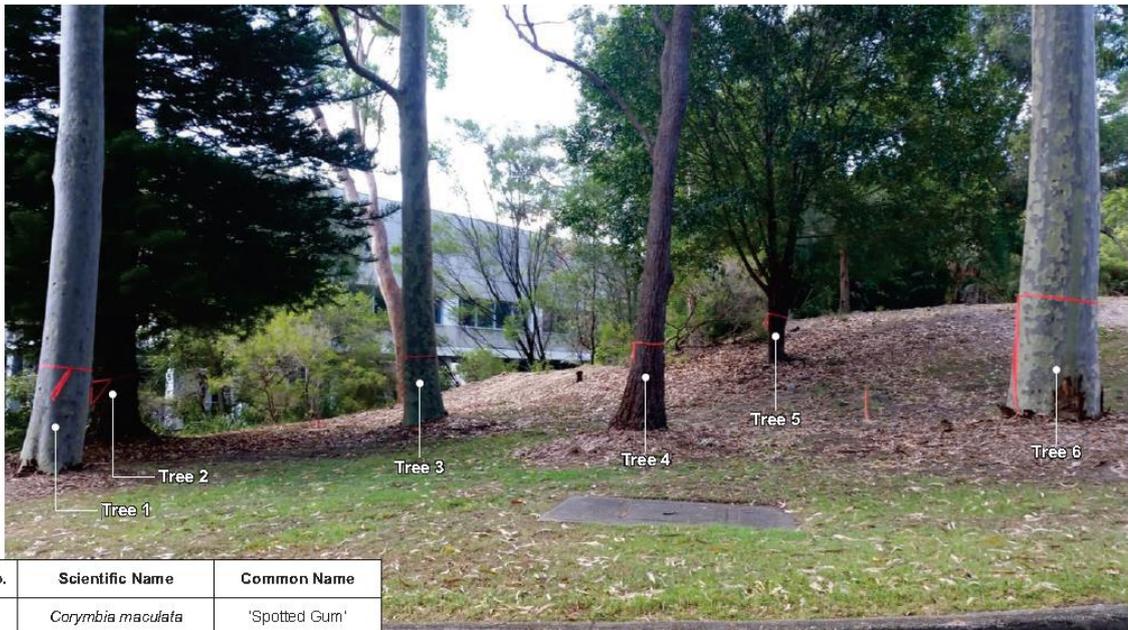
Six (6) trees are identified/confirmed as being required to be removed. (See below)

Tree No.	Scientific Name	Common Name
1	<i>Corymbia maculata</i>	'Spotted Gum'
2	<i>Araucaria heterophylla</i>	'Norfolk Island Pine'
3	<i>Corymbia maculata</i>	'Spotted Gum'
4	<i>Eucalyptus robusta</i>	'Swamp Mahogany'
5 ^(*)	<i>Glochidion ferdinandi</i>	'Cheese Tree'
6	<i>Corymbia maculata</i>	'Spotted Gum'

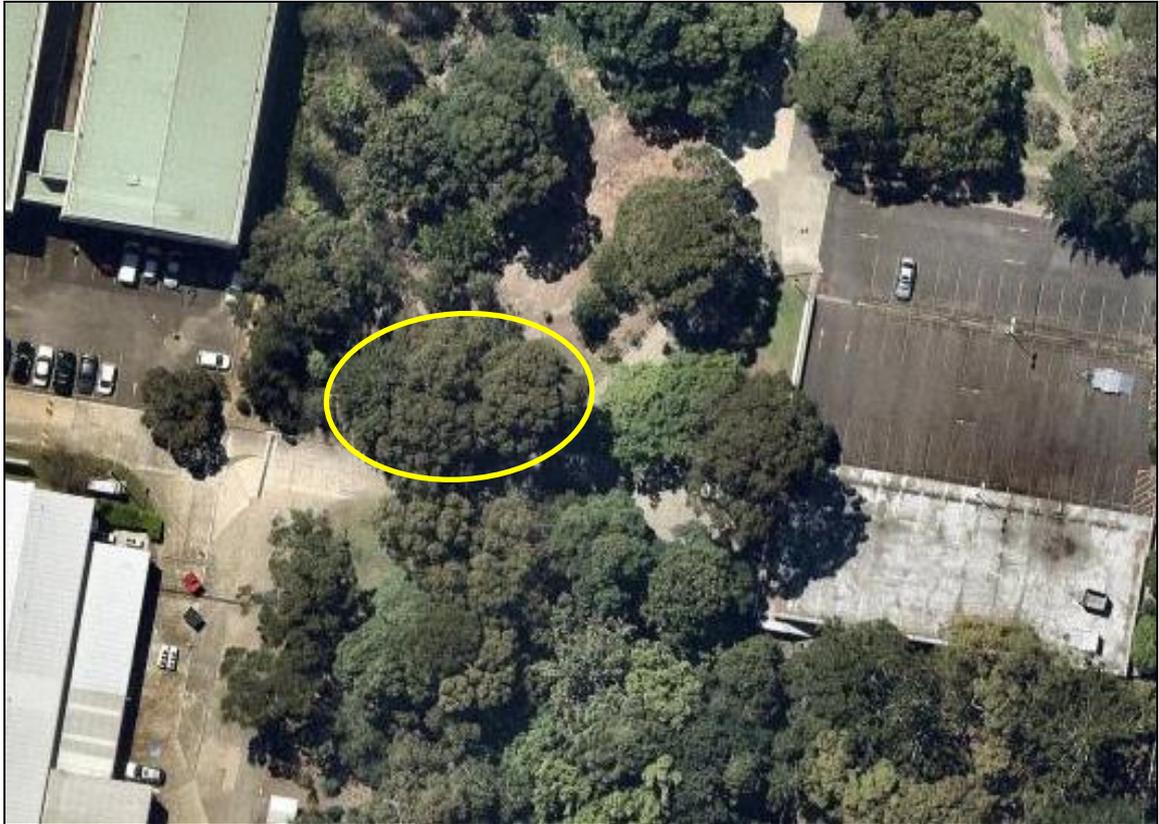
Figure 1: Previous page confirms trees (by Number, Tree #1 thru Tree #6) required to be removed. Above illustrates location (yellow circle) of trees required to be removed.

On the basis, these trees are located relatively close to each other (i.e. tree trunk bases) it is considered impossible to remove contaminated soils/materials in a manner that was viably able to preserve any individual tree root system. This is additionally reinforced on the basis same species trees, [three (3) trees are *Corymbia maculata*, Spotted Gums] often have shared root systems as a consequence of below ground root grafting.

It is presumed that all six (6) required to be removed trees will be replaced post soil remediation process with at least an equal number of preferably “locally indigenous” trees.
