Marine Habitat Survey

Address | 136 Crescent Road, Newport

Job Number 25-077-08

**JETTY, RAMP,
PONTON &
BERTHING AREA.
SKID RAMP**

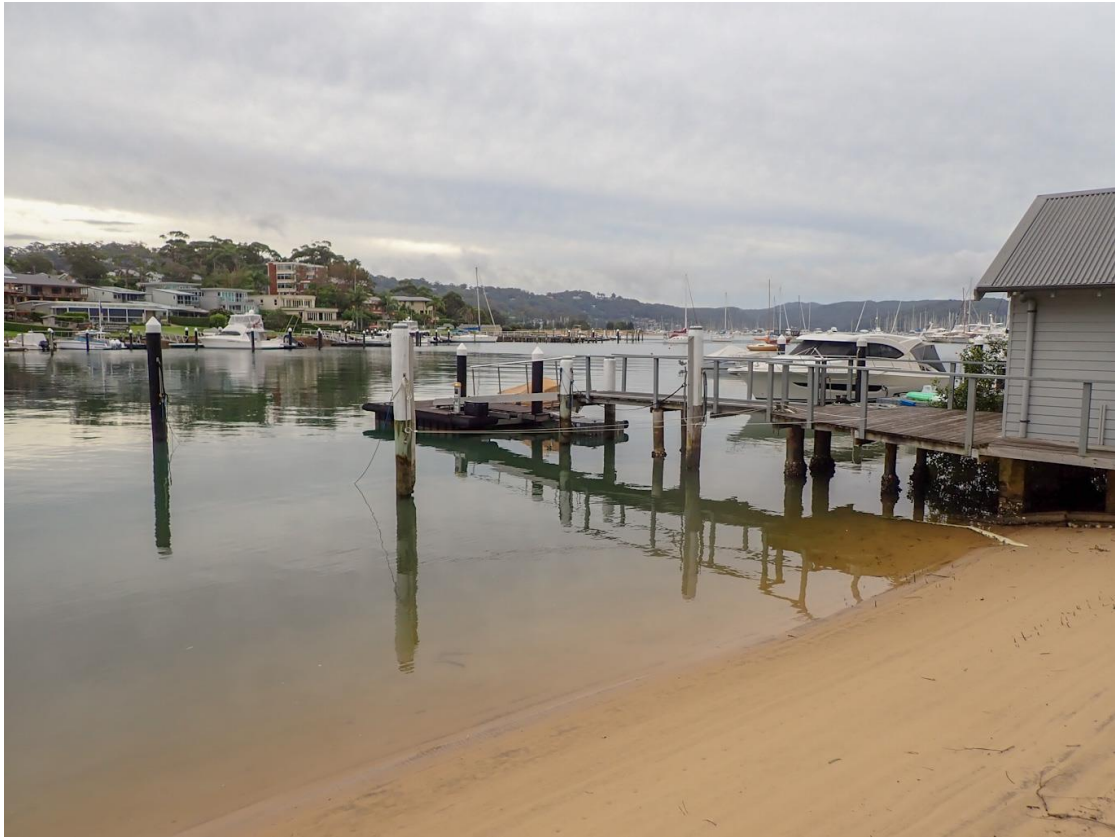
The existing waterfront structures present at The Property at the time of the on-site survey (Photos 1 - 2) included:

- a boatshed on the northern edge of The Property, extending 7 m beyond the MHW and supported on brick piers;
- an area of timber decking (4.5 x 3.7–5.5 m) off the front of the boatshed;
- a timber jetty (6.5 x 1.4 m) extending out from the centre of the timber deck, supported on two middle concrete piers and two jetty end timber piles;
- a timber ramp (6.0 x 1.4 m);
- a longitudinal pontoon (5.3 x 3.8 m) with two sleeved steel stabilising piles on the northern side; and
- two inner timber mooring piles and one outer sleeved steel mooring pile on the southern side of the ramp and pontoon, that created a 10.8 x 6.3 m berthing area.

Photo 1. The existing boatshed, timber deck, jetty, ramp, pontoon and mooring piles at The Property.

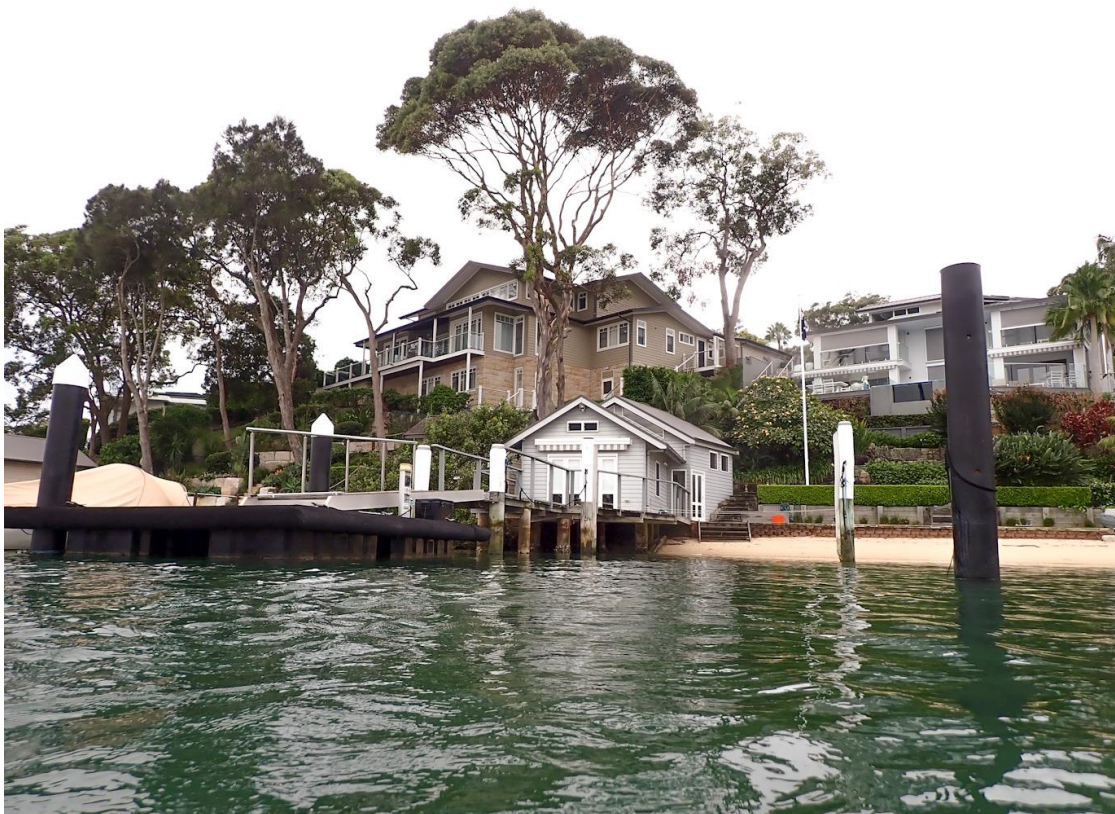
The intertidal zone within the on-site survey area of The Property consisted of artificial and natural habitats. A low brick seawall sat just beyond the MHW and was fronted by a sloping sandy beach (Photos 1 - 2) which extended offshore for 9.5 m from the wall, finishing in line with the end of the existing timber deck area (see aquatic habitat mapping in Appendix B).

Photo 2. View inshore of the existing structures – many of which will be replaced in a new location and piles relocated a small distance.

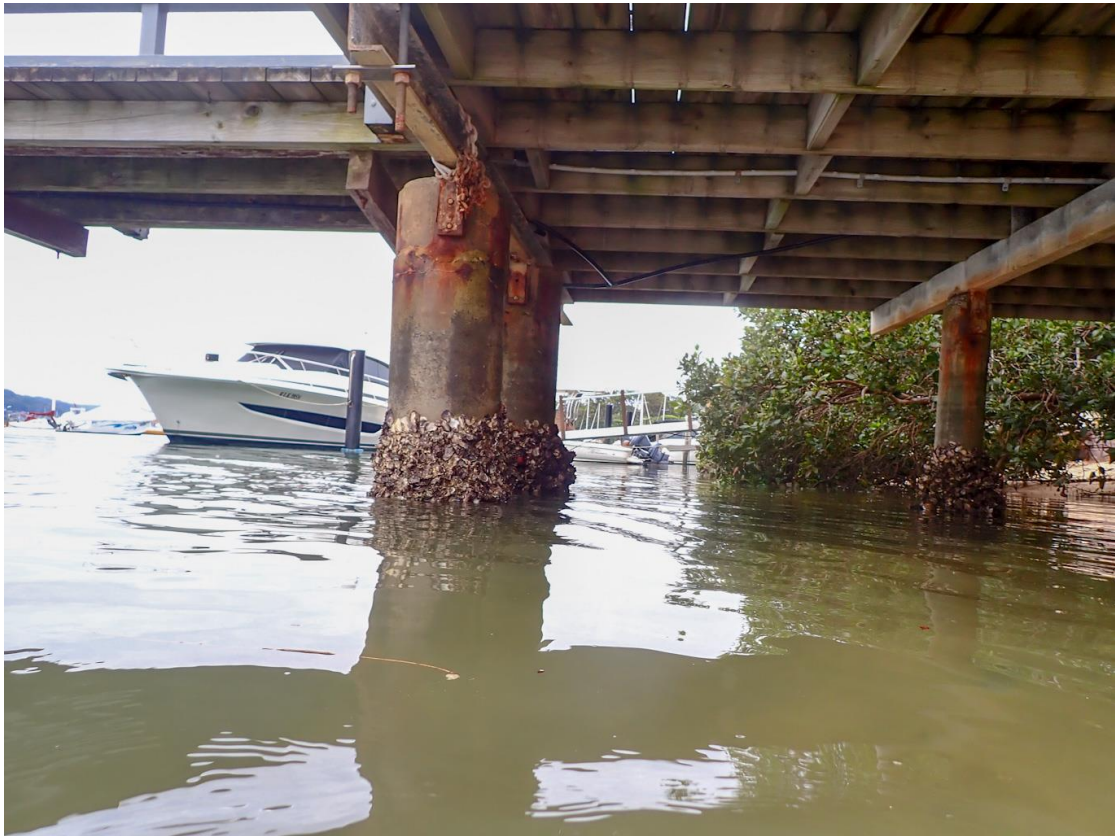
The seawall and sandy beach were bare (Photos 1, 2 and 4). The boatshed piers and deck piers (Photo 3) were colonised by a thick growth of Sydney rock oysters (*Saccostrea glomerata*). The intertidal sections of the existing jetty end piles, pontoon piles and mooring piles were bare. There were two mature grey mangrove trees on the northern side of the existing boatshed (Photo 3).

Photo 3. Concrete deck piers (to be removed when the deck is cut back) colonised by oysters. The mangrove tree branches can be seen on the far side of the deck.

- demolition of the existing timber jetty, ramp, pile stabilised pontoon and three mooring piles;
- cutting back of the existing timber deck on the front of the boatshed by 3.5 m, and the installation of a new pair of piers at the new end to the deck;

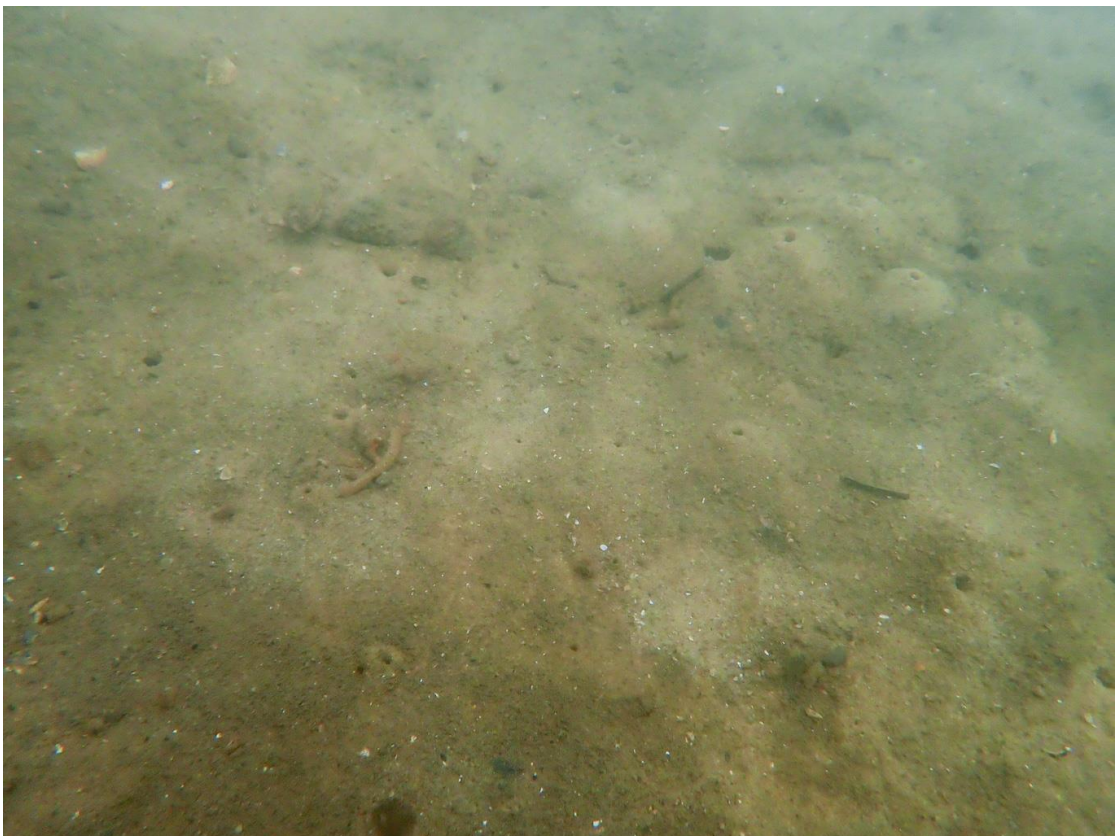
Photo 4. Submerged, unvegetated, intertidal sand located in the footprint of the proposed new relocated jetty.

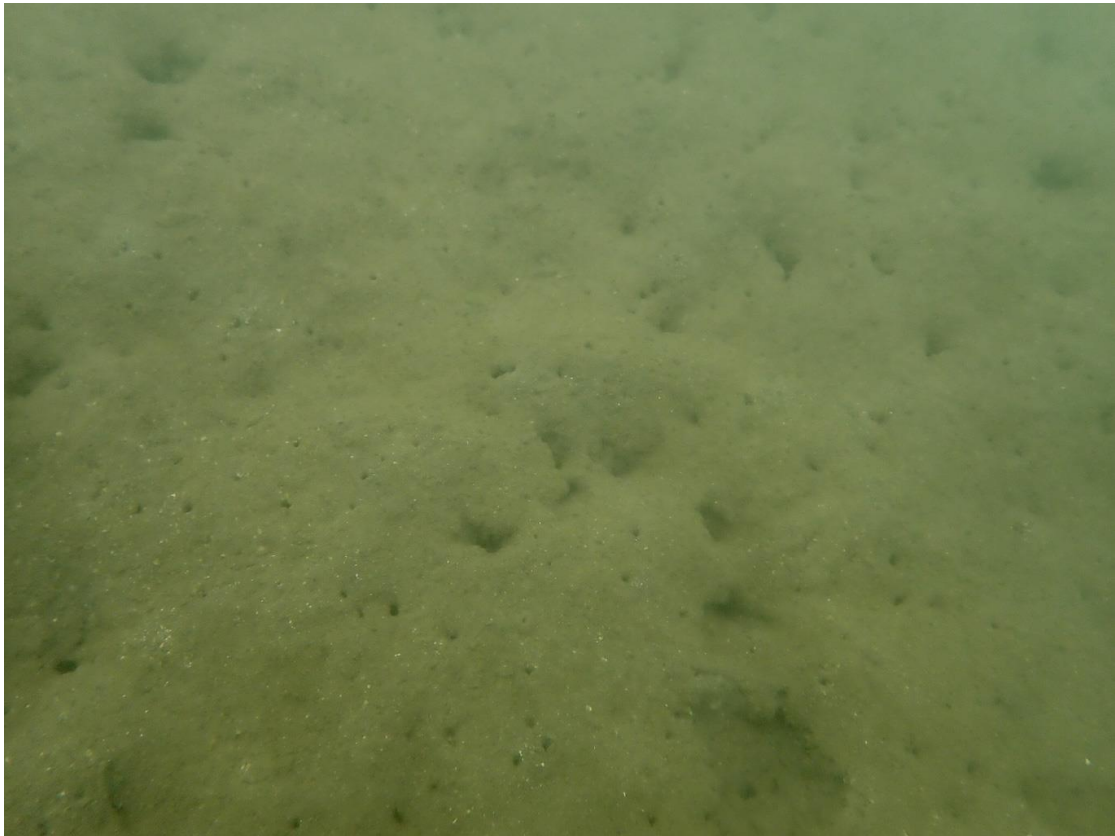
The subtidal zone within the on-site survey area of The Property started in line with the start of the existing jetty (9.5 m off the seawall) and consisted of a gradually sloping seabed composed of silty sand, that continued offshore for 9 m (Photo 5). The silty sand transitioned to gradually sloping sandy silt at the inner edge of the existing pontoon (Photo 6), and continued uniformly offshore beyond the survey area (see aquatic habitat mapping in Appendix B). The soft seabed across the whole site was bioturbated from the burrowing activities of benthic fauna (Photos 5 - 6).

The soft seabed across the entire site was unvegetated (Photos 5 - 6).

Photo 5. Unvegetated, bioturbated silty sand in the location of the proposed new pontoon.

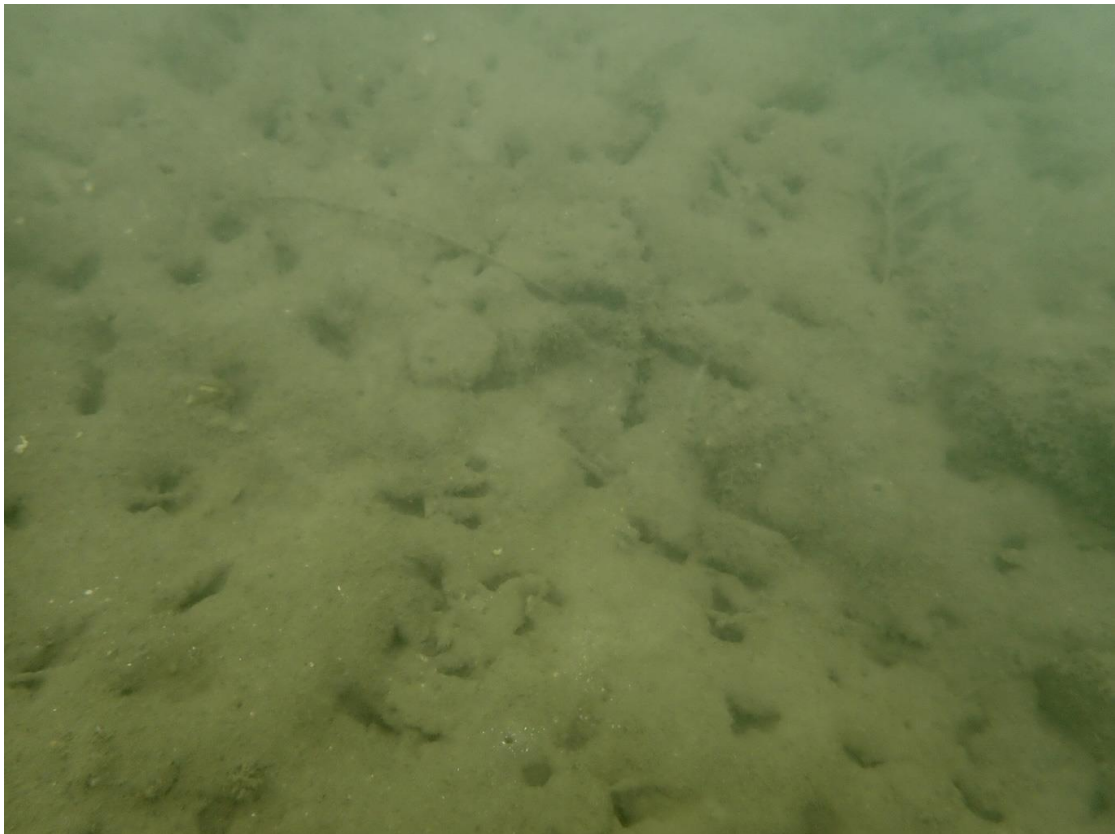
Photo 6. Unvegetated, bioturbated sandy silt in the location of the proposed new berthing area and relocated mooring piles.

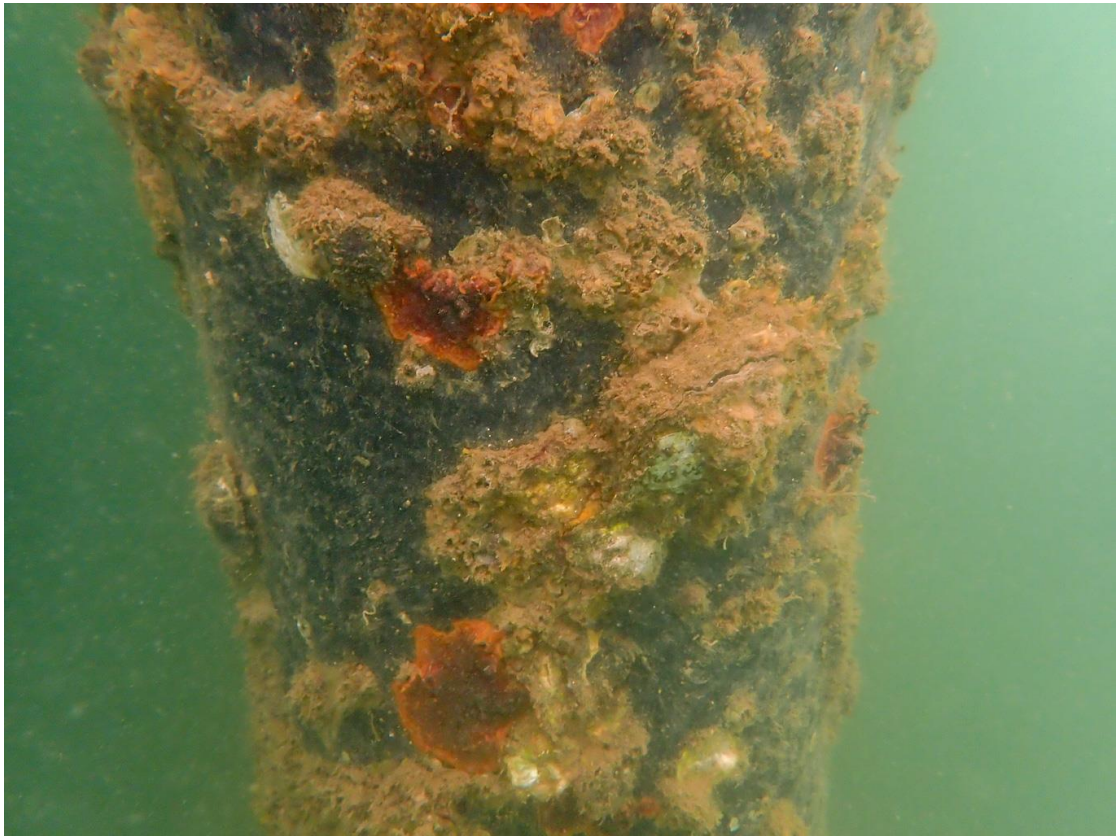
The subtidal sections of the existing timber jetty end piles (proposed to be removed) were colonised by a low density growth of Pacific oysters (*Crassostrea gigas*) along with a thin layer of brown filamentous alga. The existing pontoon piles and mooring piles (one to be removed, three relocated and one to stay in position) were colonised by a low density assemblage of subtidal biota, including brown filamentous alga, Pacific oysters, white ascidians (*Styela plicata*) and bryozoa (frilly *Bugula* sp. and hard *Watersipora* sp.) (Photo 7). The existing pontoon (Photo 8) was colonised by red filamentous alga (*Gelidium* sp.), brown filamentous alga, Sydney rock oysters, white ascidians and hard bryozoa.

Photo 7. Subtidal biota colonising the existing sleeved steel mooring pile (proposed to be relocated).

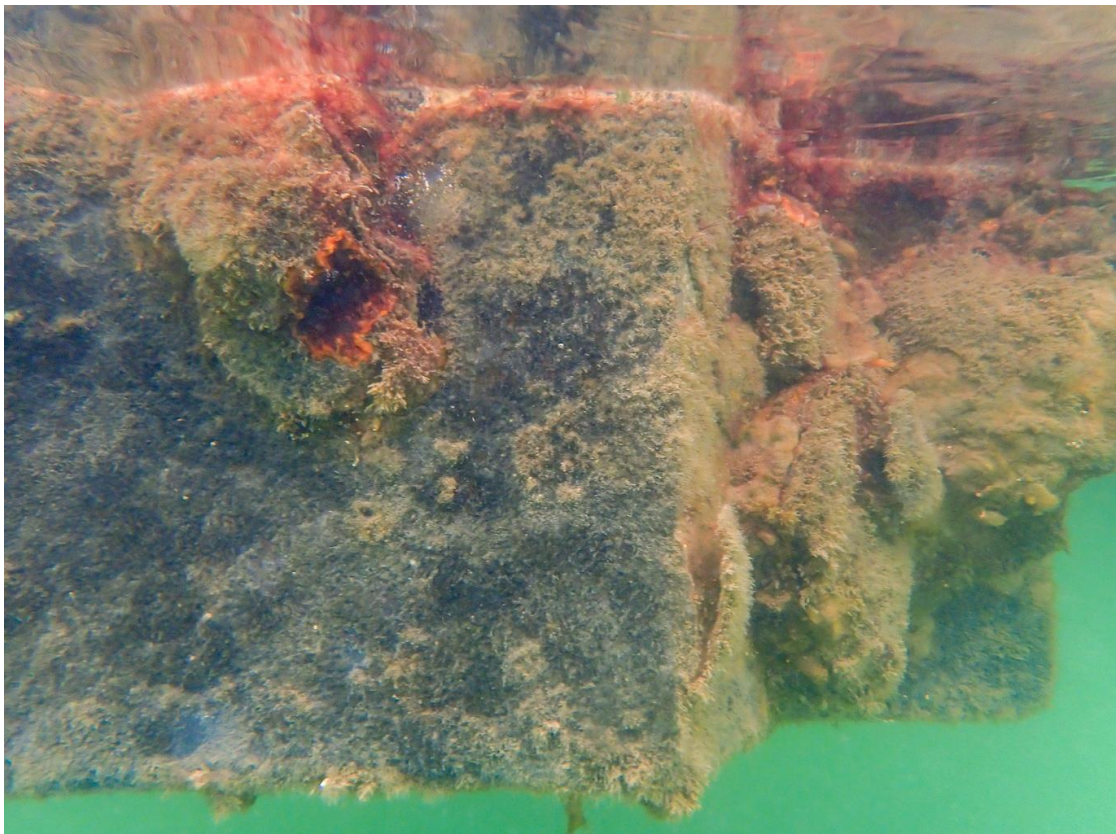
Photo 8. Subtidal biota colonising the existing pontoon (proposed to be removed).
