REPORT TO
ERILYAN

ON
ADDITIONAL ENVIRONMENTAL SITE ASSESSMENT

FOR
PROPOSED MEDICAL CENTRE

AT
**LOT 7 IN DP1020015 – 49 FRENCHS FOREST ROAD
EAST, FRENCHS FOREST, NSW**

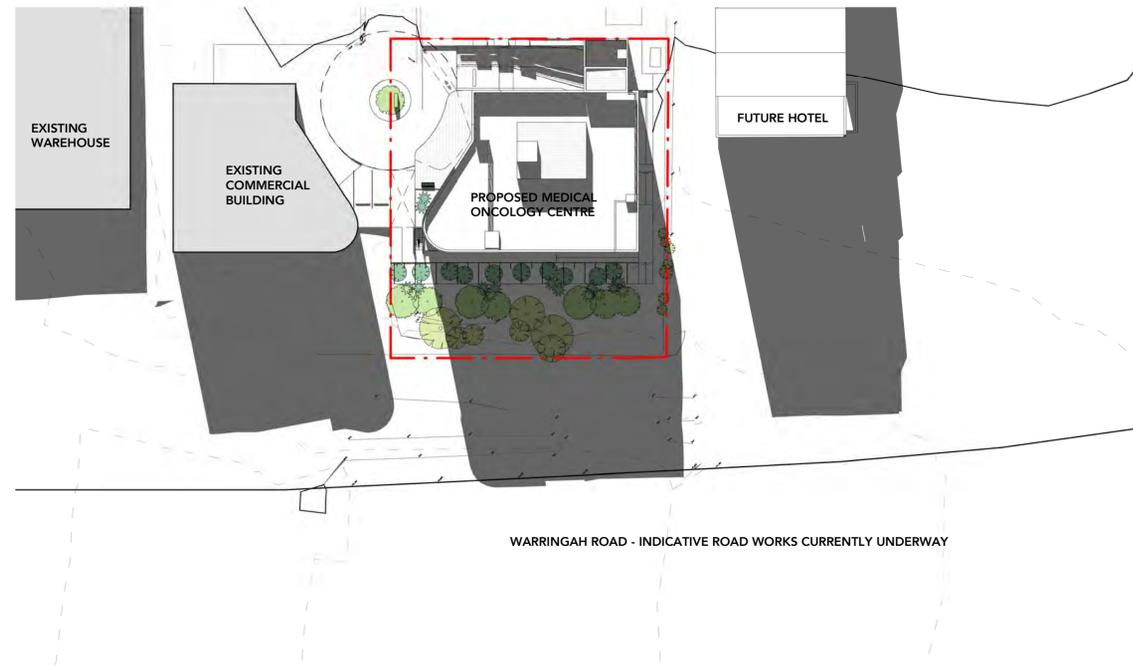
1 Shadow Diagram - 21st June 9am with Future Hotel
N.T.S

2 Shadow Diagram - 21st June 12pm with Future Hotel
N.T.S

3 Shadow Diagram - 21st June 3pm with Future Hotel
N.T.S
