# PRELIMINARY (STAGE 1) SITE INVESTIGATION

**Proposed Residential Sub-Division  
45/49 Warriewood Road, Warriewood, NSW**

**16 November 2021**

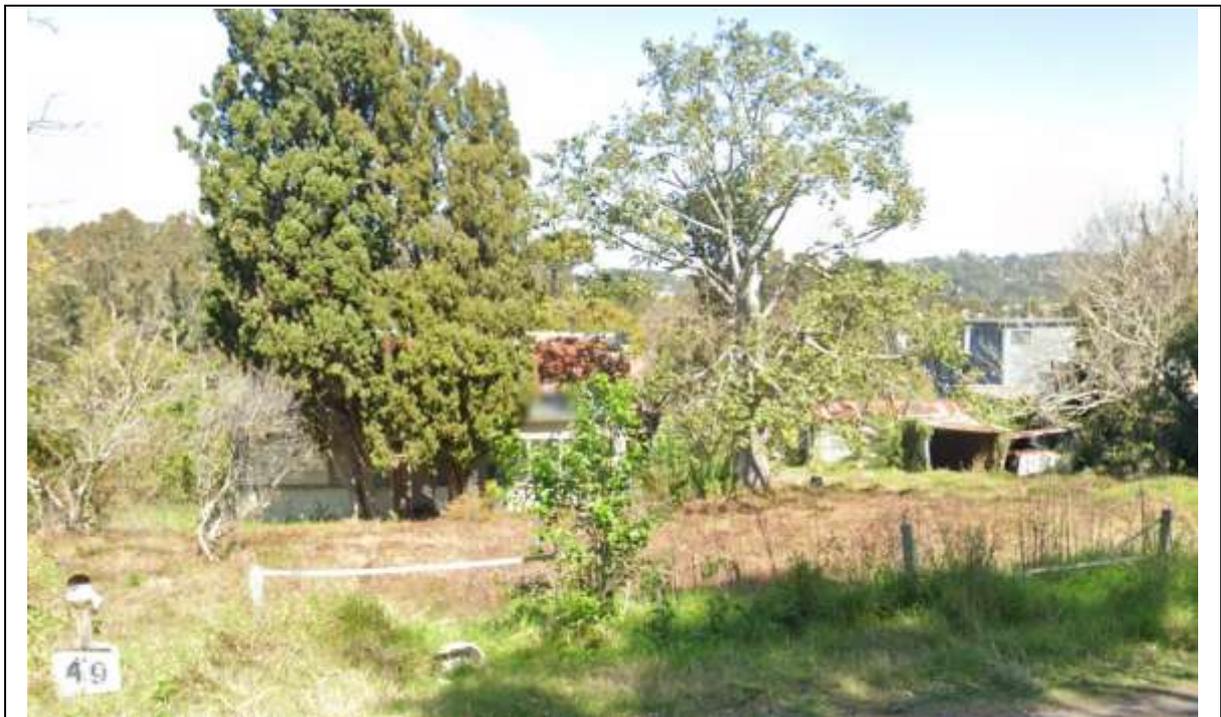
**Figure 6.1 – Existing Buildings and Structures on 49 Warriewood Road**

Given the apparent vintage and nature of the structures, and their -physical appearance, it is considered that potentially hazardous materials (including in particular asbestos cement sheeting in the form of “fibro”) are present, and comment re procedures to be followed during any future demolition operations have been provided for completeness in Section 8 and Appendix A.

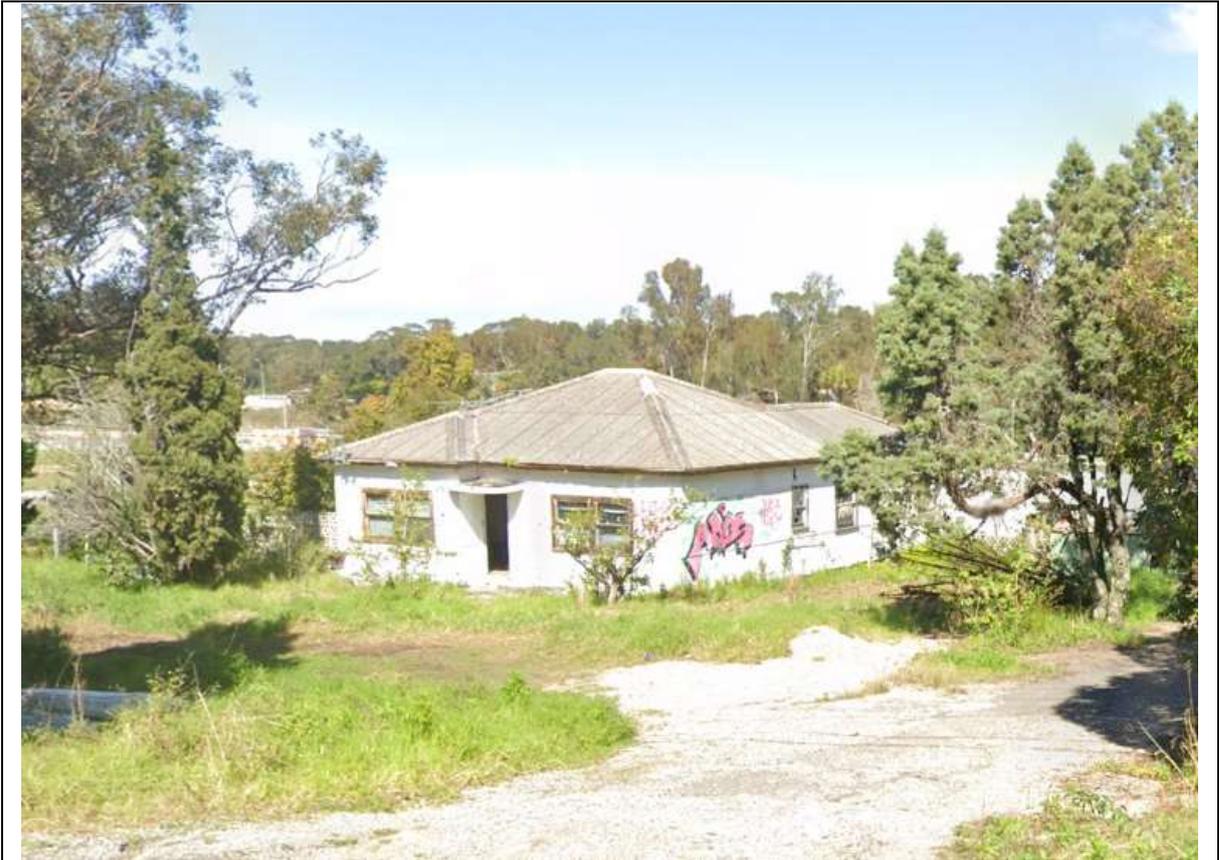
**Figure 6.2 – Existing Buildings and Structures on 45/49 Warriewood Road**

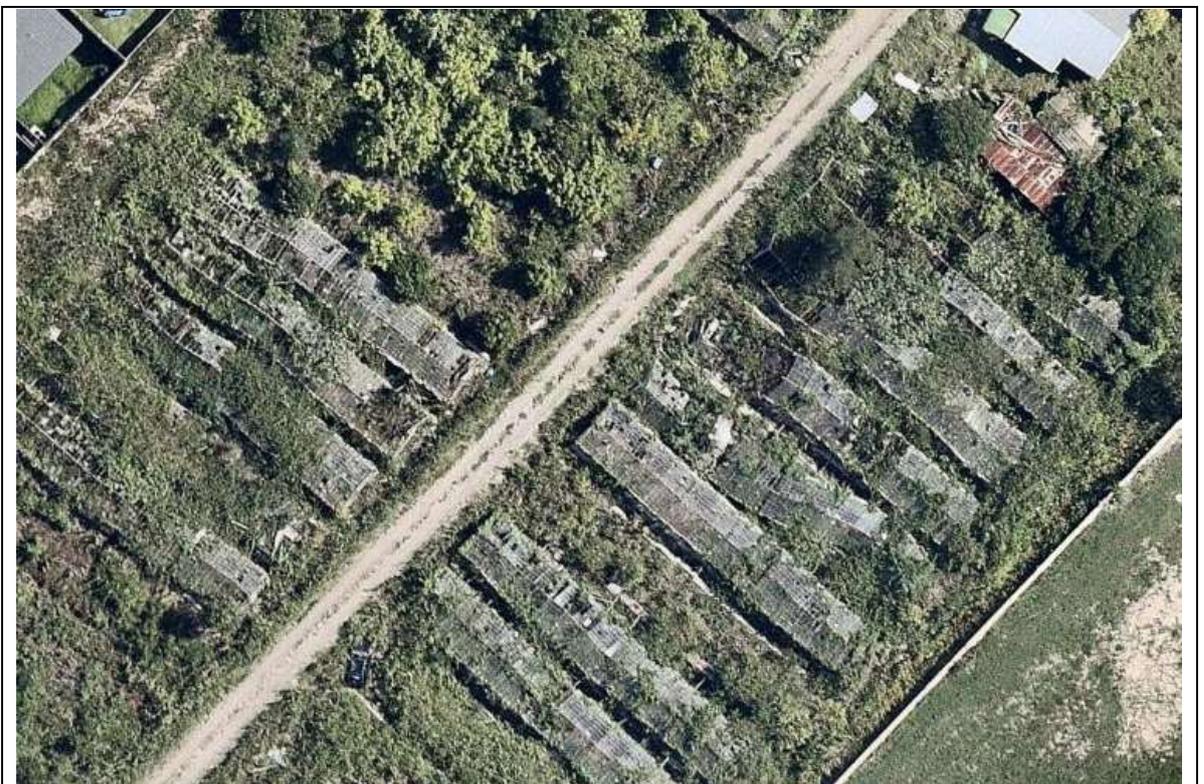
**Figure 6.4 – Disused Glasshouse Structures in Northeastern Portion of Site**

The site and associated improvements were found to be in a reasonably sound condition, although some outbuildings and structures were noted to be in a poorly maintained state.
