Arboriculture Impact Assessment Statement & Preliminary Plan of Tree Management

November 2024

Strata Body for Eurobodalla Village, Newport

267 BARRENJOEY ROAD NEWPORT NSW

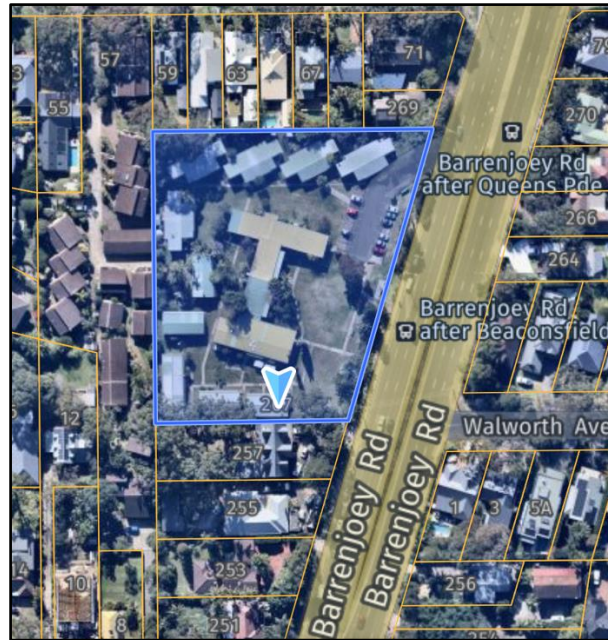
FIGURE 1: ABOVE ILLUSTRATES THE DISCUSSED TREES RELATIVE TO THE SITE 267 BARRENJOEY ROAD NEWPORT NSW. (AERIAL PHOTOGRAPH ON MONDAY 26 JUNE 2023, MAP DATA COURTESY OF NEARMAP™)

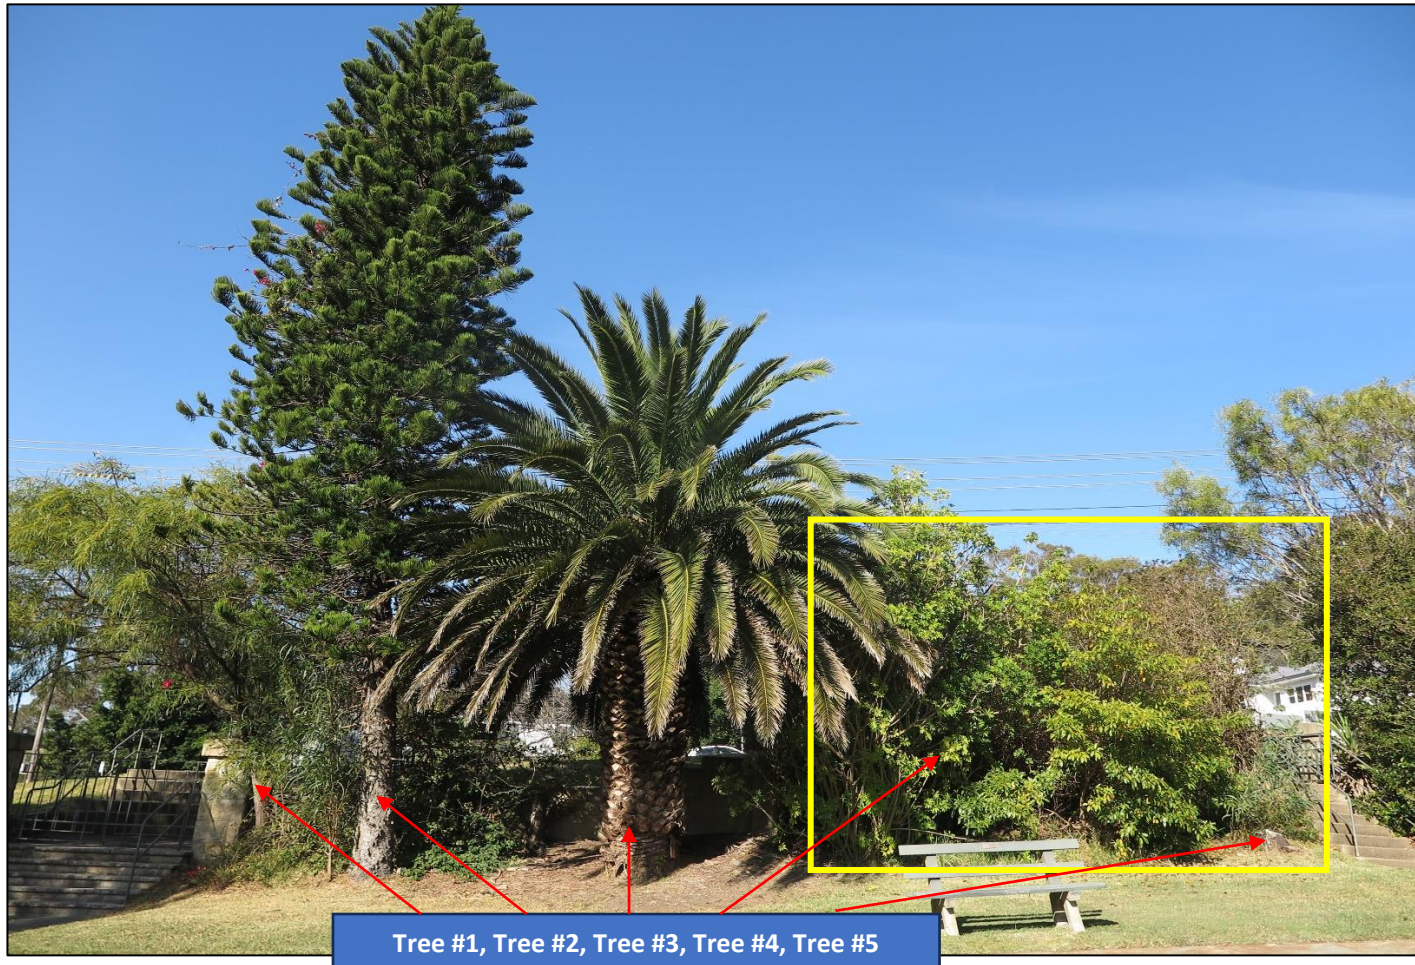
FIGURE 5: CONFIRMS THE LOCATION OF TREE #1 THROUGH TREE #5

Of the five (5) identified trees parallel to the Barrenjoey Road common boundary with the subject site only Tree #2 is a protected species. We additionally note; Tree #1 is not shown on the plans provided (confirming it to be self-sown), the tree shown as the most southern specimen has been removed. This confirms the likelihood of at least Tree #5 also being a self-sown weed species.

Tree #2 is assessed as a planted specimen. By the *Australian Standard (AS4970-2009 Protection of trees on development sites)* mathematical formula, it is determined as able to be viably retained with management.

- Remove Tree #1, Tree #3, Tree #4, Tree #5 & Tree #6.
- Grind deeply the stumps to create a greater volume of viable soil for the planting & establishment of new trees.

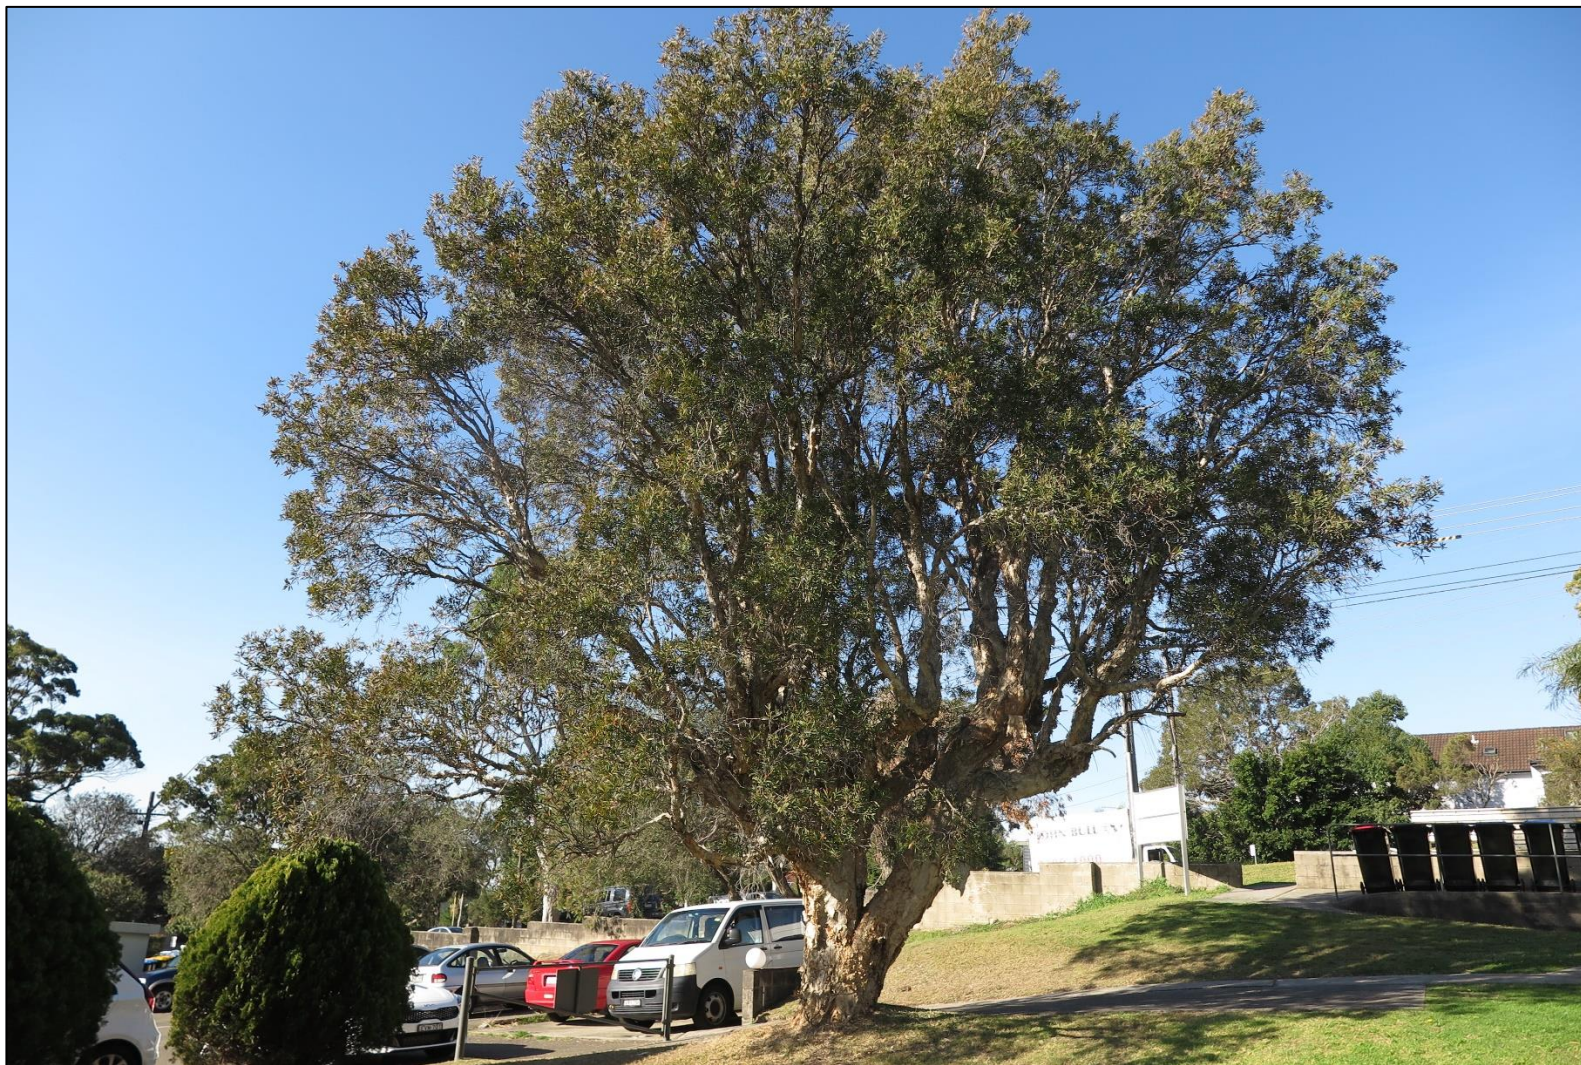
FIGURE 6: ILLUSTRATES THE LOCATION OF TREE #6 AS VIEWED FROM WITHIN AREA OF PROPOSED NEW PARKING SPACES

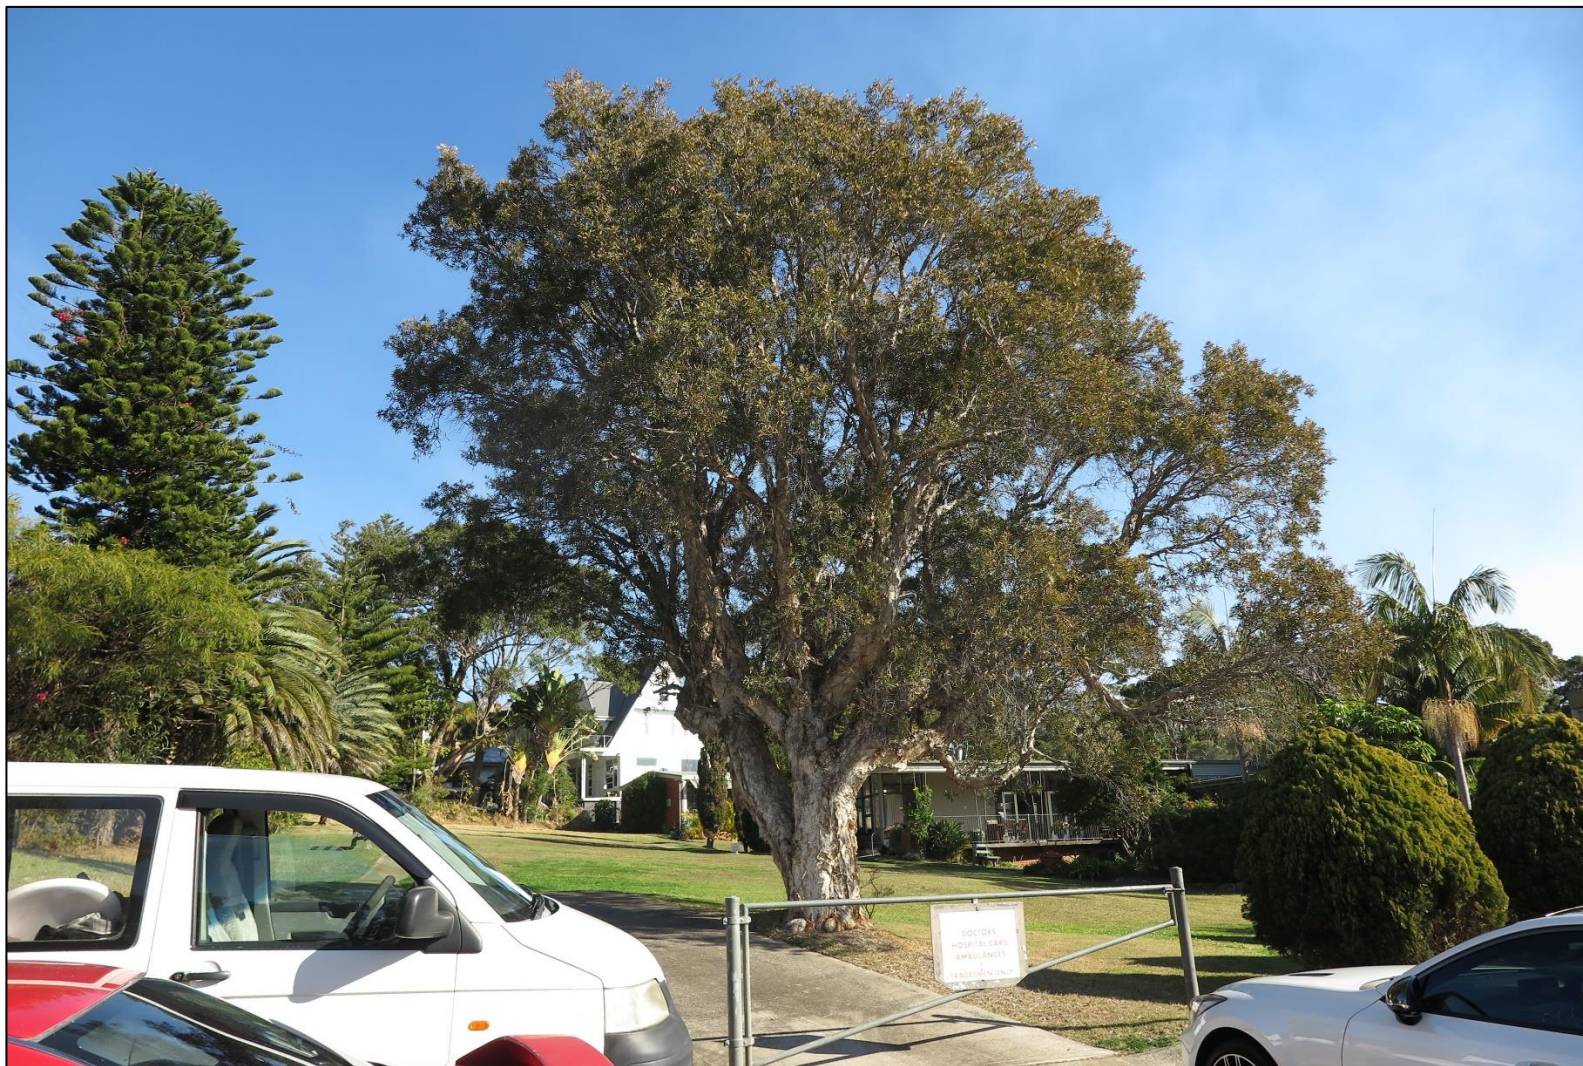
FIGURE 7: ILLUSTRATES THE LOCATION OF TREE #6 AS VIEWED FROM WITHIN AREA OF EXISTING PARKING SPACES

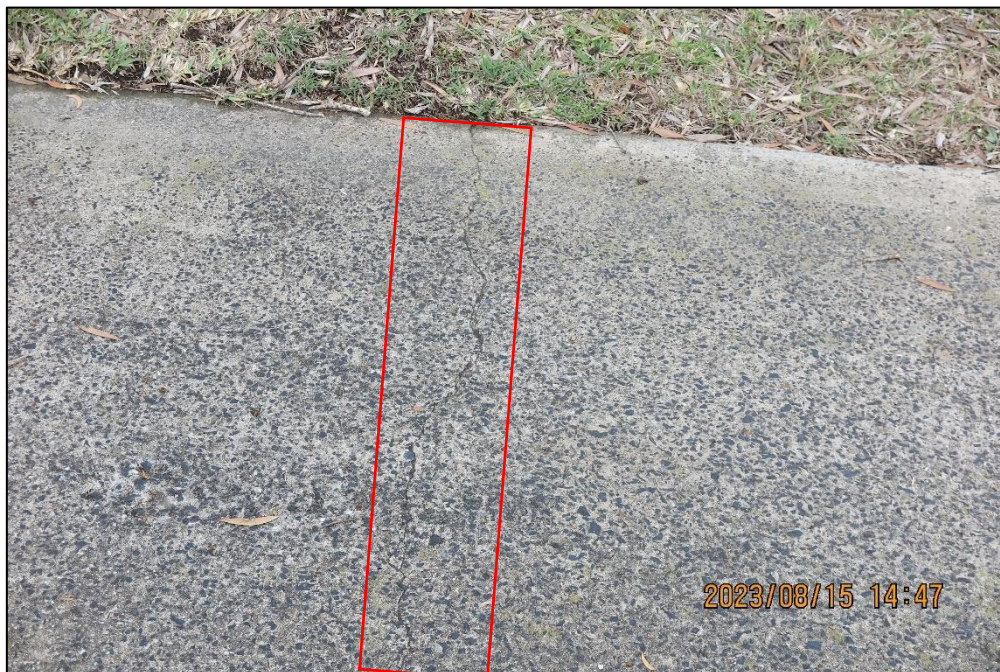
With respect to Tree #6, (also a NBC protected tree) the existing driveway is considered as best replaced. It already has cracked (see below photograph) which over time will only get worse. The crack is confirmed to be within its as calculated SRZ radial distance of 3.09m. We additionally note; the eastern side of driveway slab concrete strip to be broken &/or shifting in multiple locations. We have presumed this concrete strip to have been instated to provide better emergency or service vehicles access to the upper level where most of the proposed works are located. (See following page 16 photographs.)

FIGURE 8: INSIDE THE RED RECTANGLE IS THE WITHIN TREE #6 SRZ RADIAL DISTANCE CRACK TO EXISITNG DRIVEWAY CONCRETE SLAB

On the basis, that to achieve a structurally sound driveway access for larger, heavier emergency vehicles plus service vehicles as well as normal size vehicles we again reinforce the need for the whole of both structures to be totally replaced as the existing structures have not been designed to be used by larger / heavier emergency & services vehicles.

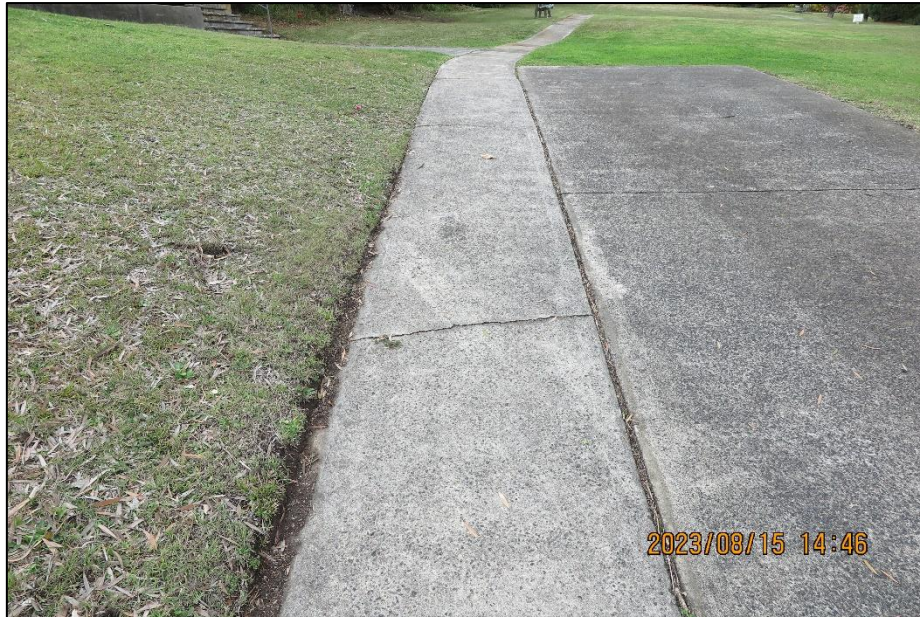
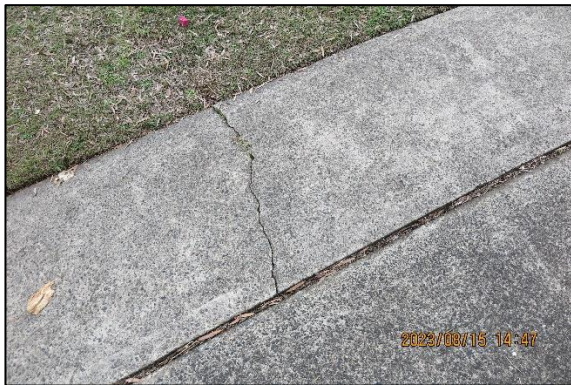
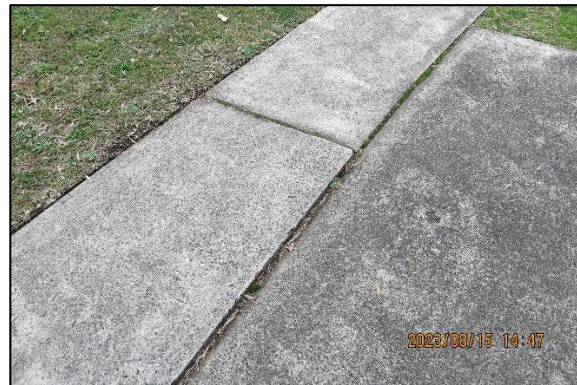
FIGURE 9: CONFIRMS DAMAGE AT THE TIME OF ASSESSEMENT TO BOTH THE CONCRETE DRIVEWAY SLAB AS WELL AS THE CONCRETE SIDE OF DRIVEWAY SLAB ADDED ON SECTION.

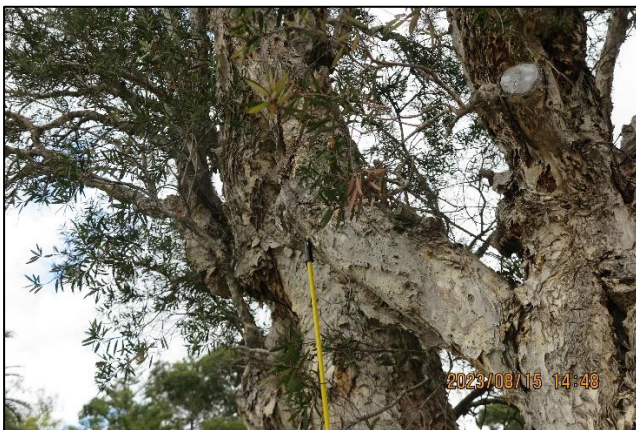
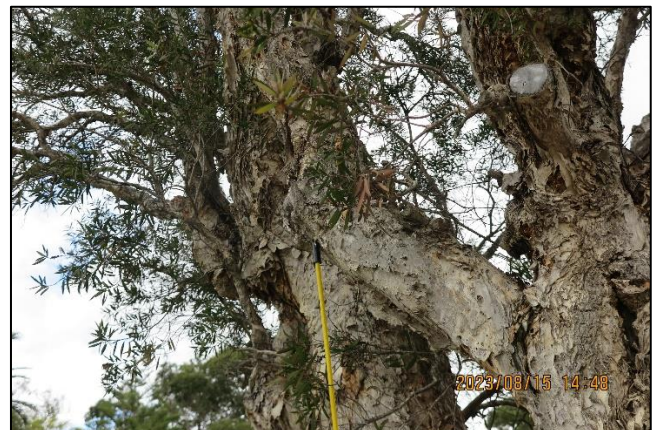
Consideration of retaining the existing concrete slab driveway / side of driveway is further compromised by the fact two (2) very large diameter 'scaffold branches' already overhang a portion of the existing concrete slab driveway. (See the below photographs.)

FIGURE 10: HEIGHT STICK WAS POSITIONED VERTICALLY ABOVE TH EXISITNG CONCRETE DRIVEWAY EDGE TO ILLUSTRATE PORTIONS OVERHANGING THE ACTUAL EXISITNG STRUCTURE
