Re: Stage 5 - New Club Areas & Carpark for the Dee Why RSL Club, Pittwater Road, Dee Why.

ABPP has been requested to examine whether the construction of the proposed Carpark extension to the Dee Why RSL Club is required to address the bushfire protection provisions of *Planning for Bushfire Protection 2006*.

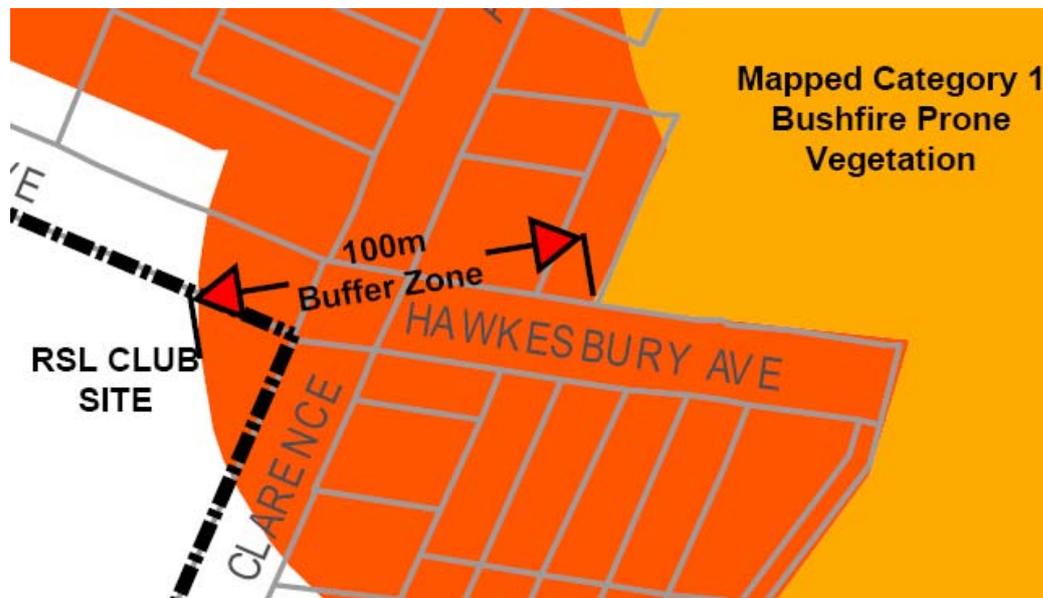
Figure 1 on Page 2 provides an extract from the Warringah 2010 Bushfire Prone Land Map showing the extent of affectation on the RSL Club site of the mapped 100 metre wide buffer zone to the Category 1 Bushfire Prone Vegetation which is shown, on the 2010 version of the Warringah Bushfire Prone Land Map, to be within the Reserve, located to the northeast of the Club.

Figure 1 – Extract from the Certified 2010 Warringah/Pittwater Bushfire Prone Land Map showing the extent of affection on the Dee Why RSL Club site of the 100 metre wide buffer zone to the Category 1 Bushfire Prone Vegetation.

The Warringah Bushfire Prone Land Map [2010 and Draft 2015 version] does not accurately record the extent of bushfire prone vegetation within the Dee Why Lagoon Wildlife Reserve and should therefore be modified.

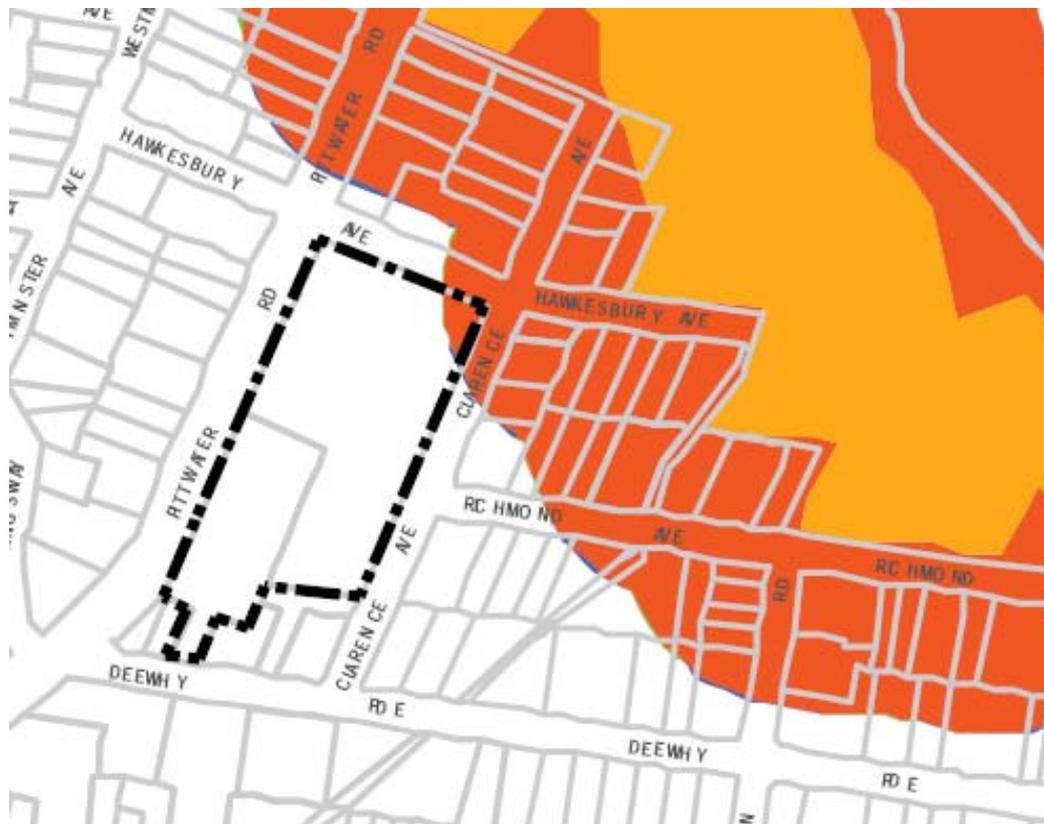
Figure 2 on Page 2 provides an extract from the Draft Warringah 2015 Bushfire Prone Land Map. This draft map continues to show the extent of the Category 1 Bushfire Prone Vegetation and the affectation on the RSL Club site of the mapped 100 metre wide buffer zone to the Category 1 Bushfire Prone Vegetation, which is shown to be within the Reserve, located to the northeast of the Club.

Figure 2 – Extract from the Draft 2015 Warringah/Pittwater Bushfire Prone Land Map which shows the extent of affection on the Dee Why RSL Club site of the 100 metre wide buffer zone to the Category 1 Bushfire Prone Vegetation.

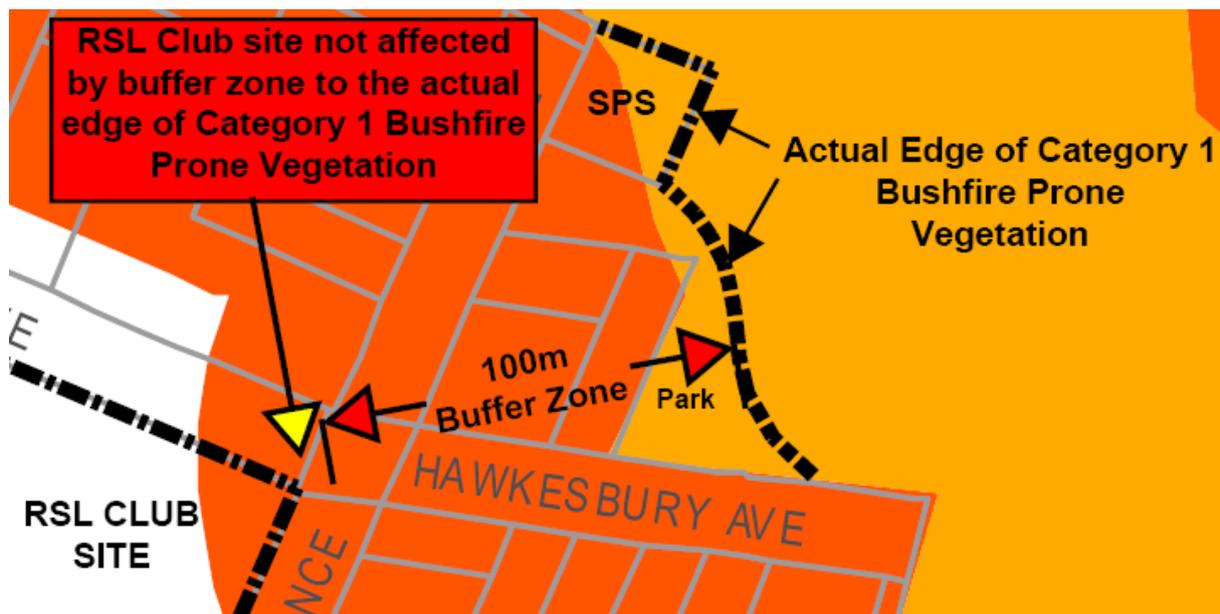
Figure 3 below shows the actual line of unmanaged vegetation within the Dee Why Lagoon Wildlife Reserve. This line has been validated from the inspection of the landuse to the northeast of the Club with the extent of the Category 1 Bushfire Prone Vegetation being correctly shown as extending up to the concrete Walking Path/Cycleway which extends from Hawkesbury Avenue to Clarence Avenue – beneath the tree canopy and within the managed south-western corner of the Reserve – refer to site photographs at Appendix A.

Figure 3 – Extract from the Certified Warringah/Pittwater Bushfire Prone Land Map showing the location of the actual extent of the Category 1 Bushfire Prone Vegetation within the Dee Why Lagoon Wildlife Reserve.

When the extent of the 100 metre wide buffer zone to the Category 1 Bushfire Prone Vegetation is measured from the actual edge of the unmanaged forest vegetation in the Dee Why Lagoon Wildlife Reserve, the buffer zone does not affect the Dee Why RSL Club site.

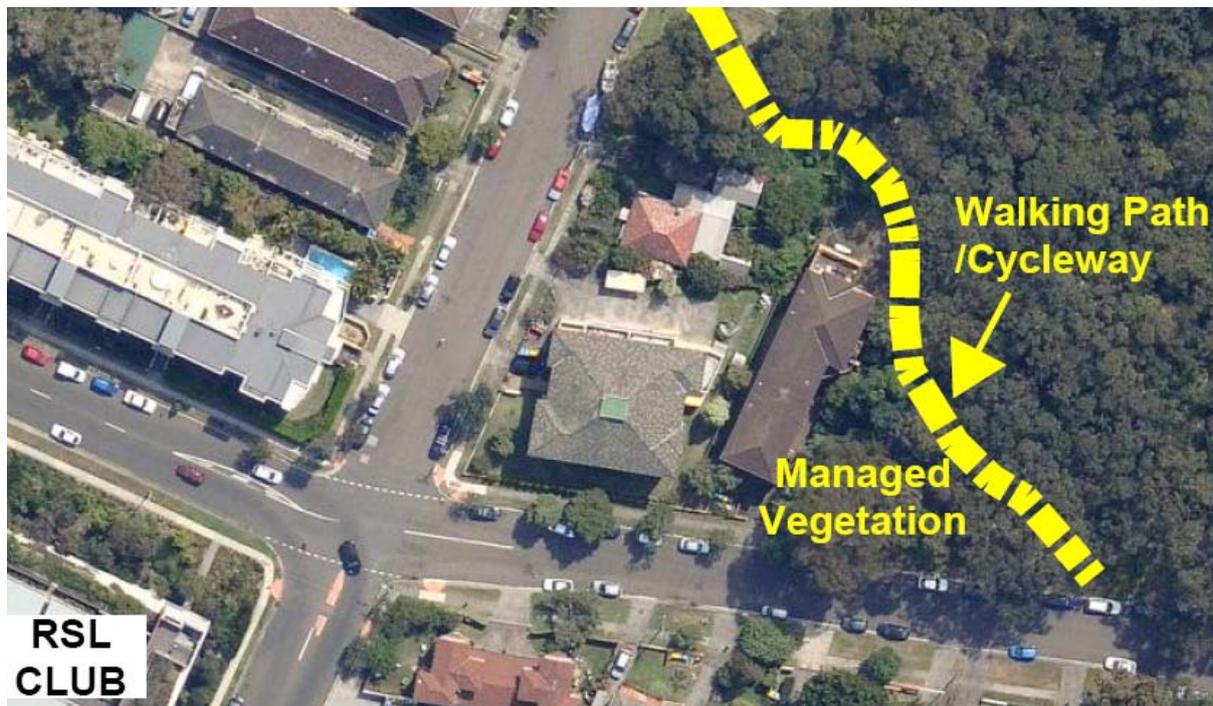
Figure 4 on Page 4 provides an Aerial Photograph of the vegetation within the south-western corner of the Dee Why Lagoon Wildlife Reserve and identifies the line of the concrete Walking Path/Cycle-way which is located beneath the tree canopy and forms the north-eastern edge of the managed section of the Reserve.

Figure 4 – Aerial Photograph of the vegetation within the south-western corner of the Dee Why Lagoon Wildlife Reserve and identifies the line of the concrete Walking Path Cycle-way located beneath the tree canopy.

The south-western corner of the Dee Why Lagoon Wildlife Reserve contains managed vegetation [mown lawn] beneath a tree canopy. This vegetation is not bushfire prone vegetation pursuant to the definitions provided by Appendix 2 of Planning for Bushfire Protection 2006.

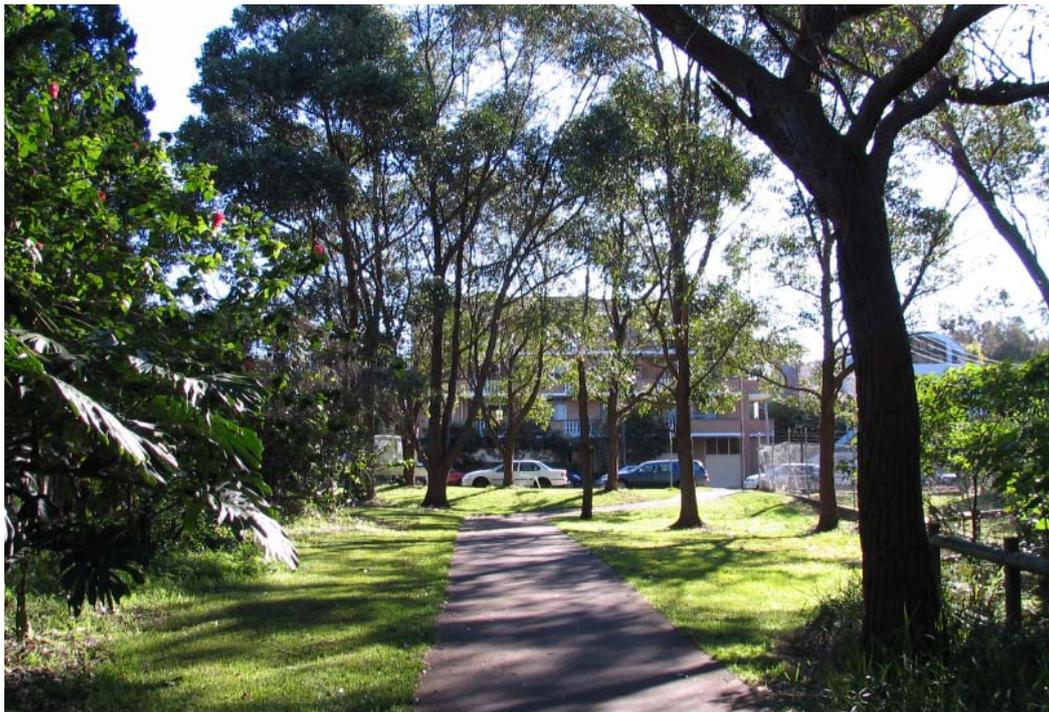
Photograph No. 1 – Looking west to Clarence Avenue showing managed vegetation in the Dee Why Wildlife Reserve.

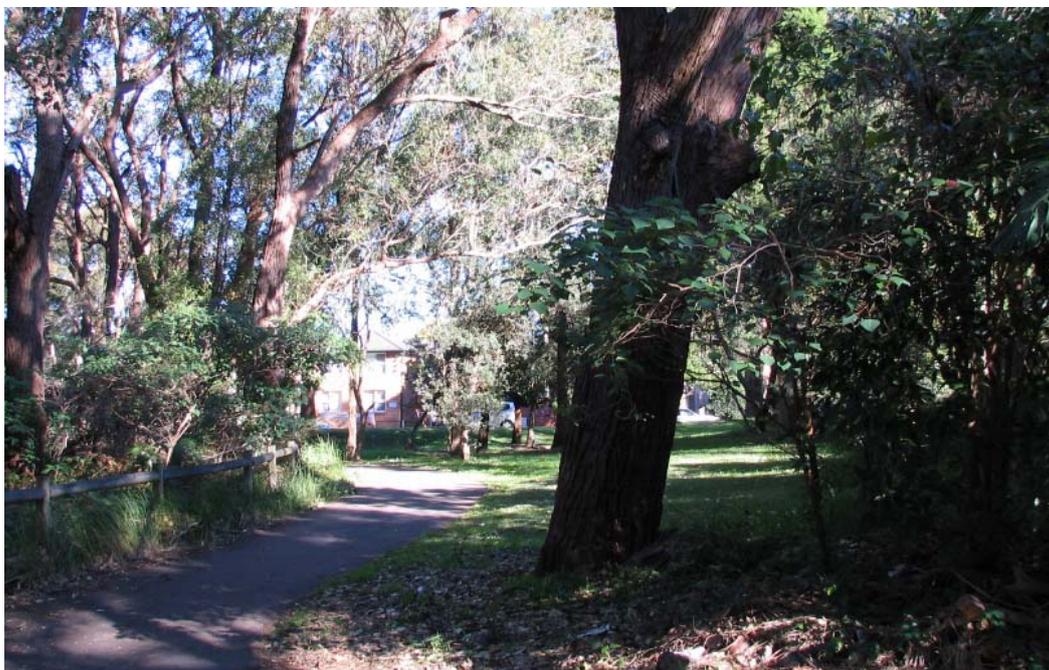
Photograph No. 2 – Looking south along pedestrian path showing managed vegetation in the Dee Why Wildlife Reserve and the existing residential development on the southern side of Richard Avenue in the background.

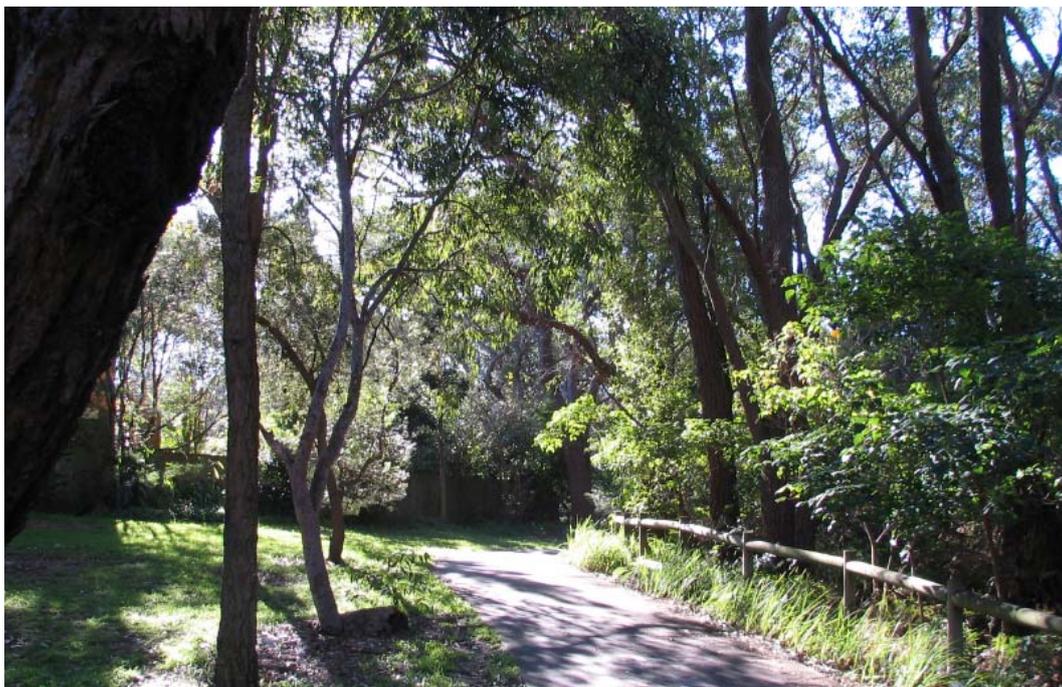
Photograph No. 3 – Looking northwest along Walking Path/Cycleway showing managed park in the south-western corner of the Dee Why Lagoon Wildlife Reserve.

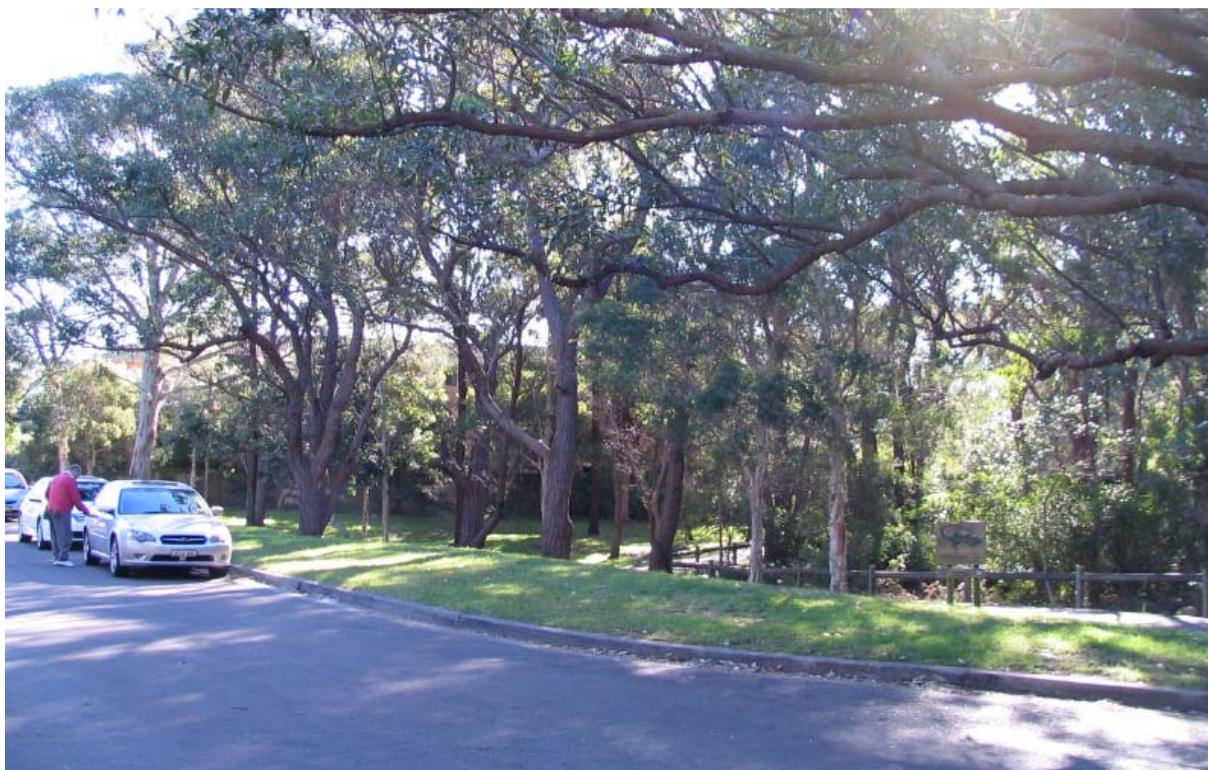
Photograph No. 4 – Looking northwest from Hawkesbury Avenue showing the managed vegetation beneath the tree canopy in the south-western corner of the Dee Why Wildlife Reserve – bushfire prone vegetation commences on the right of the Walking Path/Cycleway.
