**GEOTECHNICAL RISK MANAGEMENT POLICY FOR PITTWATER
FORM NO. 1 – To be submitted with Development Application**

Report Title: Geotechnical Report 3 Waratah Road, Palm Beach
Report Date: 17/8/23

GEOTECHNICAL INVESTIGATION:

Alterations and Additions at 3 Waratah Road, Palm Beach

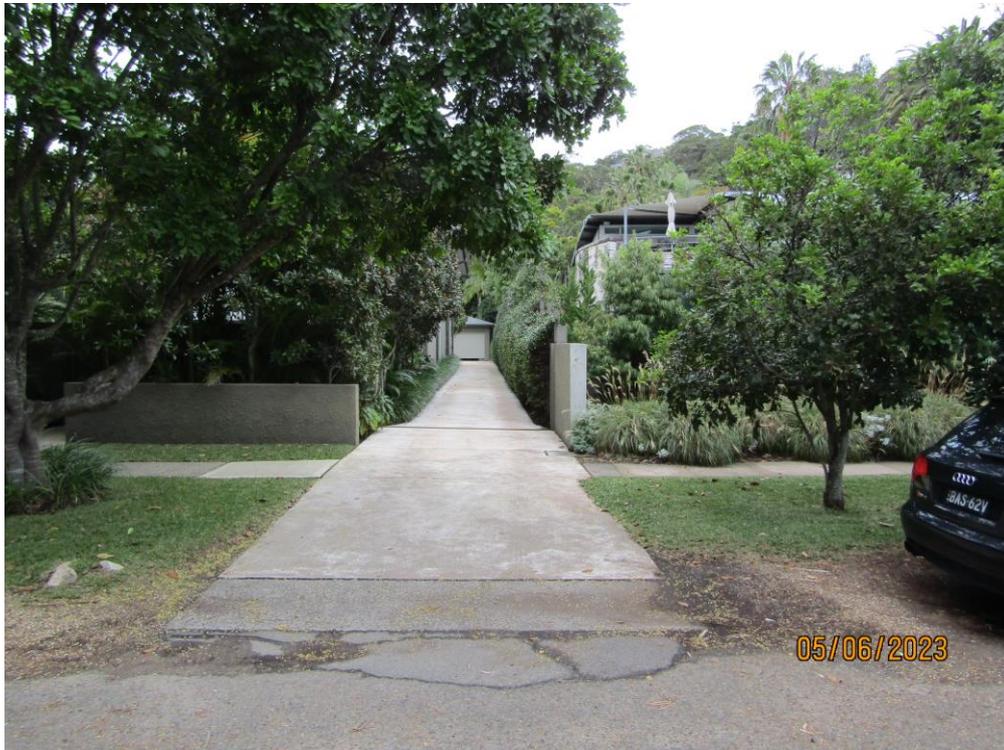
Photo 1

- 3.3** At the road frontage to Waratah Road, a concrete driveway runs past the SW side of the house (Photo 1) to a stable garage on the SE side of the property (Photo 2) which is the site of the proposed works. Between the road frontage and the house is a tile path flanked by level lawns. A pool has been cut into the N corner of the property (Photo 3). The water level indicates no ground movement has occurred in the shell of the pool since its construction. The two-storey house is supported on rendered brick walls (Photo 4). No significant signs of movement were observed in the supporting walls of the house. A gently sloping lawn surrounded by gardens extend off the SE side of the house to the Barrenjoey Road frontage. The cut for this lawn is supported by a

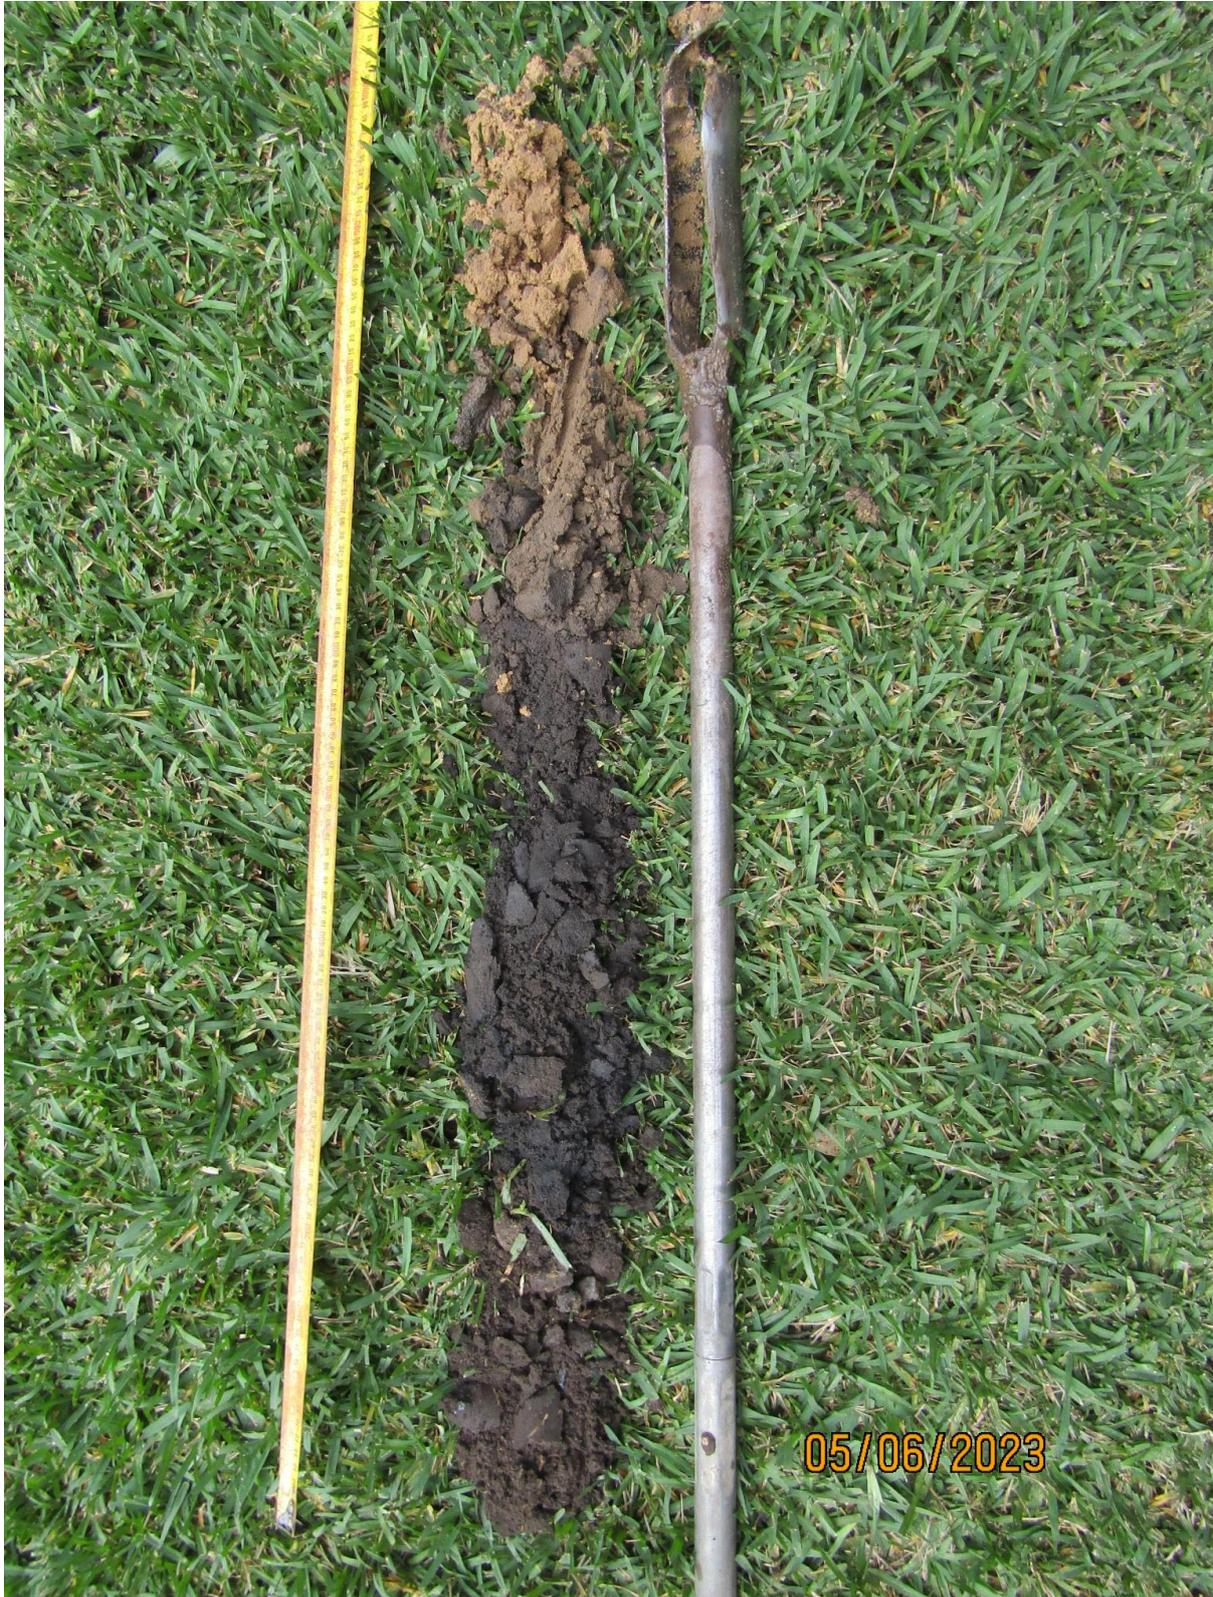
AUGER HOLE 1 (~RL2.6) – AH1 (Photo 6)

Depth (m)	Material Encountered
0.0 to 0.2	TOPSOIL , sandy soil, brown, Medium Dense to Dense, dry, medium to coarse grained, clay and organic material present.
0.2 to 0.5	CLAYEY SOIL , dark brown, Medium Dense, dry, medium grained.
0.5 to 0.75	SAND , brown, Medium Dense, damp, medium to coarse grained.
0.75 to 1.0	SAND , yellow-brown, Medium Dense, wet, medium to coarse grained.

End of hole @ 1.0m in Medium Dense Sand. Water table encountered at ~0.75m.

Photo 6: AH1 – Downhole is from bottom to top

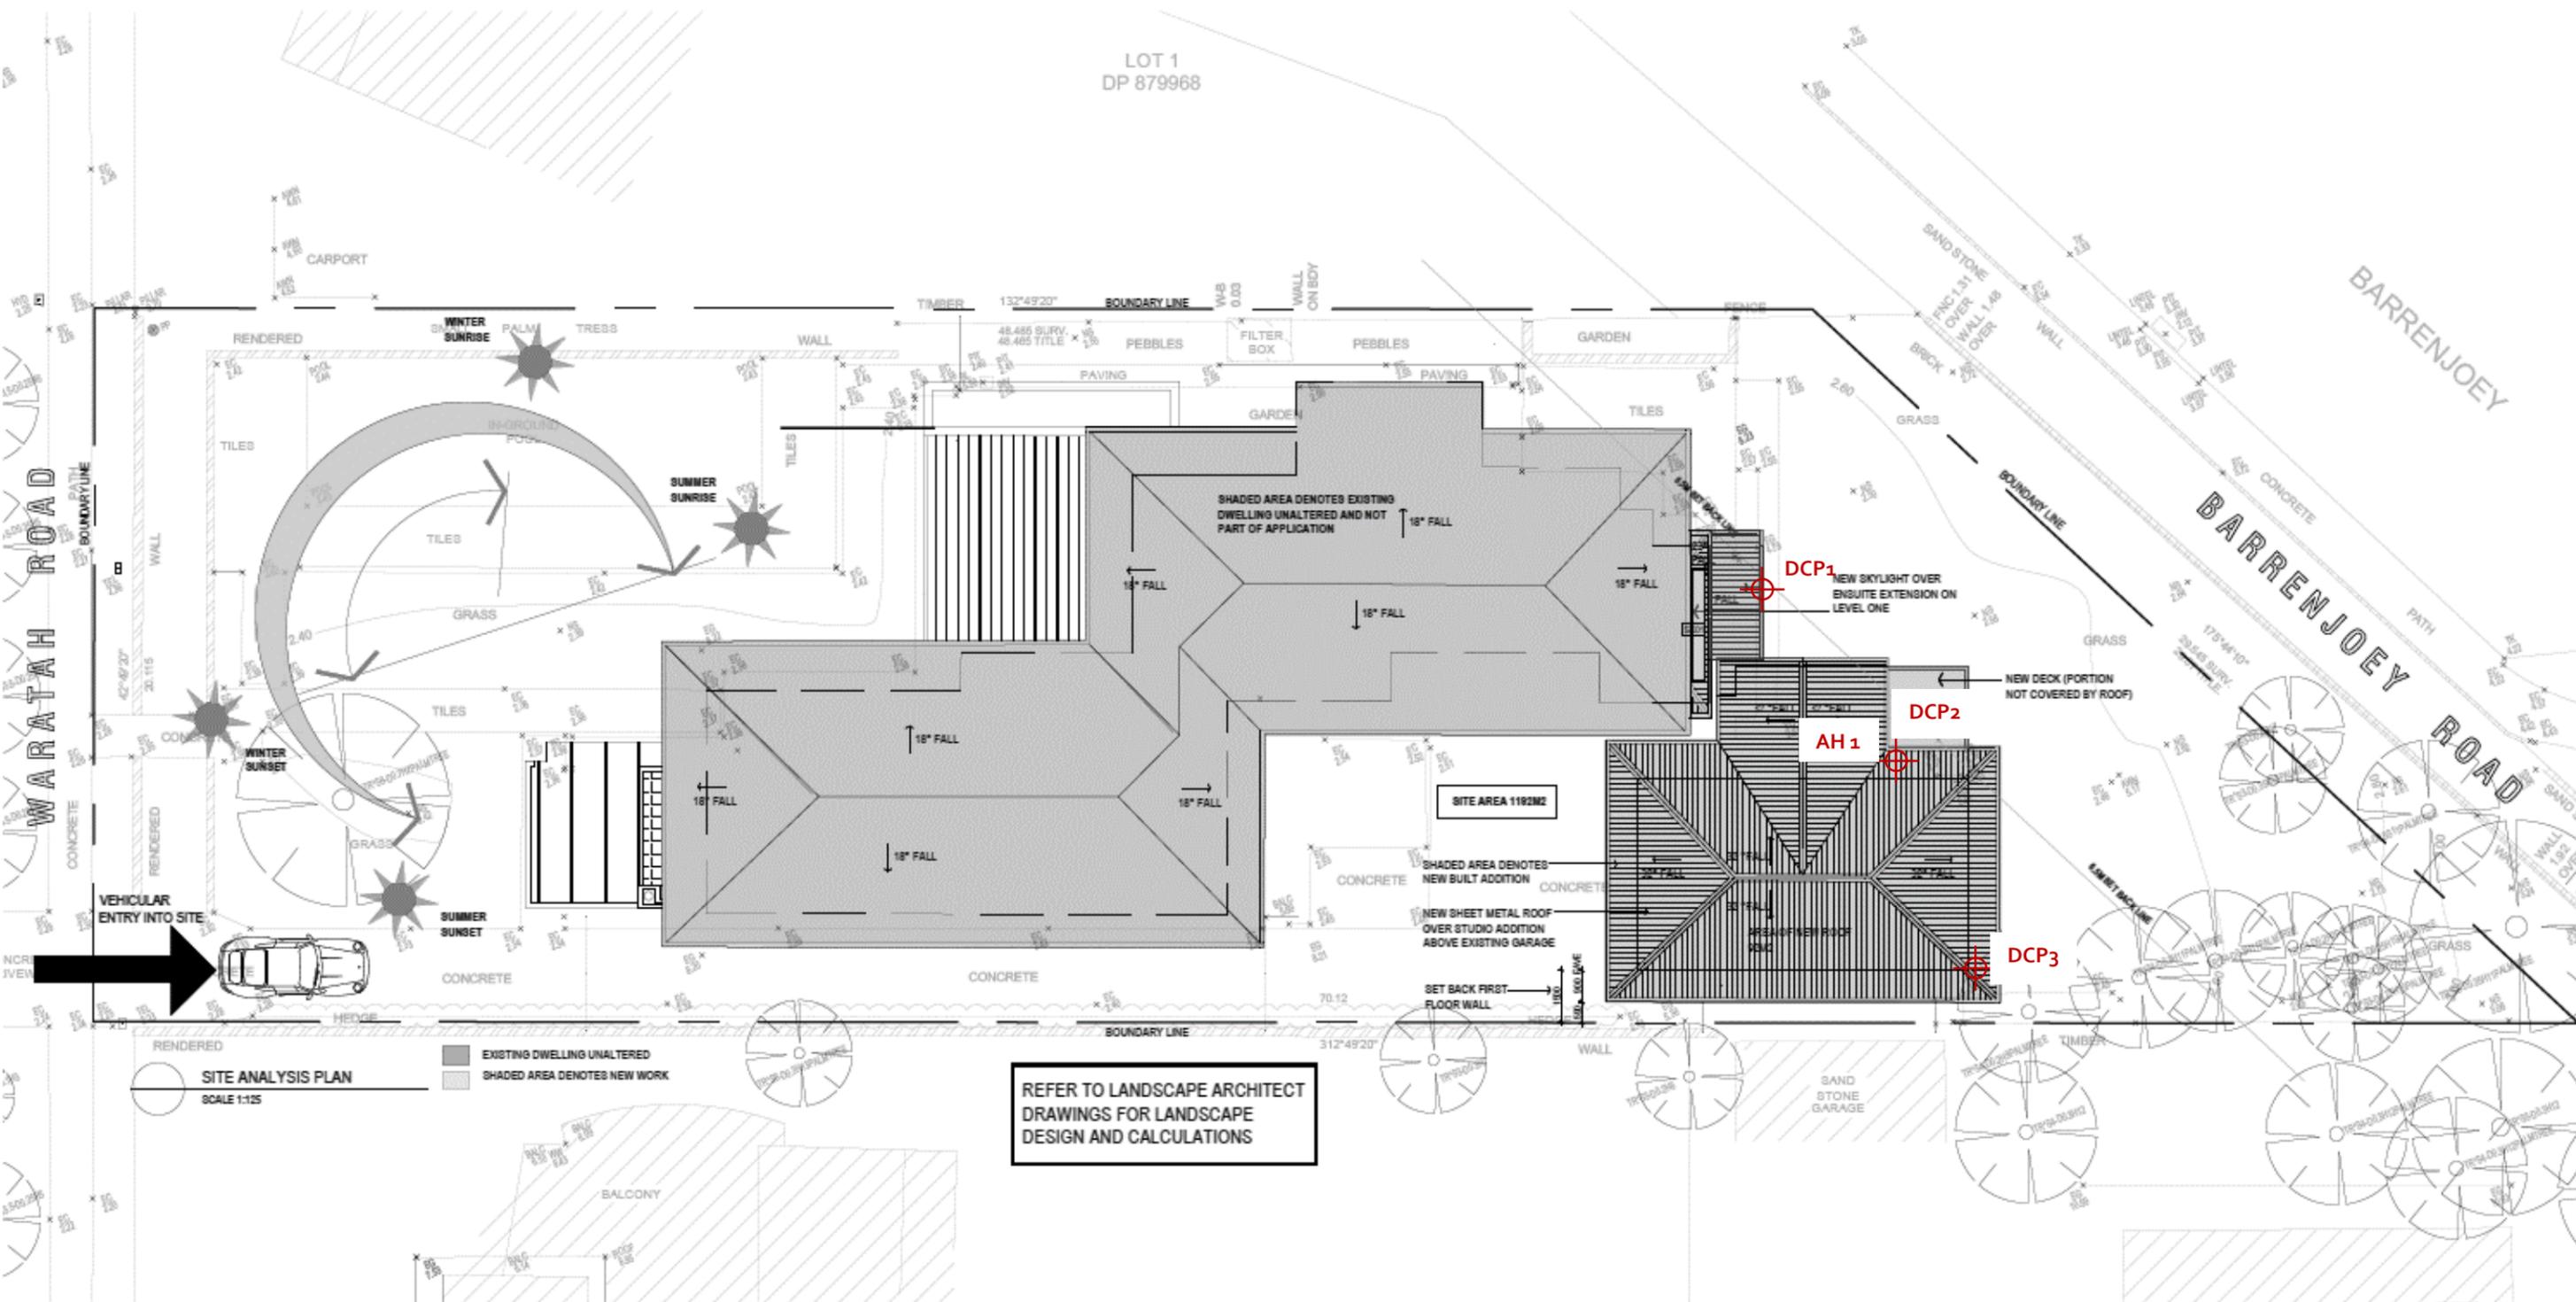
SITE PLAN – showing test locations

One hand Auger Hole (AH) was put down to identify the soil materials. Three Dynamic Cone Penetrometer (DCP) tests were put down to determine the relative densities of the soil/sands through the profile. The locations of the tests are shown on the site plan attached. It should be noted that a level of caution should be applied when interpreting DCP test results. The test will not pass through hard buried objects so in some instances it can be difficult to determine whether refusal has occurred on an obstruction in the profile or on the natural rock surface. This is not expected to be an issue for the testing on this site. However, excavation and foundation budgets should always allow for the possibility that the interpreted ground conditions in this report vary from those encountered during excavations. See the appended "Important information about your report" for a more comprehensive explanation. The results are as follows:
