GEOTECHNICAL INVESTIGATION:

Granny Flat and Parking Area at 111 Woorarra Avenue, Elanora Heights

1. Proposed Development

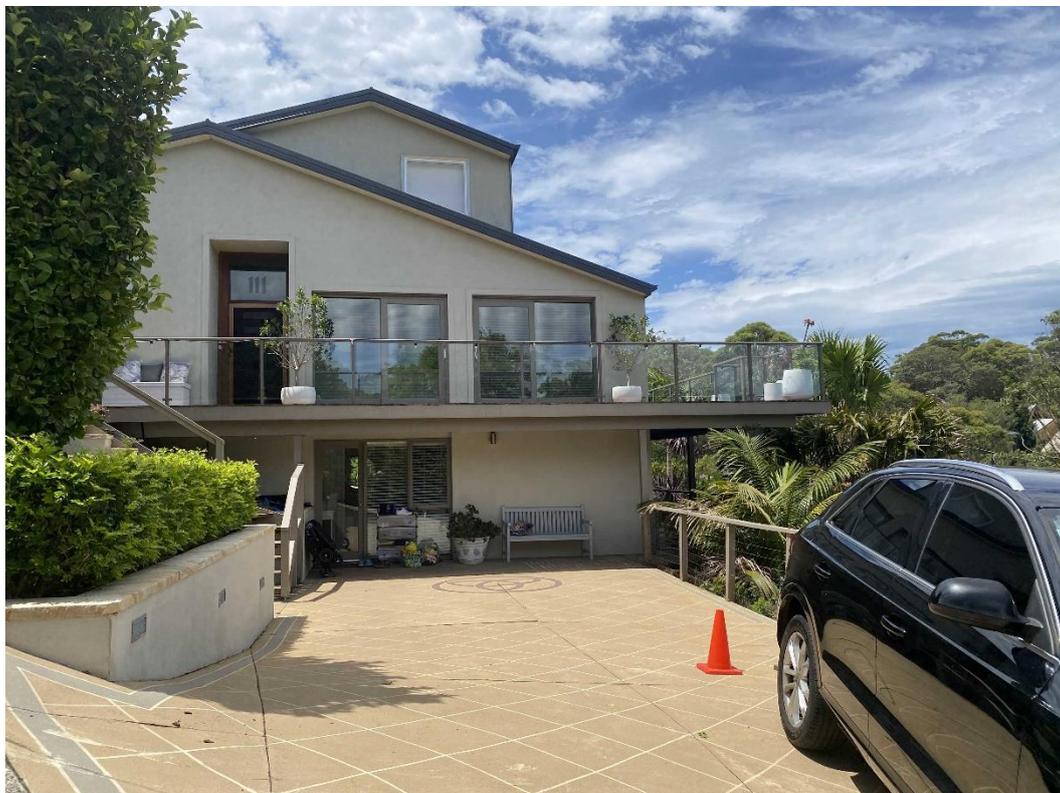
Photo 1

- 2.3** At the road frontage, a shared driveway runs down the slope to a parking area off the S side of the house (Photo 1). The fill for the parking area is supported by a series of stable timber retaining walls reaching up to $\sim 1.0\text{m}$ high (Photo 2). The part two-storey house is supported on rendered masonry walls. The walls show no significant signs of movement. Medium Strength Sandstone is observed outcropping underneath the house and it is likely the house is at least partially supported on this material (Photo 3). The cut for the house is supported by a stable $\sim 0.7\text{m}$ high concrete block retaining wall (Photo 4). A terraced lawn area extends off the uphill side of the house. The cut for the upper lawn area is supported by a stable $\sim 1.2\text{m}$ high stack rock retaining wall (Photo 5). A large sandstone floater is resting in a stable position above

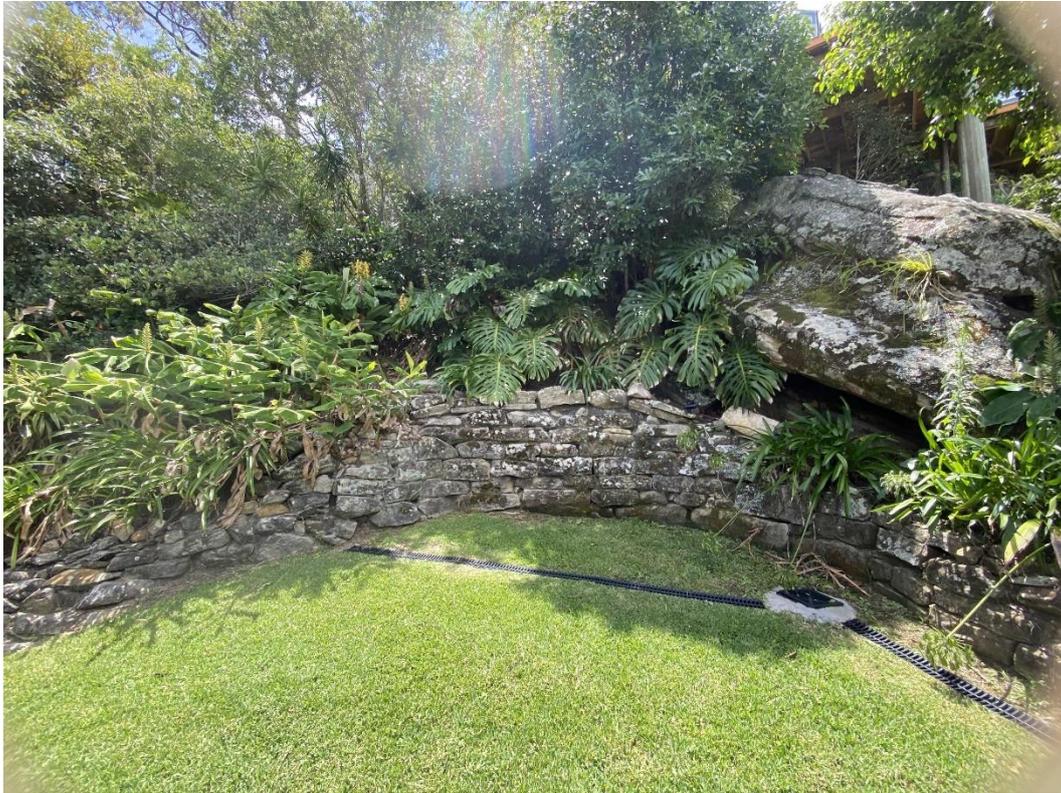
Photo 5

this wall. A moderately sloping vegetated garden extends above this wall to the upper common boundary. A series of timber retaining walls up to ~0.8m support fills for garden beds on the uphill side of the property (Photo 6). The middle retaining wall is twisting slightly but due to its position on the slope and the height of the wall, it is not a threat to life or property should it collapse. A moderately sloping lawn extends off the downhill and E sides of the house to the common boundaries (Photos 7 & 8). Medium Strength Sandstone outcrops and steps down this slope. Many large boulders and joint blocks are embedded in the slope in stable positions.

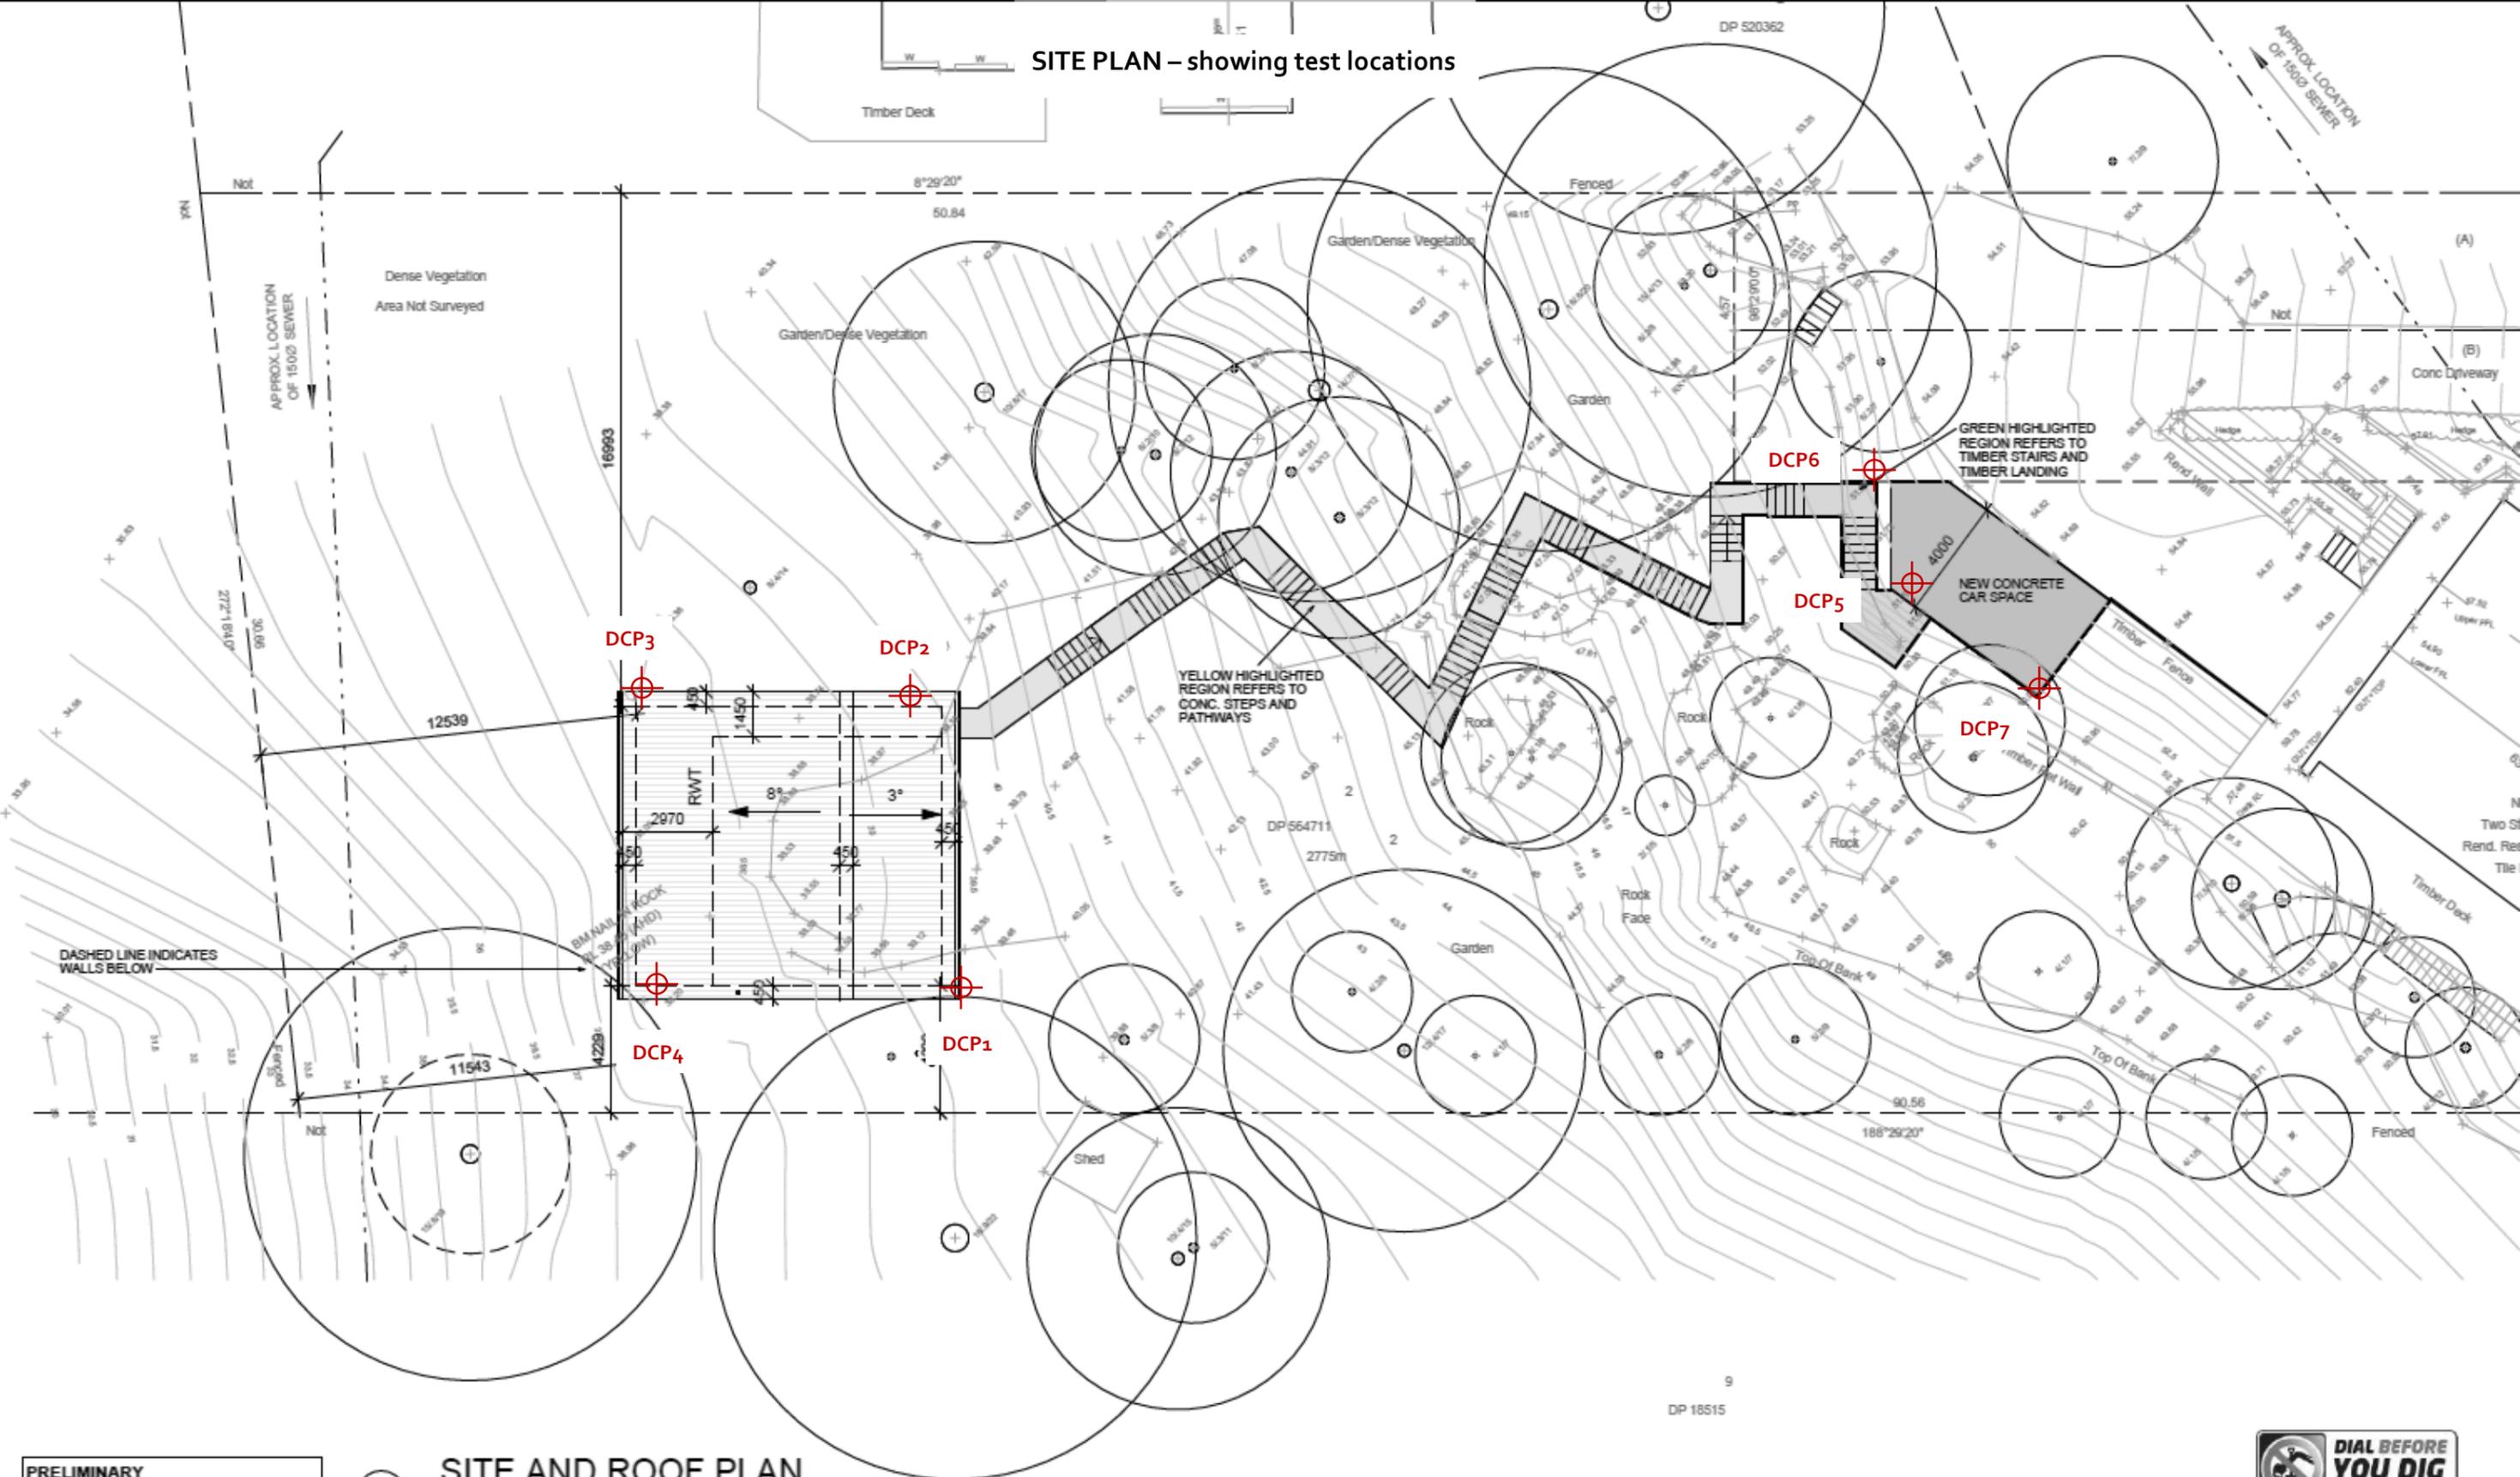
SITE PLAN - showing test locations

Seven Dynamic Cone Penetrometer (DCP) tests were put down to determine the relative density of the overlying soil and the depth to bedrock. The locations of the tests are shown on the site plan attached. It should be noted that a level of caution should be applied when interpreting DCP test results. The test will not pass through hard buried objects so in some instances it can be difficult to determine whether refusal has occurred on an obstruction in the profile or on the natural rock surface. This is not expected to be an issue for the testing on this site. However, excavation and foundation budgets should always allow for the possibility that the interpreted ground conditions in this report vary from those encountered during excavations. See the appended "Important information about your report" for a more comprehensive explanation. The results are as follows:

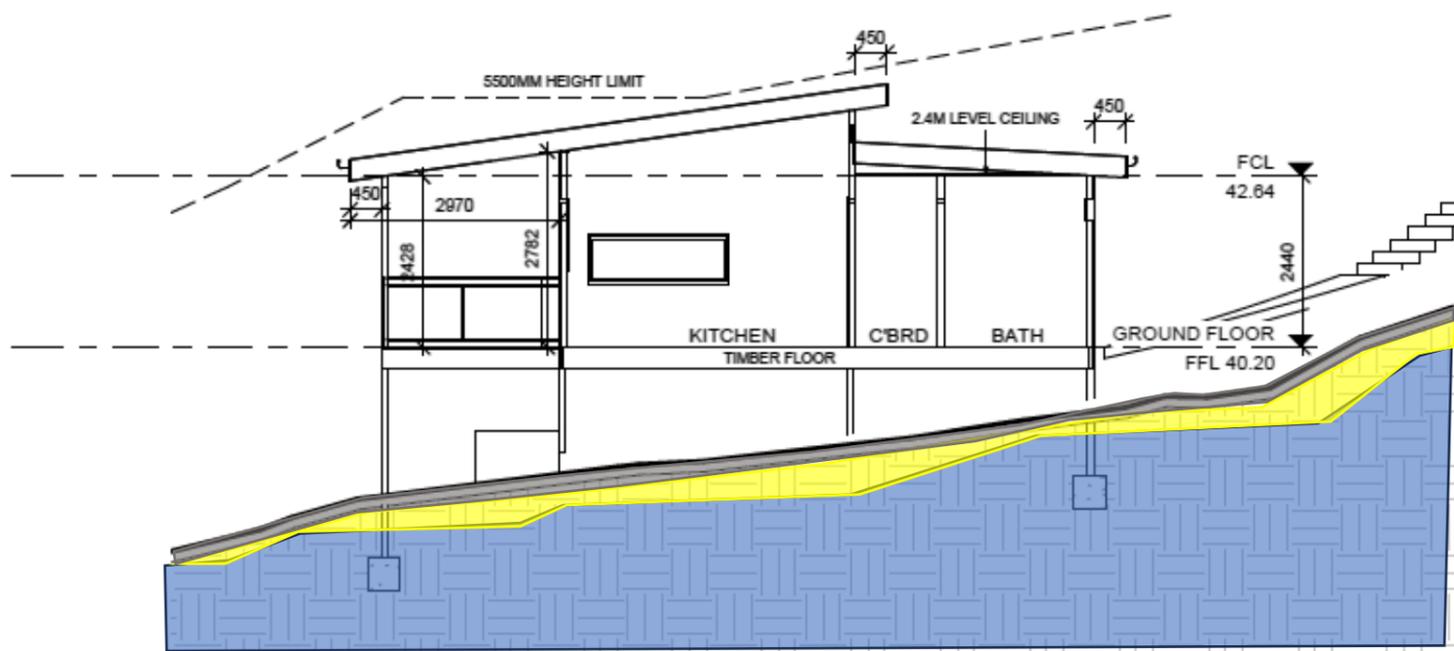
TYPE SECTION – Diagrammatical Interpretation of expected Ground Materials

The surface features of the block are controlled by the outcropping and underlying sandstone bedrock that steps down the property forming sub-horizontal benches between the steps. Where the grade is steeper, the steps are larger and the benches narrower. Where the slope eases, the opposite is true. Where the rock is not exposed, it is overlain by shallow soils over clays that fill the bench step formation. In the test locations, where the rock is not exposed, it was encountered at depths of between 0.2 to 1.1m below the current surface, being slightly deeper due to the stepped nature of the underlying bedrock. The outcropping sandstone on the property is estimated to be Medium Strength or better and similar strength rock is expected to underlie the entire site as all the DCP tests bounced at refusal. See Type Section attached for a diagrammatical representation of the expected ground materials.

- Fill
- Topsoil
- Clay – Firm to Stiff
- Hawkesbury Sandstone – Medium Strength
