Report on
Geotechnical Investigation

Dee Why RSL, Proposed Eastern Development
932 Pittwater Road, Dee Why

Prepared for
Dee Why RSL Club

Project 84926.03
March 2017

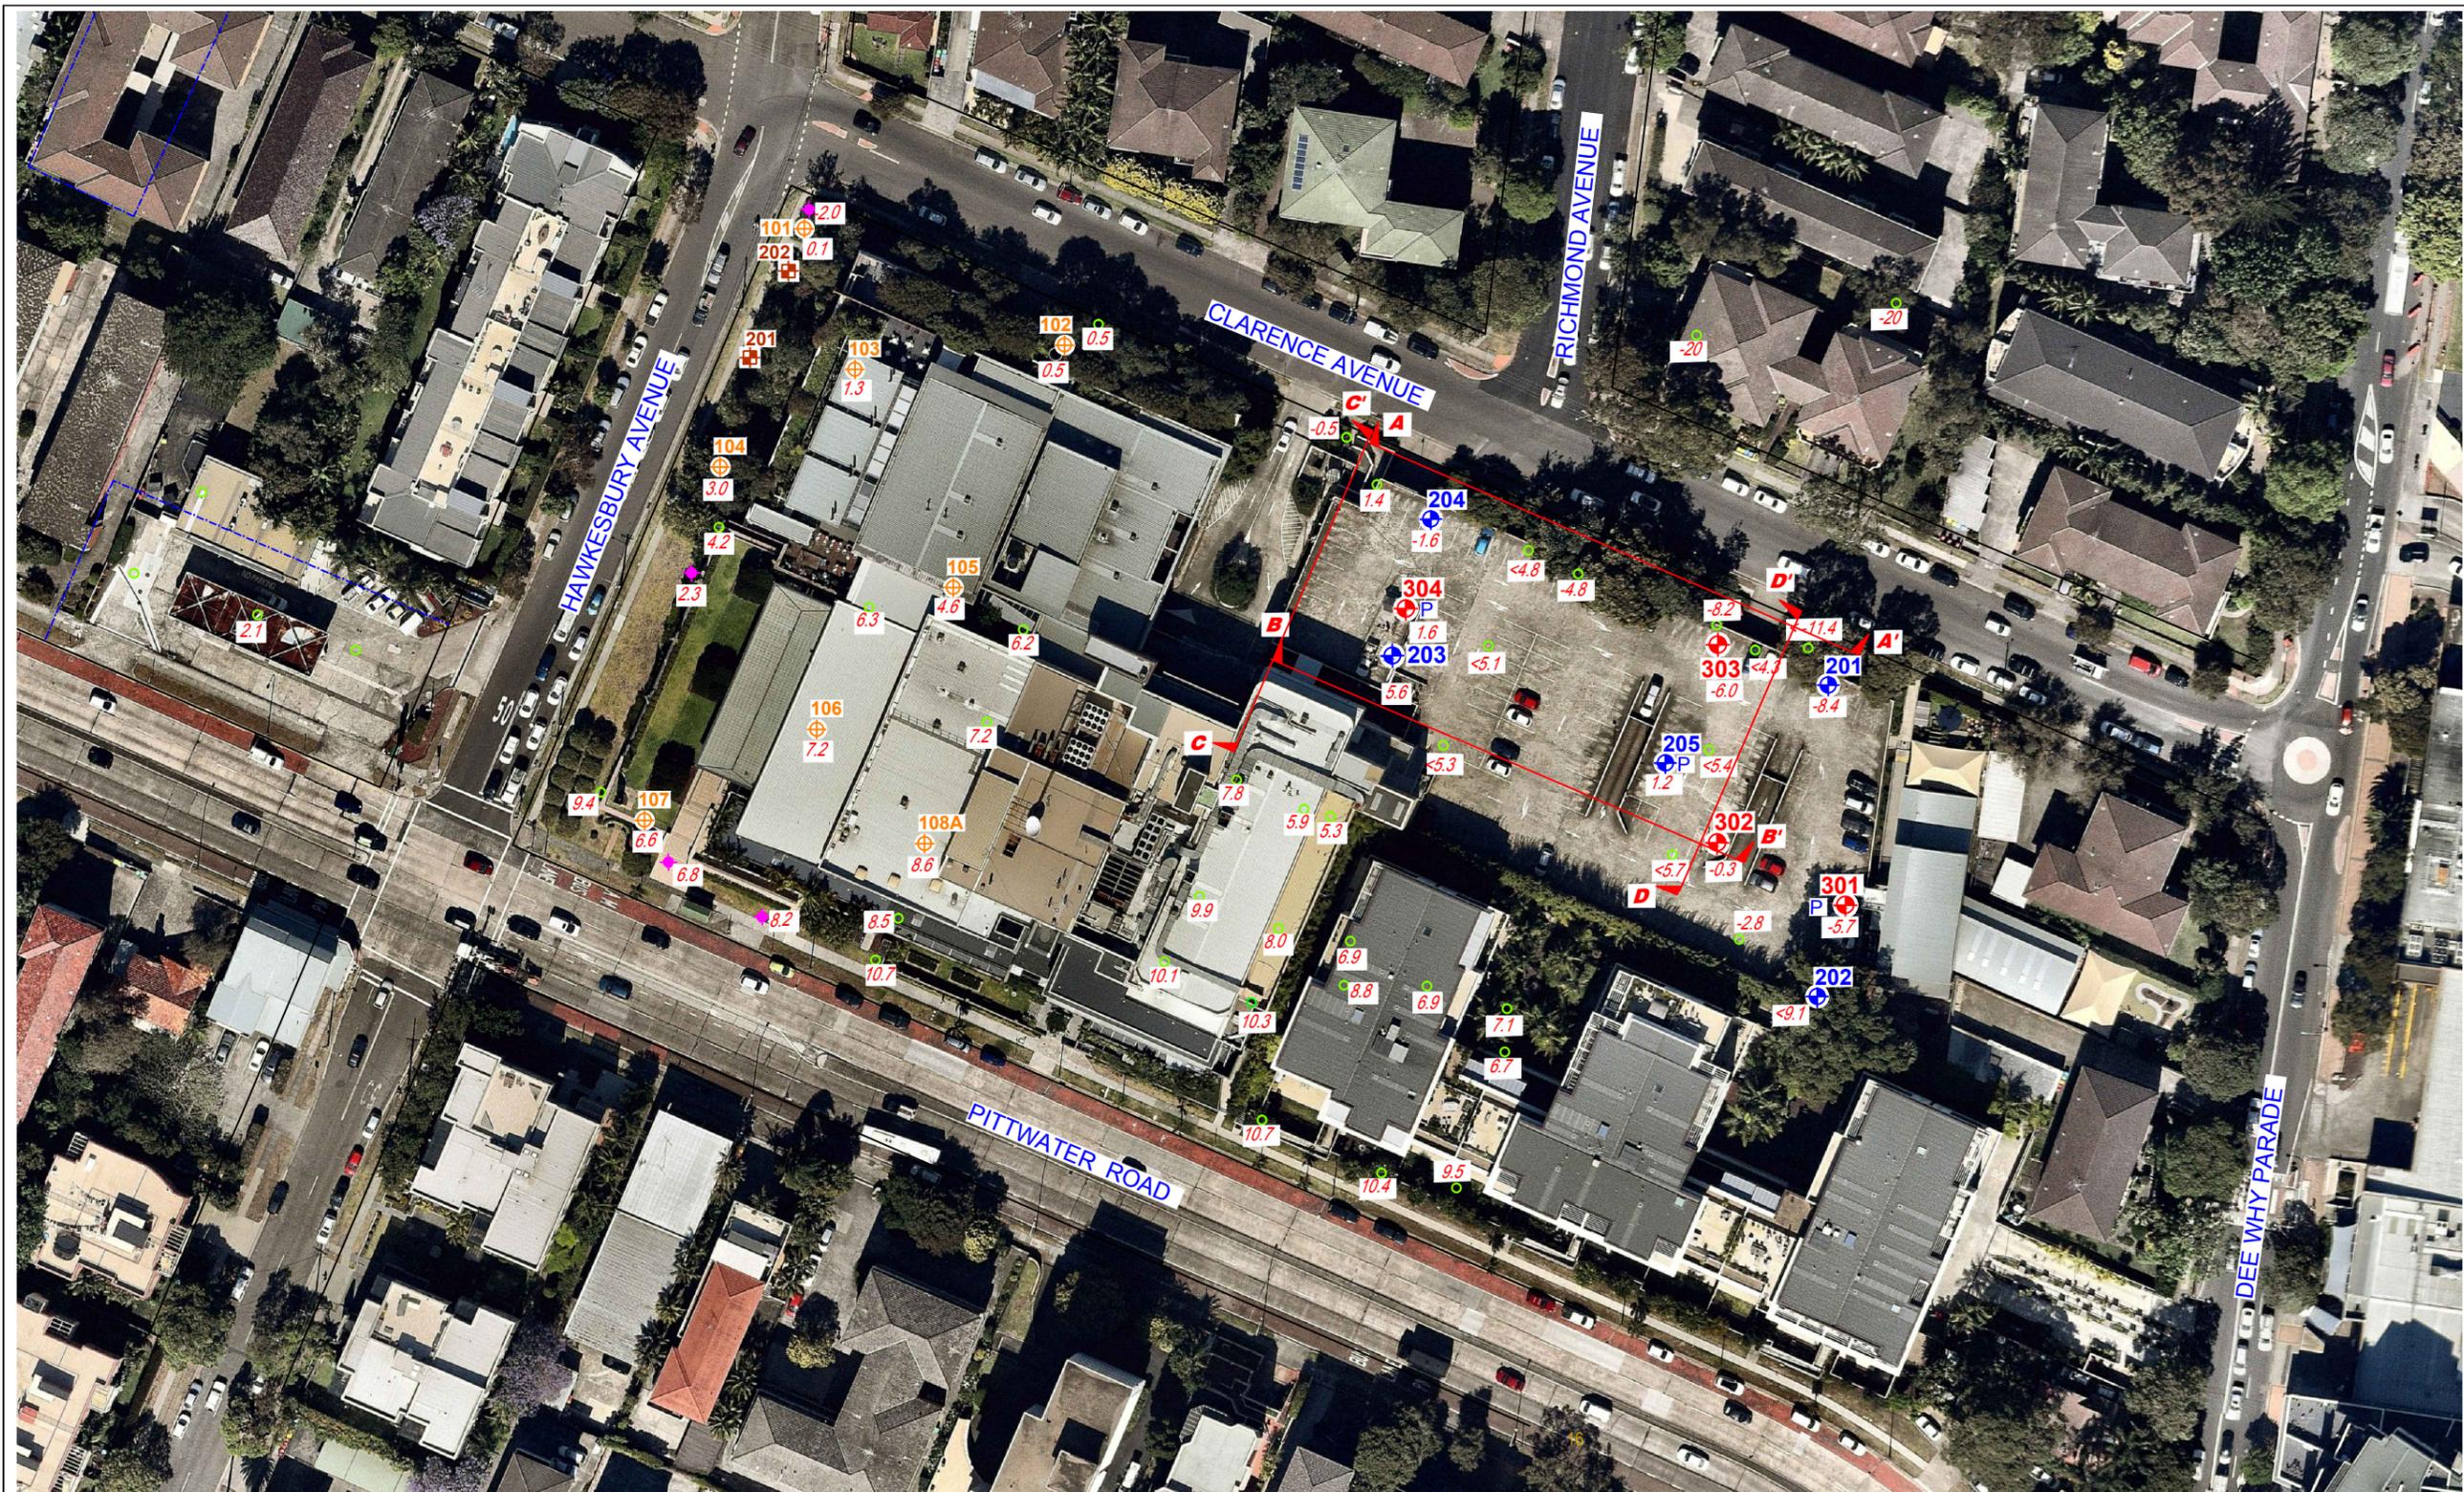
PROJECT No: 84926.03
 DRAWING No: 2
 REVISION: 2

NOTE:
 1: Base image from Nearmap.com (Nov.2016)
 2: Test locations are approximate only and are shown with reference to existing features, and from previous DP report 29420, year 2000)

TITLE: **Geotechnical Test Location Plan**
Dee Why RSL Car Park
932 Pittwater Road, DEE WHY

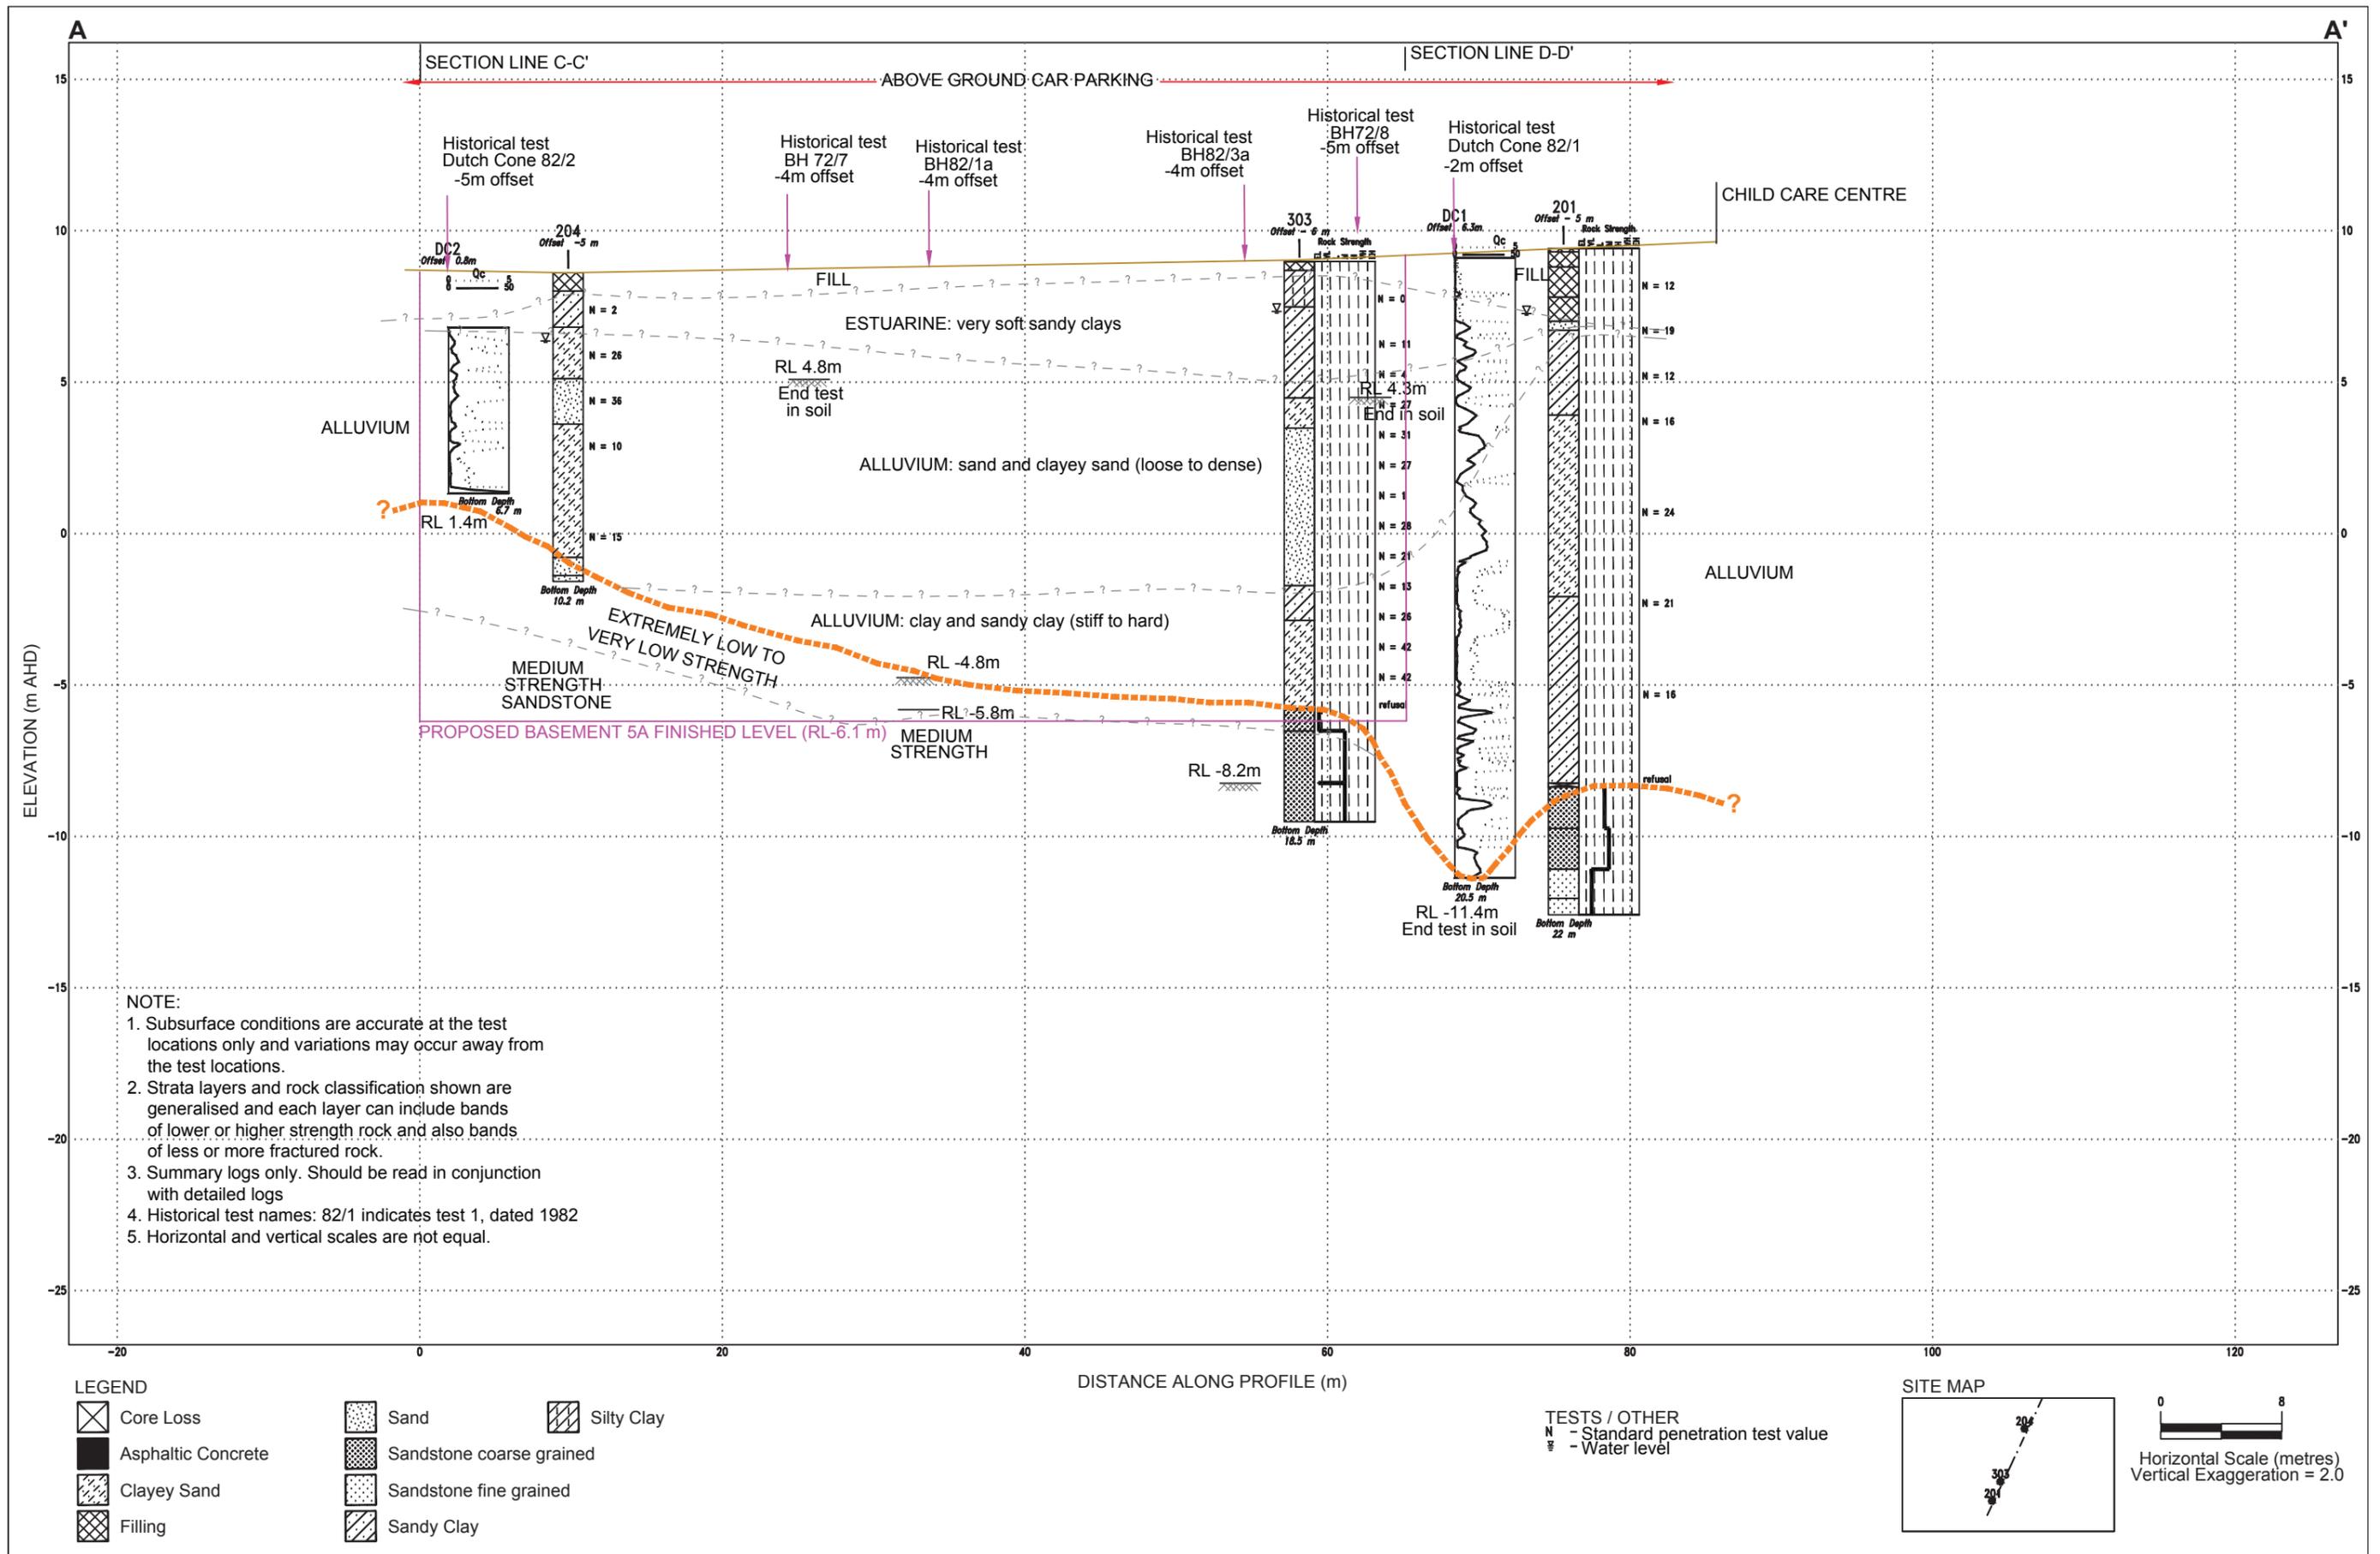
PROJECT No:	84926.03
DRAWING No:	3
REVISION:	4

TITLE: **Geotechnical Cross-Section A-A'**
Proposed Car Park Upgrade
932 Pittwater Road, Dee Why

The geotechnical model for the site is characterised by a shallow thickness of filling, thicker in the south-east of the site, overlying very soft to soft, estuarine silty clay or sandy clay with organic matter in the eastern and north-eastern part of the site (absent, up to 3.4 m thick in Borehole 303), over loose to dense alluvial sand and clayey sand, and then stiff to hard alluvial clay and sandy clay overlying a sandstone profile which has an apparent slope to the east. The sandstone is initially extremely weathered and extremely low to very low strength, rapidly becoming slightly weathered to fresh and medium or high strength. The geotechnical model for the site is presented as four cross sections in Appendix B: Section A-A' to Section D-D', Drawings 3 to 6.

Extending the cut-off wall to the medium strength rock, such as to RL -10 m in the south-east corner (refer Drawings 3 and 6), should result in an adequate factor of safety against piping under normal groundwater conditions, however, if the groundwater levels outside the basement area rise significantly during a flood event, then the factor of safety will reduce. During the final design process, a formal analysis of up-flow velocities and piping should be carried out to ensure that piping will not occur during construction.

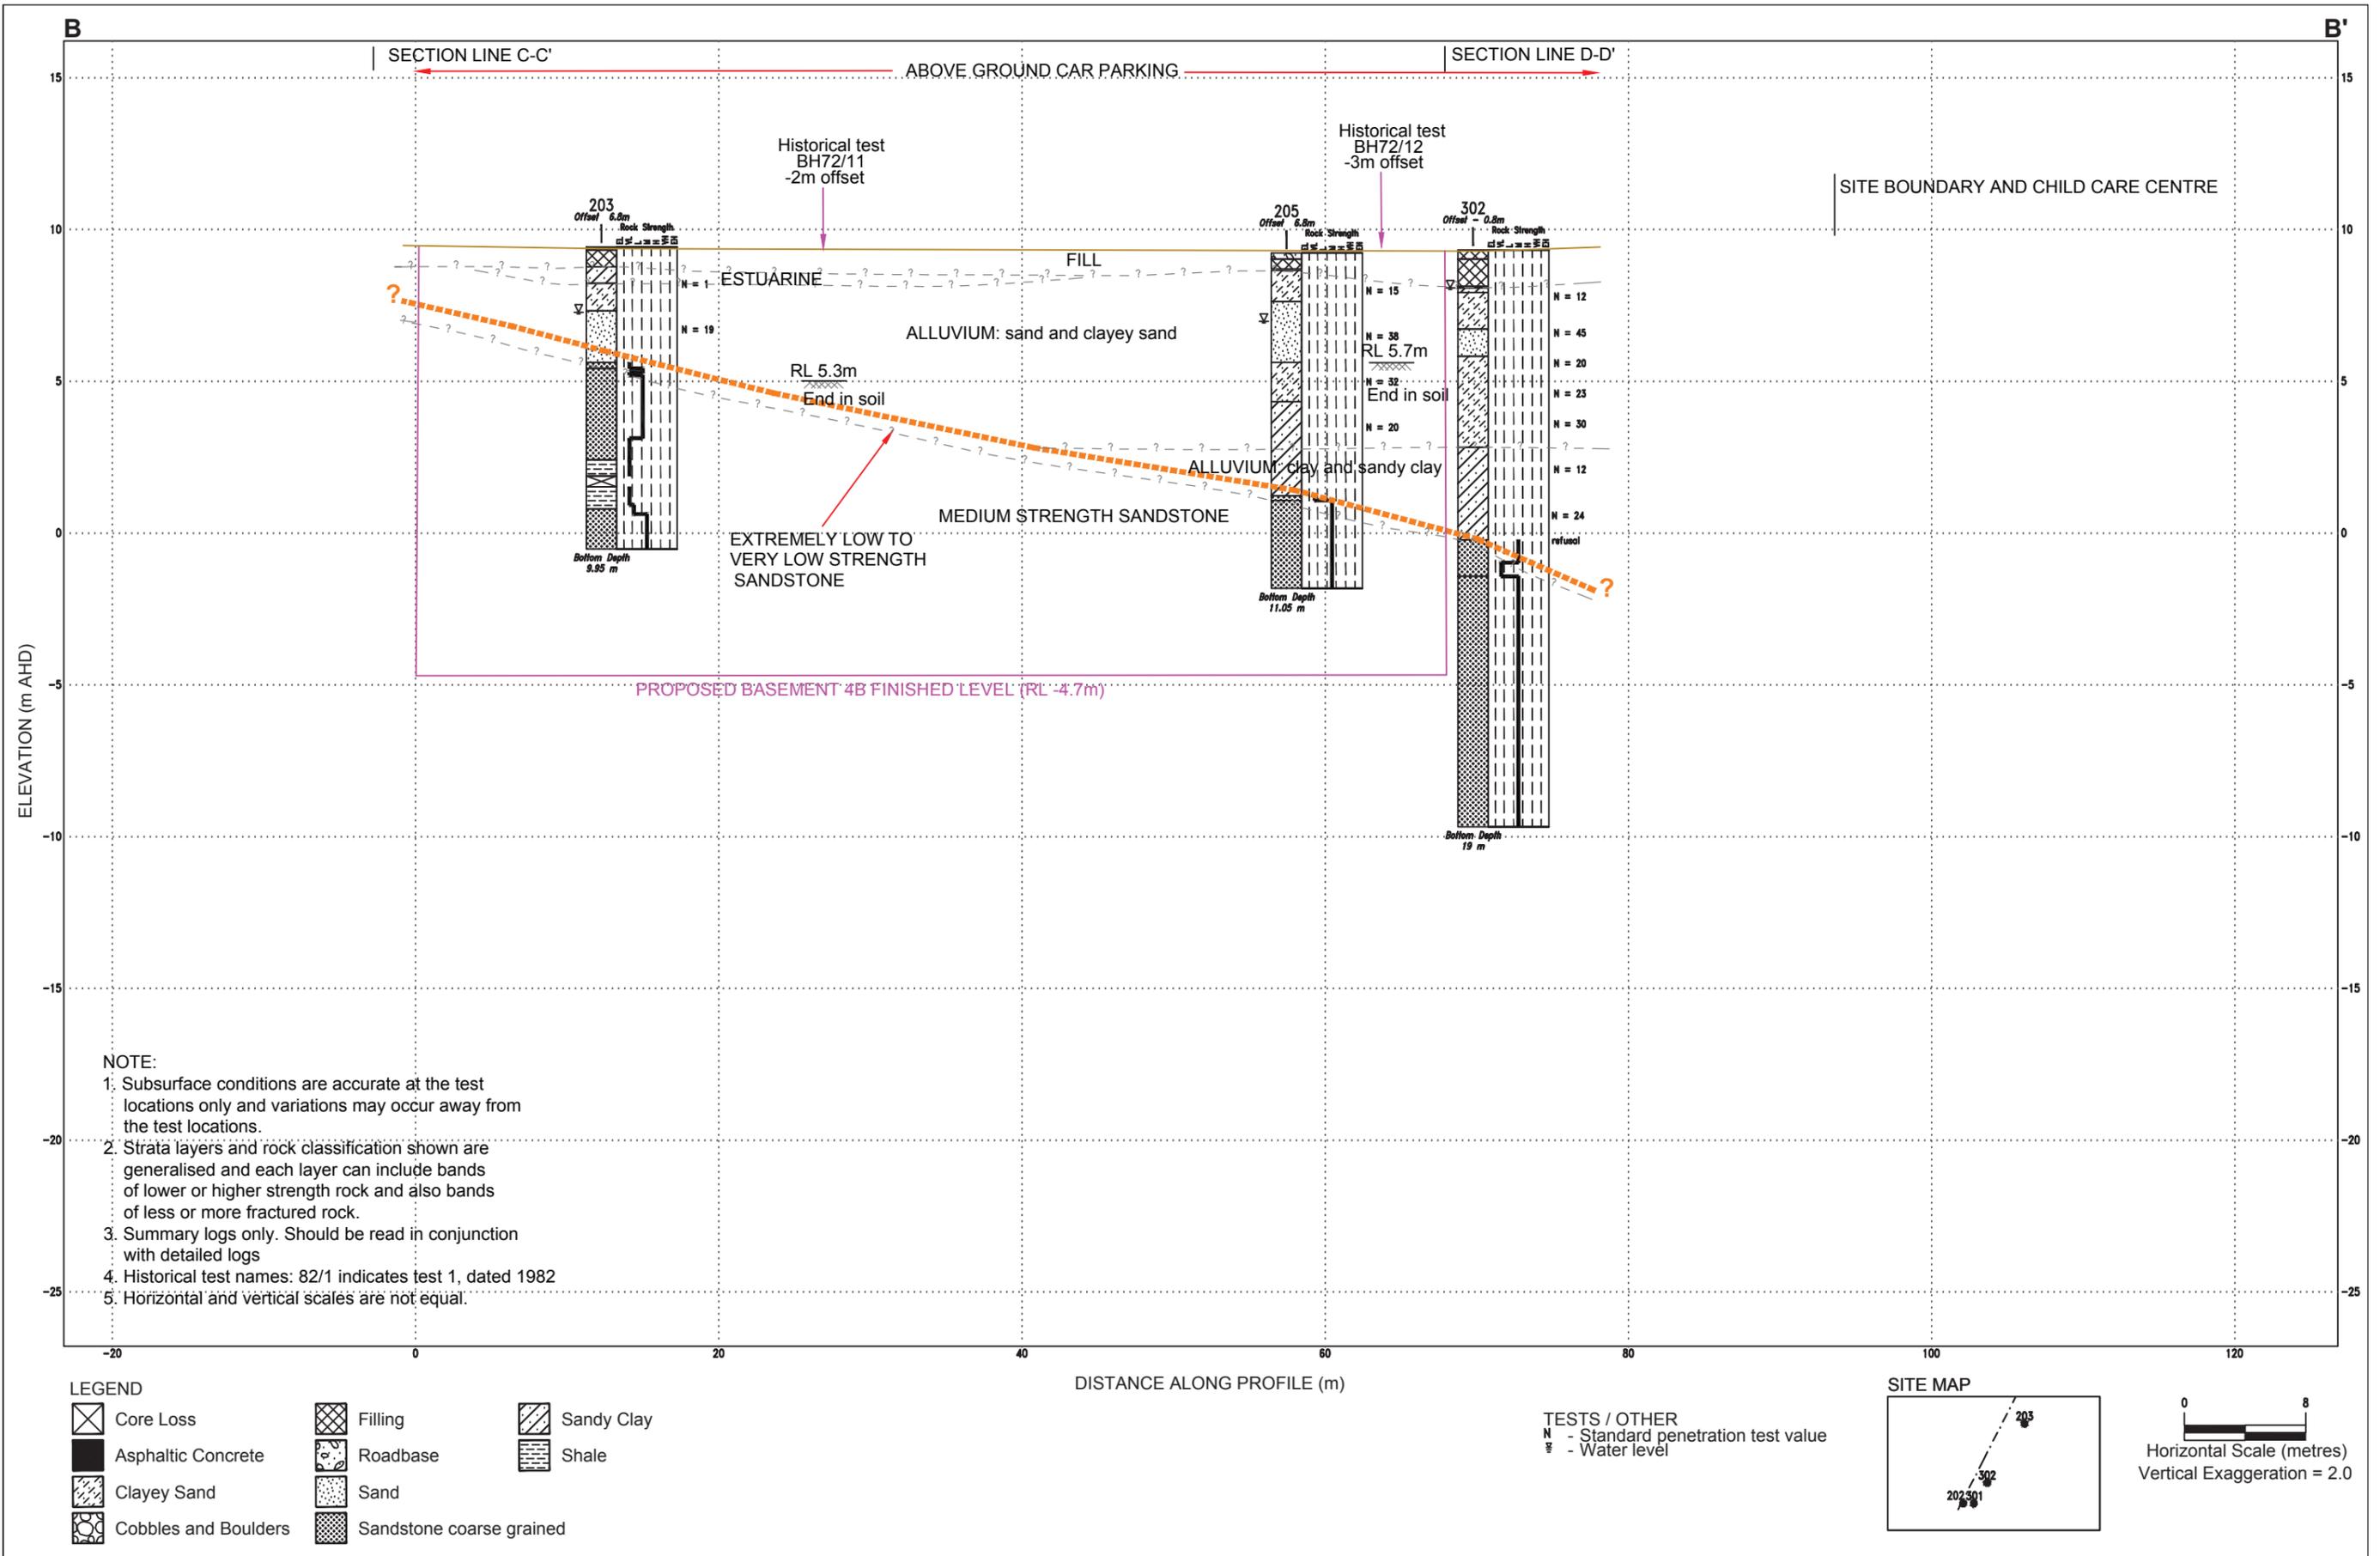
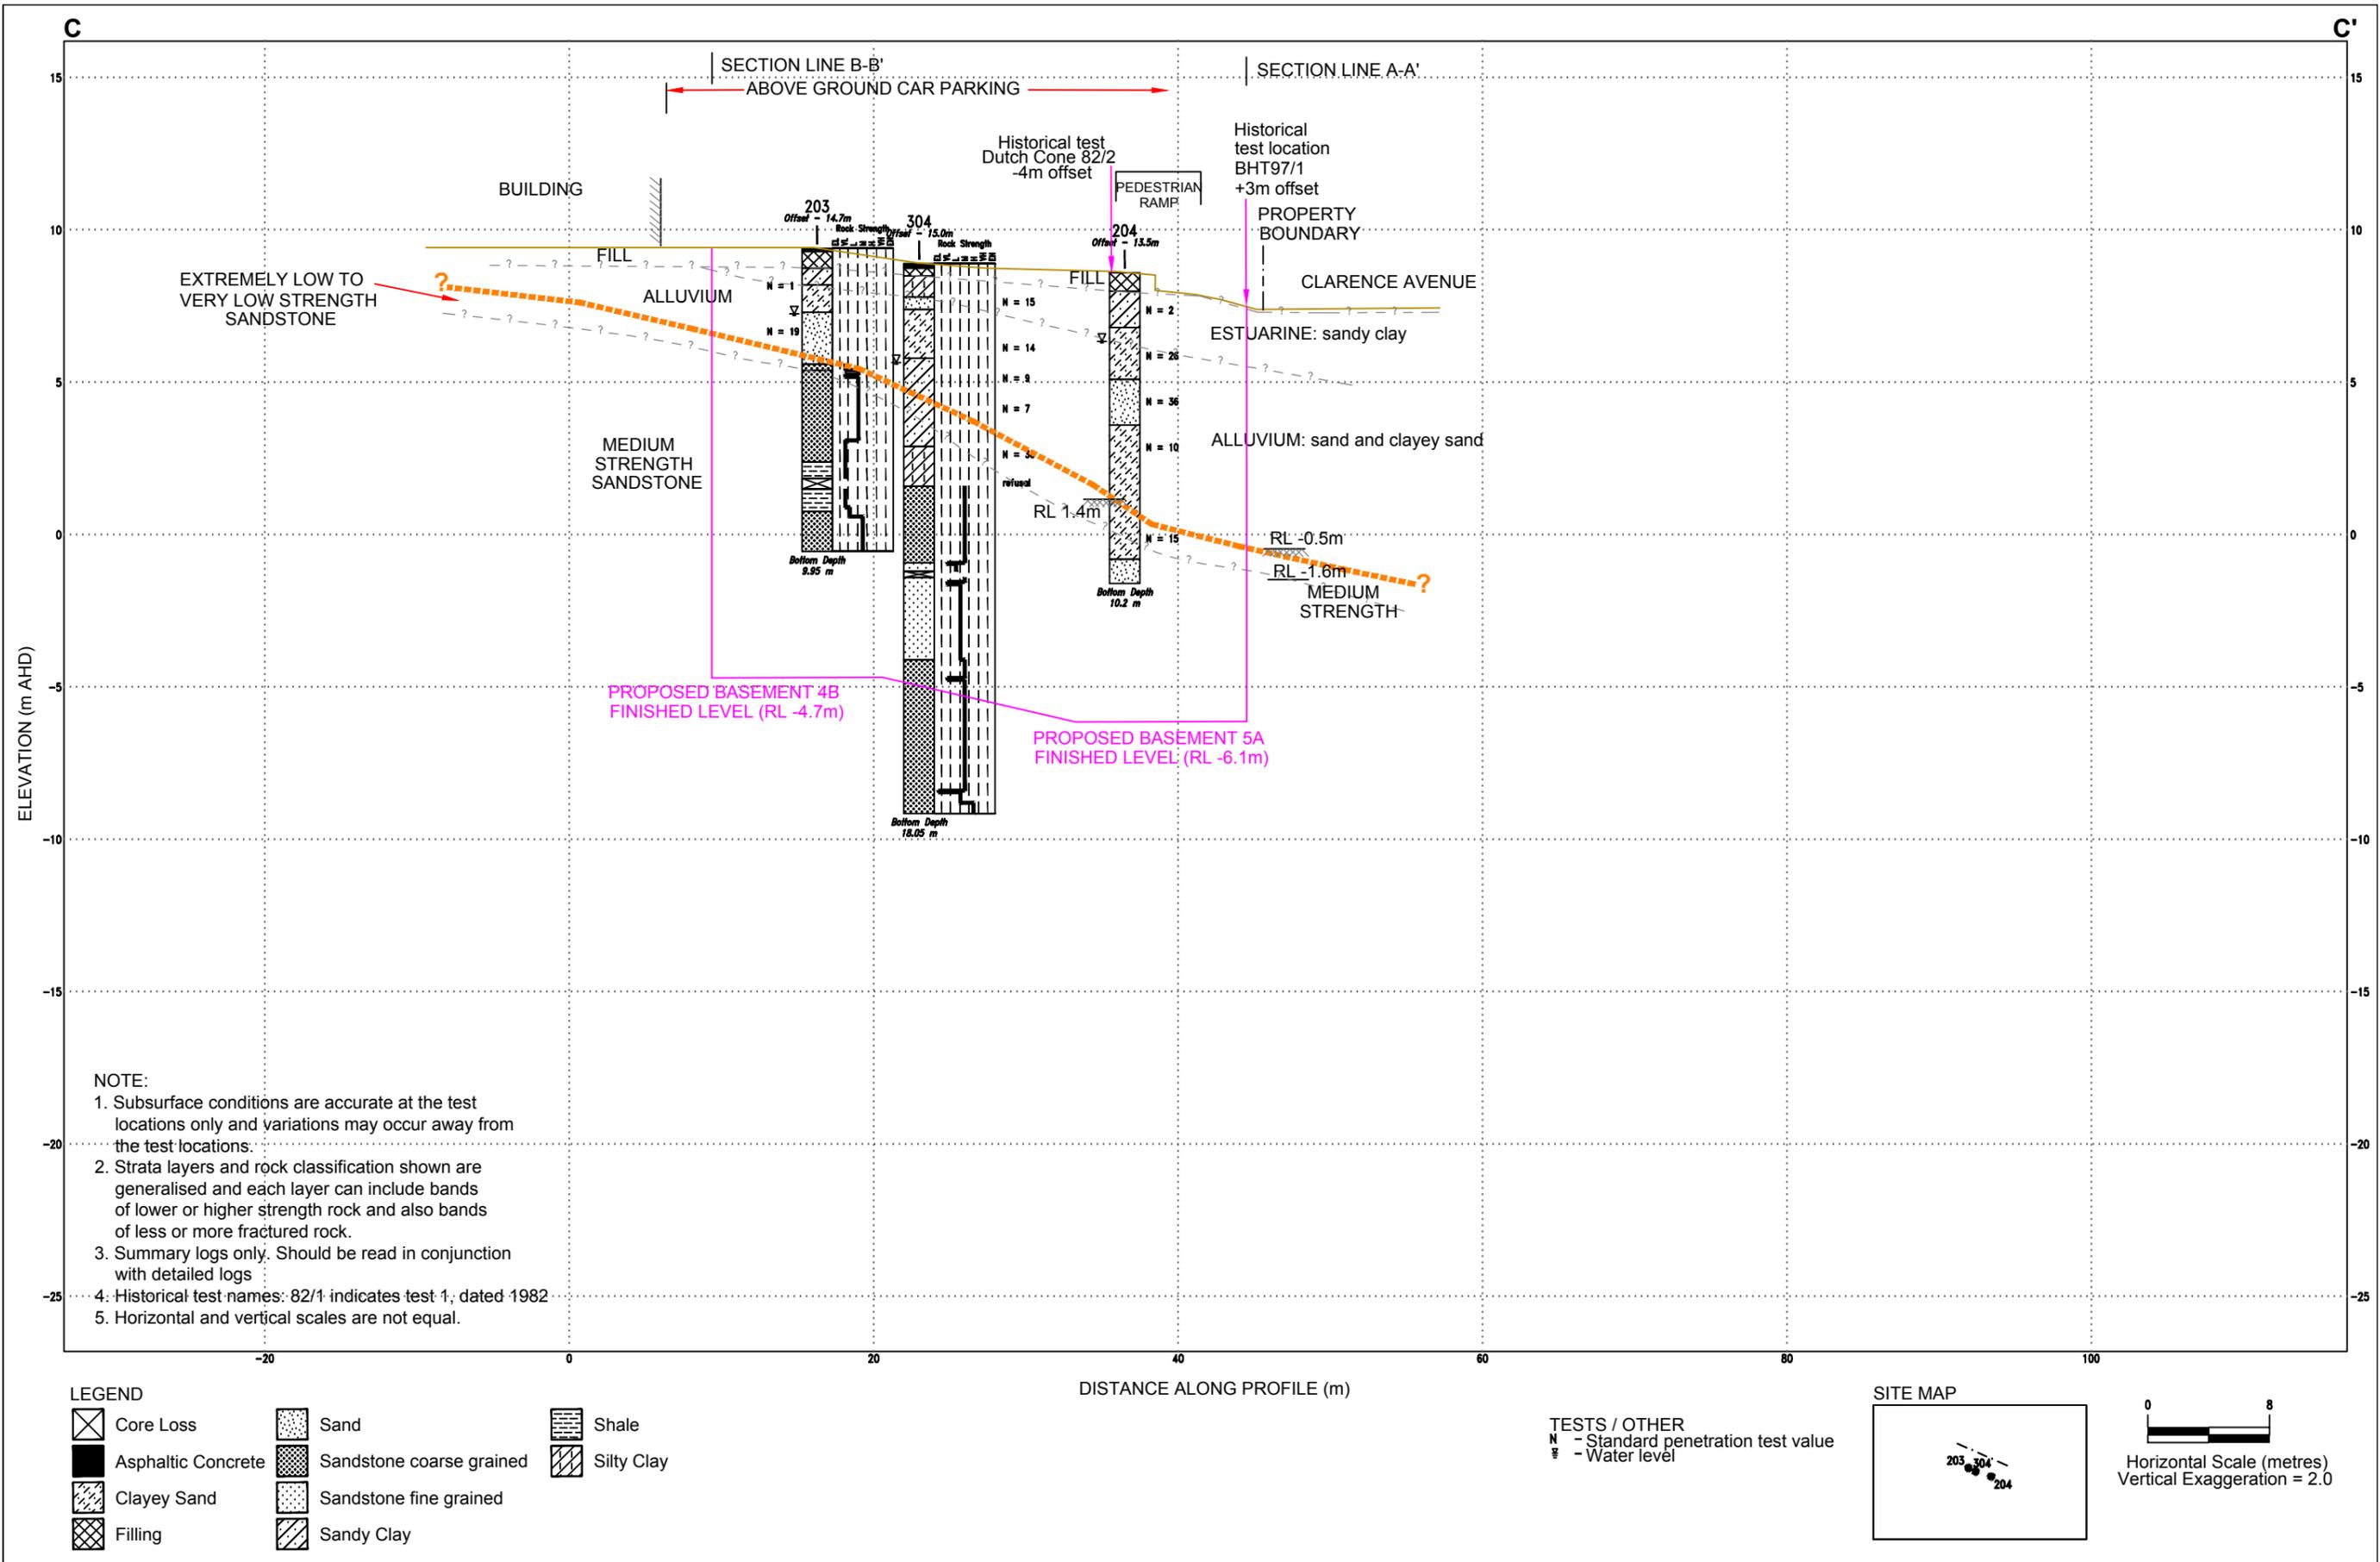
PROJECT No: 84926.03
DRAWING No: 5
REVISION: 2

TITLE: Geotechnical Cross-Section C-C' Proposed Car Park Upgrade 932 Pittwater Road, Dee Why

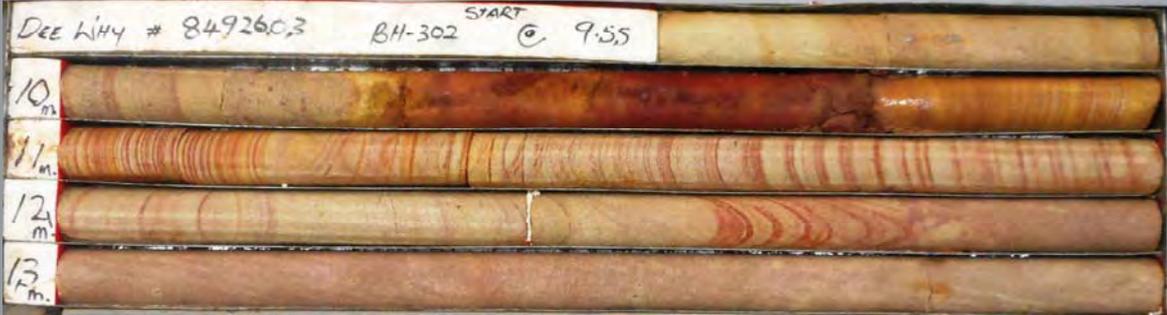
Project No: 84926.03
BH ID: 302
Depth: 9.55 - 14.00 m
Core Box No.: 1

16.55 - 14.0m

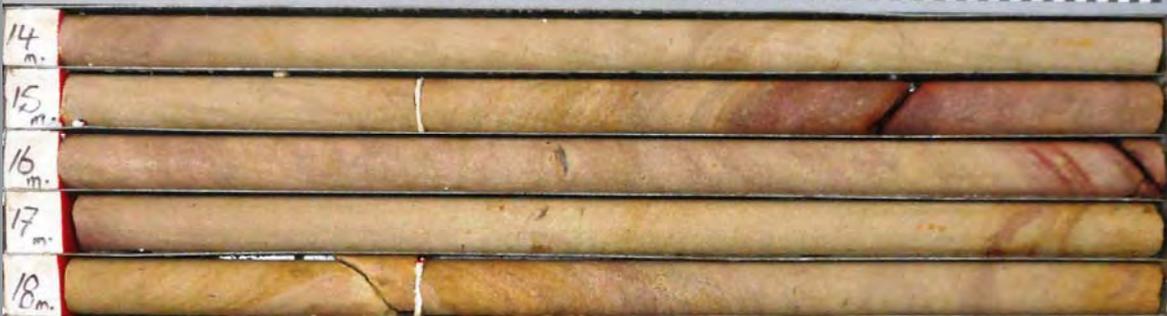
Project No: 84926.03
BH ID: 302
Depth: 14.00 - 19.00 m
Core Box No.: 2

14.0 - 19.0m

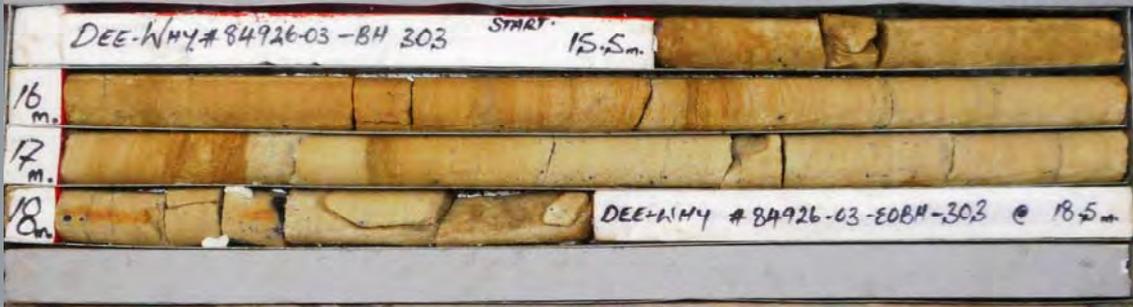
Project No: 84926.03
BH ID: 303
Depth: 15.50 - 18.50 m
Core Box No.:

15.5 - 18.5m

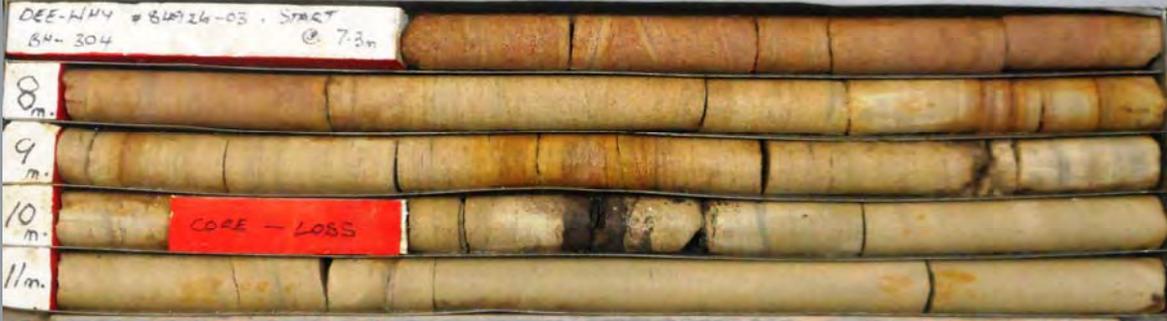
Project No: 84926.03
BH ID: 304
Depth: 7.30 - 12.00 m
Core Box No.: 1

7.3 - 12.0m

Groundwater level observations from standpipe piezometers are summarised in Table 2. It is noted that the standpipe piezometer screened wholly within the low and medium strength rock (Borehole 304) indicates a groundwater level of 3 m compared with the level encountered during drilling (RL5.6 m).

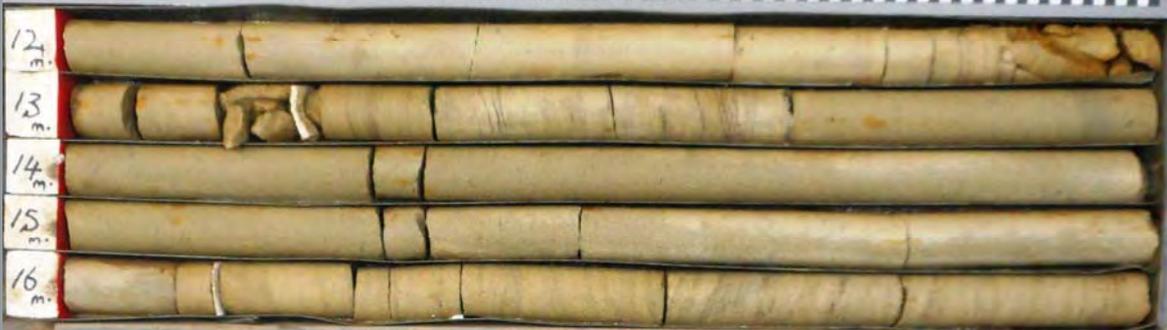
Project No: 84926.03
BH ID: 304
Depth: 12.00 - 17.00 m
Core Box No.: 2

12.0 - 17.0m

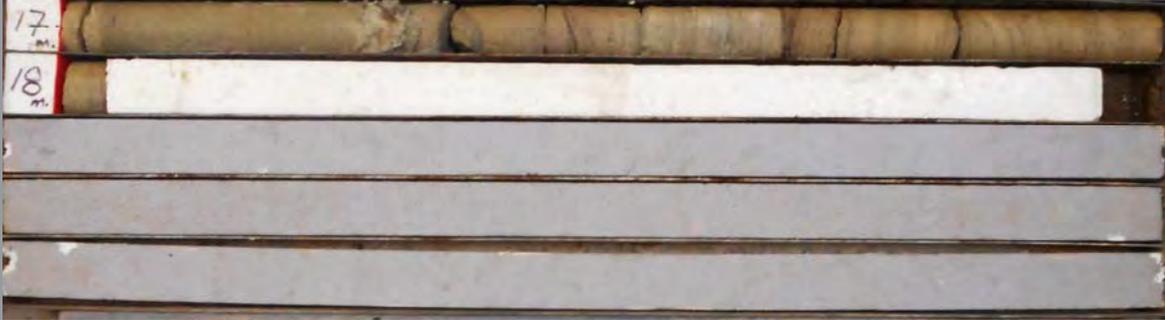
Project No: 84926.03
BH ID: 304
Depth: 17.00 - 18.05m
Core Box No.: 3

17.0 - 18.05m

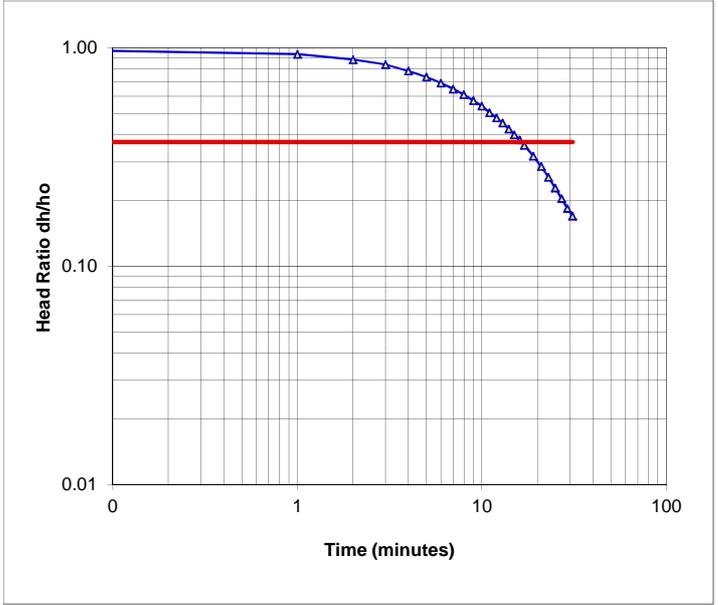
Details of Well Installation			
Well casing diameter (2r)	76 mm	Depth to water before test	1.21 m
Well screen diameter (2R)	76 mm	Depth to water at start of test	6.69 m
Length of well screen (Le)	3 m

Test Results			
Time (min)	Depth (m)	Change in Head: δH (m)	$\delta H/H_0$
0	6.69	5.48	1.000
1	6.33	5.12	0.934
2	6.05	4.84	0.883
3	5.8	4.59	0.838
4	5.5	4.29	0.783
5	5.24	4.03	0.735
6	4.99	3.78	0.690
7	4.76	3.55	0.648
8	4.56	3.35	0.611
9	4.35	3.14	0.573
10	4.18	2.97	0.542
11	3.98	2.77	0.505
12	3.83	2.62	0.478
13	3.69	2.48	0.453
14	3.54	2.33	0.425
15	3.4	2.19	0.400
16	3.29	2.08	0.380
17	3.17	1.96	0.358
19	2.96	1.75	0.319
21	2.78	1.57	0.286
23	2.61	1.40	0.255
25	2.46	1.25	0.228
27	2.33	1.12	0.204
29	2.22	1.01	0.184
31	2.14	0.93	0.170
33	2.05	0.84	0.153

To = 16 mins
960 secs

Theory:	Falling Head Permeability calculated using equation by Hvorslev $k = [r^2 \ln(L_e/R)] / 2L_e T_o$ where r = radius of casing R = radius of well screen L _e = length of well screen T _o = time taken to rise or fall to 37% of initial change
----------------	---

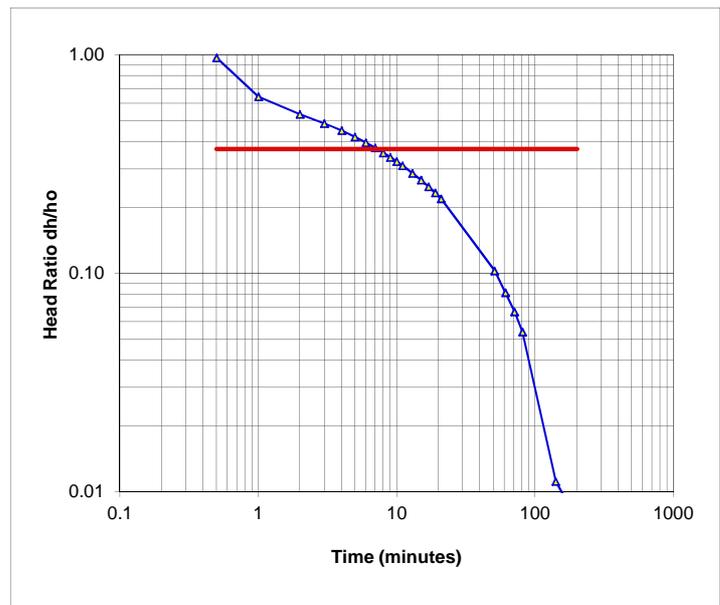
Time (min)	Depth (m)	Change in Head: δH (m)	$\delta H/H_0$
0	3.84	3.50	1.000
0.5	3.734	3.39	0.970
1	2.589	2.25	0.643
2	2.21	1.87	0.534
3	2.037	1.70	0.485
4	1.913	1.57	0.449
5	1.813	1.47	0.421
6	1.726	1.39	0.396
7	1.652	1.31	0.375
8	1.587	1.25	0.356
9	1.528	1.19	0.339
10	1.477	1.14	0.325
11	1.43	1.09	0.311
13	1.344	1.00	0.287
15	1.274	0.93	0.267
17	1.211	0.87	0.249
19	1.157	0.82	0.233
21	1.107	0.77	0.219
51	0.699	0.36	0.103
61	0.625	0.29	0.081
71	0.573	0.23	0.067
81	0.529	0.19	0.054
141	0.379	0.04	0.011
201	0.314	0.03	0.007

To = 7 mins
420 secs

Theory:	Falling Head Permeability calculated using equation by Hvorslev $k = [r^2 \ln(L_e/R)] / 2L_e T_o$ where r = radius of casing R = radius of well screen L _e = length of well screen T _o = time taken to rise or fall to 37% of initial change
----------------	---
