REPORT TO
**ARCH MANLY MANAGEMENT (AUSTRALIA) PTY
LTD ATF ARCH MANLY TRUST**

ON
GEOTECHNICAL INVESTIGATION

FOR
PROPOSED RESIDENTIAL DEVELOPEMENT

AT
195-197 SYDNEY ROAD, FAIRLIGHT, NSW

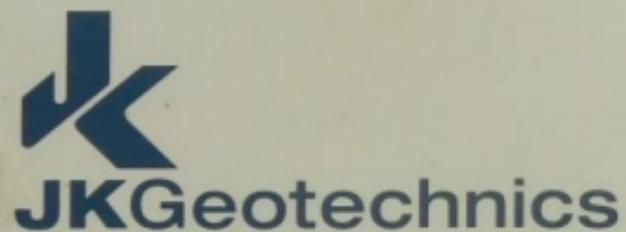
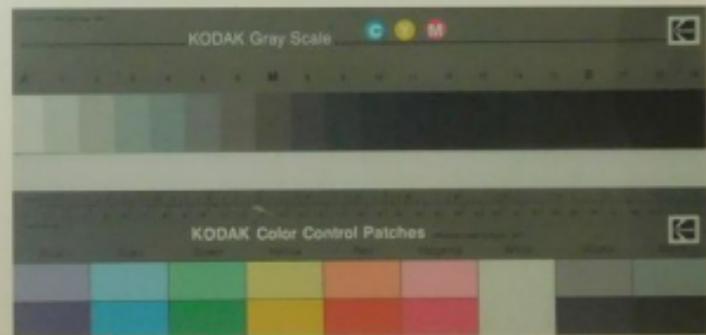
Job No: 33708PN
Borehole No: BH3
Depth: 0m - 1.6m

JOB No. 33708PN, BH3, CORING STARTS AT 0m

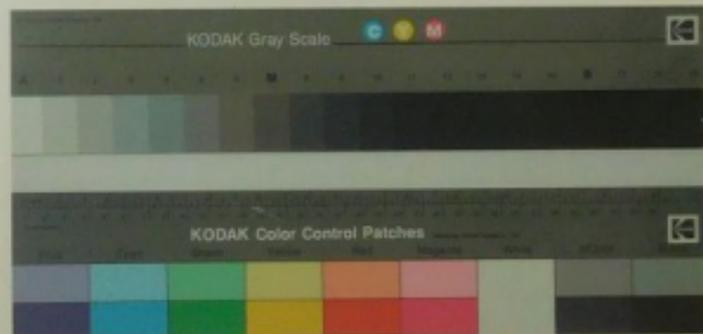
Job No: 33708PN
Borehole No: BH6
Depth: 0m - 1.57m

JOB NO. 33708PN, BH6, CORING STARTS AT 0m

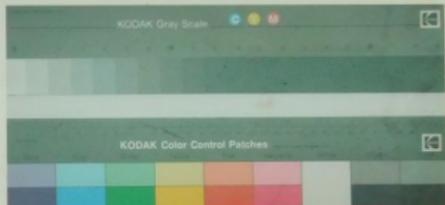
Job No: 33708PN
Borehole No: BH8
Depth: 0m - 6.09m

JOB No. 33708PN, BH8, CORING STARTS AT 0.72m
