REPORT TO
**TRUSTEE OF THE NORTHERN BEACHES CENTRAL
BUSINESS PARK NO.2 UNIT TRUST**

ON
GEOTECHNICAL ASSESSMENT

FOR
PROPOSED SUBDIVISION

AT
120 OLD PITTWATER ROAD, BROOKVALE, NSW

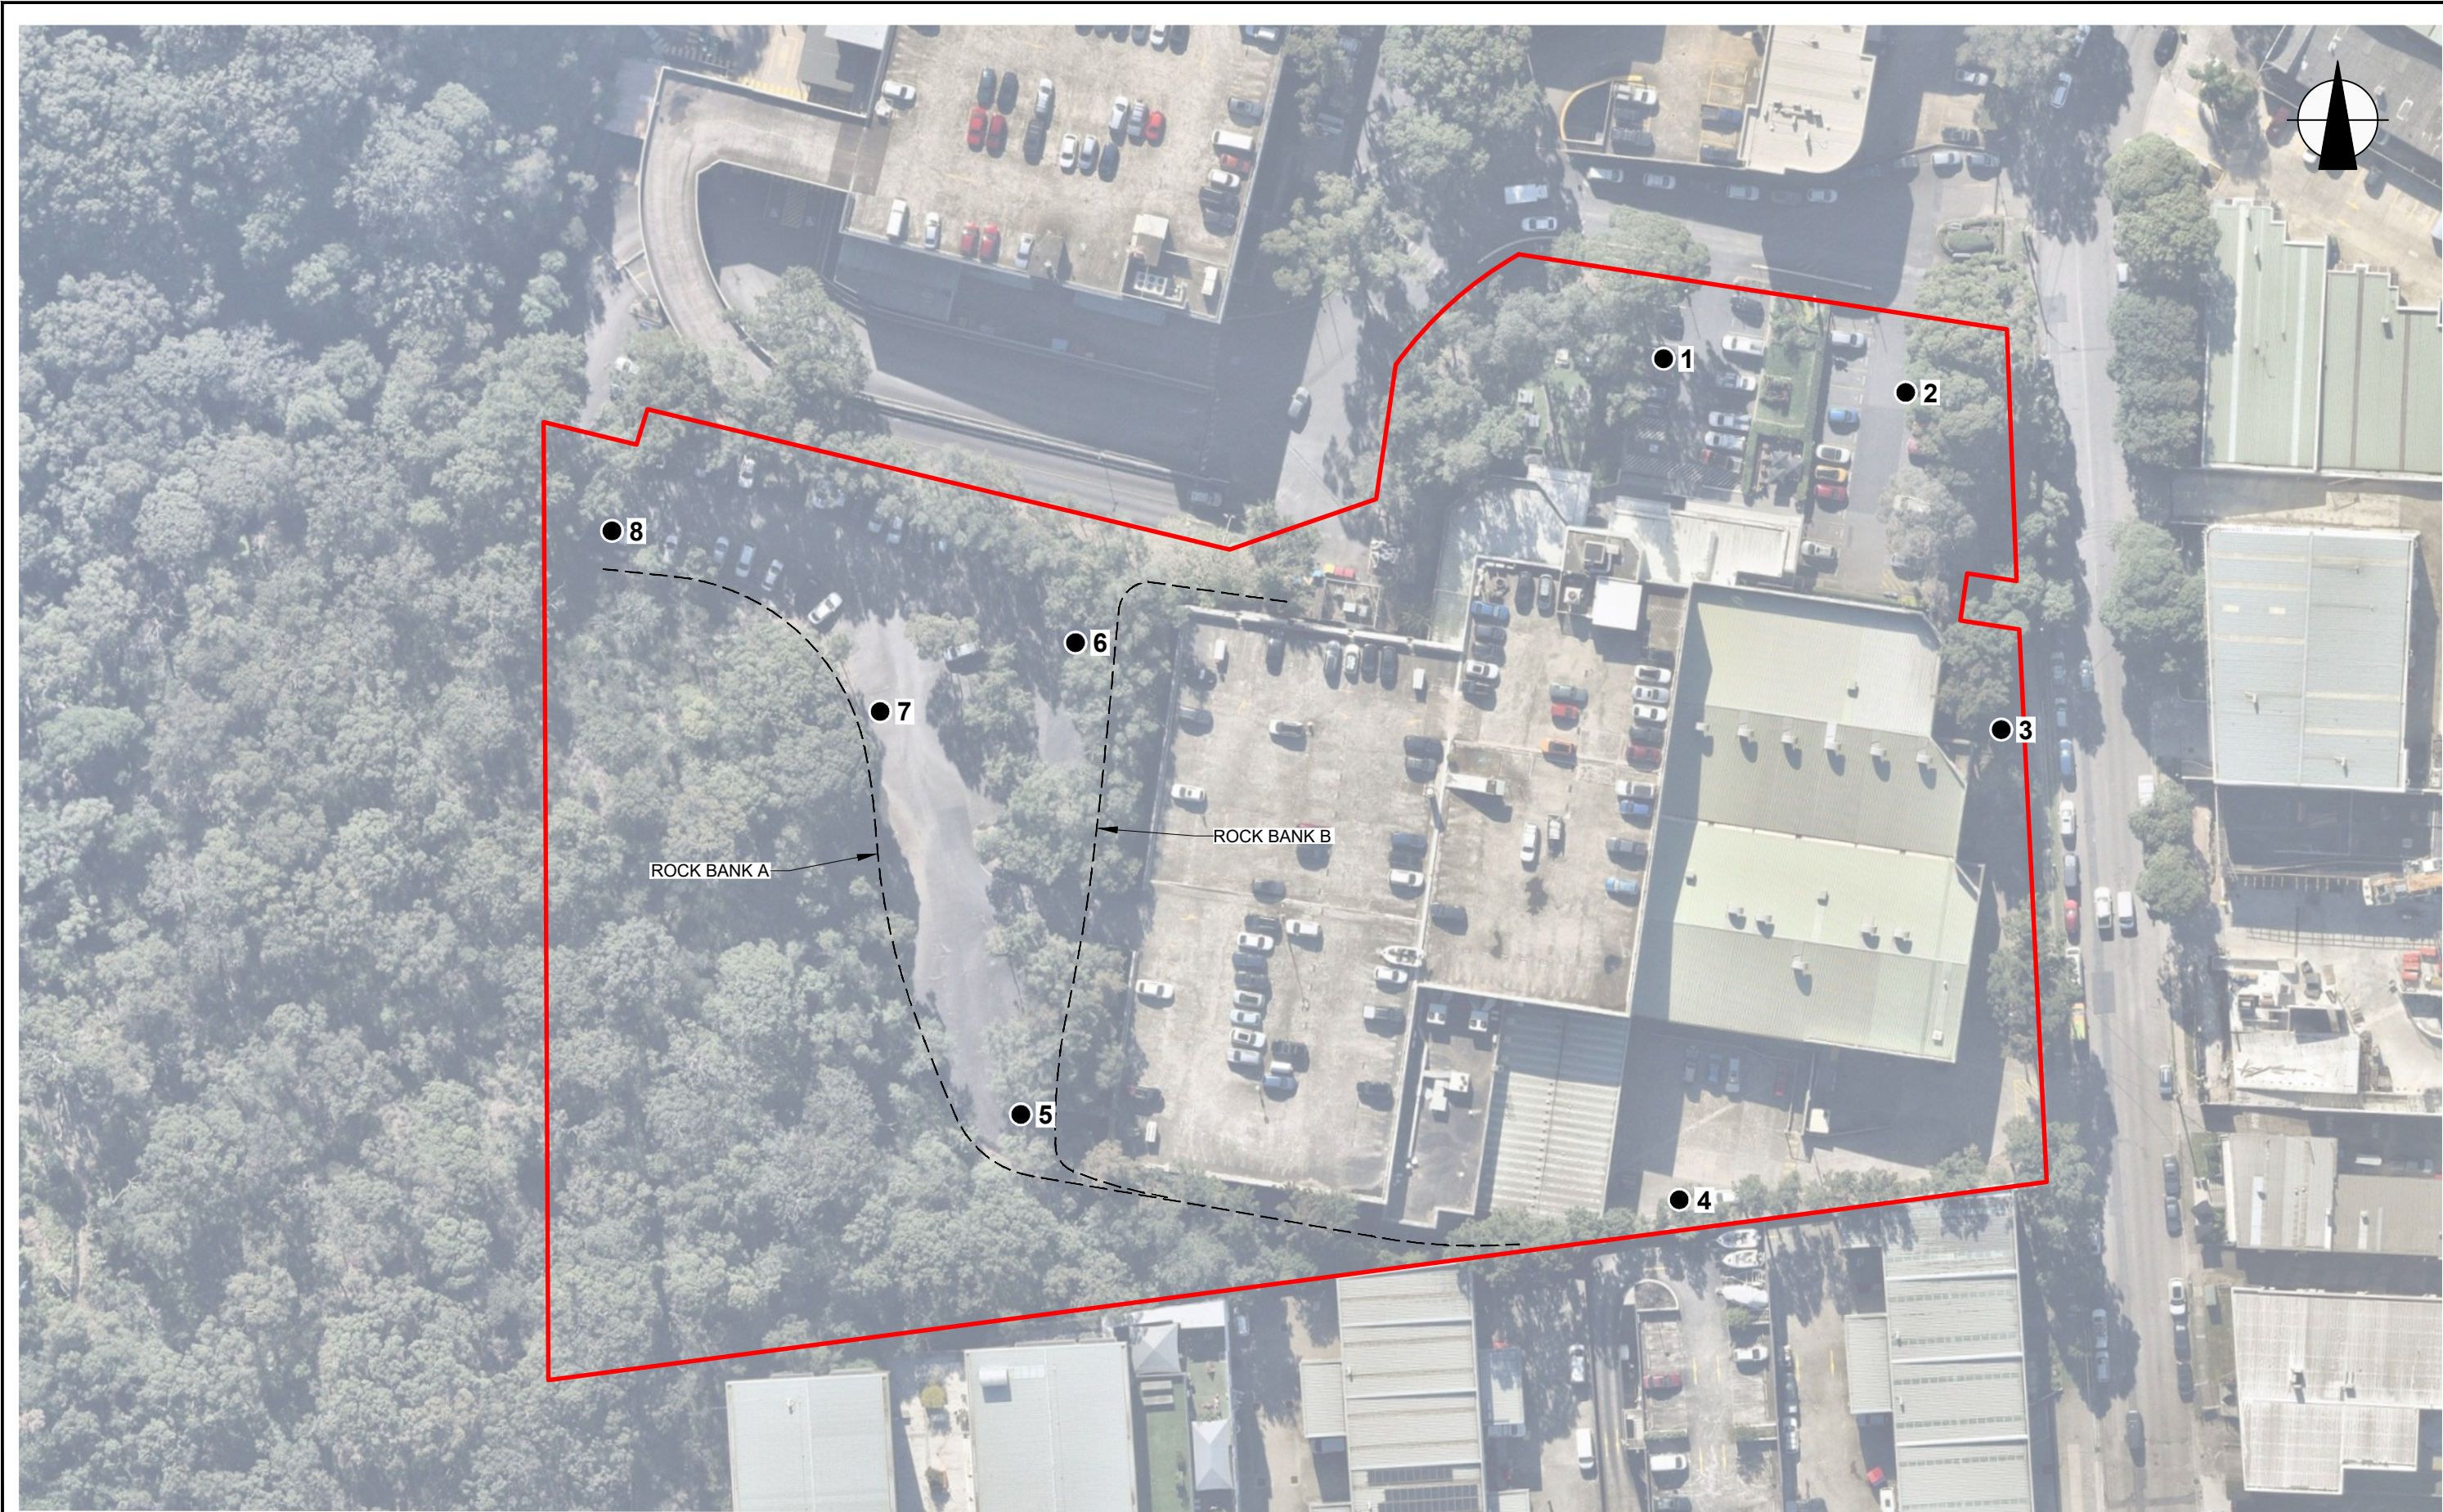
The majority of the site is relatively level with the exception of two rock banks, which have been determined to be the critical hazards present onsite. For the purposes of this report the western-most cut face has been designated as 'Rock Bank A' and the existing cut face adjacent to the existing building as 'Rock Bank B' (please refer to the attached Figure 2).

These potential hazards are indicated in schematic form on the attached Figure 2.
