# **NORTH HARBOUR MARINA MODIFICATIONS**

## **AQUATIC ECOLOGY ASSESSMENT**

**Marine Pollution Research Pty Ltd**  
**September 2024 Update**

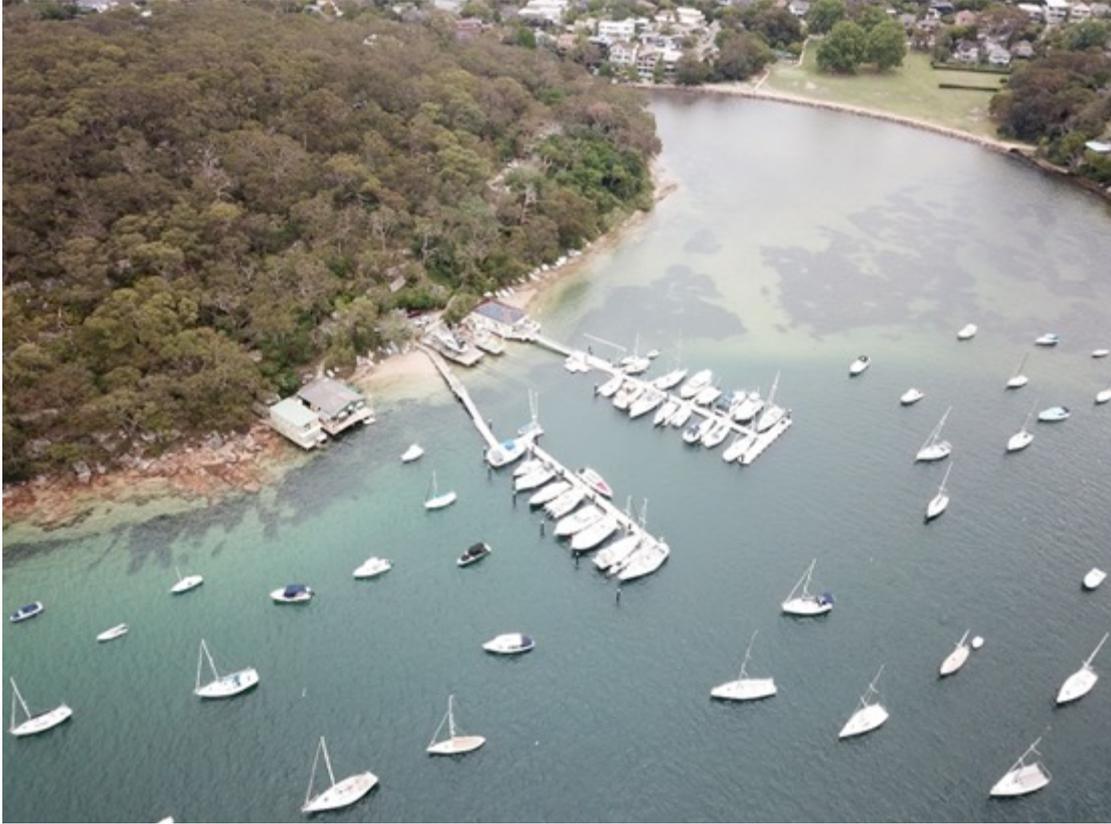
**Figure 1** Drone view looking SW over the North Harbour Marina

- There is a thin strip of lower riparian rock habitat abutting the sandy beach under the shore facility with intertidal rocky shore located to the north and south of the sandy beach habitat at and under the marina shore facilities (**Figure 1**).

- The darker patches that can be seen around the sliprails in **Figures 1 & 3** are *Zostera* wrack and leaf litter laying within a slight depression. There were a few *Zostera* and *Halophila* sprigs noted amongst the wrack. but no seagrass patches or beds.

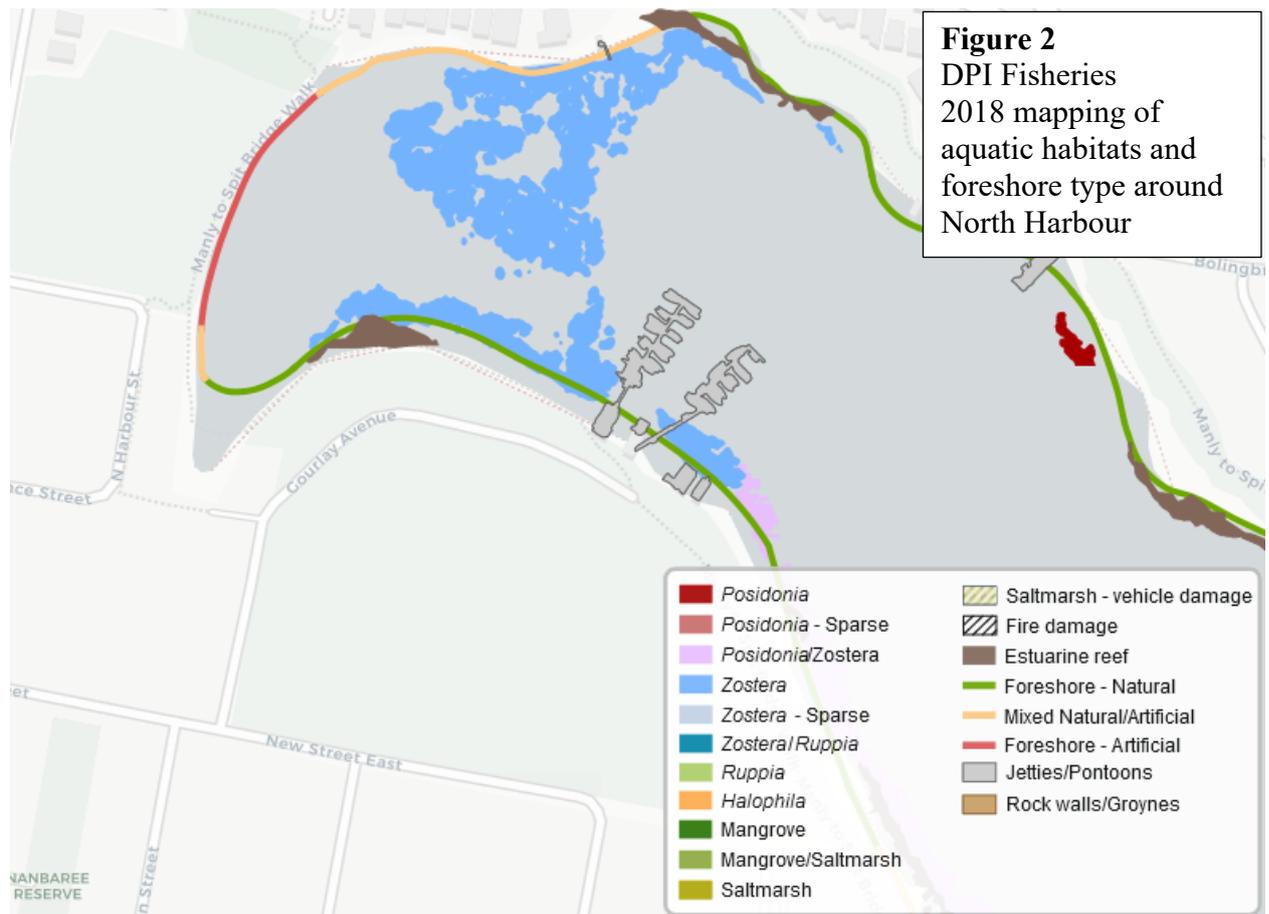
The DCP Mapping for SEPP(BC)2021 indicates a “*mixed rocky intertidal and sand*” aquatic habitat and Sheet 16 for the DCP indicate 'wetlands' along the whole western foreshore of North Harbour. DPI Fisheries habitat mapping in 2018 (**Figure 2**) indicates that there are *Zostera* seagrass beds to the west in the shallower areas along with in the inshore areas stretching east. It is concluded that the designated “*wetland*” at the site indicates the *Zostera* seagrass bed offshore.

- The western *Zostera* bed continues north along the edge of the North Harbour inner sand bank and east along the North Harbour west foreshore as indicated on **Figure 1** and on the DPI 2018 Fisheries mapping (**Figure 2**).

- The mixed *Zostera* and *Halophila* seagrass beds identified for this proposal in **Figures 2 and 3** are Type 1 “highly sensitive KFH”.
- The pile habitats with dense marine algae growth are Type 2 “moderately sensitive KFH, due to the presence of *Sargassum sp.* and *Ecklonia radiata*.”
- The remaining un-vegetated marine sand and shell habitats are Type 3 “minimally sensitive” KFH.

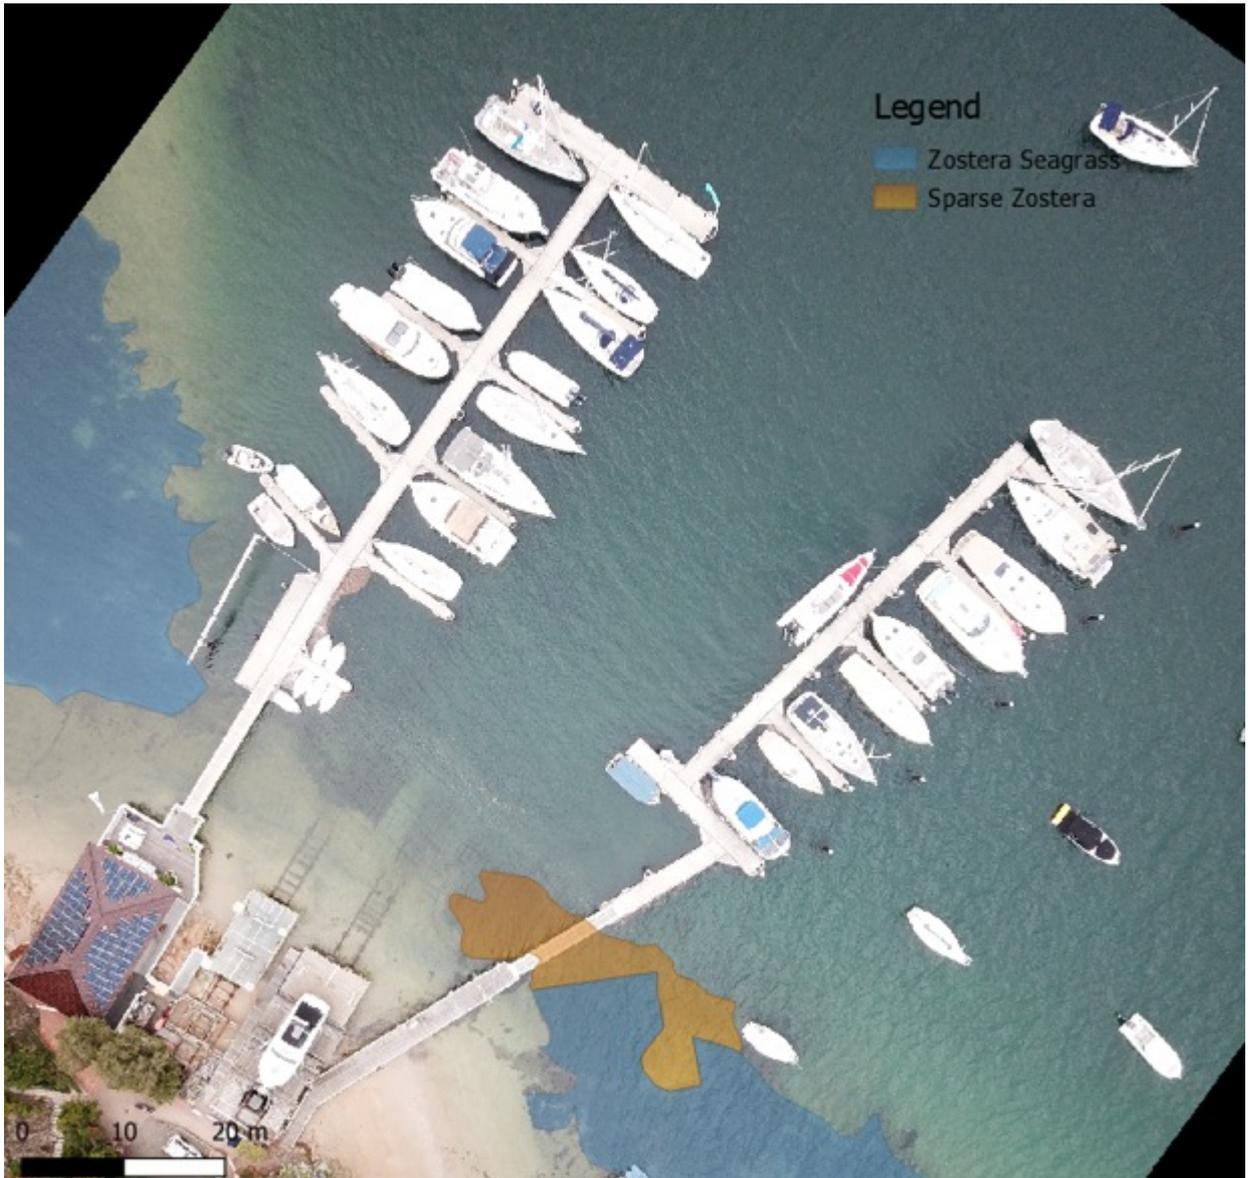
**Figure 3** Marine habitats at the site comprise bare sand habitat intertidally with silty sand seabed offshore that *supports* a *Zostera* seabed inshore and encrusting mixed algae and fauna on intertidal to sub-tidal built structures. There is wrack accumulation at the base of the sliprails.

A dive survey of the site was undertaken on 16 November 2023. The day was generally clear with a moderate to strong easterly breeze. Waters were clear with good underwater visibility. **Figure 3** provides a drone view of the site and surrounding area on the day, and shows the seagrass habitats found at the location:

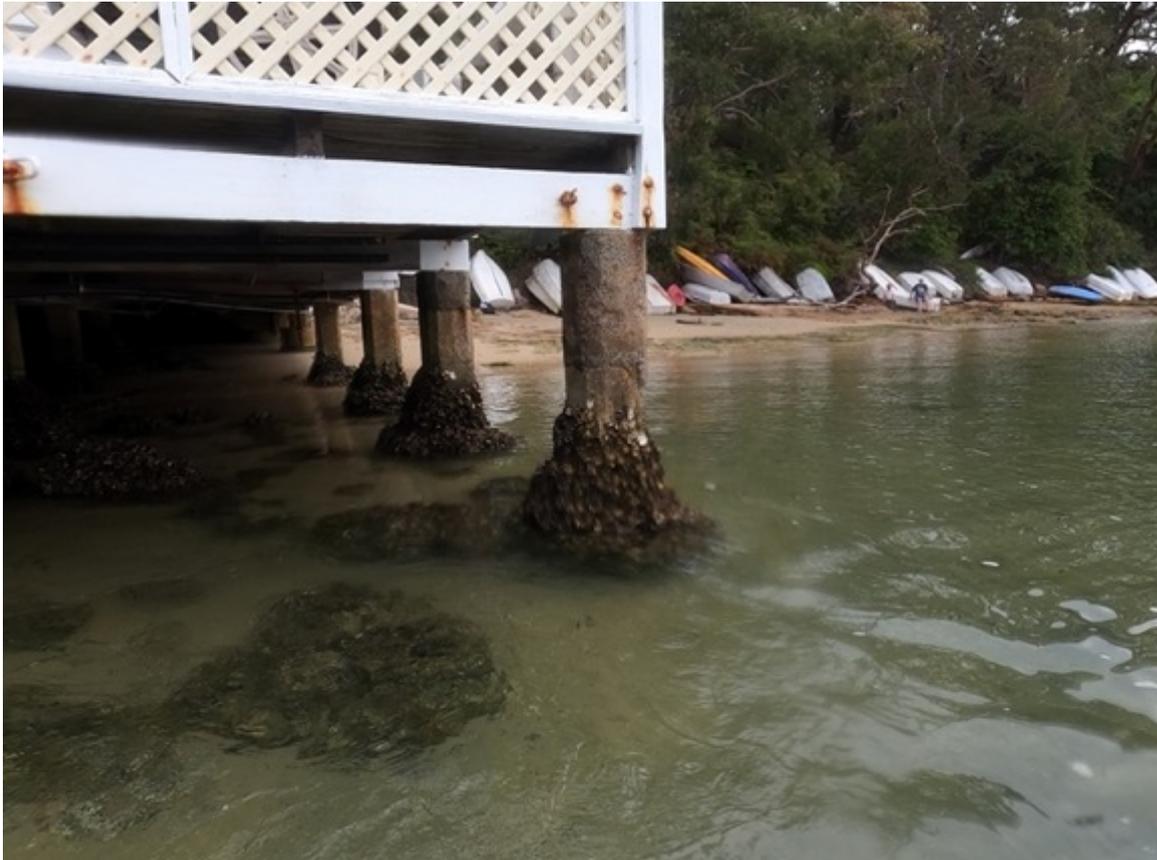
**Figure 4** Looking inshore along the beach sands to the west of the marina office.

- The substratum inshore of the marina comprises generally clean, well sorted and mobile marine sands with increasing silt fraction with depth offshore. (**Figures 2 & 4**).

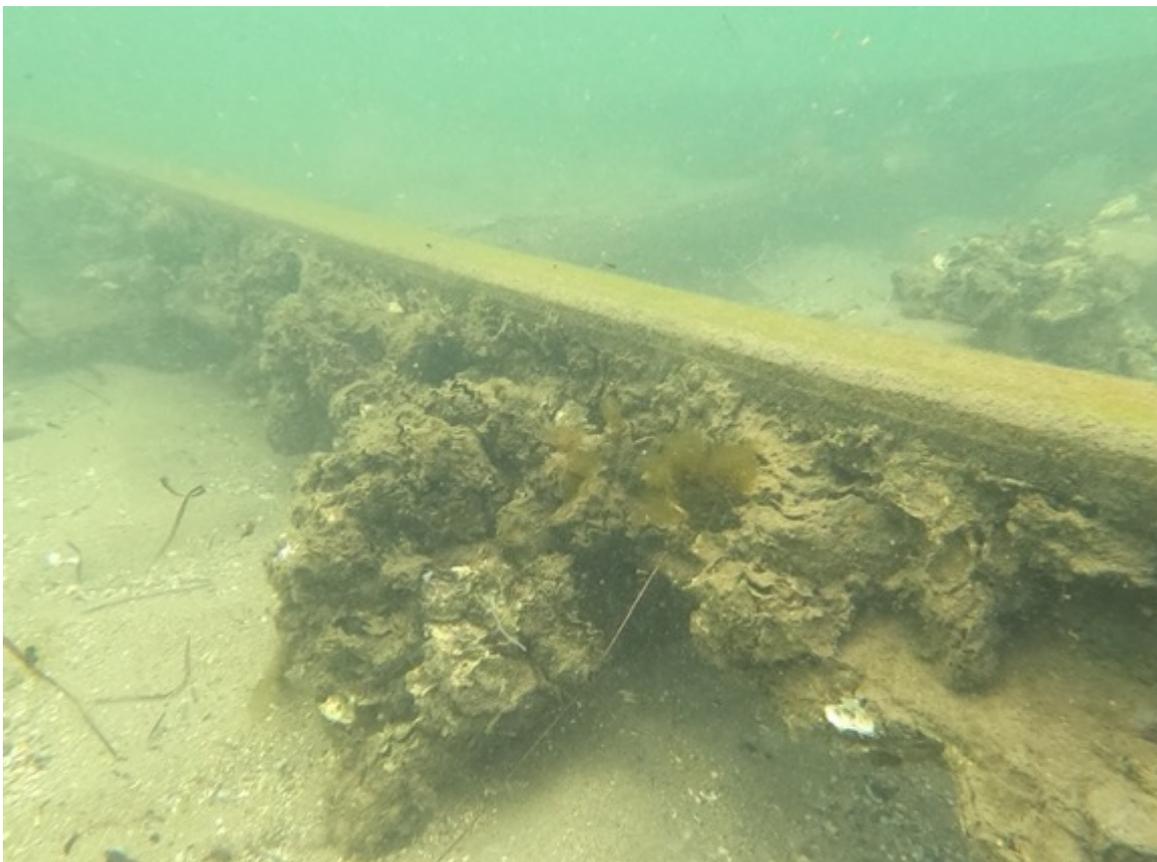
**Figure 5** Intertidal section of the sliprails with oyster growth.

- Intertidal sections of the existing sliprails supported an encrusting assemblage of oysters and sea squirts (**Figure 5**) with kelp and *Sargassum* sp. algae on the deeper subtidal sections.

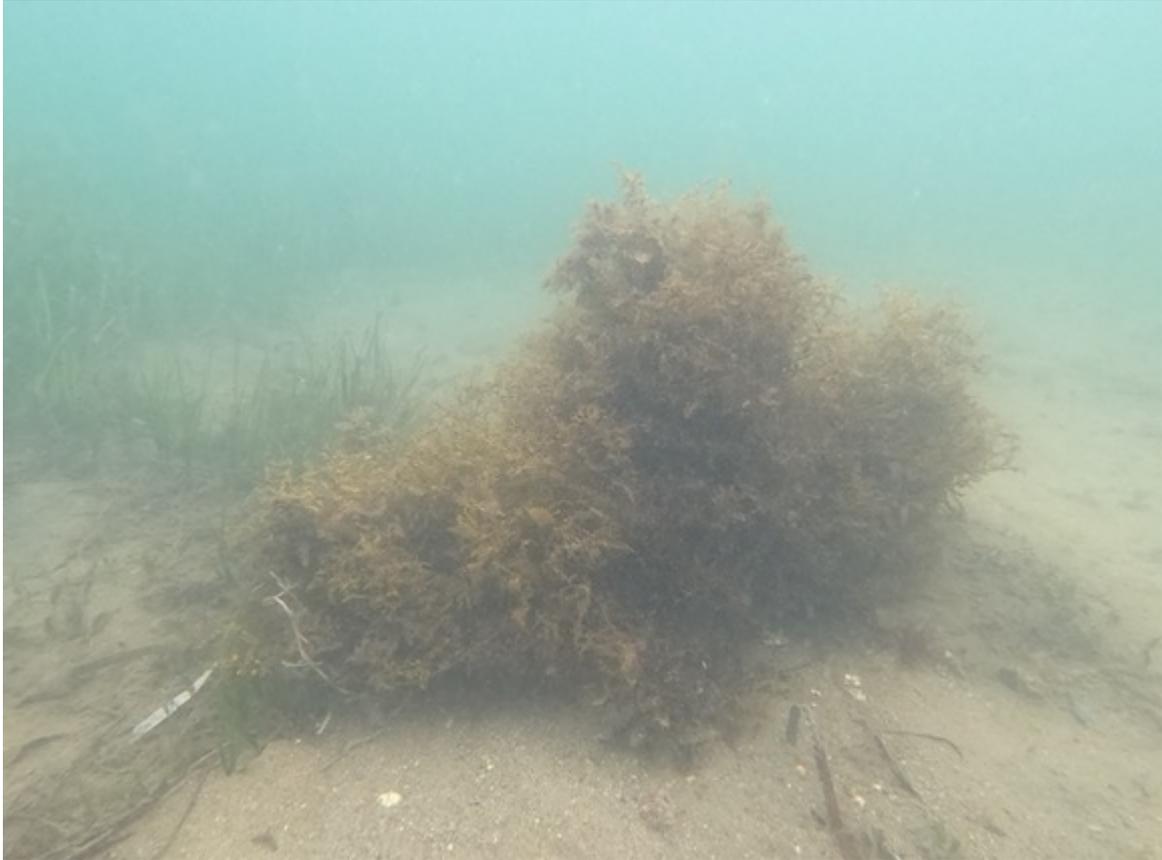
**Figure 6** Attached *Sargassum sp.* on isolated rock rubble.

- There are small amounts of rock rubble plus some disused mooring blocks scattered across the site offshore that supported some mixed algae; kelp *Ecklonia Radiata*, plus *Sargassum* sp and *Padina* sp (**Figure 6**).

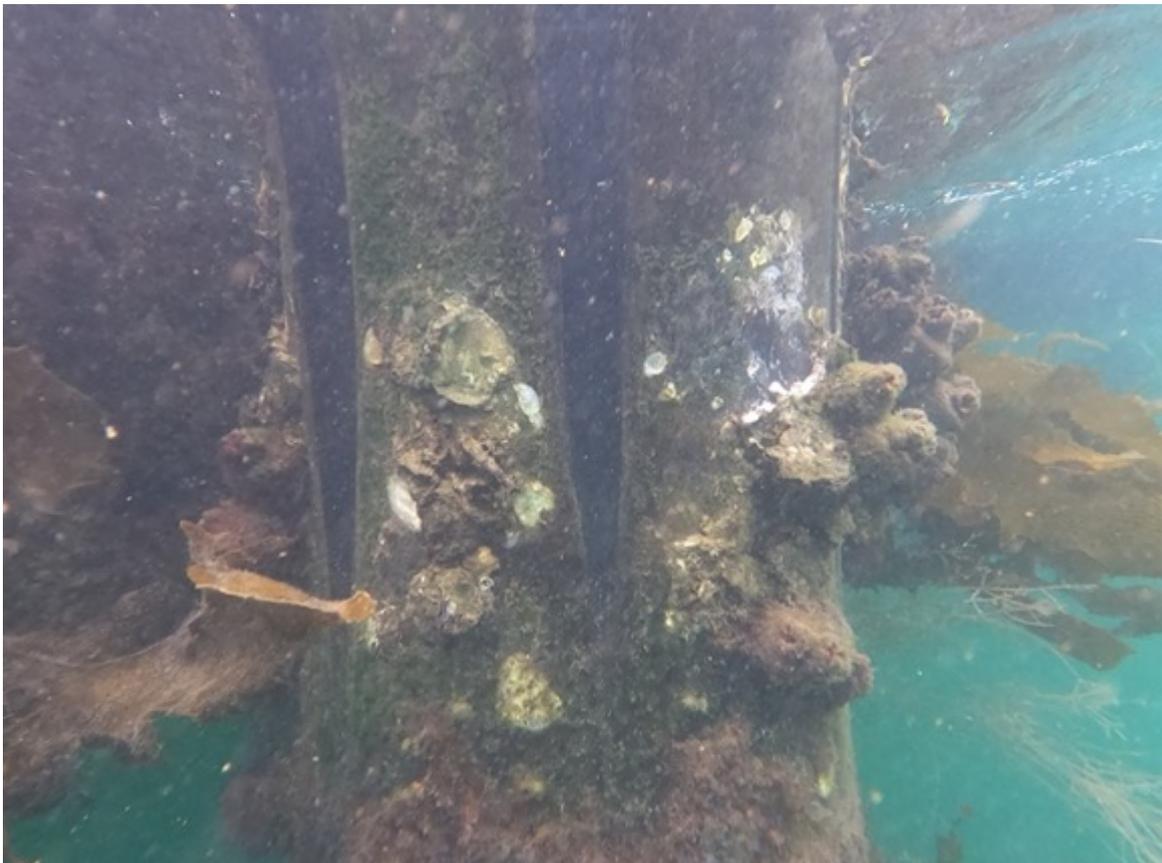
**Figure 7** Oyster band in the upper intertidal pile sections.

- Intertidal pile sections also supported an encrusting assemblage of Sydney rock oysters, *Saccostrea glomerata*) with sea squirts, *Pyura stolonifera* which included mussels, *Mytilidae* sp in the subtidal fringe (**Figures 7 & 8**). Lower subtidal sections supported mixed algae; dense kelp, *Padina*, and *Dictyota* plus a variety of encrusting fauna, mostly bryozoans, sponges and ascidians (**Figures 9 & 10**).

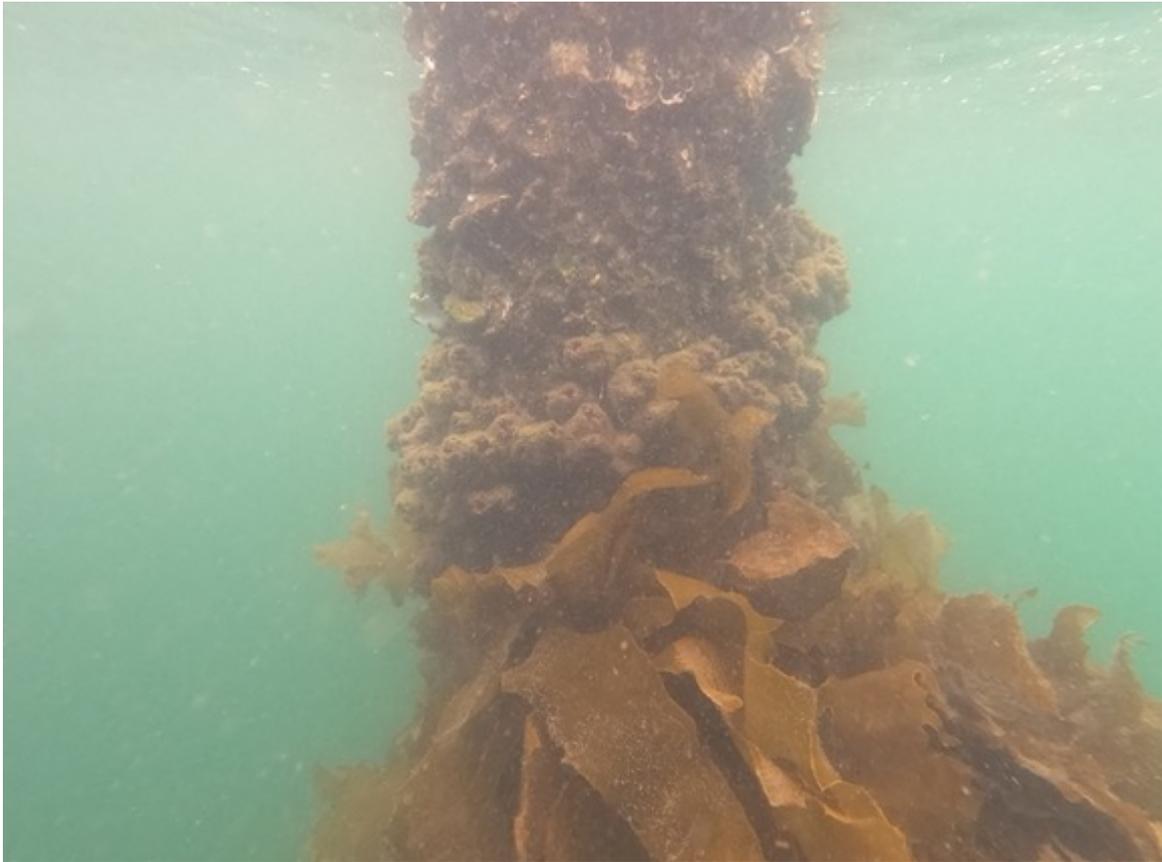
**Figure 8** Sea squirts, *Pyura stolonifera* in the upper subtidal section of pile and kelp below..

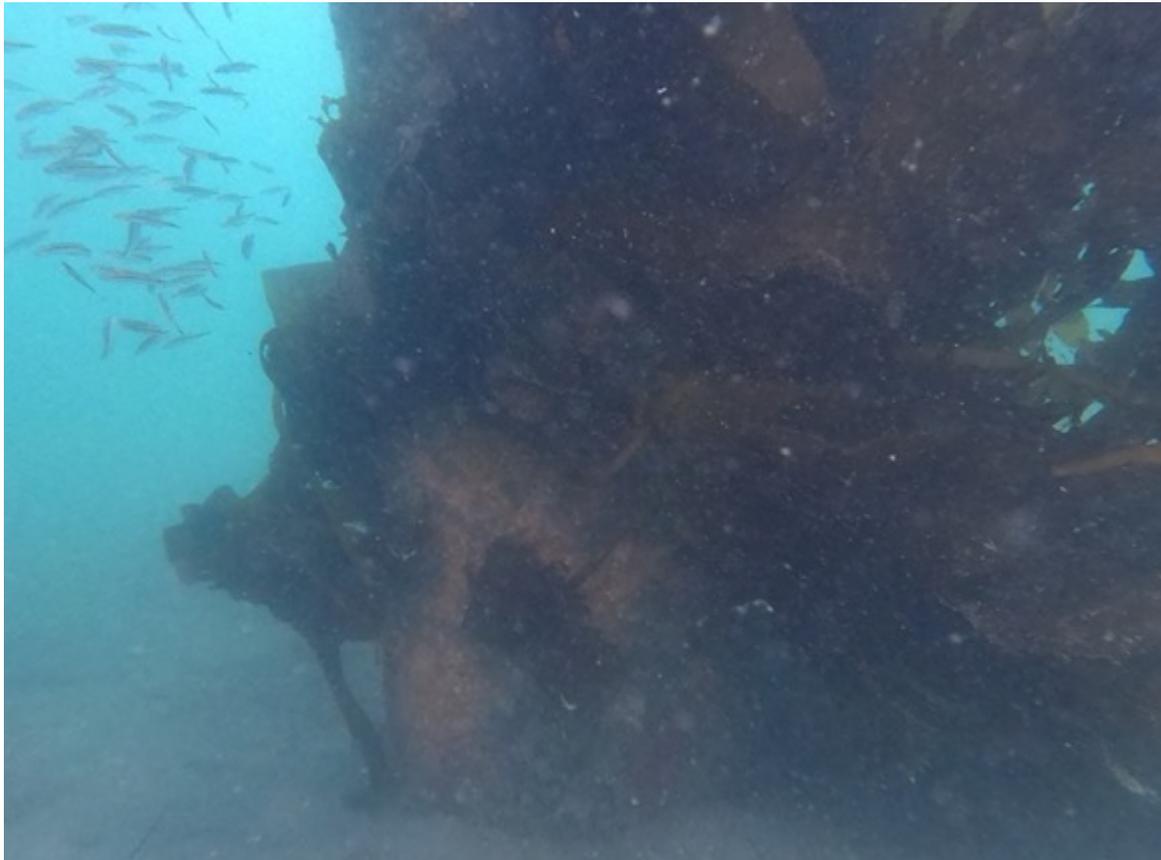
**Figure 9** Mid tide kelp and encrusting fauna on an outer pile.

In terms of overall existing habitat protection arising from the proposal, there is no loss of seagrass habitat arising from the reconfiguration in terms of direct damage from pile placement or from potential shading loss, and as there is a net gain in hard surface wetted surface areas (from extra piles and pen pontoons placed over bare sand seabed habitat), there will be a net increase in overall marine algae and associated encrusting assemblage habitat that benefits overall fish utilisation (see **Figure 9** above).

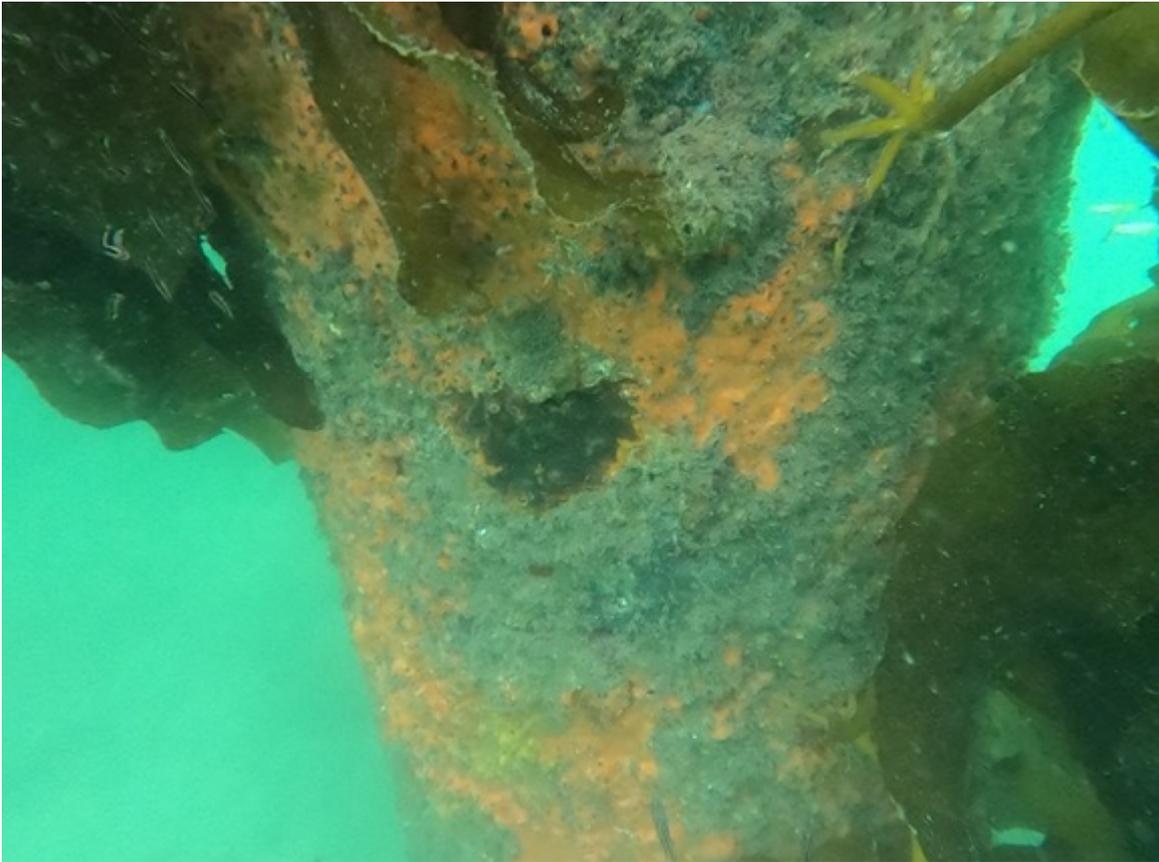
**Figure 10** Kelp and bryozoans on deeper subtidal pile sections.

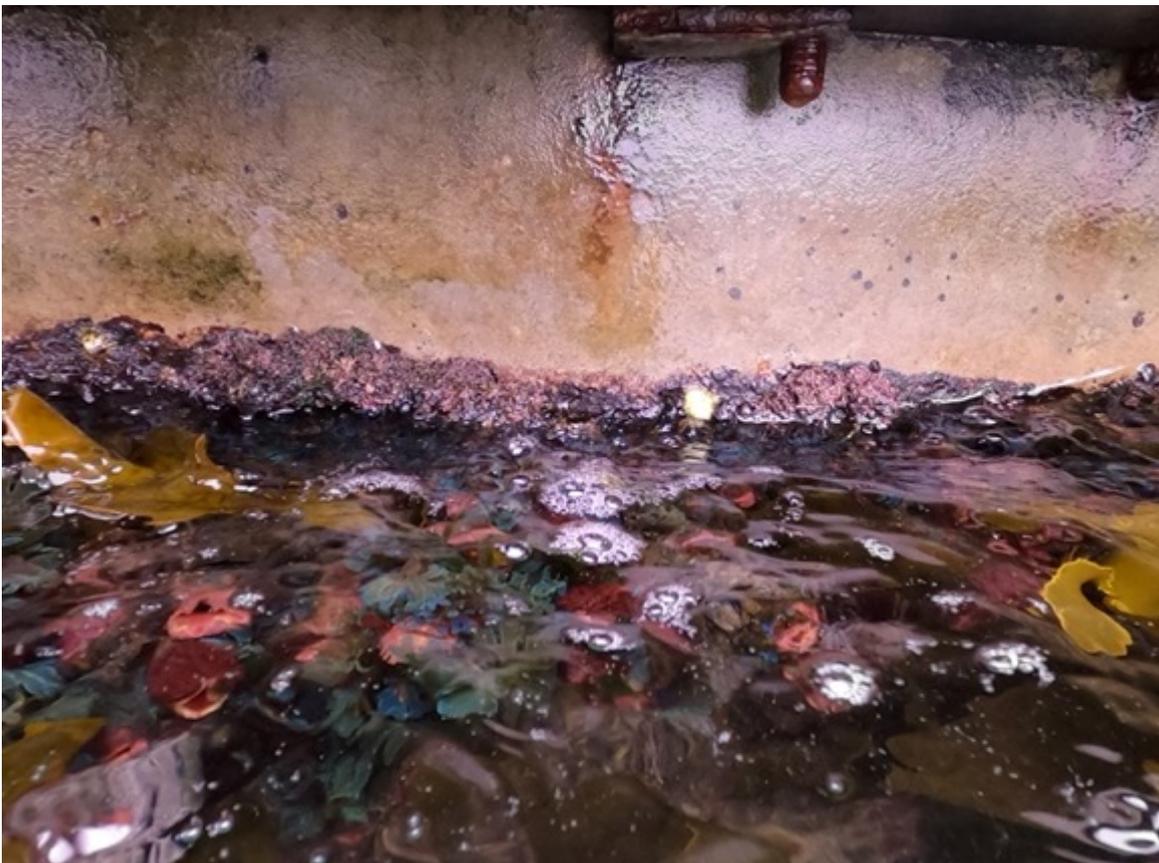
**Figure 11** Vertical edge of floating pontoon supporting a variety of brown and red alga.

- The pontoons vertical surfaces supported similar marine growth to the piles with coralline red algae, *Pyura stolonifera*, mussels, kelp, *Padina*, *Dictyota* and bryozoans (**Figure 11**). The undersides of the pontoons supported an encrusting assemblage of barnacles and bryozoans.

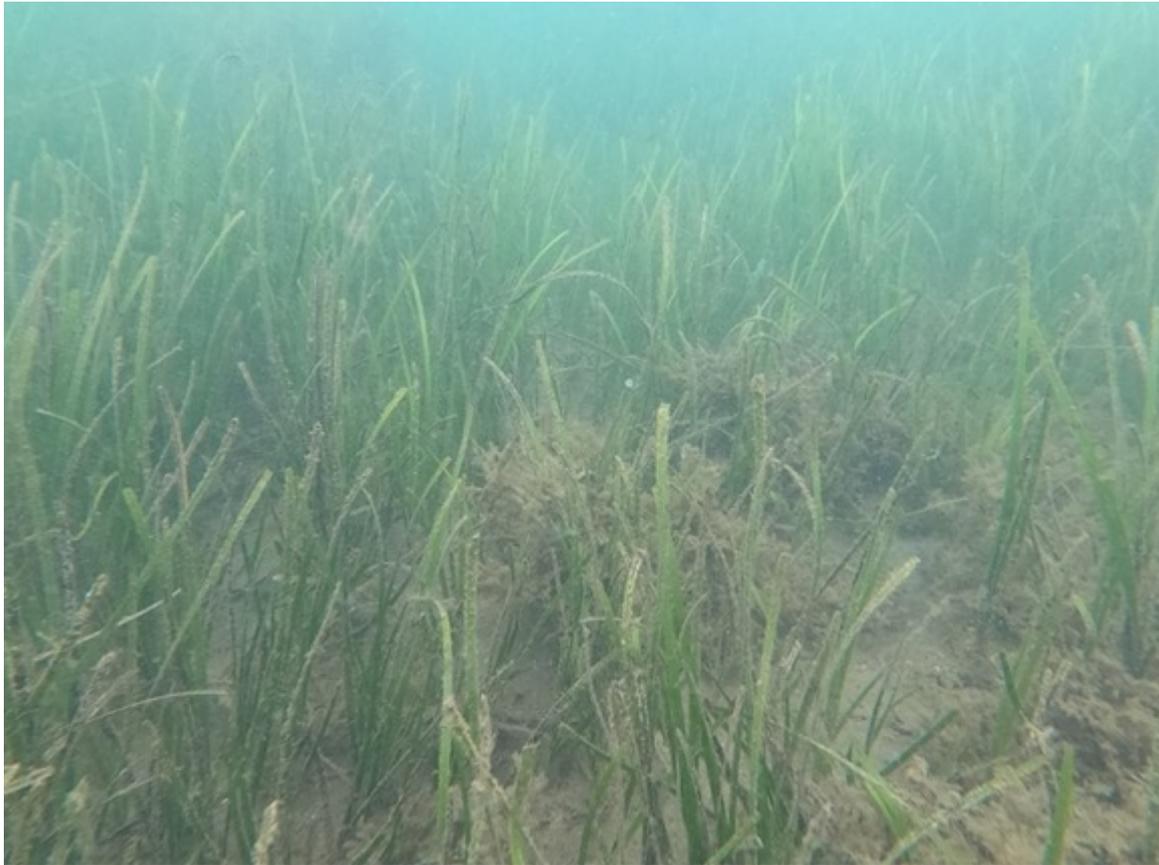
**Figure 12** *Zostera* seagrass at the closest eastern edge of the Marina.

- The two large seagrass beds located to the west and east of the marina comprise medium to dense cover *Zostera* with some sparser sections in deeper waters under the eastern arm of the marina (**Figures 12 & 13**). Some sections of seagrass had a dense covering of seasonal smothering algae.

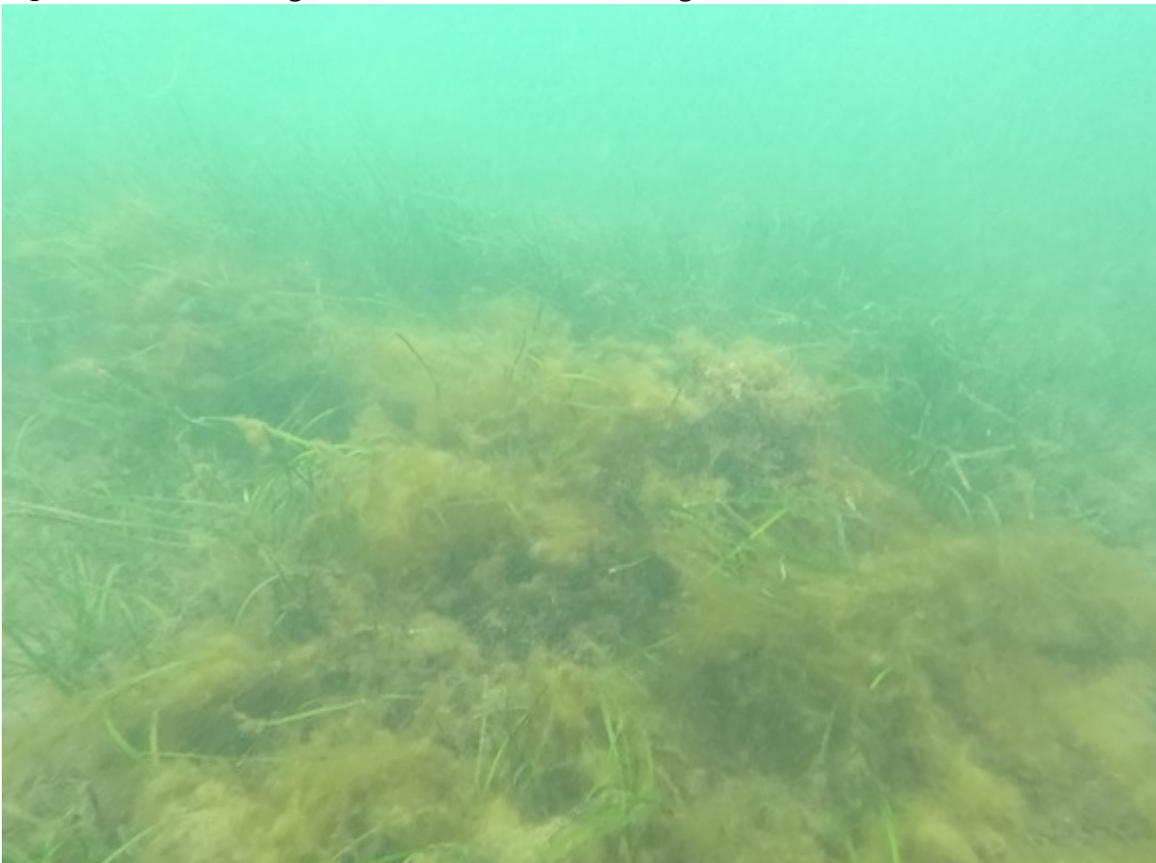
**Figure 13** Dense seasonal filamentous algae patch covering *Zostera* seagrass.

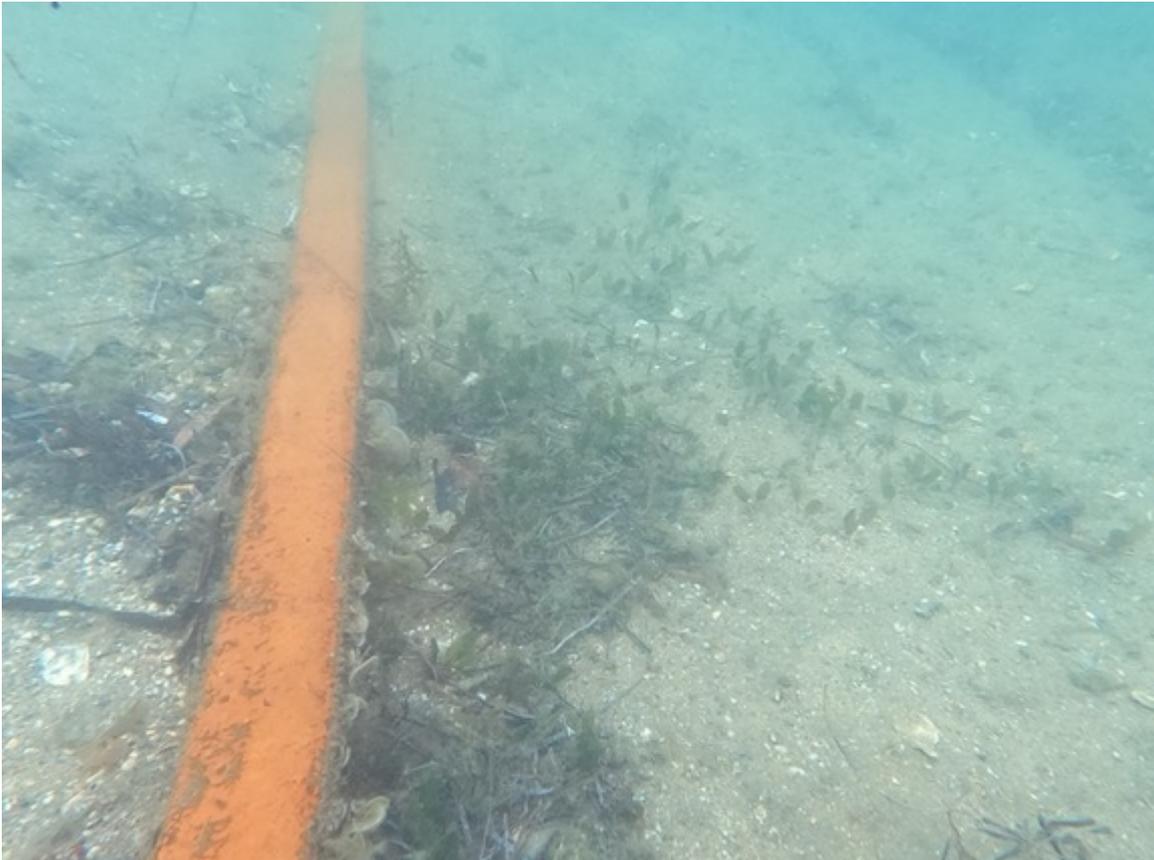
**Figure 14** Sparse patch of *Halophila* alongside sliprails.

- There are small amounts of *Halophila* throughout the seagrass distribution, occurring either as a minor understory with the *Zostera* seagrass or forming small random clumped patches across the site (**Figure 14**).

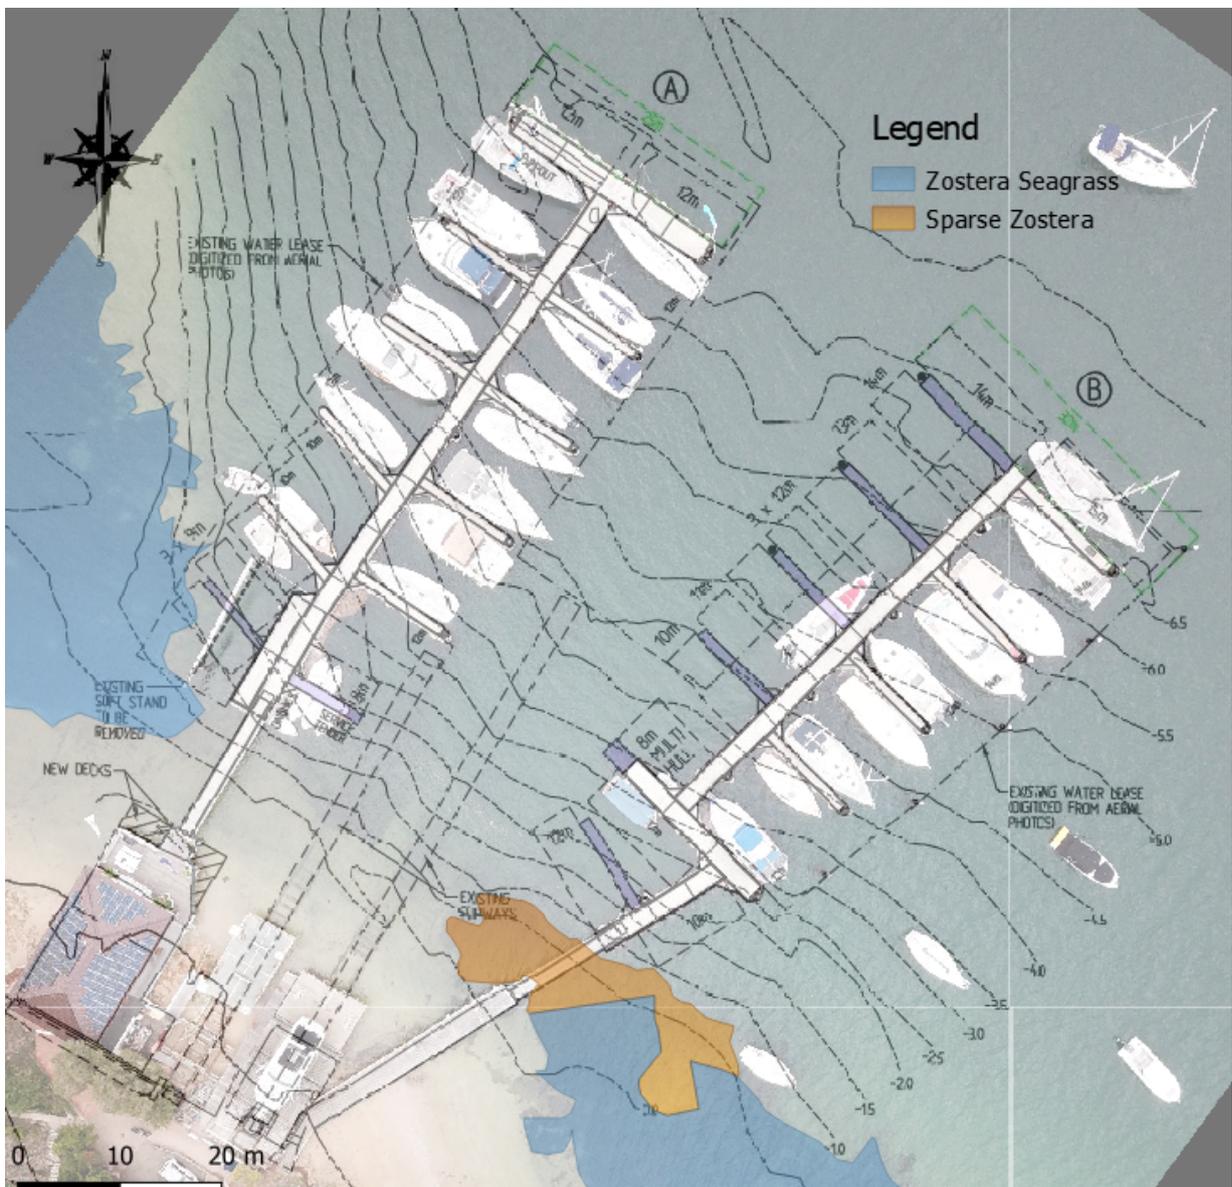
**Figure 15** Marina modification proposal overlaid onto habitat map.

The marina re-configuration proposal is shown in **Figure 15 and Appendix A**, and this section considers potential losses and gains of aquatic habitat to construction activities plus provides recommended construction mitigation procedures to avoid and minimise impacts on the aquatic biota at and around the site.

The proposal is for the existing marina arm structure to remain, but with a restructuring of marina pens to include the addition of several new pontoons to achieve an extra nine marina berths. The proposal also includes an extension to the inshore boatshed deck over the intertidal sands. Further, ten swing moorings to be removed. The marina arm restructure requires installation of three additional pontoon locator piles, four berthing pen finger pontoons and three smaller finger pontoons. The deck extension will require up to six support piles.

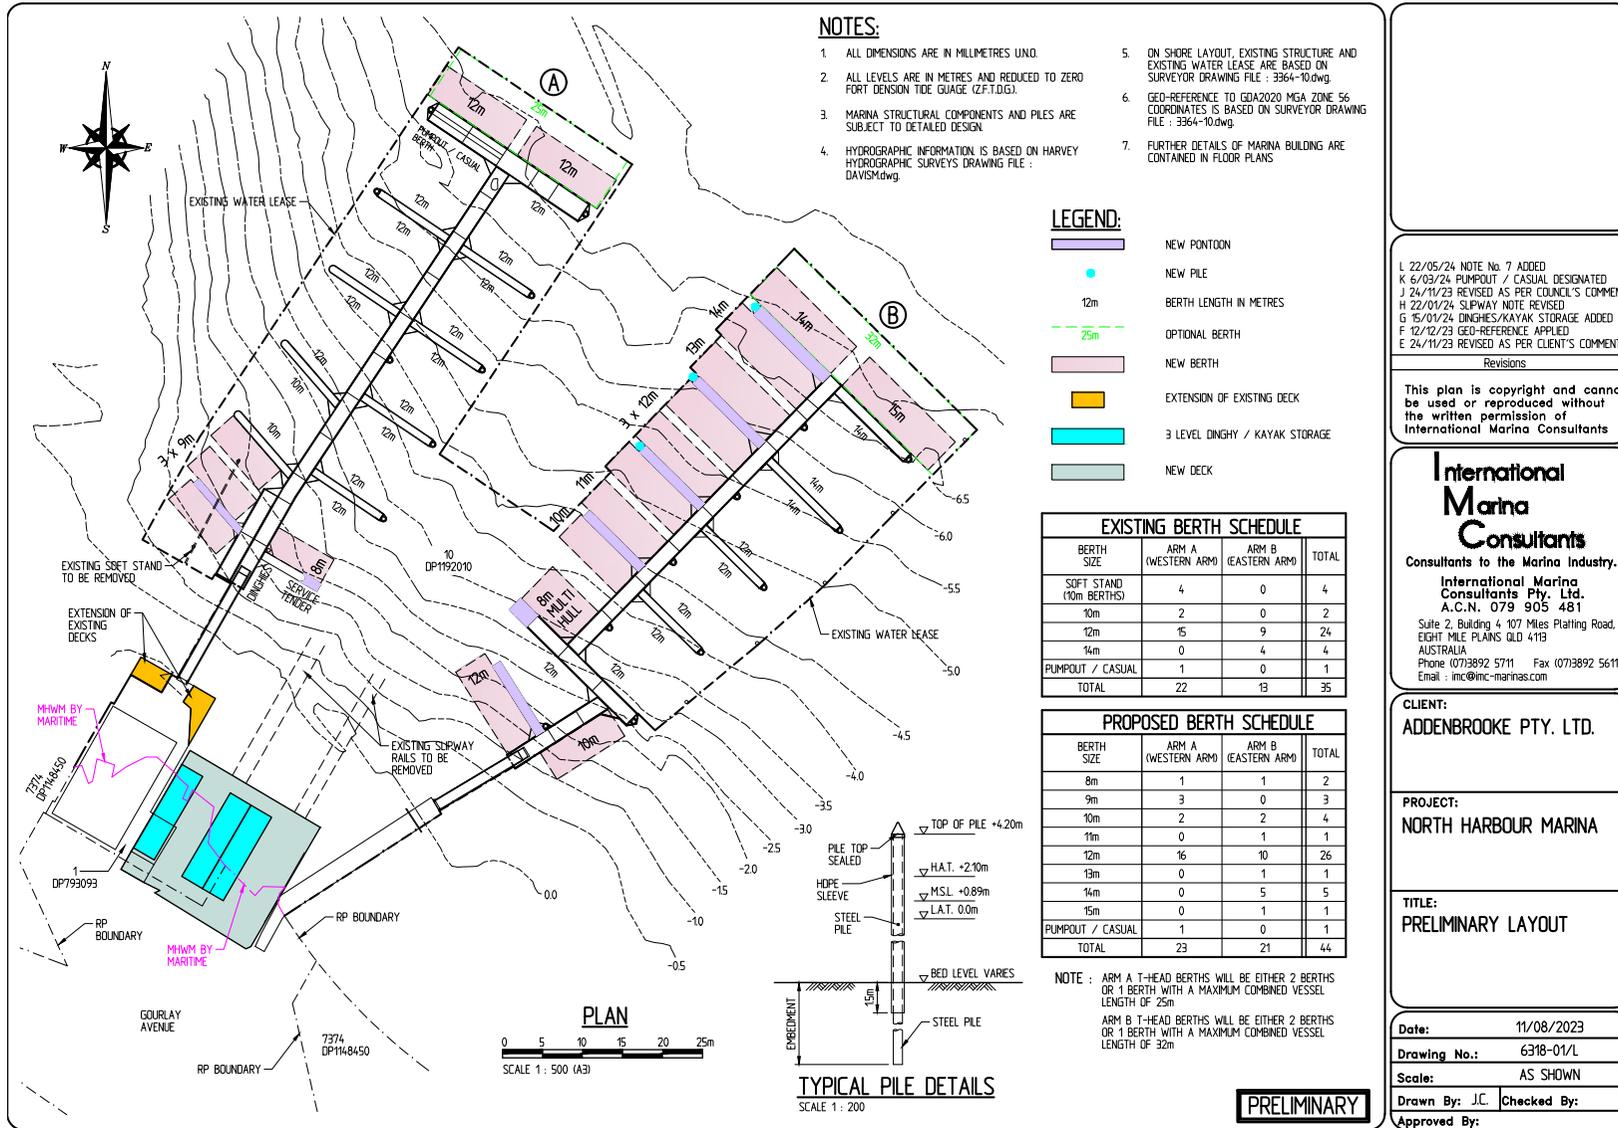
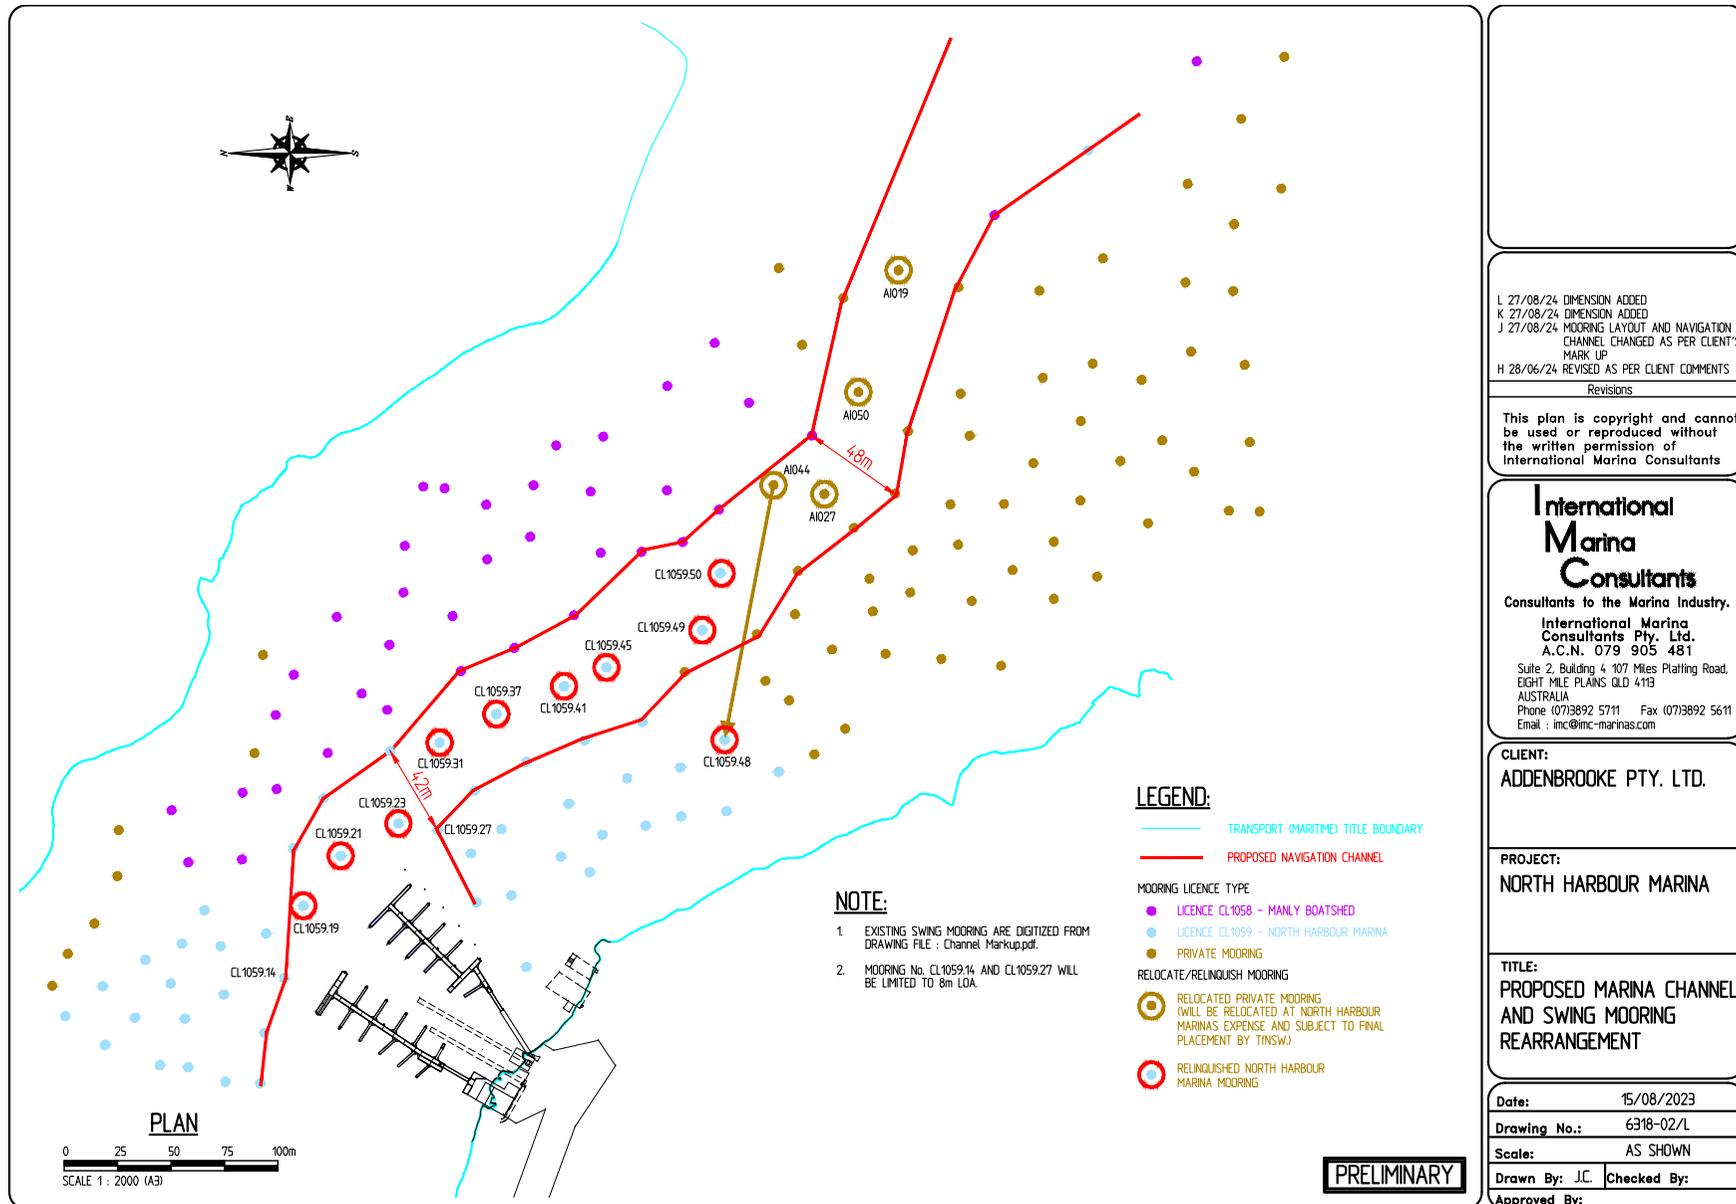
**Drawing No.:** 6318-02/L

**TITLE:**  
 PROPOSED MARINA CHANNEL AND SWING MOORING REARRANGEMENT
