Site Audit Statement

Site audit statement no. 0301-2017

Northern Beaches Business Park

Long-Term Environmental Management Plan – Soil Vapour Intrusion Management

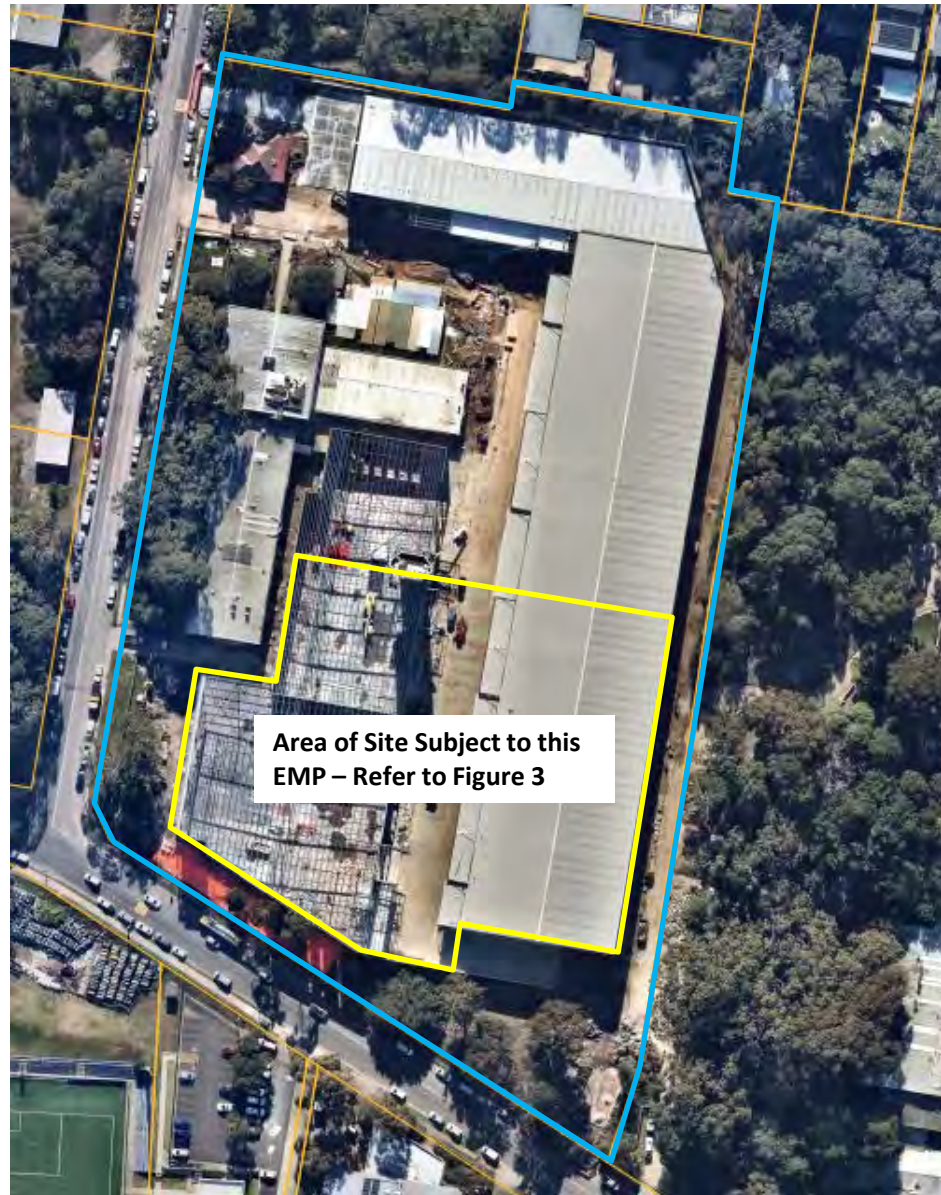
Source: Nearmap
Image Date: 26 June 2023

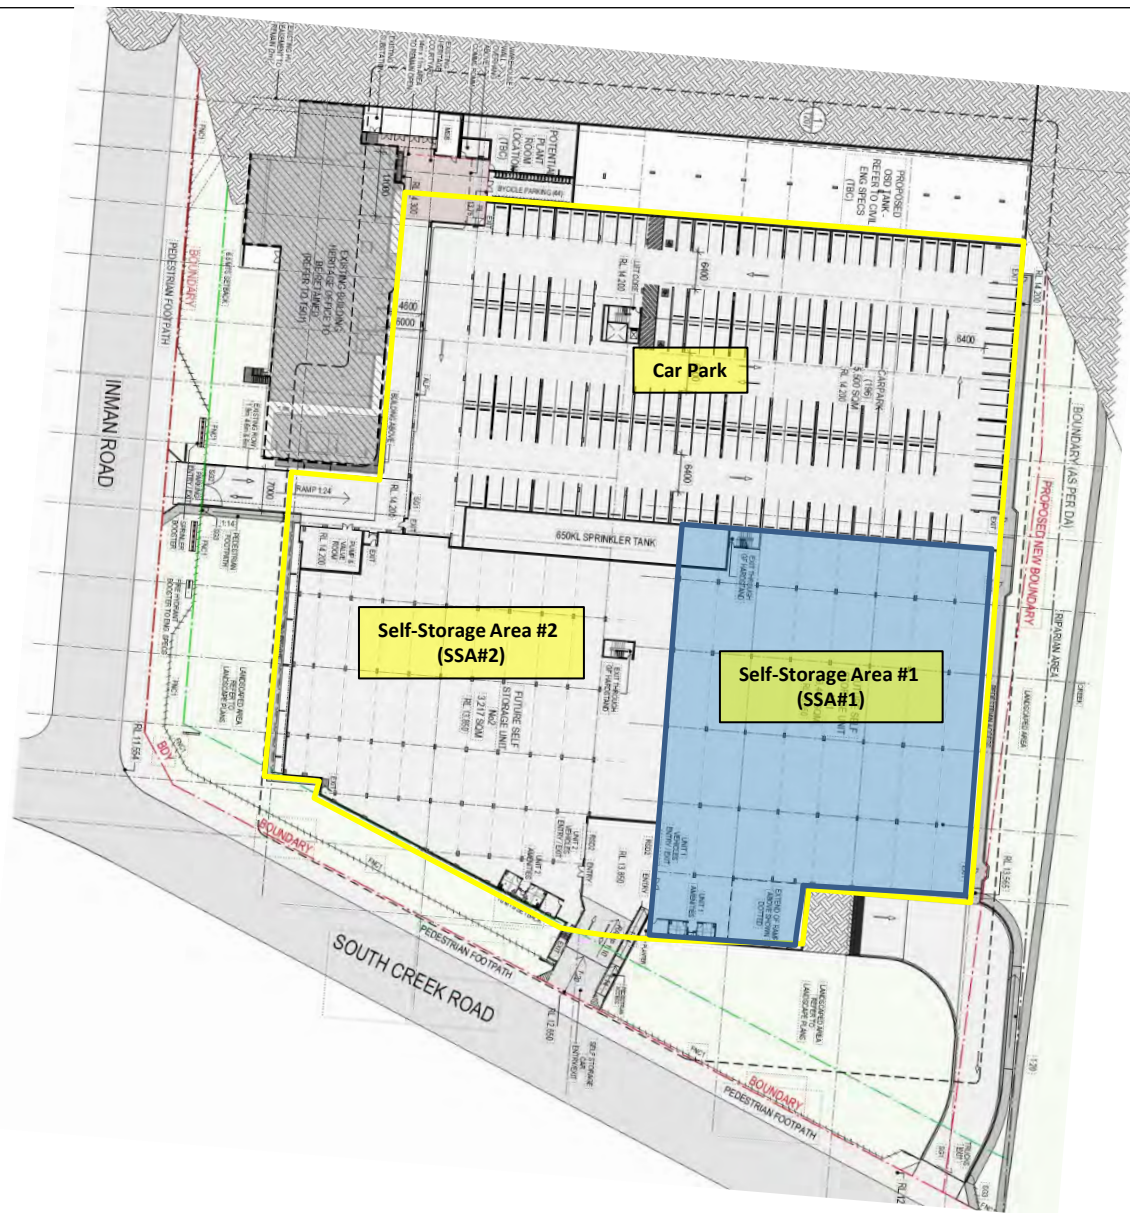
Extent of SVVS

Source: EG

The portions of the building applicable to this EMP includes the following areas (refer to **Figure 3**):

At the SSA#1, SSA#2 and car park areas (**Figure 3**), the building floor and SVVS components (as described above in **Section 2**) are to be maintained as constructed at all times to ensure these structures are intact and the integrity of the floor/SVVS are maintained as designed. Inspections of these areas/components (as referenced below in **Section 3.4**), as well as any observations noted from site tenants, will assist in making sure appropriate actions are taken to properly maintain these structures/areas.

- The floor of the entire basement level per **Figures 3 and 4** (SSA#1, SSA#2 and the car park). This includes: inspection for cracks associated with the floors (including at foundation pillars, walls) and any penetrations (such as monitoring wells discussed below); inspecting for potential spills/chemical odours or unexpected finds (as outlined below in **Section 3.7**); and inspection for areas of ponded water;

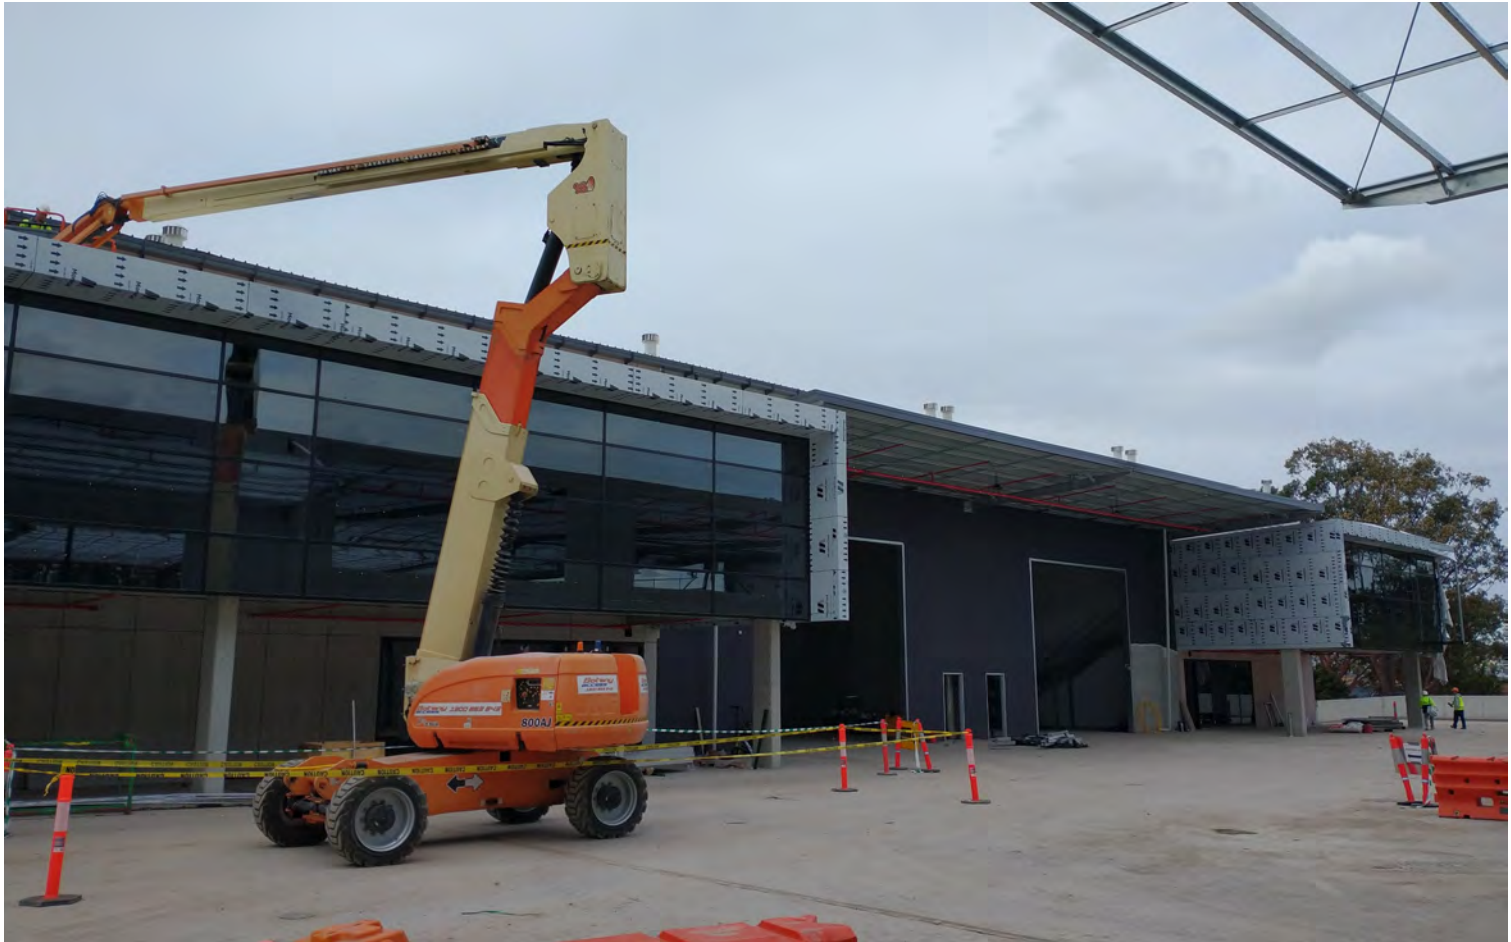
Photograph 1 (facing south-east): View of warehouse and driveway areas on Level 1. Note whirlybird ventilators for the SVVS outlet risers visible at the roof level.

- Nine SVVS outlet risers that extend to 'whirlybird' vents at the roof of the overlying warehouse (**Figure 4**). Vents should be rotating freely, in particular during windy conditions;

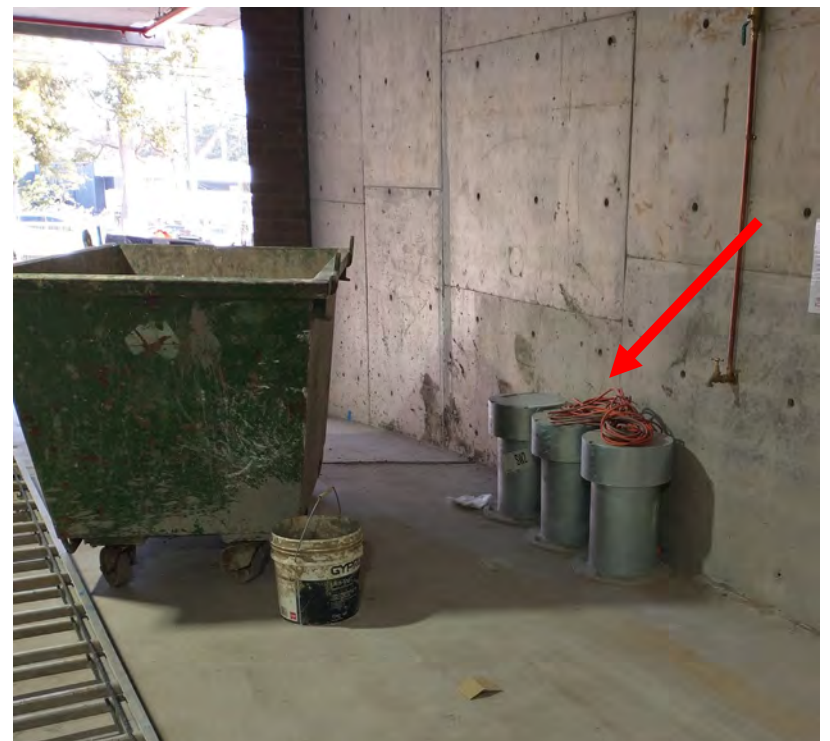
Photograph 3: View of three of four air inlet bollards (red arrow) at the entrance driveway on the lower level to the self-storage areas.

- The eastern area of SSA#2 as shown on **Figure 4**, which contains 11 air inlet bollards associated with the SVVS, with seven in the driveway at Level 1 above SSA#2 and four in the lower-level entranceway (from South Creek Road) to both self-storage unit areas. Bollards/inlets should be free of debris and not blocked or damaged to allow air to flow through the system.

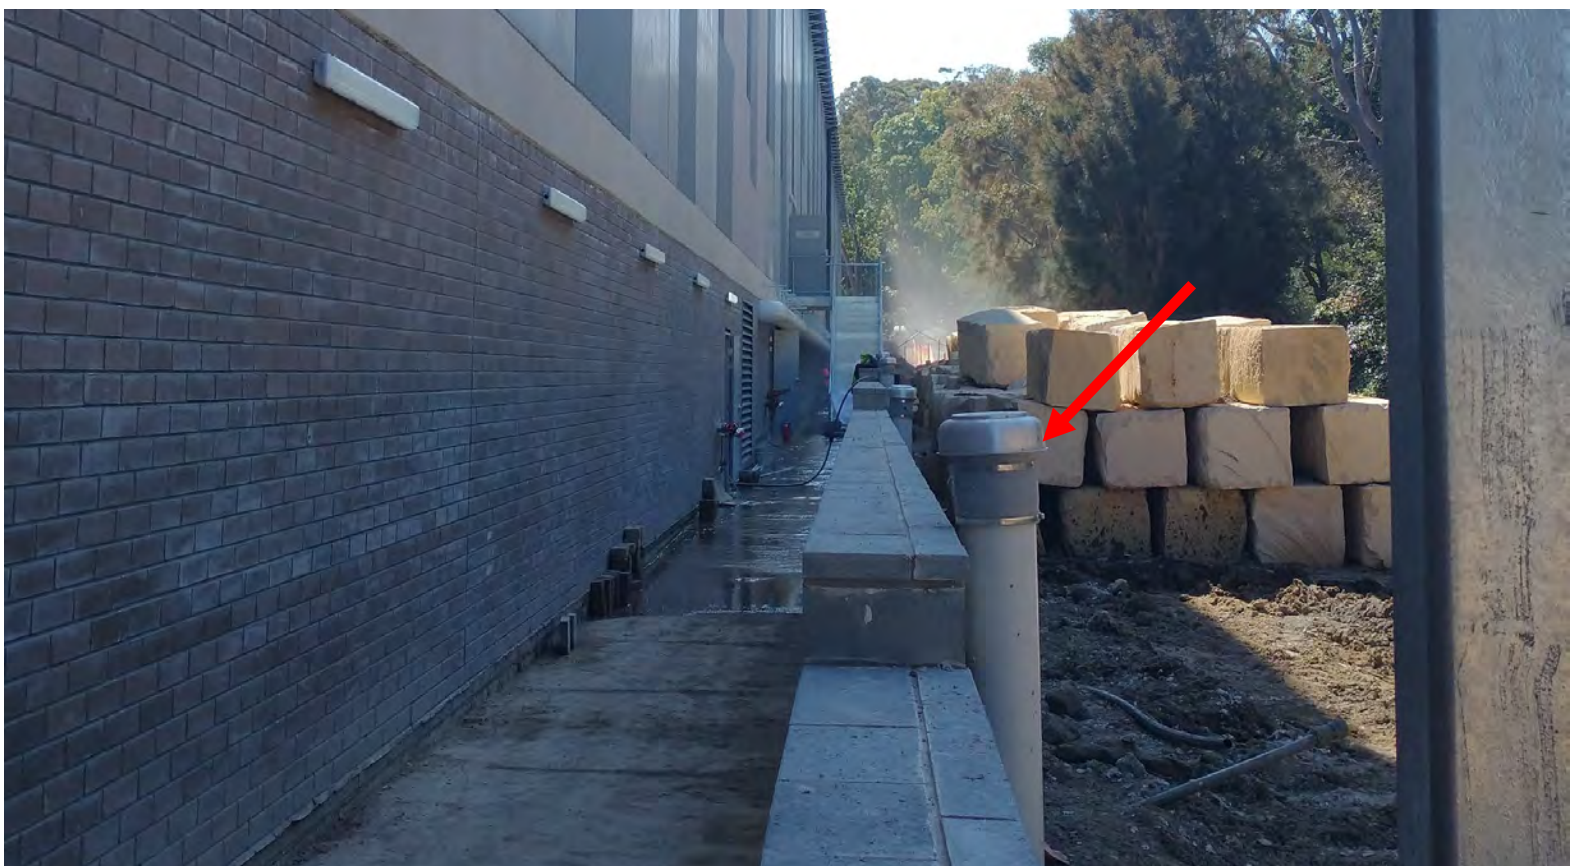
Photograph 5 (facing north): View of a typical 'mushroom cap' inlet pipe (red arrow) east of SSA#1. 11 caps are located along the eastern side of SSA#1.

- 'Mushroom cap' air inlets (11) associated with the SVVS along the eastern wall of SSA#1 (**Figure 4**). Inlets should be free of debris and not blocked or damaged to allow air to flow the system; and

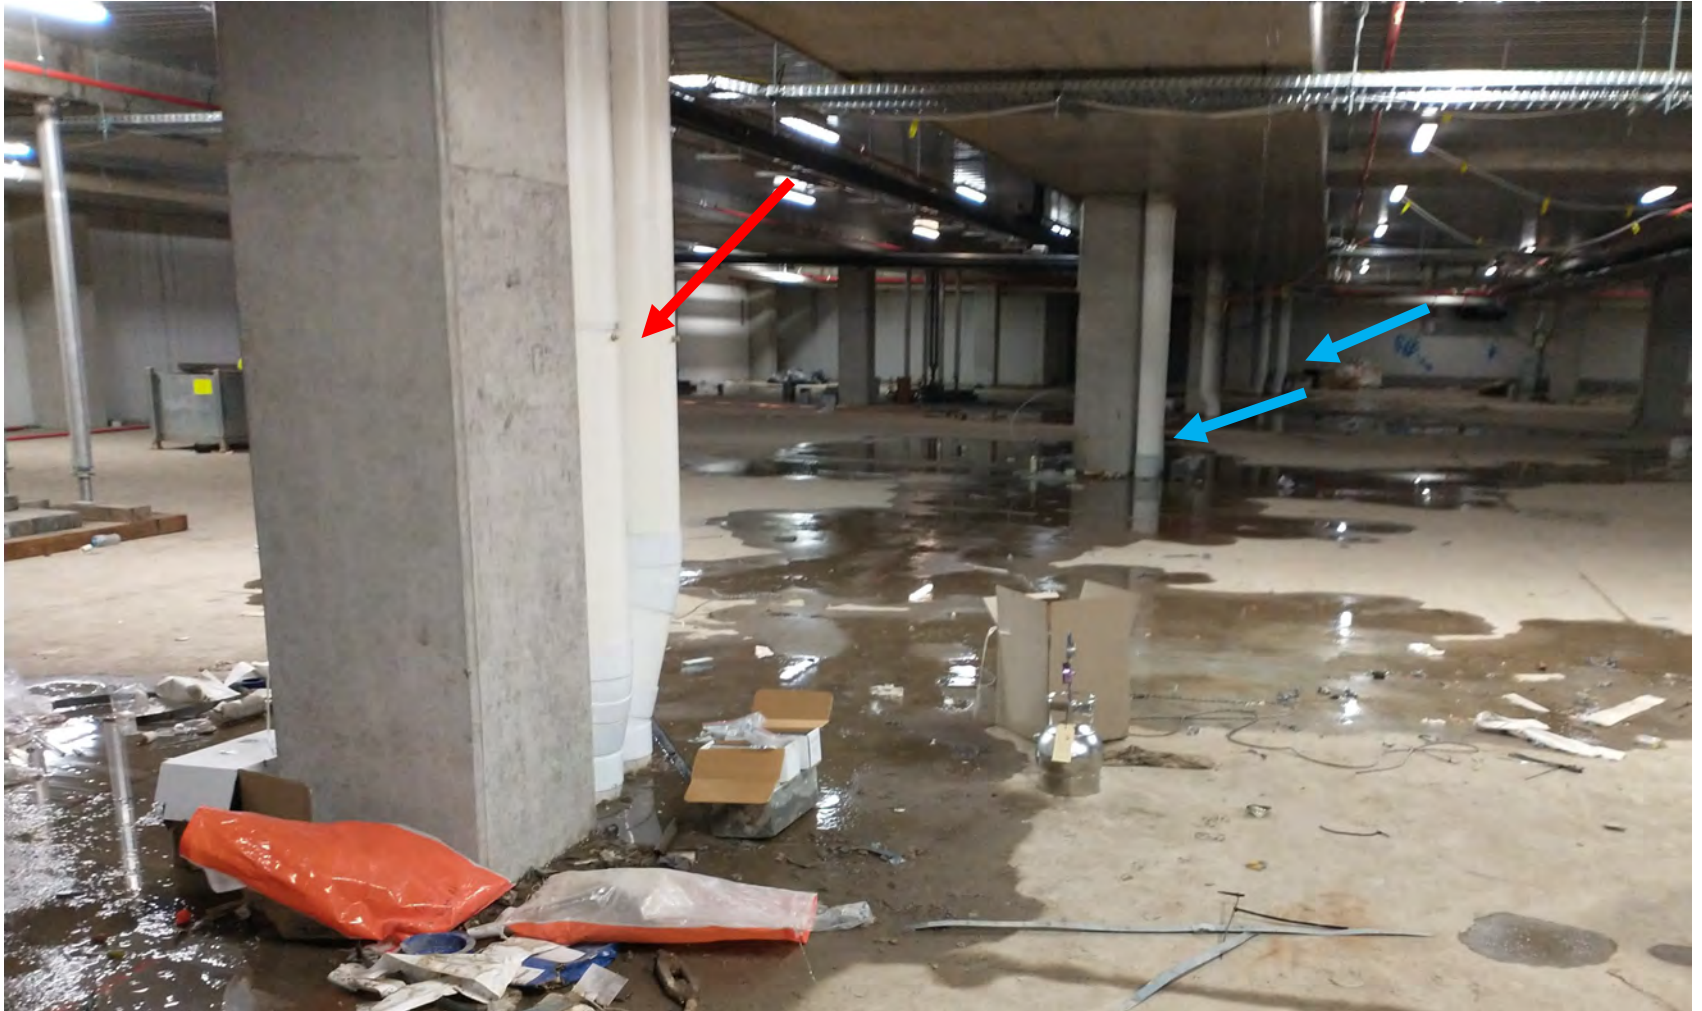
Photograph 6: View of typical outlet risers at SSA#1. Note brass riser sampling ports (red arrow). Additional outlet risers visible in the background (blue arrows).

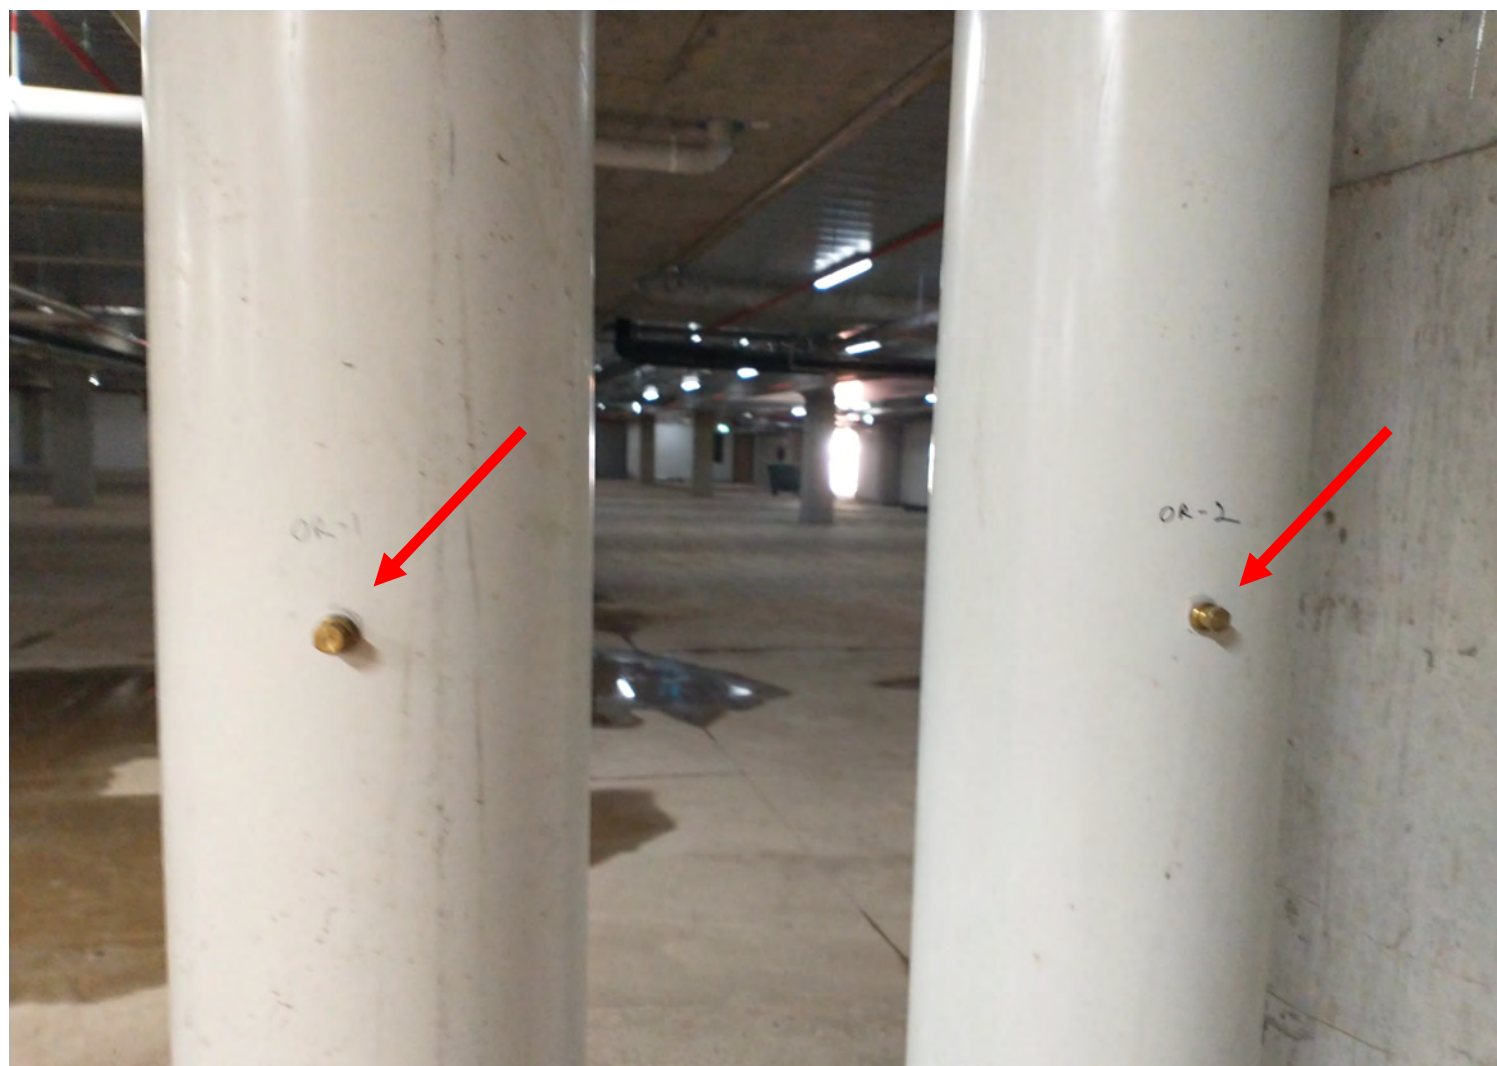
Photograph 8: View of typical brass sampling ports (red arrows) at the outlet risers (locations OR-1 and OR-2 shown).

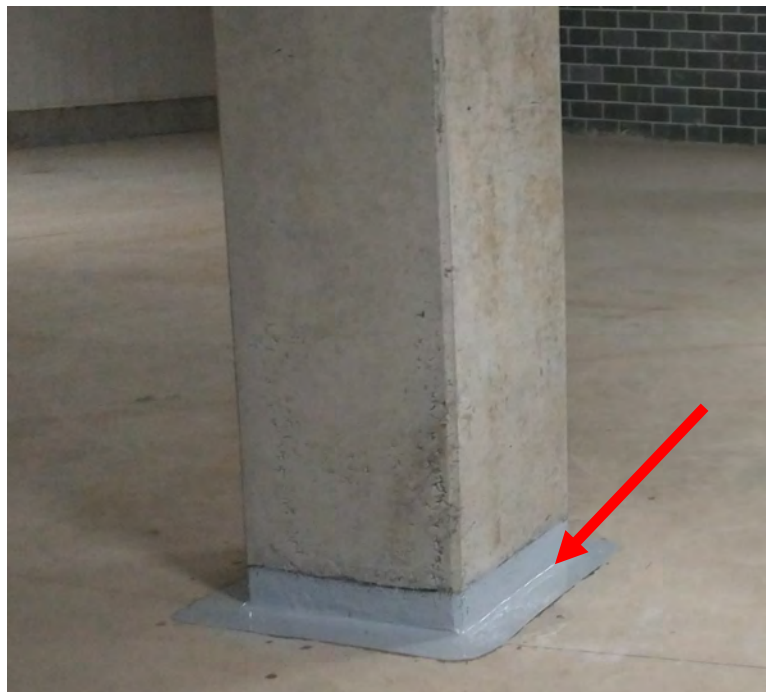
Photograph 9: View of grey 'Retrocoat' topcoat at the base of columns at the eastern half of SSA#1. Retrocoat should provide a complete seal extending approximately 10cm up the column to approximately 10cm out from the column on the concrete floor. No cracks or evidence of shrinkage should be observed.

The column Retrocoat applies to the columns at the eastern half of SSA#1 ('Pour 2' and 'Pour 2A') as shown on the diagram below (Columns 1-17, 20, 23, 26 and 29)

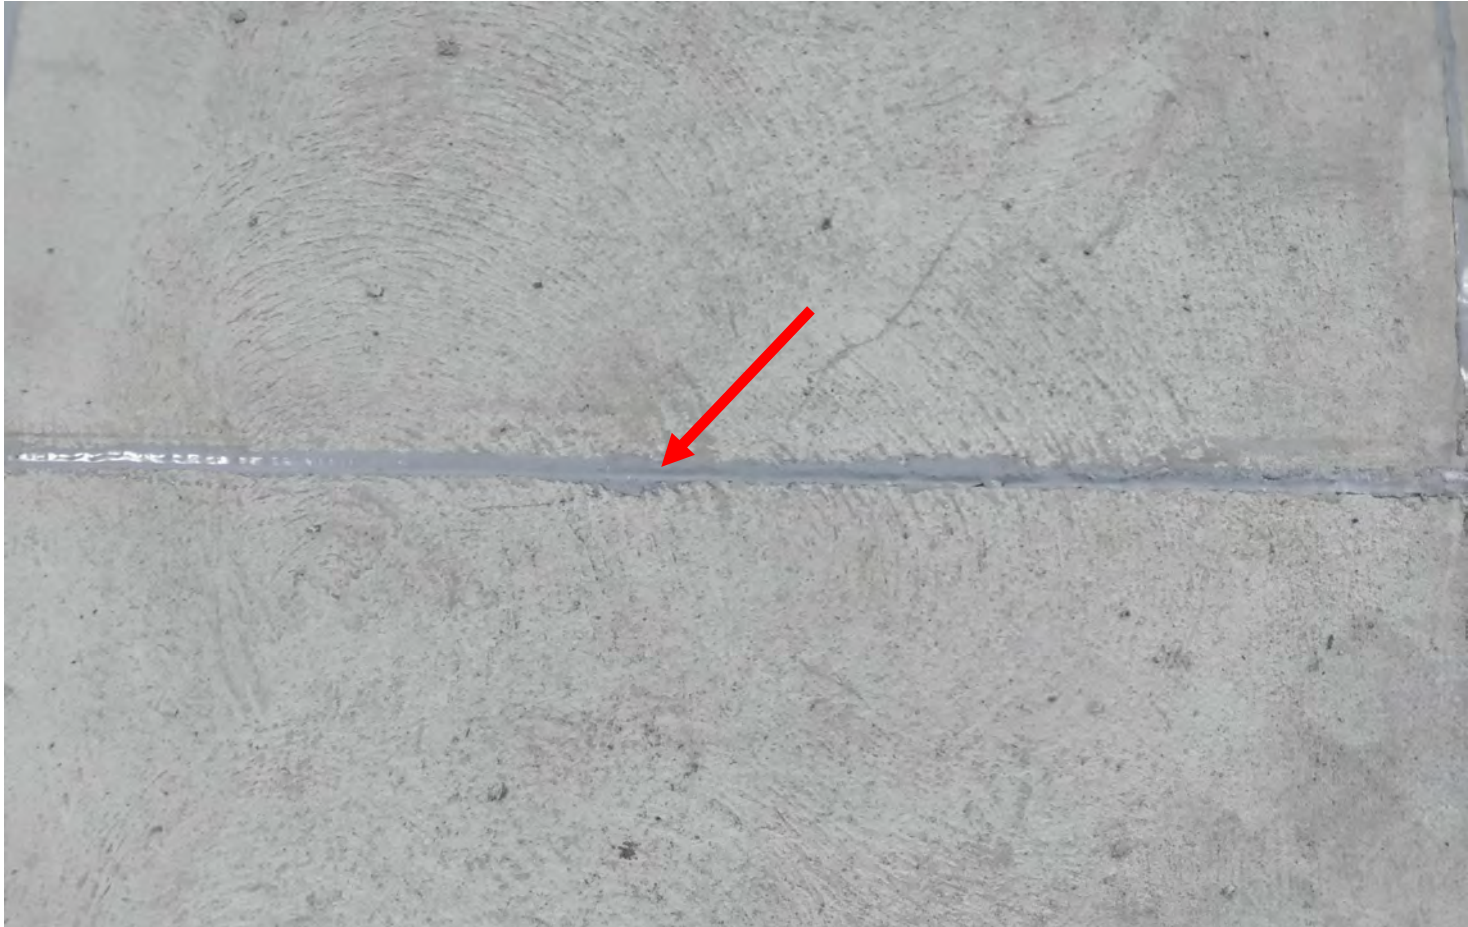
Photograph 10: View of typical caulking seam (red arrow) between expansion joints of the concrete floor and along the north wall at SSA#1. No cracks or evidence of shrinkage should be observed.

- No cracks in the floor are present. Specialised sealing of cracks or penetrations within SSA#1 will be required to maintain the integrity of the SVVS, and any repairs conducted at the car park or SSA#2 areas will be conducted to ensure the concrete floor is restored as originally designed;

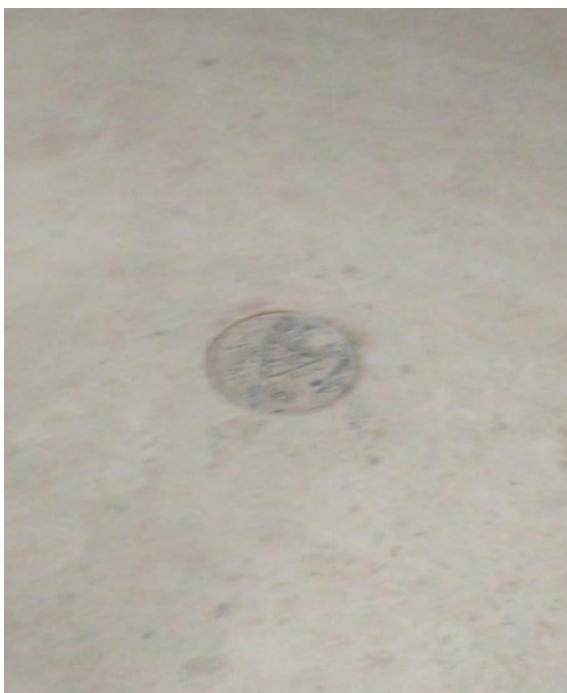
Photograph 11: View of typical monitoring well gatic cover. The cover should make a seal when bolted down.

- Ensuring the well cap plug is replaced to the top of the PVC standpipe of the monitoring well;
- Ensuring the monitoring well gatic cover is properly placed and bolted down after sampling;
- Reporting evidence of damage or cracking in the vicinity of the monitoring wells to the Site Manager; and
- Inspecting the gatic of the monitoring wells installed within SSA#1 to ensure that the inside of the gatic is lined with non-shrink grout (refer to photographs in **Appendix B**).

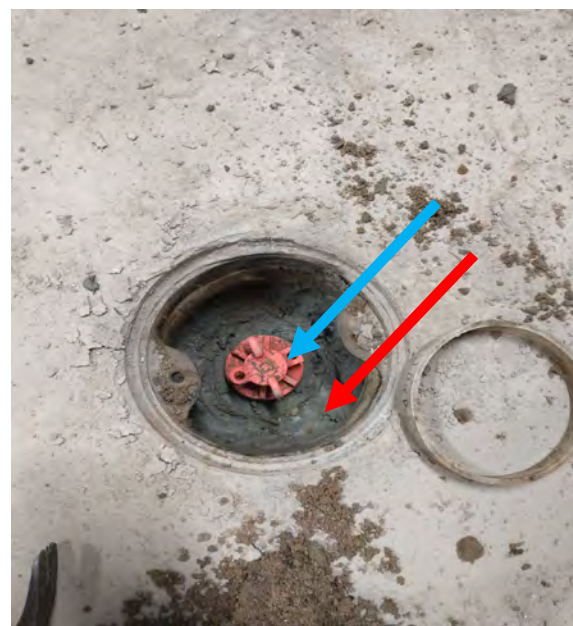
Photograph 12: View of typical orange expandable monitoring well plug (blue arrow) and grout seal (red arrow). The grout seal is required for all monitoring wells installed at SSA#1.

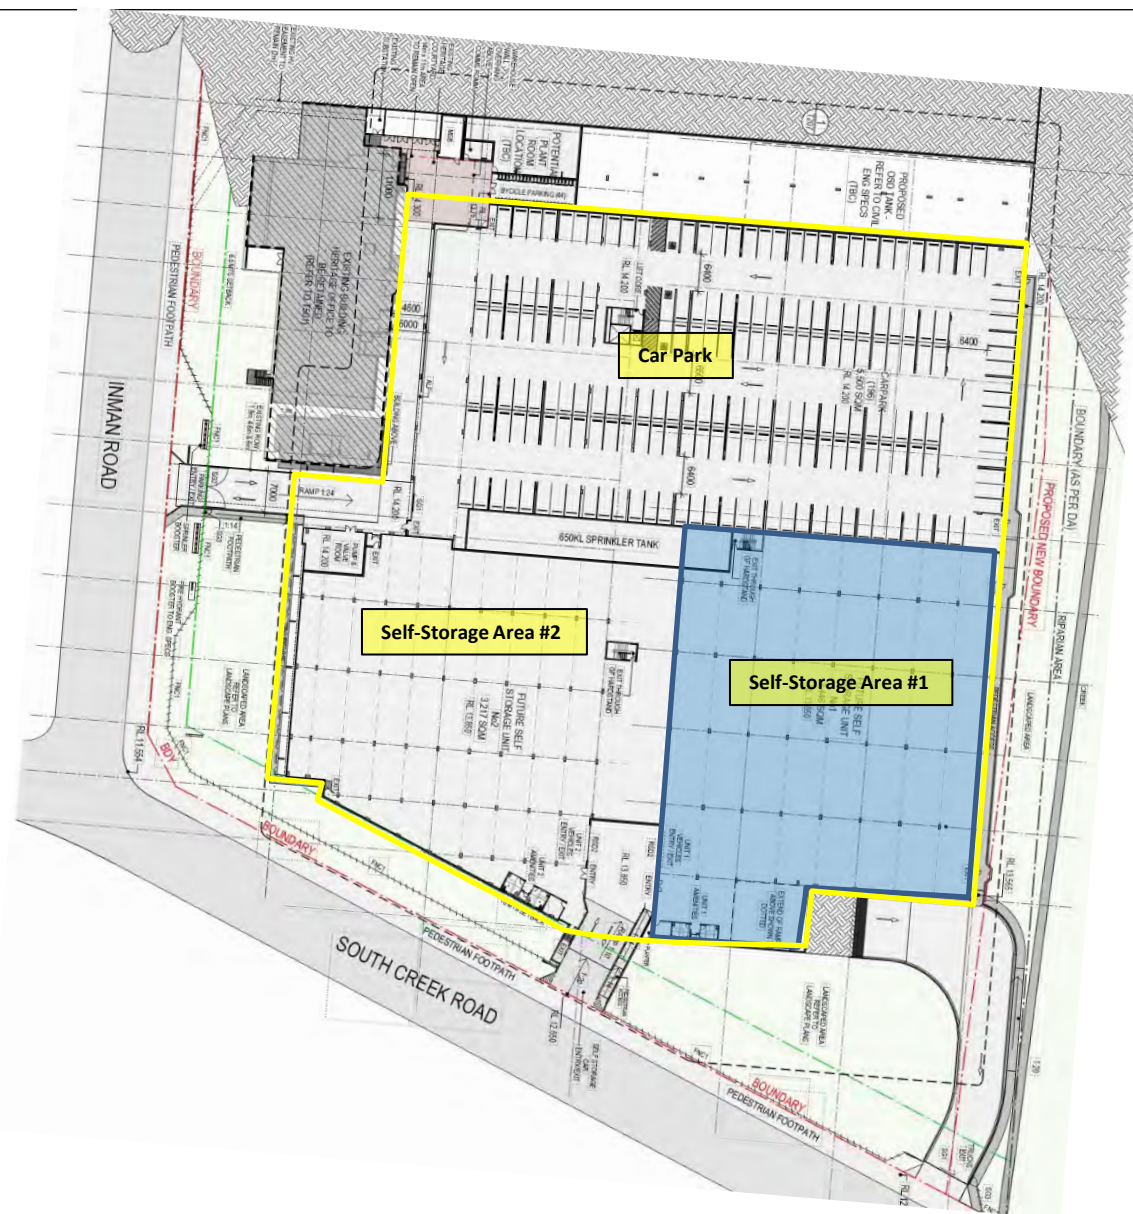
Source: EG

The portions of the site building applicable to this SAQP includes the following areas (refer to **Figure 3**):

- Construction of a reinforced concrete ground-bearing floor slab (i.e., a design that does not permit infiltration of groundwater [if encountered]); and
- Installation of a sub-slab SVVS that is passively vented to draw out any vapours that may accumulate beneath the building slab (refer to **Figures 3 and 4**).

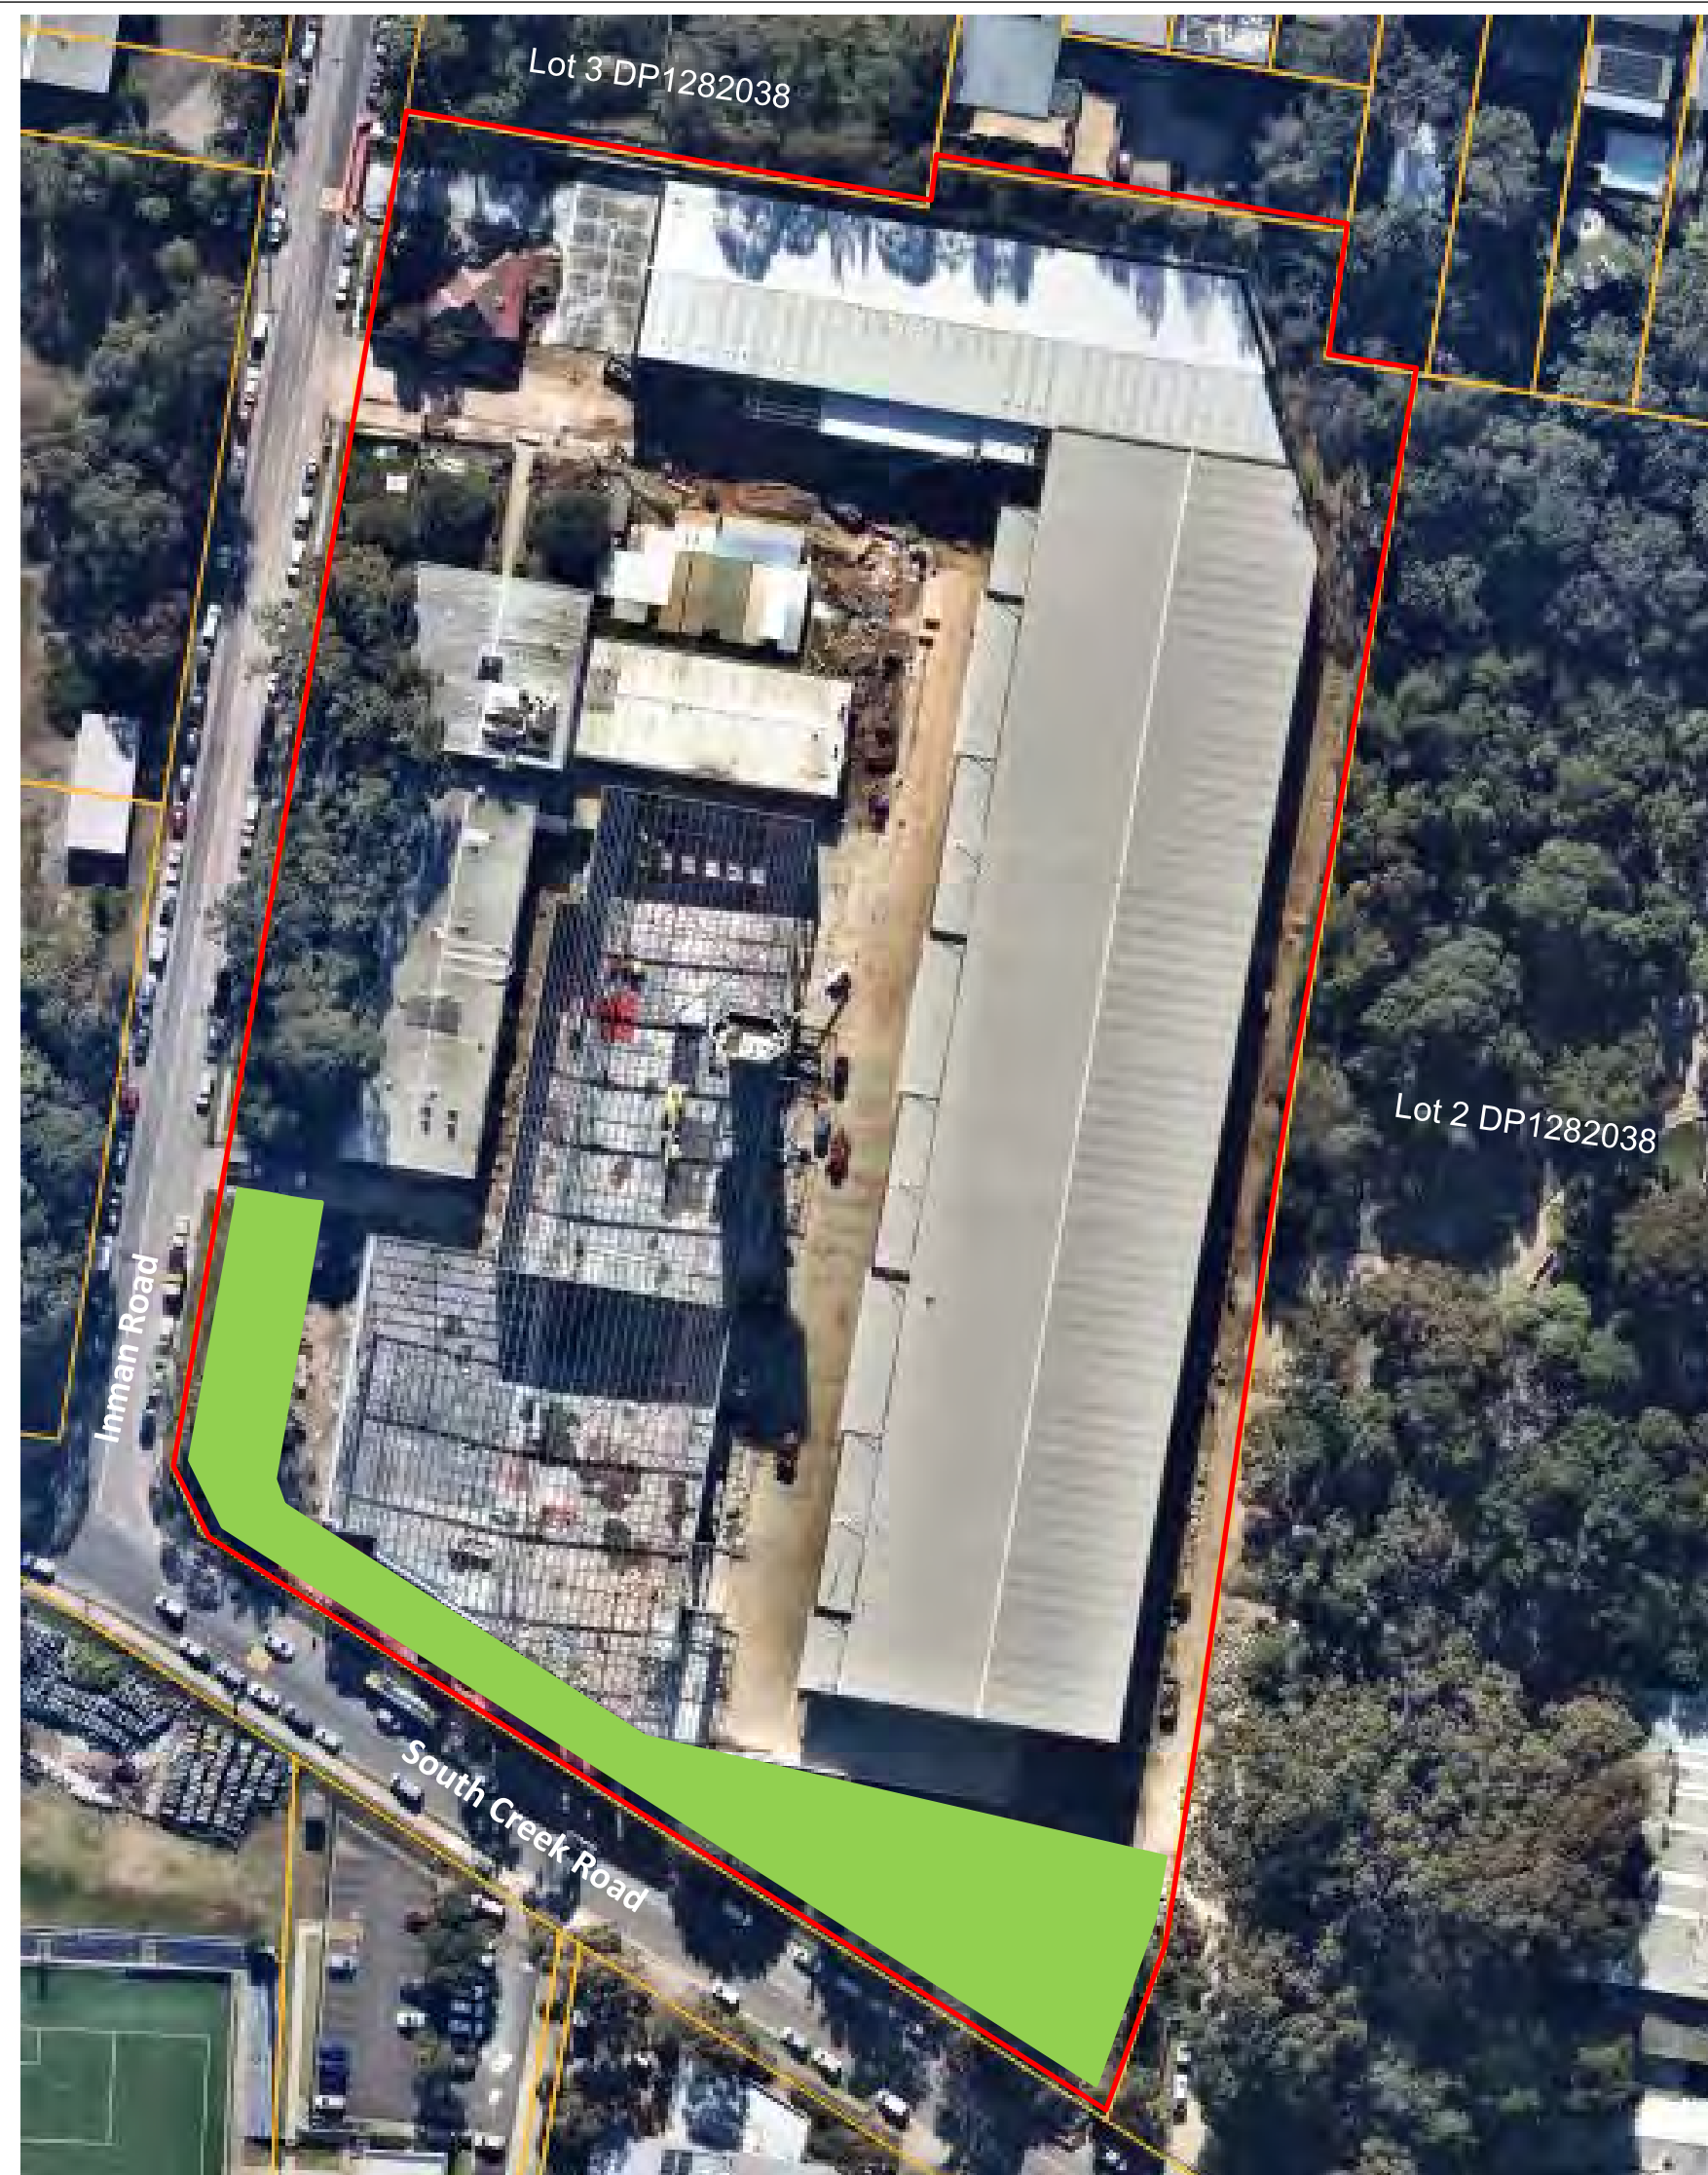
Boundary of Southern
Landscaping Area subject to
this LTEMP (refer to **Figure 3**)

Source: Nearmap

This EMP applies to a landscaping area located south of the on-site building along South Creek Road, herein referred to as 'the Southern Landscaping Area'. Historical environmental investigations conducted at this area of the site (refer to **Section 1.1** below) noted asbestos fragments within shallow fill soil, and this EMP outlines the ongoing management requirements relating to these materials. The area subject to this EMP is shown in **Figure 3** and in survey diagrams provided in **Appendix A**.

- 200mm of sandy soil with vegetative ground cover overlying an orange geotextile marker layer. This system overlies the asbestos impacted sandy fill material; and
- Concrete capping at two driveway areas (shown on **Figure 3**). This includes construction of a concrete surface over 100mm thickness of roadbase overlying an orange geotextile marker layer. This system overlies the asbestos impacted sandy fill material.

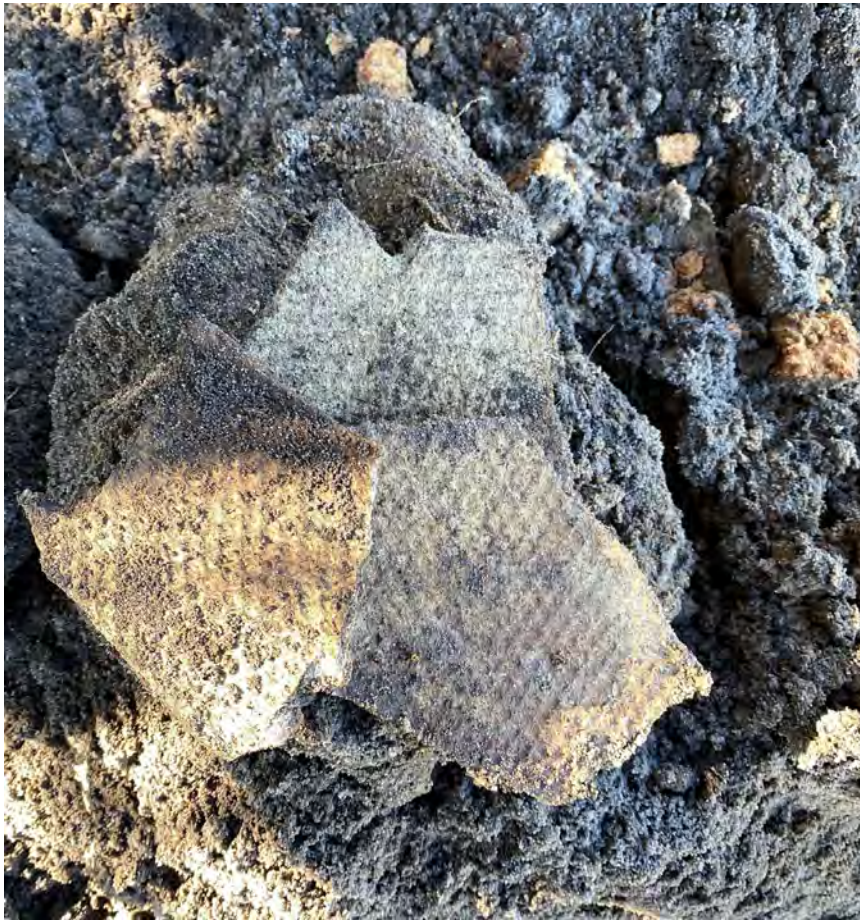
Photograph 1: Typical ACM fragment

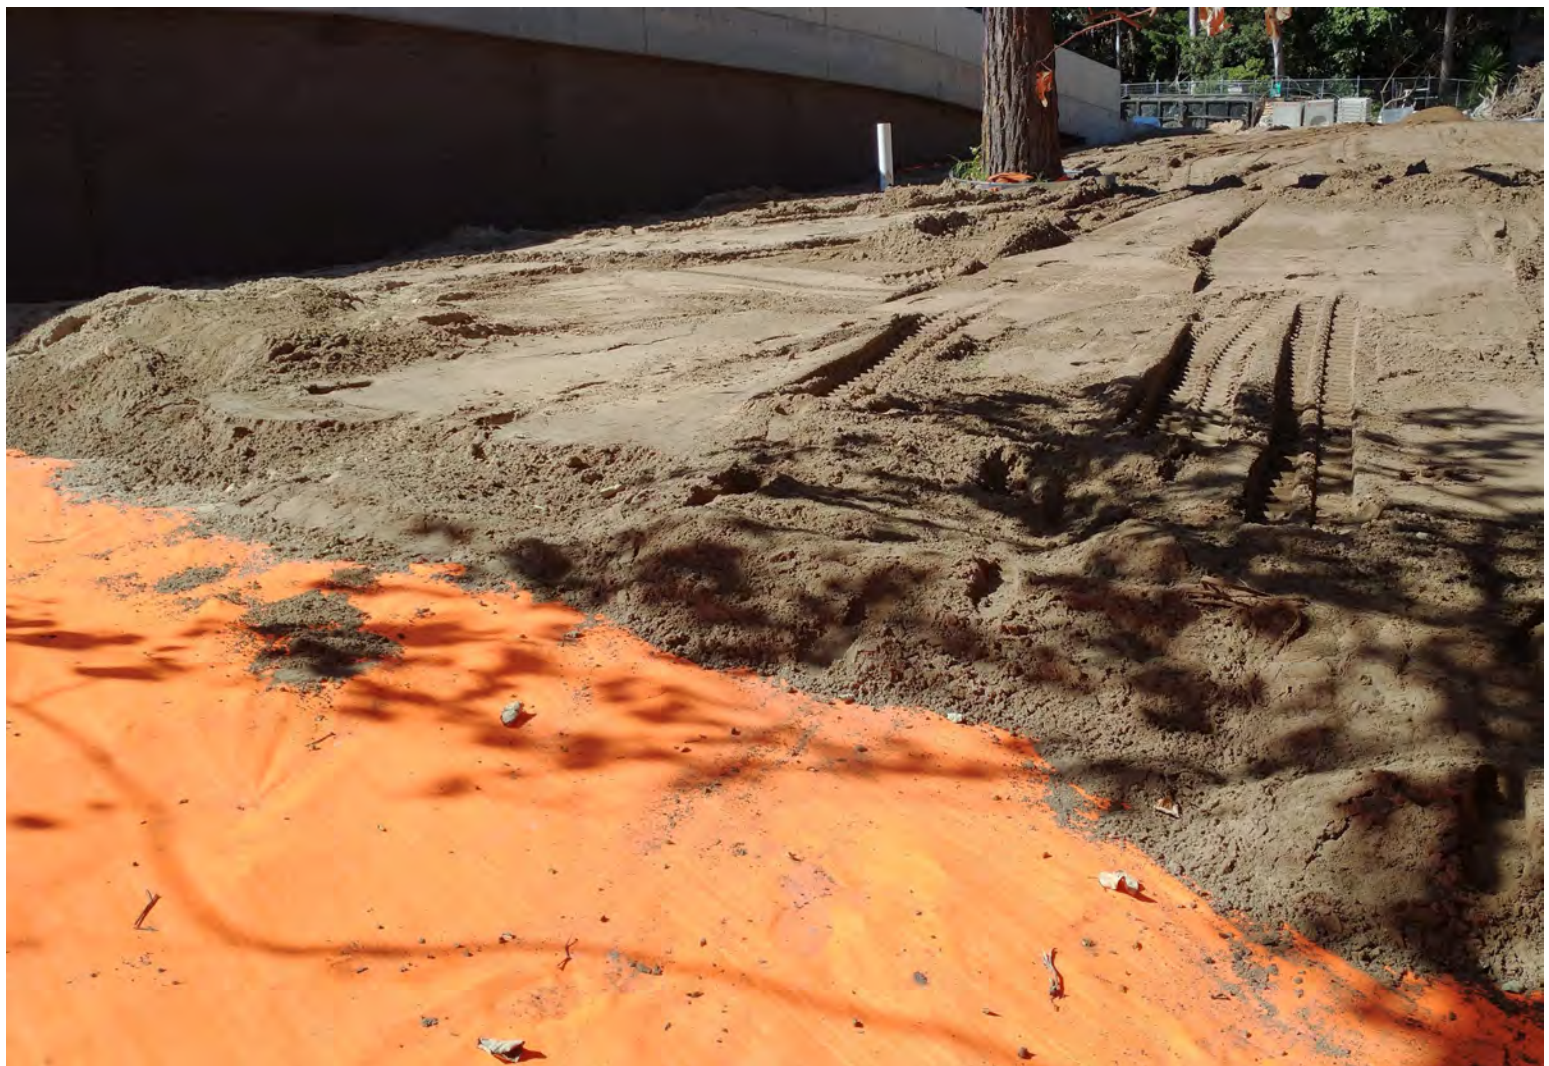
Photograph 2: View of orange marker layer during construction of capping.

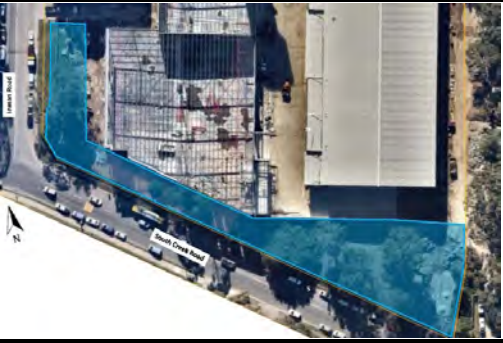
Occurrence Details	Type of Material (Identified/Assumed)	Is Asbestos Friable or Non-Friable?	Feature/Location of identified or assumed asbestos	Sample ID	Sample Status	Condition of Asbestos	Recommendations & Comments	Location Diagram
Inspection date: 30/8/23	Asbestos fragments (ACM) in soil	May contain Friable Asbestos (FA) or Asbestos Fines (AF) associated with degraded ACM fragments	Soil - Beneath capping at Southern Landscaping Area (per figure at right)	N/A	N/A	Presumed to be poor	Maintain vegetative ground cover in vegetated areas per EMP Maintain concrete capping in driveways per EMP

Management of the asbestos as contained at the 'Southern Landscaping Area' (per the figure) is managed in accordance with the *Long-Term Environmental Management Plan - Southern Landscaping Area, Northern Beaches Business Park, 4-8 Inman Road, Cromer, NSW*, prepared by TRACE Environmental, dated 15 September 2023.
