ACID SULPHATE SOIL ASSESSMENT & MANAGEMENT PLAN

RESIDENTIAL DEVELOPMENT

Lots 1-11 43-45 & 49 Warriewood Road Warriewood NSW

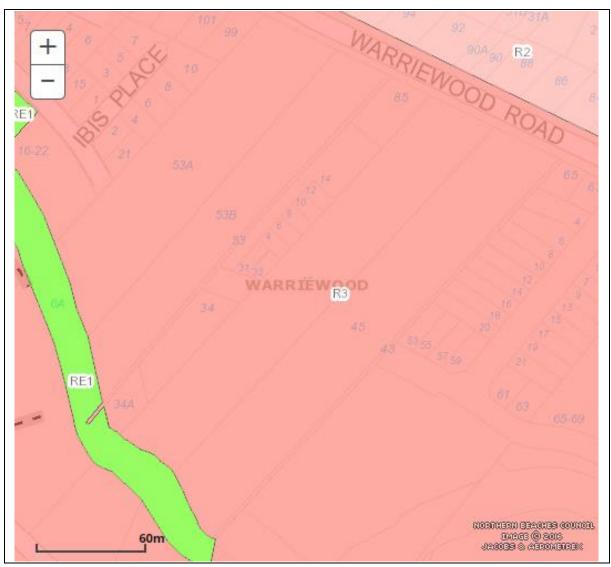
Figure 1.3 - Land Zoning Diagram

The zoning of the proposed development site, and surrounding properties, is shown in Figure 1.3, below.

The site is shown at the approximate centre of Figure 1.9 and is zoned R3 Medium Density Residential.

Immediate surrounding land is also zoned R3 Medium Density Residential, with R2 low density residential land present on the opposite (northern) side of Warriewood Road, and a strip of public recreation land along the creek line bordering the site to the south.

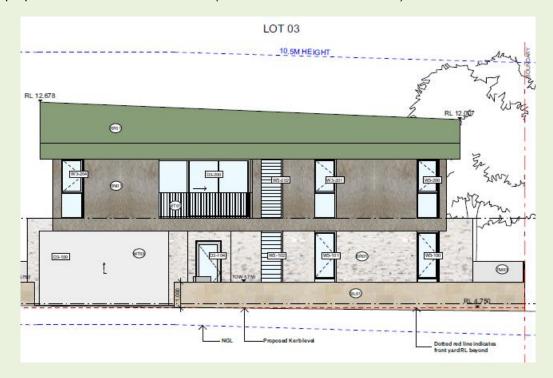
For the five development Lots in the Class 4 ASS area, typical construction levels are indicated by the proposed central or Lot 3 elevation (as viewed from Lorikeet Grove) shown below:

Natural ground level is indicated by the dotted blue line.

It can be seen that the five proposed residential developments along the Lorikeet Grove boundary will be constructed above the natural ground level, and construction is not proposed to involve excavation works that would intersect the [possible ASS risk depth, which for a Class 4 ASS area is defined as 2 metres or more below the natural ground level.

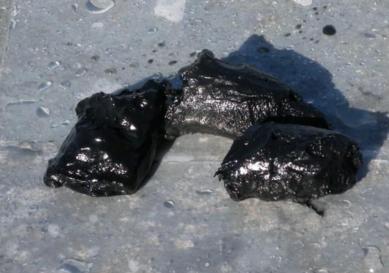
Figure 2 - Black oily appearance of MBO gel collected from the Peel region, Western Australia.

The environmental setting of the sediments may also indicate the likelihood of the presence of MBOs. Monosulfidic black oozes accumulate in large quantities in locations with the appropriate conditions for their formation, including waterways affected by one or a combination of ASS materials, eutrophication or salinisation. These sites are usually dominated by low velocity flow conditions where there is an abundant supply of organic matter, iron and sulfate. Recent research by Wong et al. (2016) indicates accumulation of sulfidic materials (including monosulfidic materials) occurs preferentially downstream of channel obstructions, such as submerged logs or in scour pools. The accumulation of these MBOs was not limited to lower energy parts of the channel as would be expected for fine-grained organic sediments.
