SITE HYDROGEOLOGY REPORT

**4 DELMAR PARADE &
812 PITTWATER ROAD,
DEE WHY NSW**

Reference: P3018_07 rev1

2 May 2024

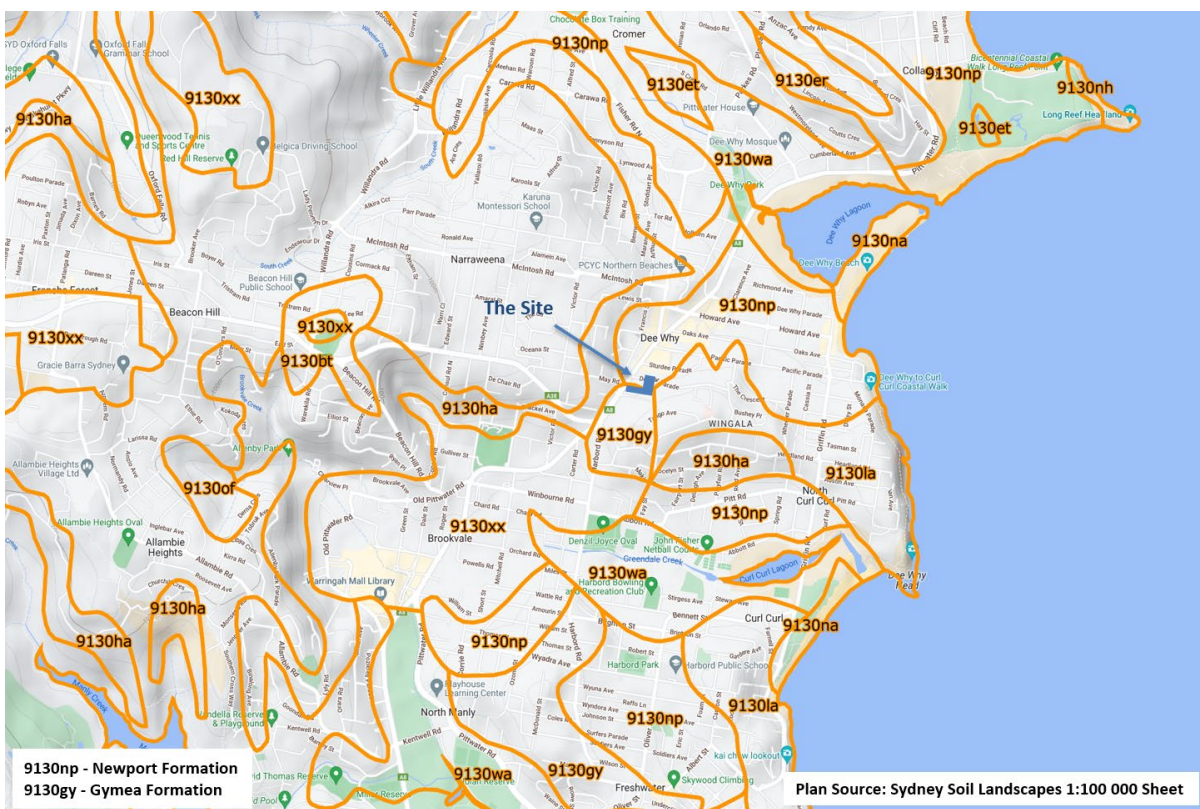
Figure 2: Soil Landscapes taken from Sydney 1:100,000 Soil Landscape Sheet

The Gymea landscape type typically includes undulating to rolling rises and low hills on Hawkesbury Sandstone. Soils are generally shallow to moderately deep (0.3 – 1 m) yellow earths and earthy sands. These soils are noted to present localized steep slopes, high soil erosion hazard, rock outcrop and shallow highly permeable soil.

The Newport landscape type typically includes gently undulating plains of Holocene sands to rolling rises over other soils or bedrock. Soils are generally shallow (<0.5 m) siliceous sands overlaying moderately deep buried sands (< 1.5m) yellow podzolic soil with sandy topsoil on crests and deep (> 2.0m) podzols in depressions earthy sands. These soils are noted present high soil erosion hazards, localized steep slopes, very low soil fertility and non-cohesive topsoil.

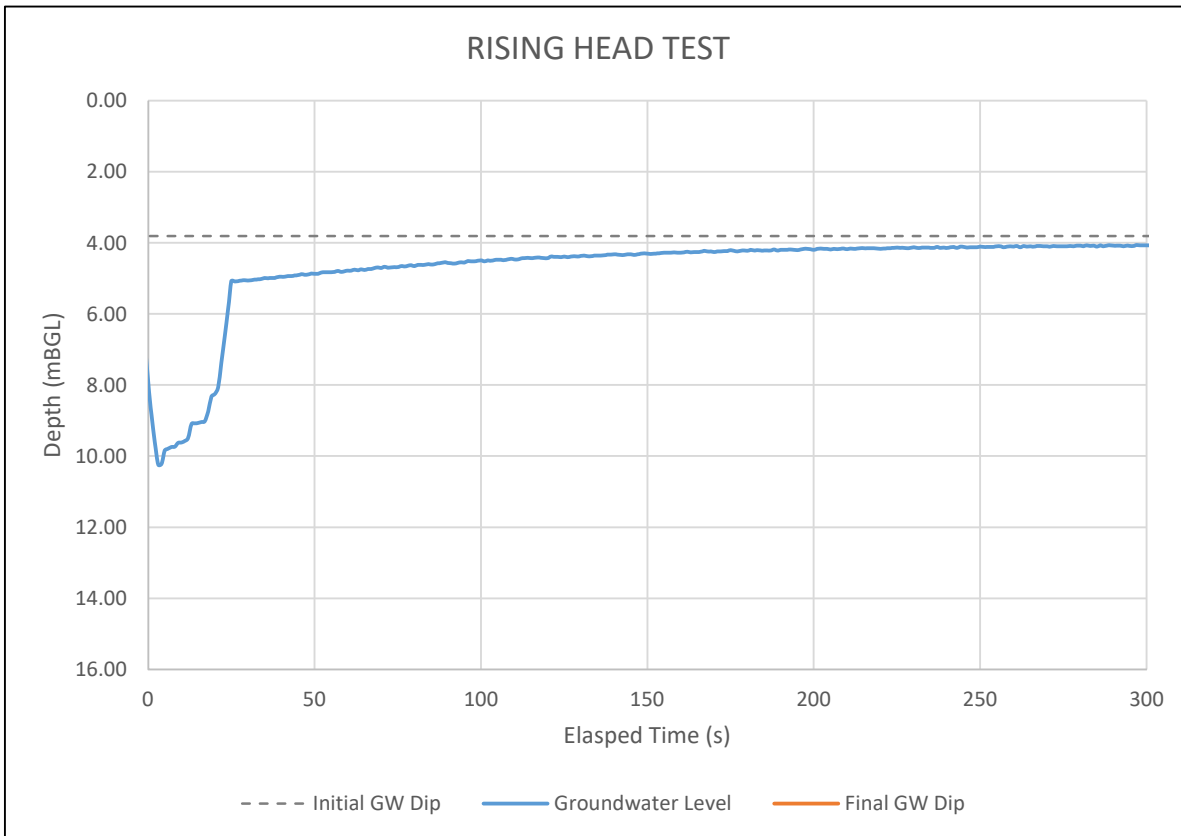
Time (t1) (s)	20
Time (t2) (s)	26
Initial Head (H1) at (t1)	8.26
Final Head (H2) at (t2)	5.08
Length of Response Zone (L)	1.25
Cross Sectional Area (A)	0.0038

Stratigraphy Description: **Fill and Alluvial Soil over Sandstone and Shale bedrock**

$$\text{Intake Factor (F) Case D} = \frac{2pL}{\log_e [(L/D) + \sqrt{1 + (L/D)^2}]} = \frac{7.85}{3.58} = 2.20$$

$$\text{Permeability (k)} = \frac{A}{F(t_2 - t_1)} \log_e \frac{H_1}{H_2} = 1.42E-04 \text{ m/s}$$
