J2474. 19th November, 2019. Page 1.

GEOTECHNICAL INVESTIGATION:

Alterations and Additions at 55 Tasman Rd, Avalon

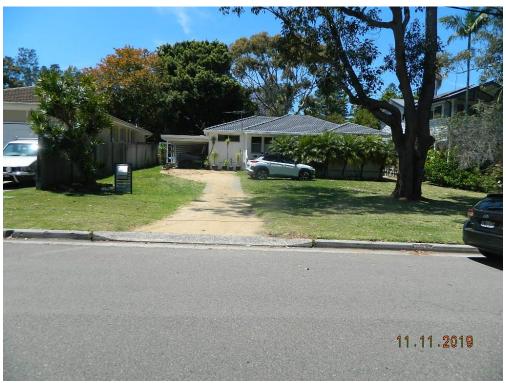
Photo 1

- **2.1** The site was inspected on the 11th November, 2019.
- 2.2 This residential property is on the high side of the road and has an E aspect. It is located on the gently graded lower reaches of a hillslope. The natural slope rises along the property at angles of <5°. The slope above and below the property continues at similar angles.
- 2.3 Between the road frontage and the house is a gently sloping lawn and gravel driveway (photo 1). The single-storey brick and timber clad house (photo 2) is supported on brick piers that are in good condition and show no significant signs of movement (photo 3). A gently sloping lawn extends from the E side of the house to the E boundary (Photo 4).

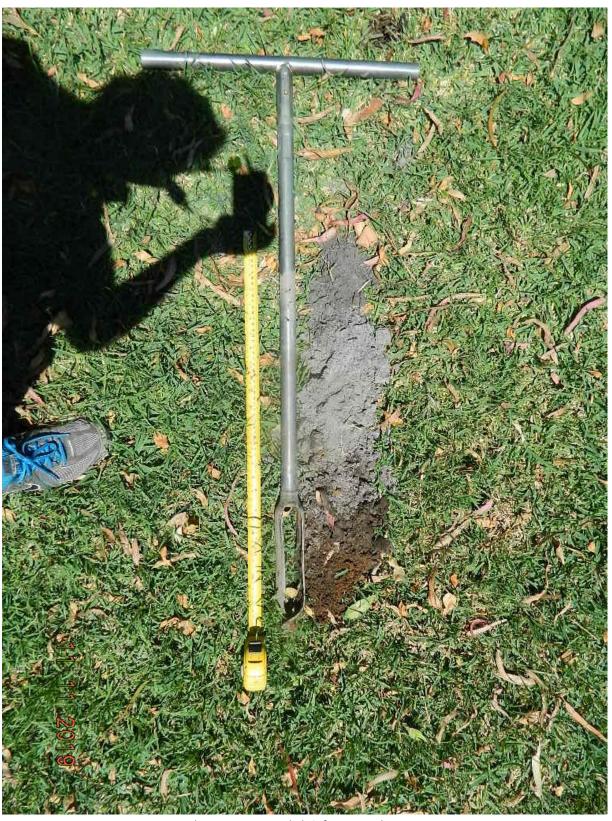
AUGER HOLE 1 – AH1 (~RL12.7) (Photo 5)

Depth (m)	Material Encountered
0.0 to 0.5	SILTY SAND, grey, fine to medium grained.
0.5 to 0.7	SAND, brown, fine to medium grained, dry.

End of hole @ 0.7m in sand. No watertable encountered.

Photo 5:AH1 – Downhole is from top to bottom.
