GEOTECHNICAL REPORT

Hills Marketplace Extension
287 Mona Vale Road
Terrey Hills NSW, 2084

Report reference: 2101129TRpt01FinalV03_24Nov23

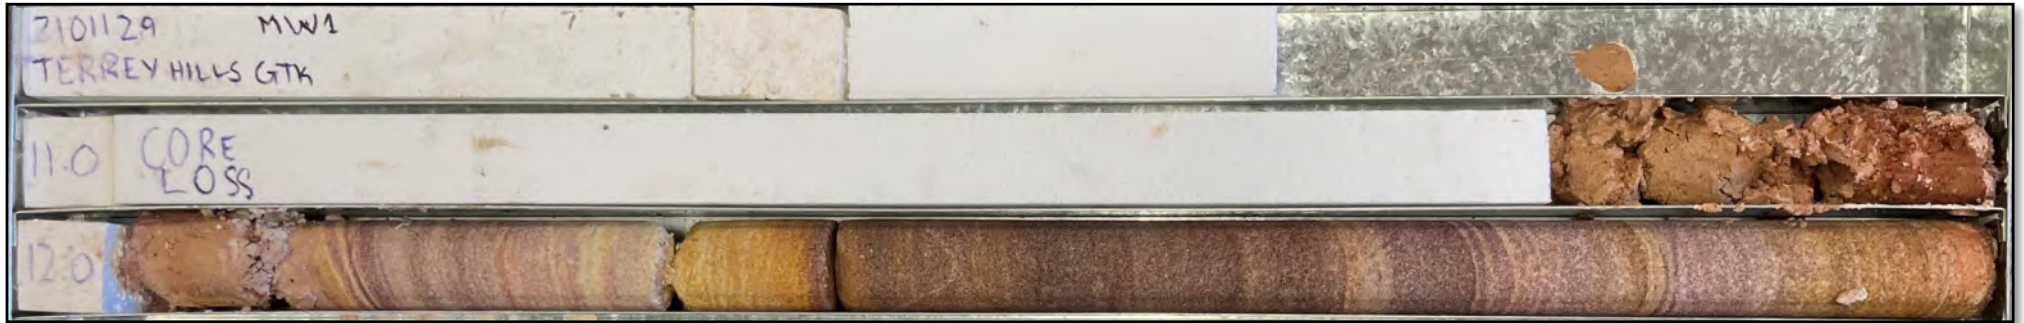
Borehole MW1 – NMLC coring completed from 11.00 to 13.00 mbg.

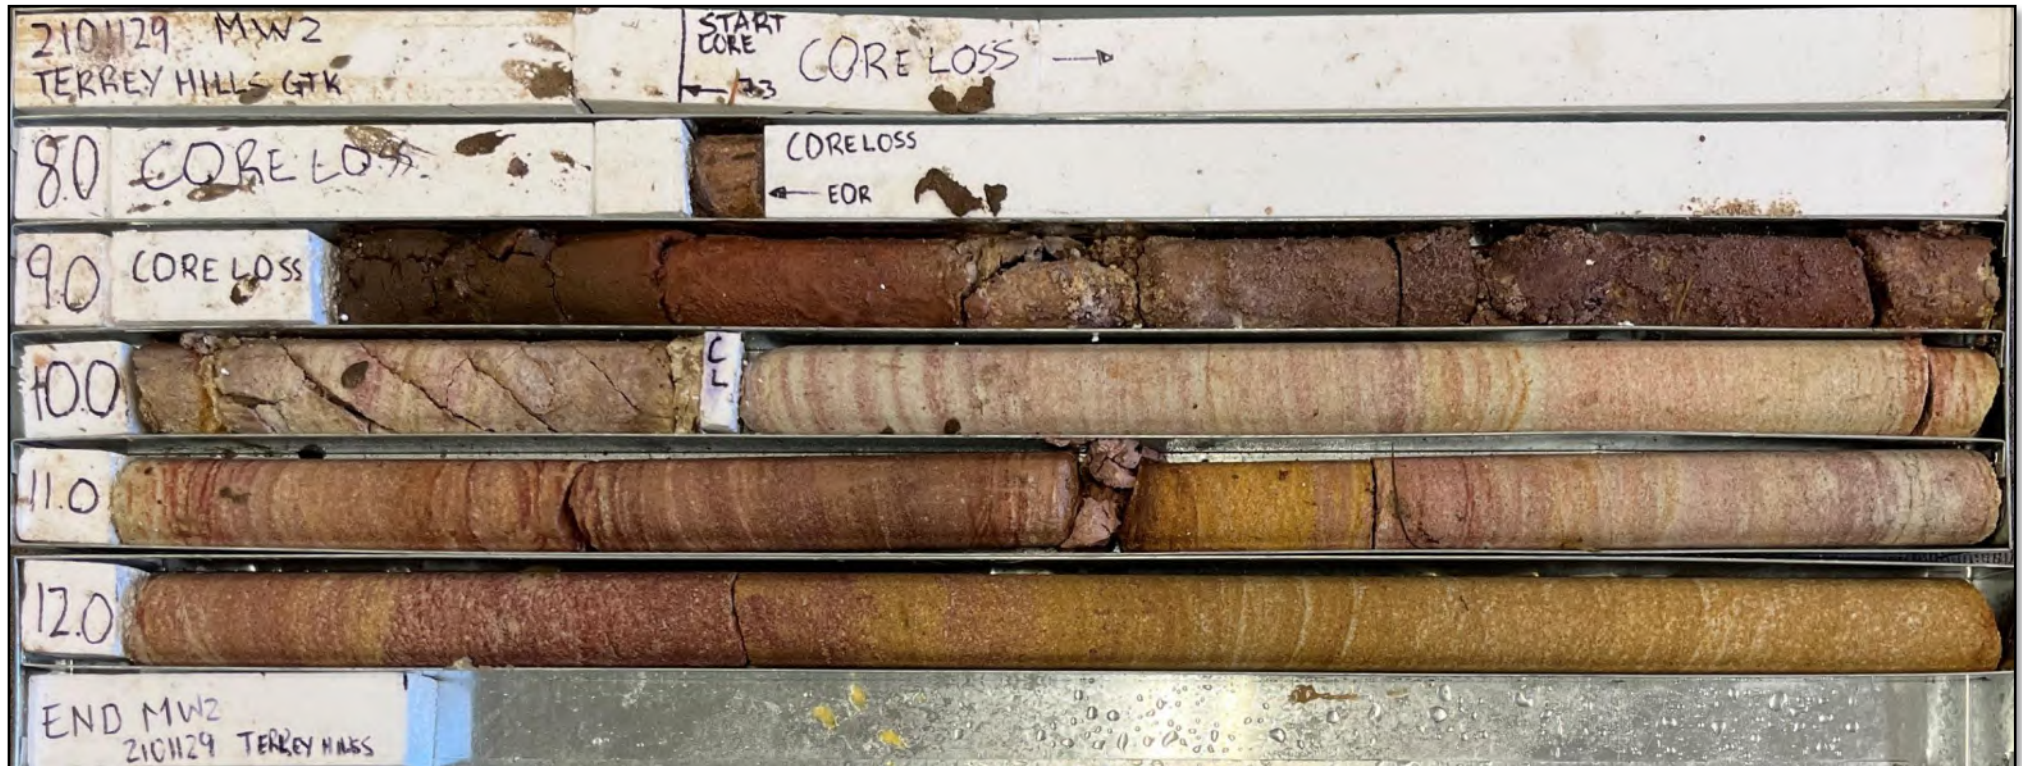
Borehole MW2 – NMLC coring completed from 7.30 to 13.00 mbg.

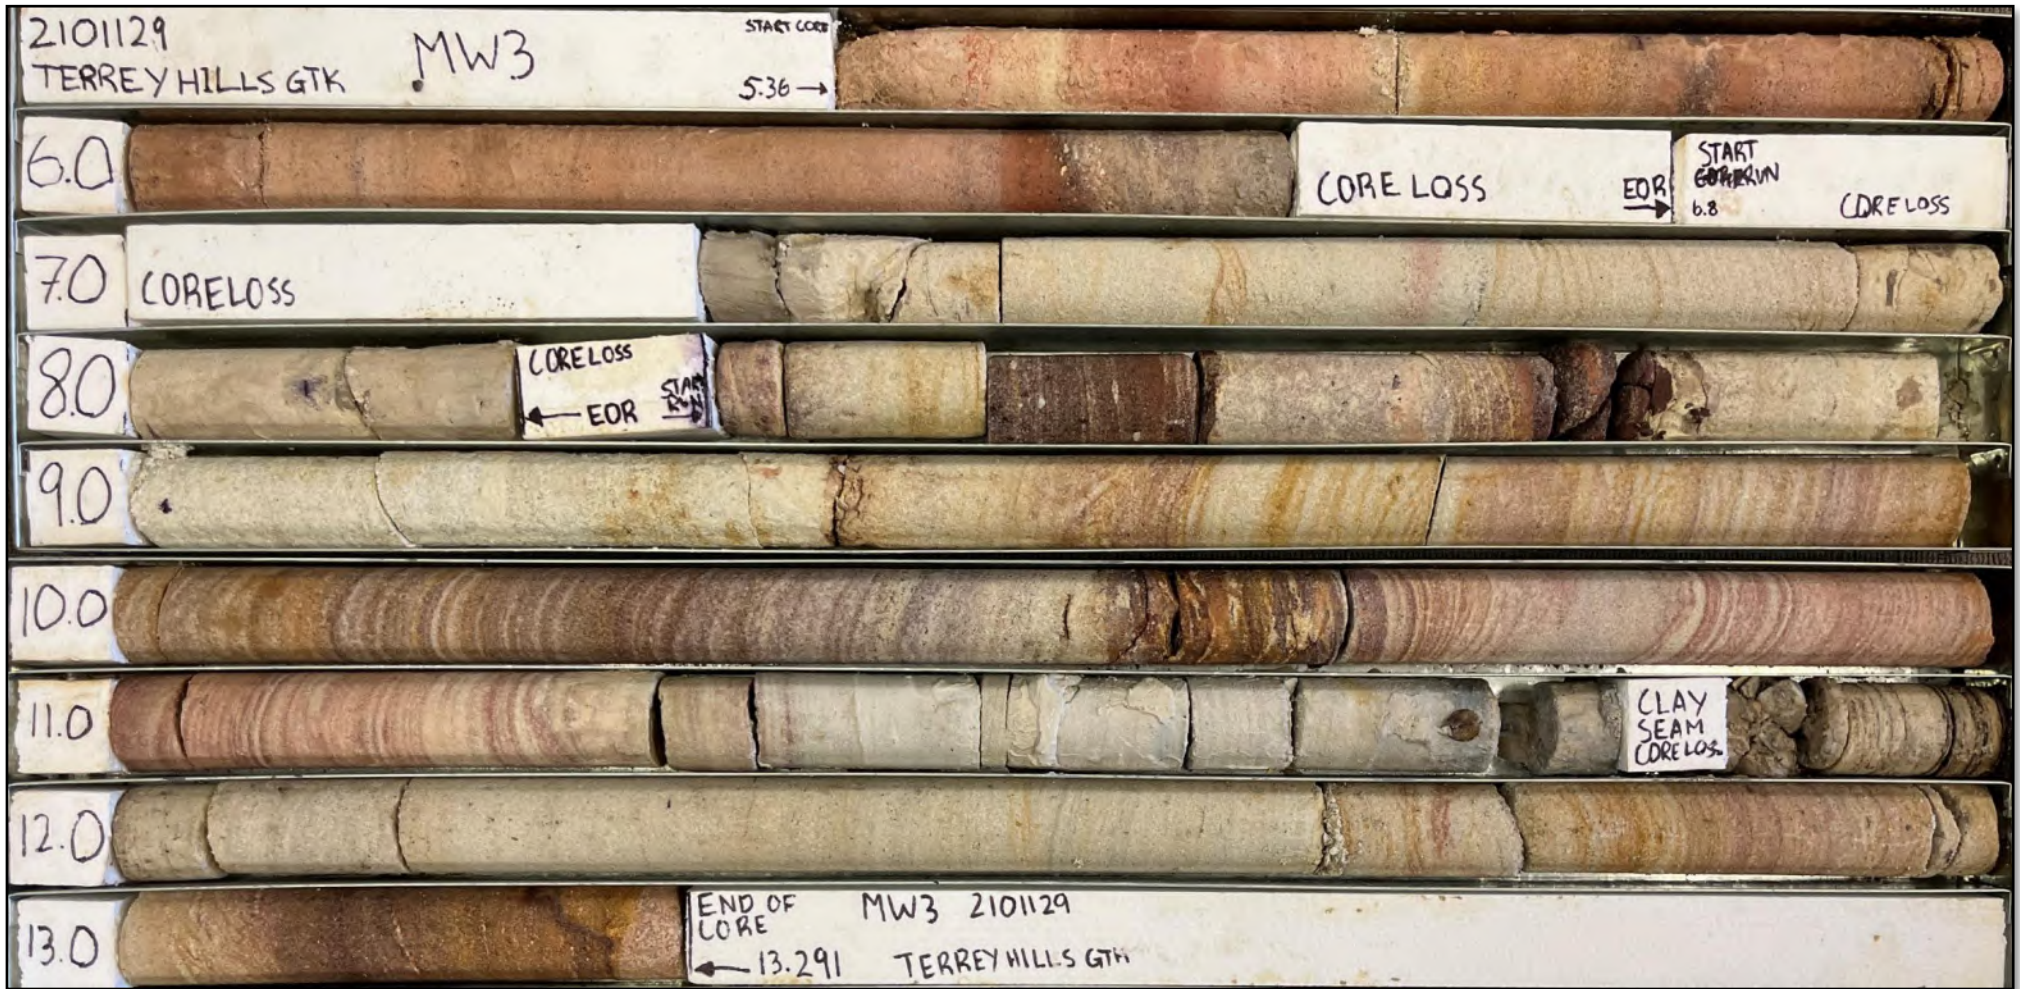
Borehole MW3 – NMLC coring completed from 5.36 to 13.29 mbg.

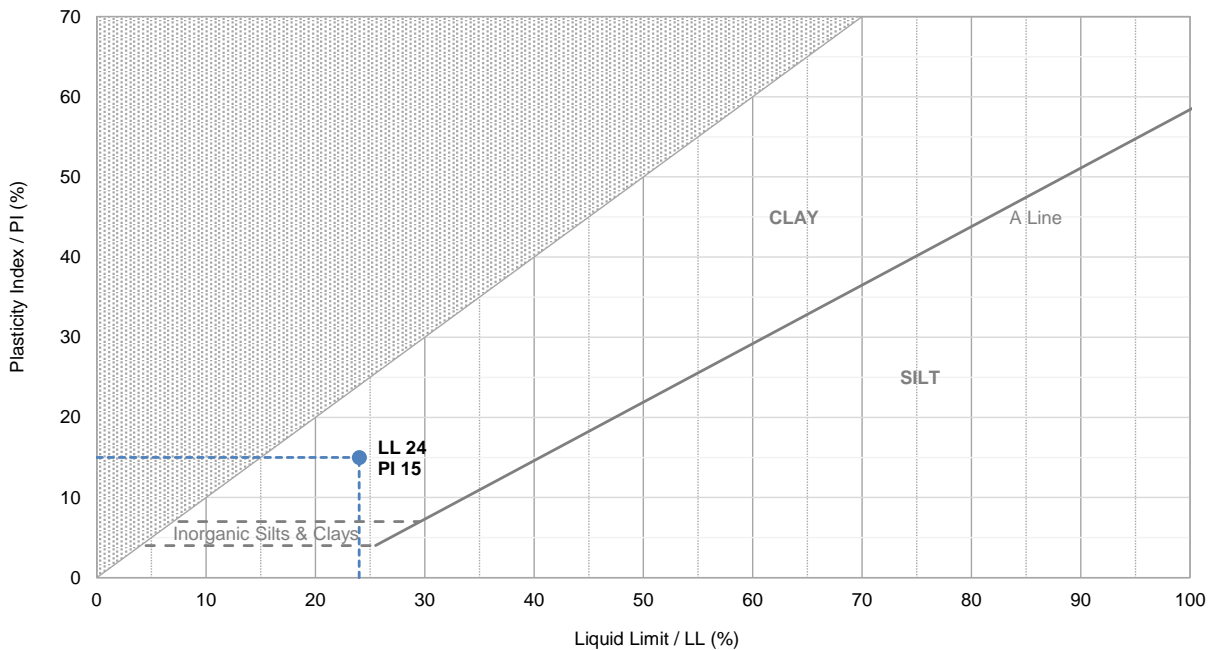
Plasticity Chart for Classification of Fine-Grained Soils
AS 1726:2017 Clause 6.1.6 (Figure 5)

Dry Sieved	24
Air Dried	9
	15
	3.5
	Linear

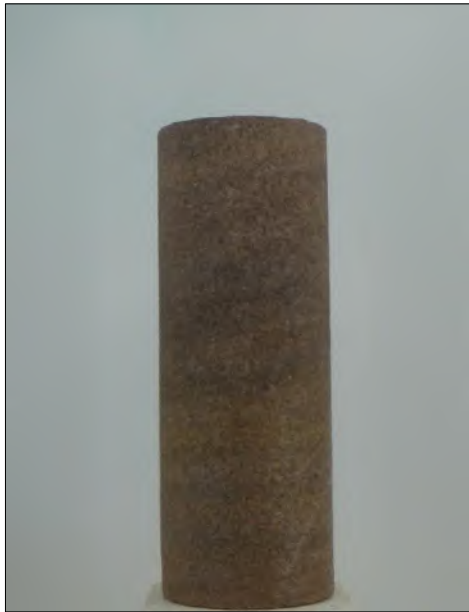
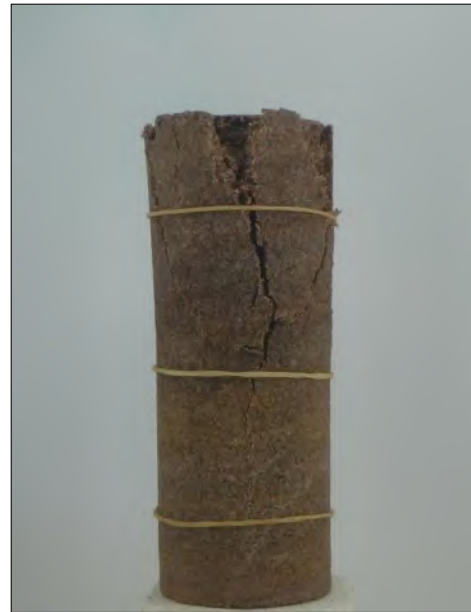
Client	Geo-Logix Pty Ltd	Sample Source	MW1 12.40-12.60m
Address	Building Q2, Level 3, 2309/4 Daydream St, Warriewood, NSW 2102	Sample Description	Sandstone
Project	Terry Hills (2101129)	Report No.	S76616-UCS
Job No.	S21598-1	Lab No.	S76616
Test Procedure	AS 4133.4.2.2 Determination of uniaxial compressive strength-Rock strength less than 50 MPa		
Testing Machine	Matest 2000 kN Compression Machine	Sample Curing	-
Sampling Method	Sampled by Client - results apply to the sample as received	Date Sampled	6/04/2022
Storage History	Core Box	Storage Environment	Sealed at as received moisture condition

Uniaxial Compressive Strength 22 MPa

Date Tested: 26/04/2022	Moisture Content: 8.0 %
Specimen Height: 146.8 mm	Duration of Test: 667 seconds
Average Specimen Diameter: 51.8 mm	Rate of Displacement: < 0.1 mm/min
Failure Type: Mixed mode	
Other Pertinent Observations:

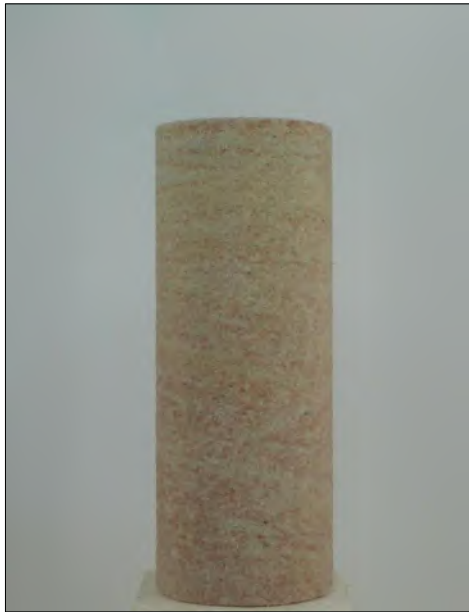
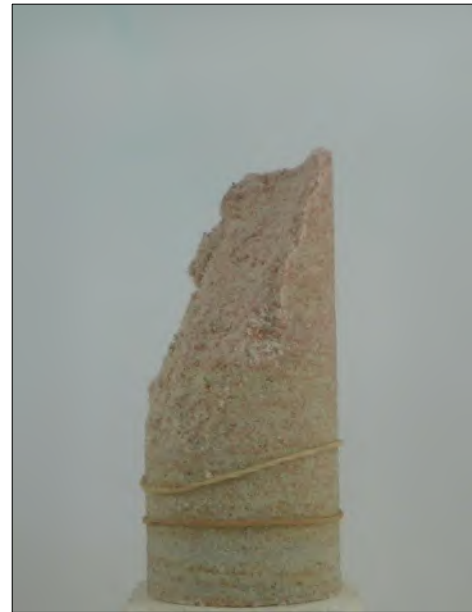
Client	Geo-Logix Pty Ltd	Sample Source	MW2 10.73-10.95m
Address	Building Q2, Level 3, 2309/4 Daydream St, Warriewood, NSW 2102	Sample Description	Sandstone
Project	Terry Hills (2101129)	Report No.	S76617-UCS
Job No.	S21598-1	Lab No.	S76617
Test Procedure	AS 4133.4.2.2 Determination of uniaxial compressive strength-Rock strength less than 50 MPa		
Testing Machine	Matest 2000 kN Compression Machine	Sample Curing	-
Sampling Method	Sampled by Client - results apply to the sample as received	Date Sampled	5/04/2022
Storage History	Core Box	Storage Environment	Sealed at as received moisture condition

Uniaxial Compressive Strength 9.8 MPa

Date Tested: 26/04/2022	Moisture Content: 10.5 %
Specimen Height: 147.1 mm	Duration of Test: 641 seconds
Average Specimen Diameter: 51.4 mm	Rate of Displacement: < 0.1 mm/min
Failure Type: Single shear plane	
Other Pertinent Observations:

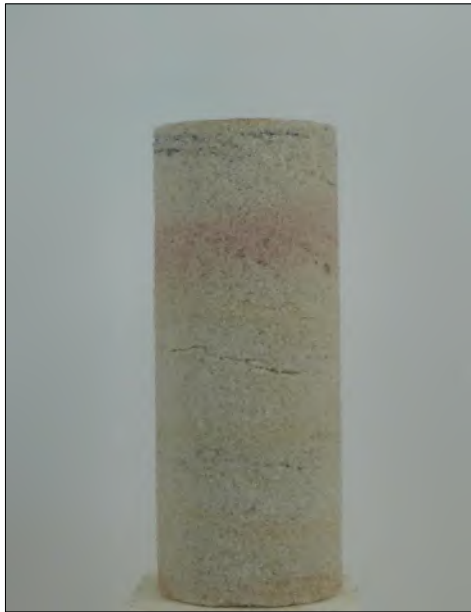
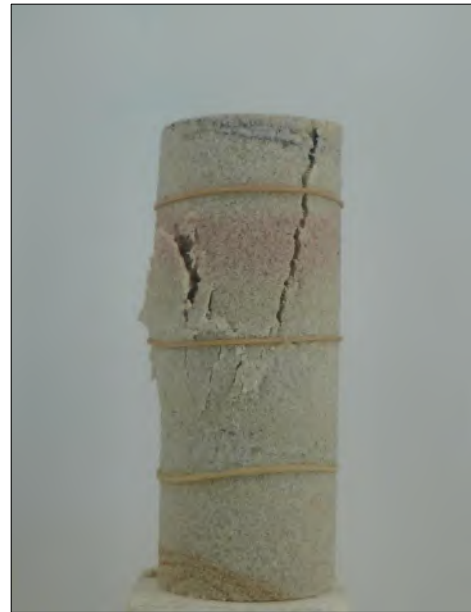
Client	Geo-Logix Pty Ltd	Sample Source	MW3 7.57-7.72m
Address	Building Q2, Level 3, 2309/4 Daydream St, Warriewood, NSW 2102	Sample Description	Sandstone
Project	Terry Hills (2101129)	Report No.	S76631-UCS
Job No.	S21598-1	Lab No.	S76631
Test Procedure	AS 4133.4.2.2 Determination of uniaxial compressive strength-Rock strength less than 50 MPa		
Testing Machine	Matest 2000 kN Compression Machine	Sample Curing	-
Sampling Method	Sampled by Client - results apply to the sample as received	Date Sampled	4/04/2022
Storage History	Core Box	Storage Environment	Sealed at as received moisture condition

Uniaxial Compressive Strength 3.7 MPa

Date Tested: 26/04/2022	Moisture Content: 11.2 %
Specimen Height: 139.8 mm	Duration of Test: 628 seconds
Average Specimen Diameter: 50.9 mm	Rate of Displacement: < 0.1 mm/min
Failure Type: Mixed mode	
Other Pertinent Observations:

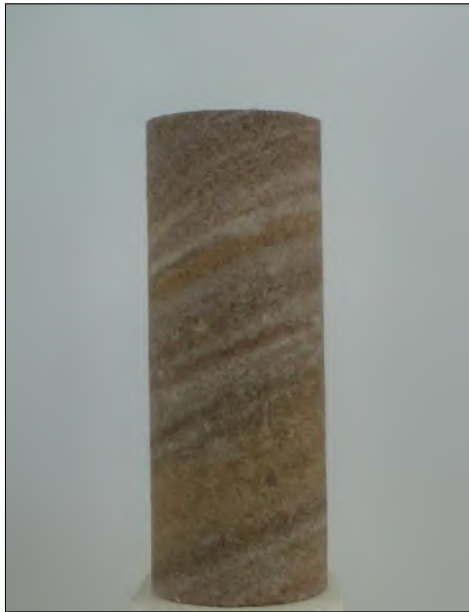
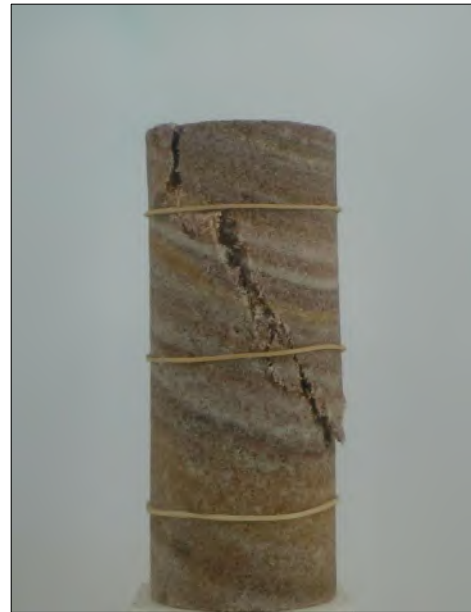
Client	Geo-Logix Pty Ltd	Sample Source	MW3 10.10-10.30m
Address	Building Q2, Level 3, 2309/4 Daydream St, Warriewood, NSW 2102	Sample Description	Sandstone
Project	Terry Hills (2101129)	Report No.	S76632-UCS
Job No.	S21598-1	Lab No.	S76632
Test Procedure	AS 4133.4.2.2 Determination of uniaxial compressive strength-Rock strength less than 50 MPa		
Testing Machine	Matest 2000 kN Compression Machine	Sample Curing	-
Sampling Method	Sampled by Client - results apply to the sample as received	Date Sampled	4/04/2022
Storage History	Core Box	Storage Environment	Sealed at as received moisture condition

Uniaxial Compressive Strength 21 MPa

Date Tested: 26/04/2022	Moisture Content: 7.9 %
Specimen Height: 146.8 mm	Duration of Test: 662 seconds
Average Specimen Diameter: 51.7 mm	Rate of Displacement: < 0.1 mm/min
Failure Type: Single shear plane	
Other Pertinent Observations:
