PRELIMINARY ASSESSMENT: Acid Sulfate

For New Garage and Driveway at **139 Lagoon St, Narrabeen**

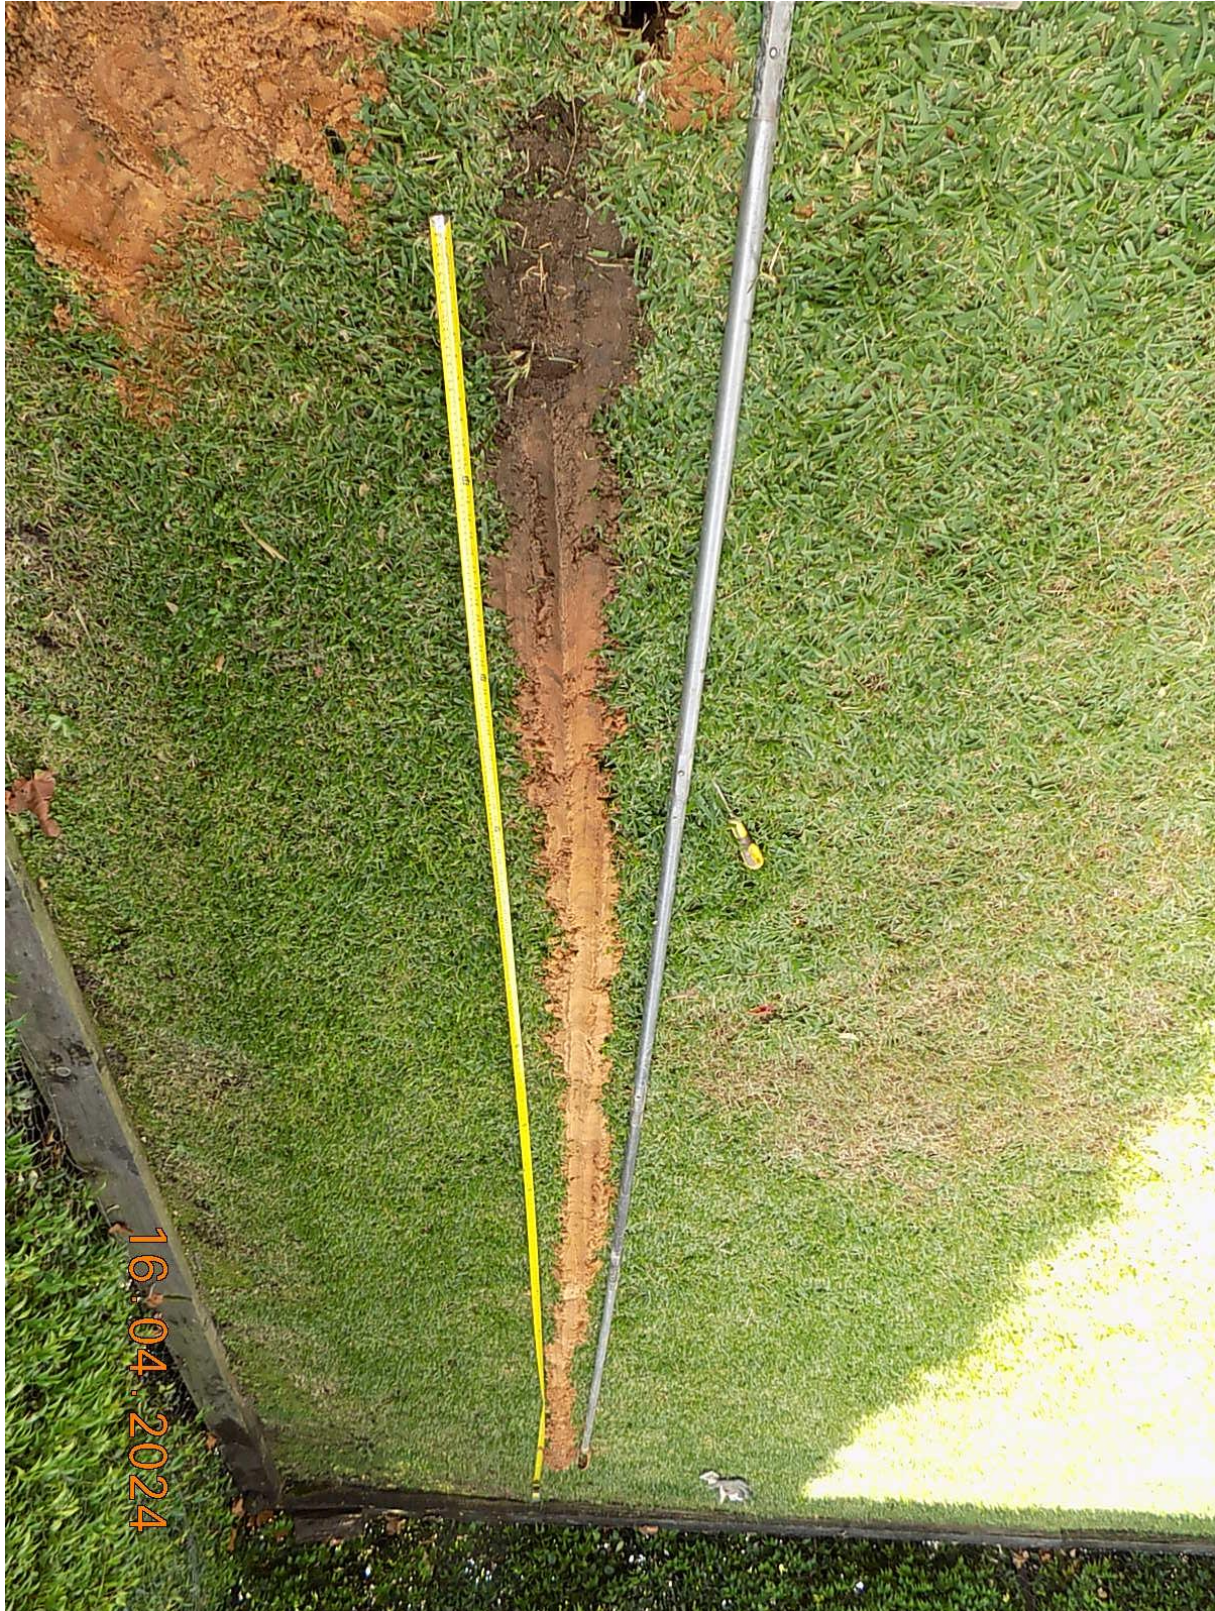
Photo 1: AH1 – Downhole is from top to bottom

AUGER HOLE 1 (~RL7.9) – AH1 (Photo 1)

Depth (m)	Material Encountered
0.0 to 0.2	SANDY FILL , dark brown, medium dense, dry, fine to coarse grained, rock fragments and fine organic material (roots) present.
0.2 to 0.5	LOAMY SAND , brown, medium dense, dry, medium grained, fine organic material (roots) present.
0.5 to 4.4	SAND , orange, orange brown, yellow brown, medium dense, dry to moist, medium grained.

End of hole @ 4.4m in Sand. No water table encountered.

TEST: AH1	FIELD pH & PEROXIDE RESULTS				
Sample depth (m)	pH _F	30% Peroxide reaction	pH _{FOX}	pH _F - pH _{FOX}	SS=Shell J=Jarosite R=Roots
0.2	7.4	M	7.1	0.3	R
0.5	7.4	M	7.1	0.3	R
1.0	7.3	M	7.1	0.2	-
1.5	7.3	M	7.1	0.2	-
2.0	7.3	M	7.2	0.1	-
2.5	7.3	M	7.3	0	-
3.0	7.4	M	7.3	0.1	-
3.5	7.5	M	7.4	0.1	-
4.0	7.7	M	7.6	0.1	-
4.4	7.9	M	7.9	0	-

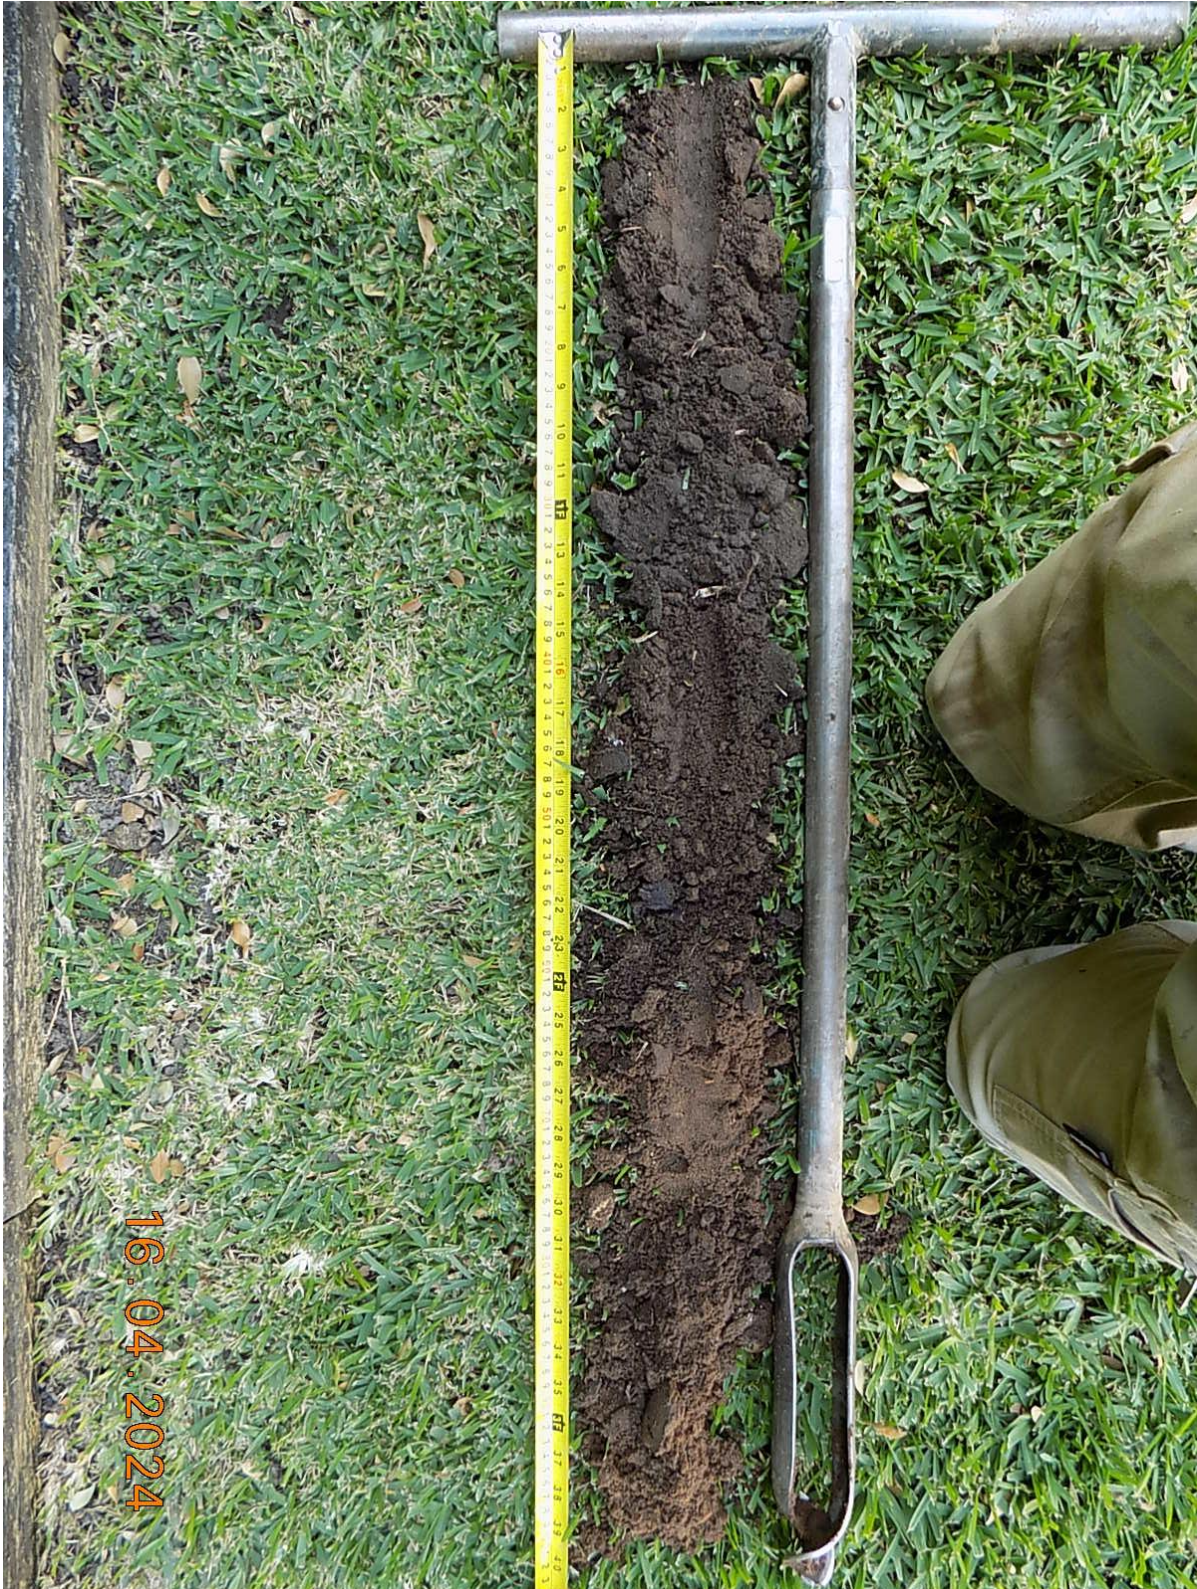
Photo 3: AH3 – Downhole is from top to bottom

AUGER HOLE 3 (~RL7.8) – AH3 (Photo 3)

Depth (m)	Material Encountered
0.0 to 0.6	SANDY FILL , dark brown, medium dense, dry, fine to coarse grained, rock fragments and fine organic material (roots) present.
0.6 to 1.0	LOAMY SAND , brown, medium dense, dry, medium grained, fine organic material (roots) present.

End of hole @ 1.0m in Loamy Sand. No water table encountered.

TEST: AH3	FIELD pH & PEROXIDE RESULTS				
Sample depth (m)	pH _F	30% Peroxide reaction	pH _{FOX}	pH _F - pH _{FOX}	SS=Shell J=Jarosite R=Roots
0.5	6.4	H	6.3	0.1	R
1.0	7.0	M	6.9	0.1	R

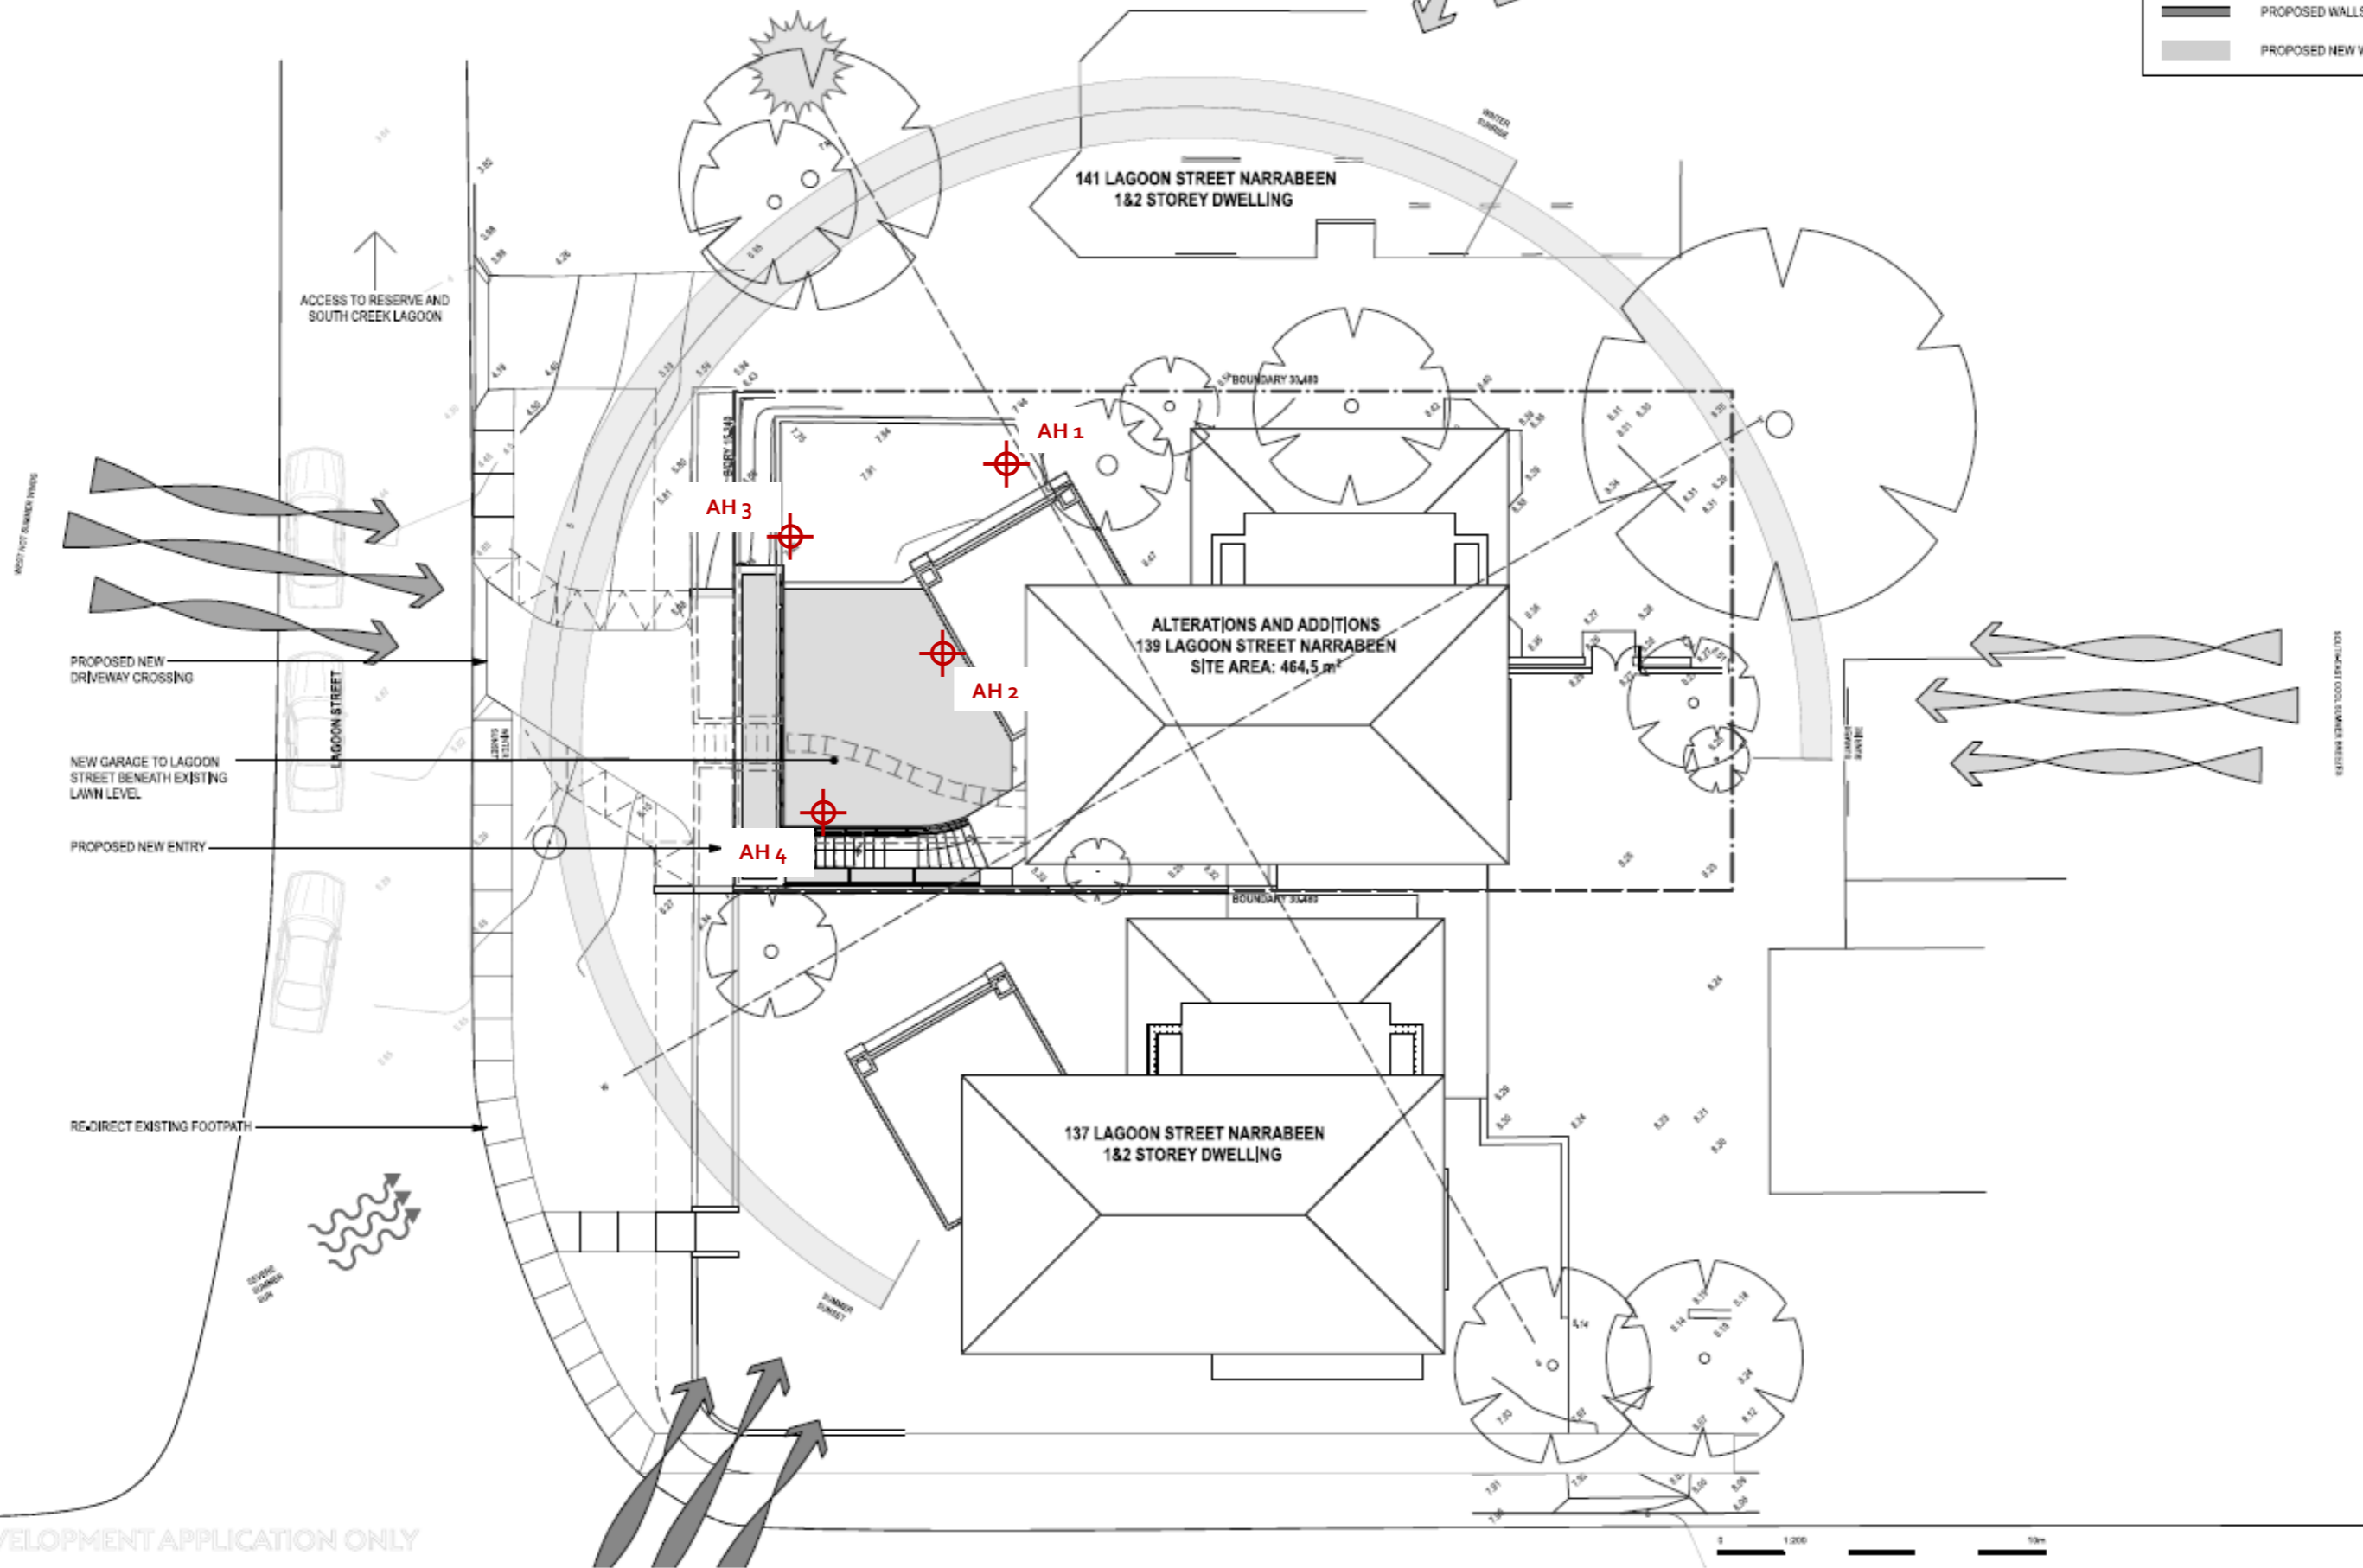
SITE PLAN – showing test locations

Four hand Auger Holes (AH) were put down in the locations shown on the site plan attached. Field pH and peroxide testing was carried out on samples taken from the auger holes at regular intervals. The logs of the auger holes and the test results are as follows. The soil reaction rating scale for the pHFOX test is shown in Appendix 1.
