Due Diligence Environmental Site Assessment

40 Myoora Road, Terrey Hills NSW

Prepared for Isaac Property

21 January 2022

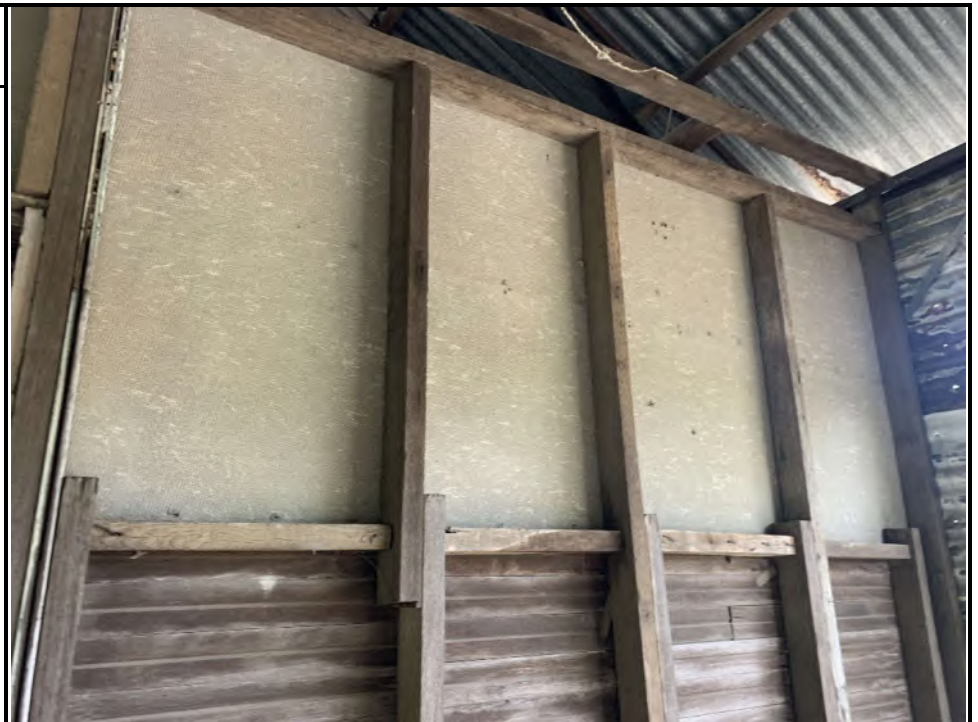
Photo No.	Date
2	16.12.21
Description: ACM fibre cement sheeting in the storage building/shed in the south-east of the site.

- Preparation and implementation of a RAP to address the identified asbestos in soil contamination.
- Preparation of an interim site management plan (ISMP) to appropriately manage human health risks posed by the identified asbestos in soil contamination on site prior to site remediation works.
- Development of an Asbestos Management Plan (AMP) and asbestos register for the site to comply with WHS Regulation (2017) when the site becomes a 'workplace' (i.e. during any excavation and construction).
- Completion of a Hazardous Materials Survey of on site buildings before commencement of demolition works.
- Classification of all materials requiring removal from the site for the proposed development in accordance with NSW EPA (2014) Waste Classification Guidelines.

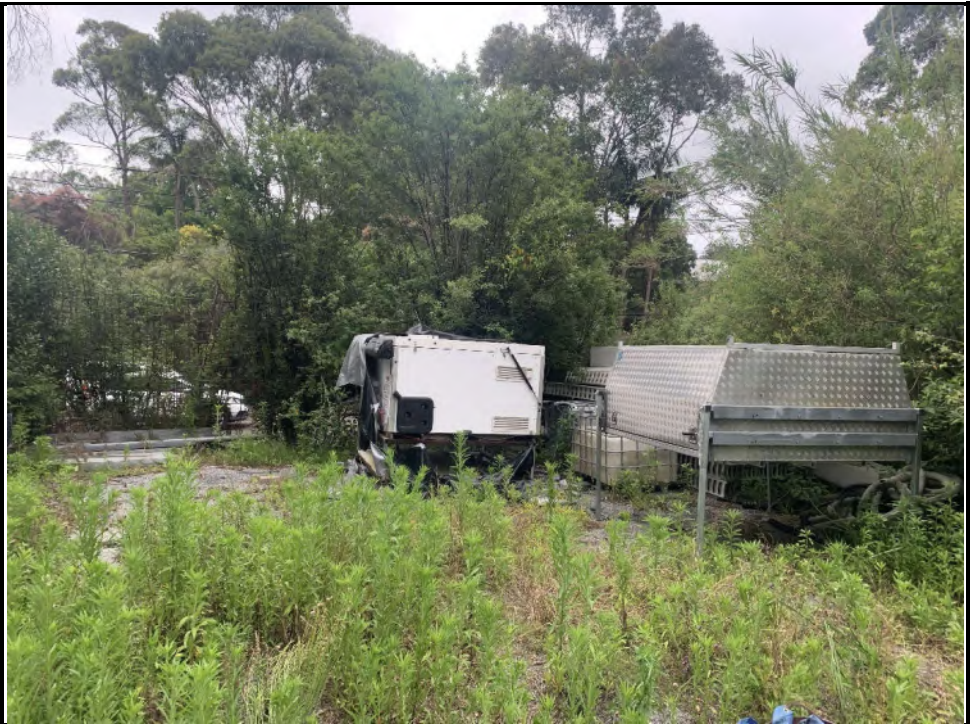
Photo No.	Date
5	16.12.21
Description: Stored items and empty IBC in the north-west of the site.

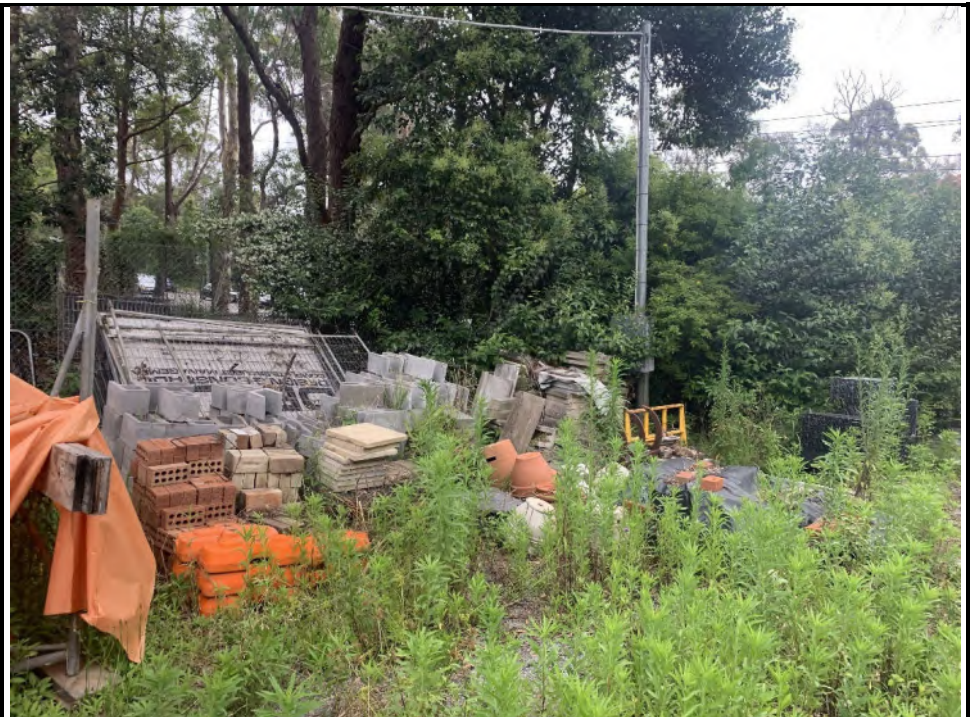
Photo No.	Date
6	16.12.21
Description: Stored building and construction materials in the north-west of the site.

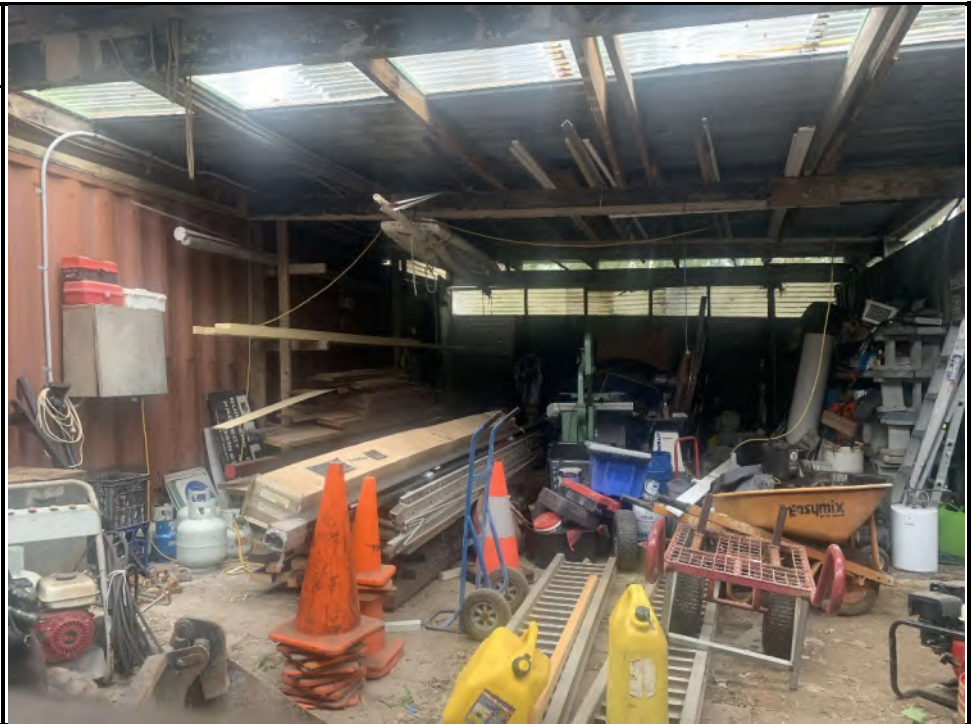
Photo No.	Date
7	16.12.21
Description: Stored machinery, parts, LPG gas cylinders, oil cans and materials in the north-west of the site.

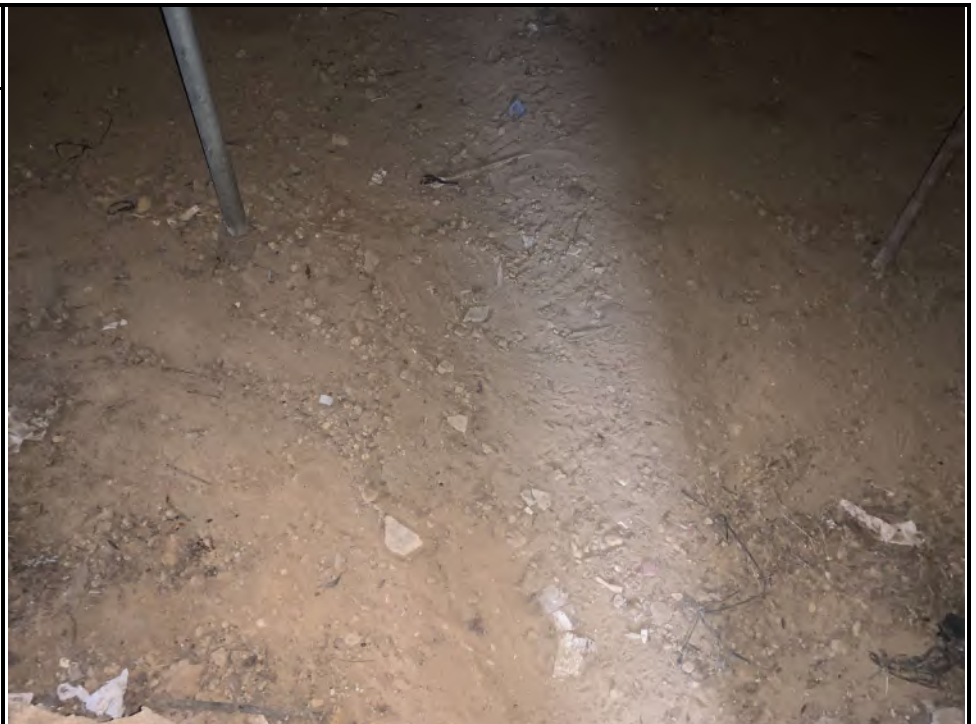
Visible signs of contamination observed on site during the assessment performed by Reditus on 16th December 2021 included asbestos containing fibre cement sheeting debris on the soil surface within the sub-floor space of the residential dwelling and in two (2) test pits within shallow (<0.3m depth) fill in the centre of the site.

Photo No.	Date
8	16.12.21
Description: Bonded ACM fibre cement debris on the soil surface within the residential building sub-floor space.

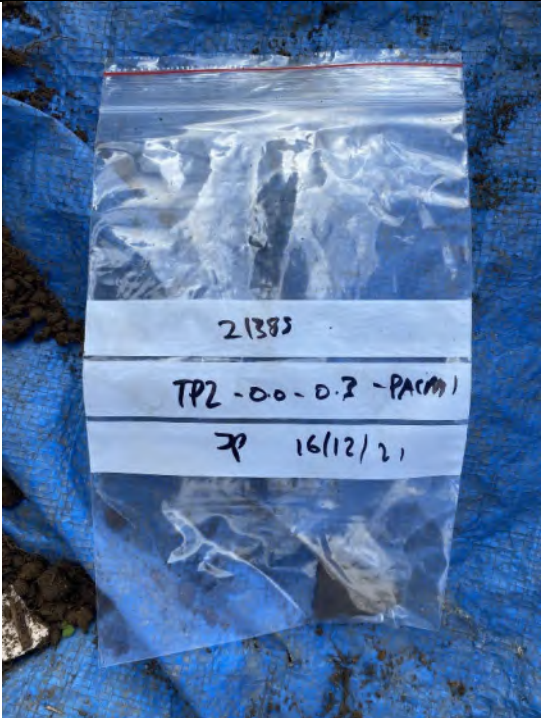
- Bonded ACM fragments were observed during 10L field screening of soils in TP02 and TP04 at depths of up to 0.3mbgl within fill materials at concentrations

Photo No.	Date	
9	16.12.21	
Description: ACM fragment collected with 10L field screening sample in TP02.

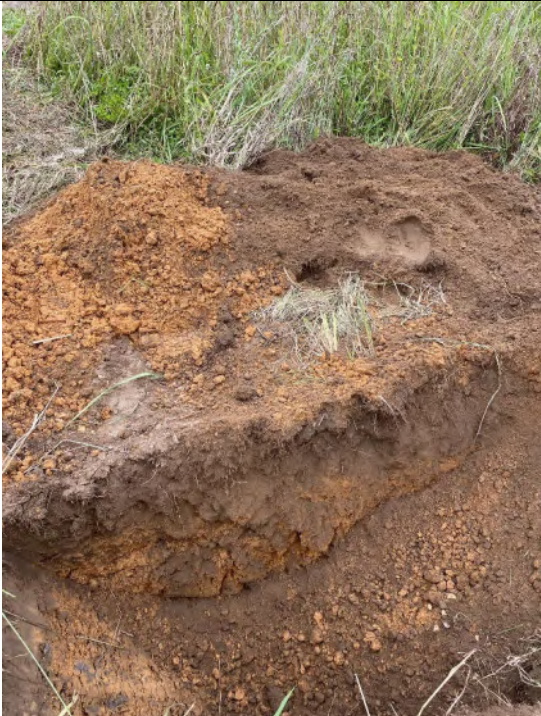
During intrusive works, fill material was observed in all boreholes ranging from 0.15 – 1.3 m in depth. Fill material was deepest in the north-west of the site and shallowest in the south-east of the site.

Photo No.	Date	
10	16.12.21	
Description: Typical soil profile encountered within the centre of the site.
