10 April 2015
BH Ref: 5702

RE: Comments on Slope Instability Risk & Site Development
Proposed Additions, Lot 1 DP 232164
No 1B The Serpentine, Bilgola Beach

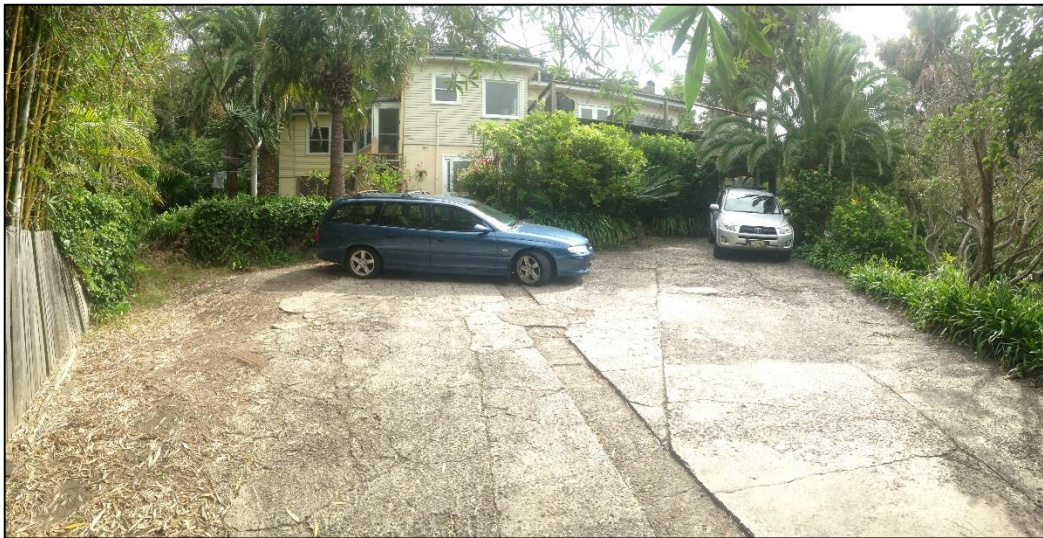
Photograph P1 – View towards west from near south-eastern corner of property

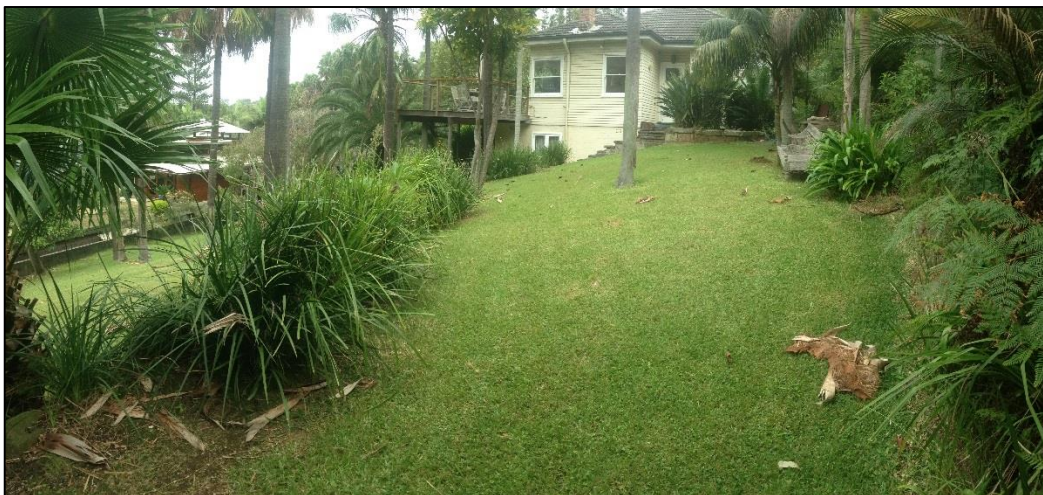
Photograph P2 – View towards south taken from near northern corner of property

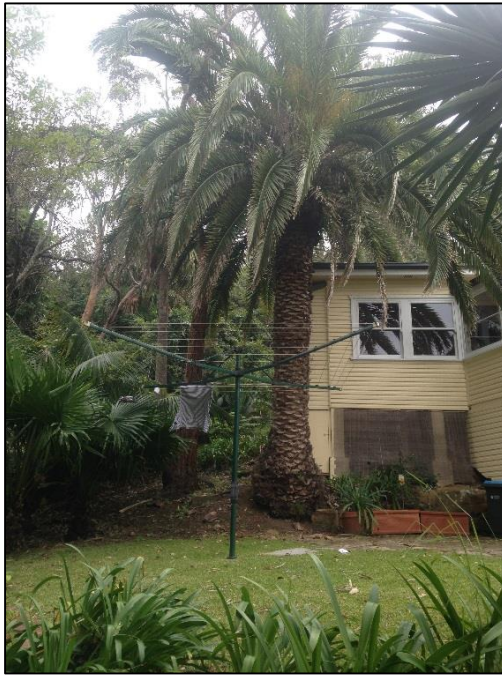
Photograph P3 – View towards west;
showing southern end of dwelling

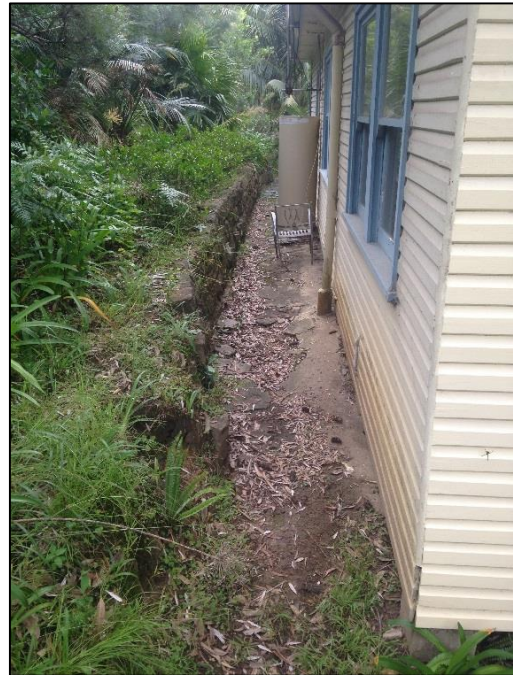
Photograph P4 – View towards north
along western side of dwelling

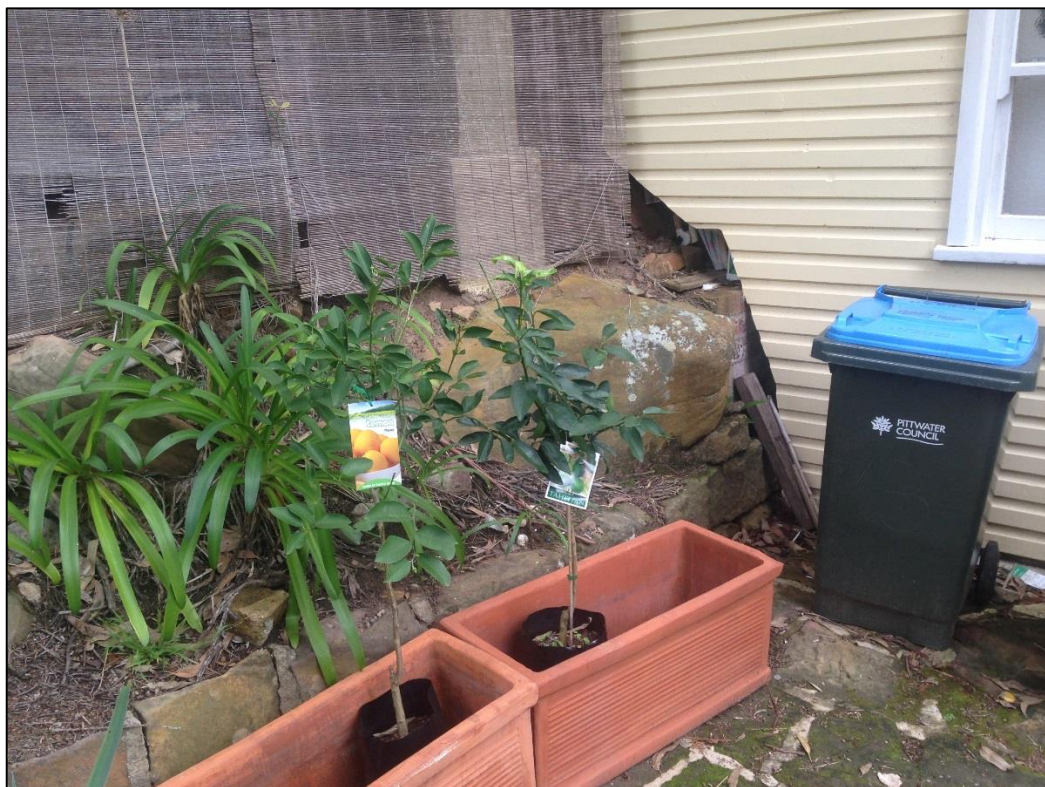
Photograph P5 – Sandstone boulders exposed in cut area at lower ground floor level of
existing dwelling; view towards north-west

In places on site, it is anticipated that boulders of weathered sandstone will be present within the clay soils present as colluvium on site as observed in the cut adjacent to southern side of the lower ground floor area of the existing dwelling.

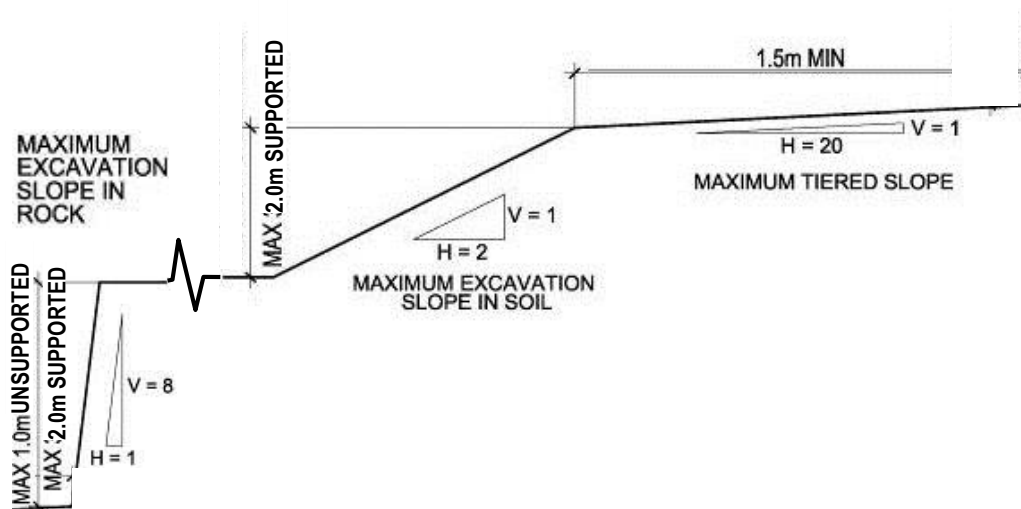
Figure 1 – Guidelines for Excavations in Soil and Rock

Unsupported cuts in soil must be battered in accordance with the requirements of the Building Code of Australia, but in no case should be steeper than 2H:1V and must be protected from erosion. All excavations greater than 0.8 m deep should be supported by properly designed and constructed retaining walls.

Depending on the degree of weathering and fracturing exposed during excavations for the proposed development, rock faces may be battered as steep as 1H:8V. This suggested batter slope should be confirmed by geotechnical inspection at the time of excavation.

Figure 1 shows diagrammatically the excavation guidelines given above.

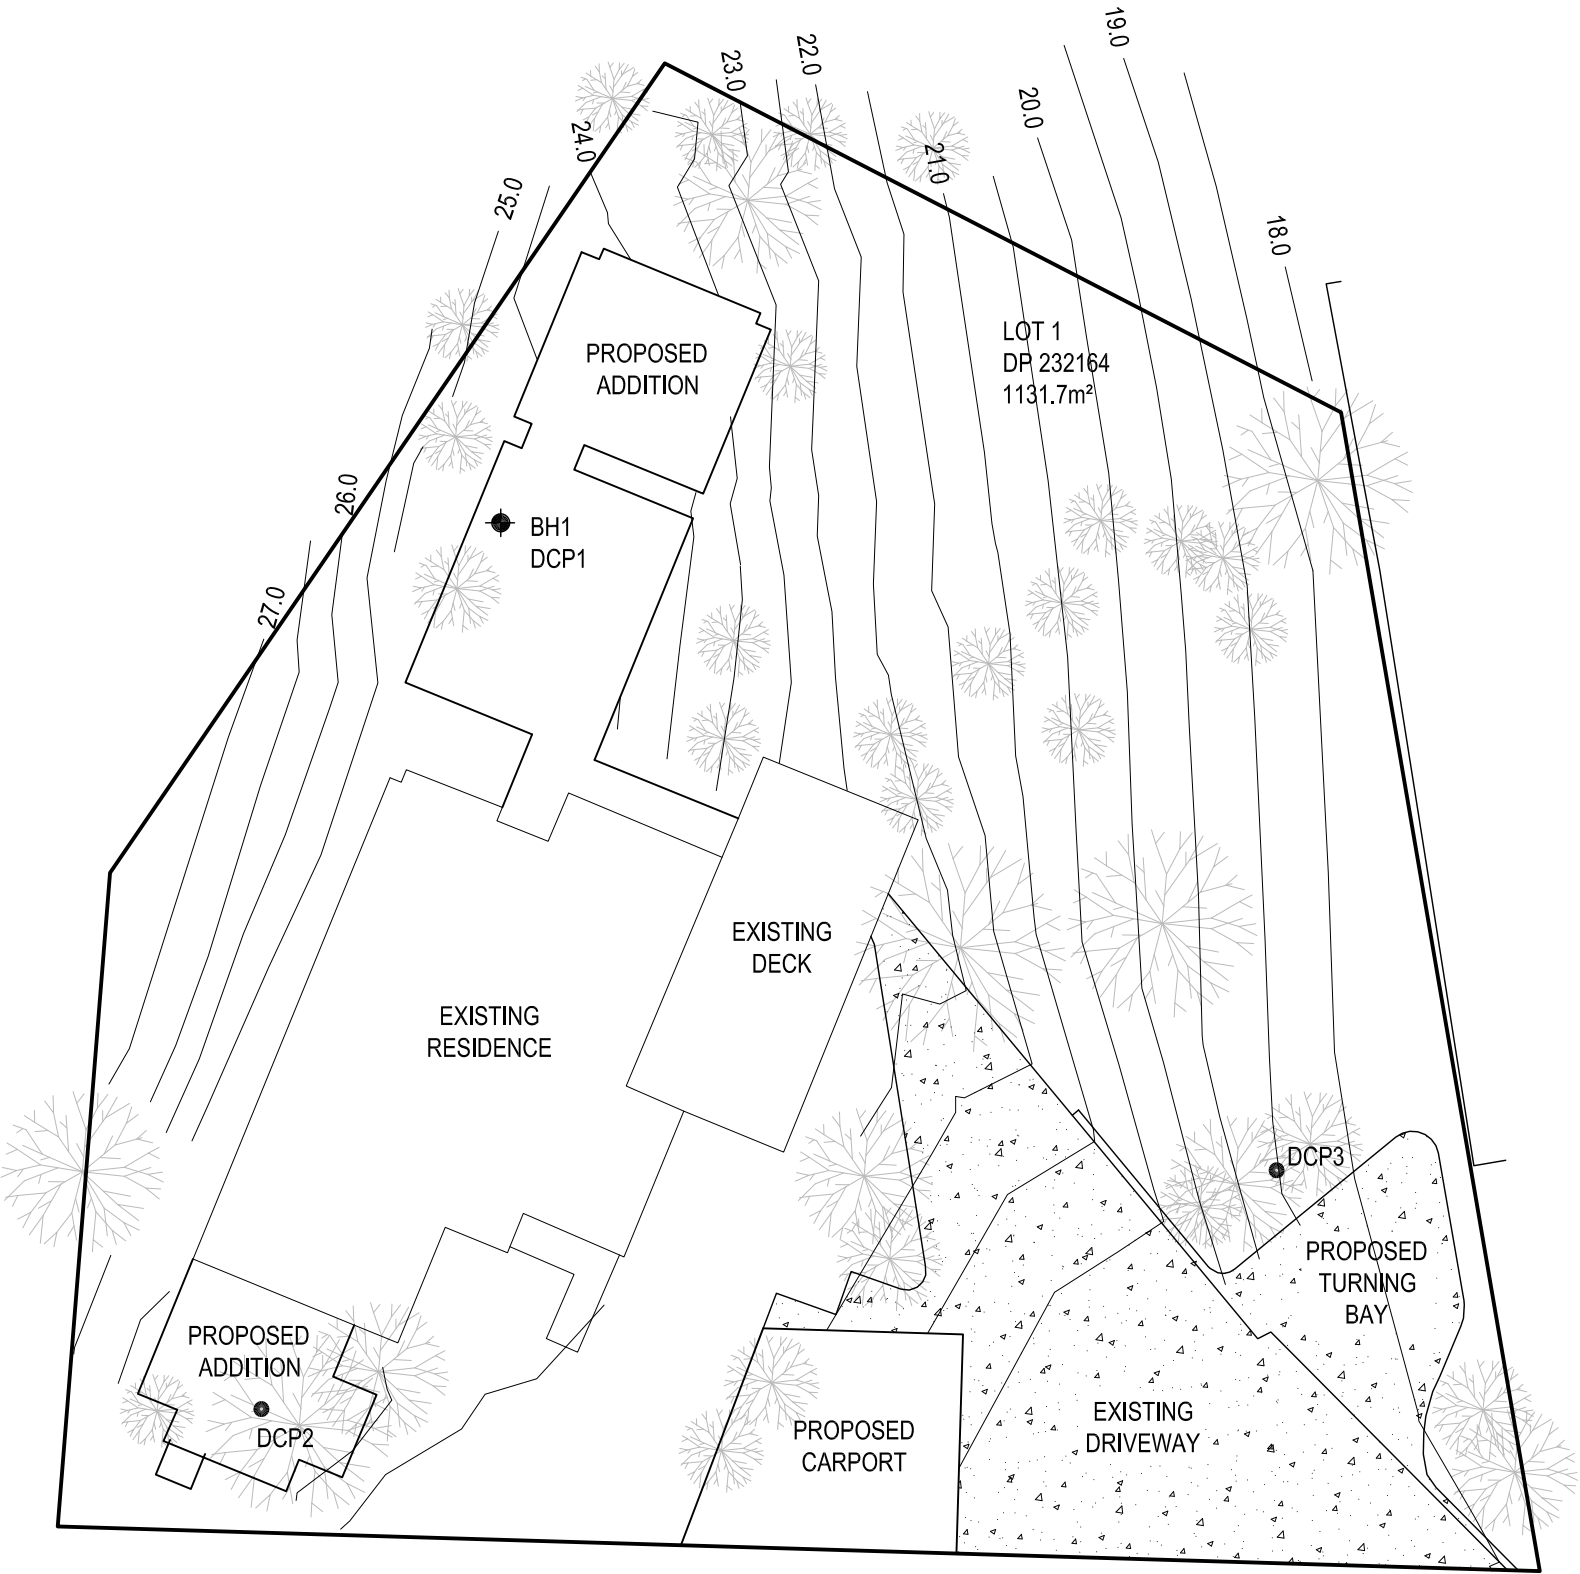
Drawing 5702/GEO1 shows the approximate locations of the boreholes and DCP tests.

NOTE:
PROPERTY AND RESIDENCE LAYOUT
TAKEN FROM DETAIL SURVEY BY
GEOMAT ENGINEERING PTY LTD (REF
14107-01, REV A DATED 25/02/15)

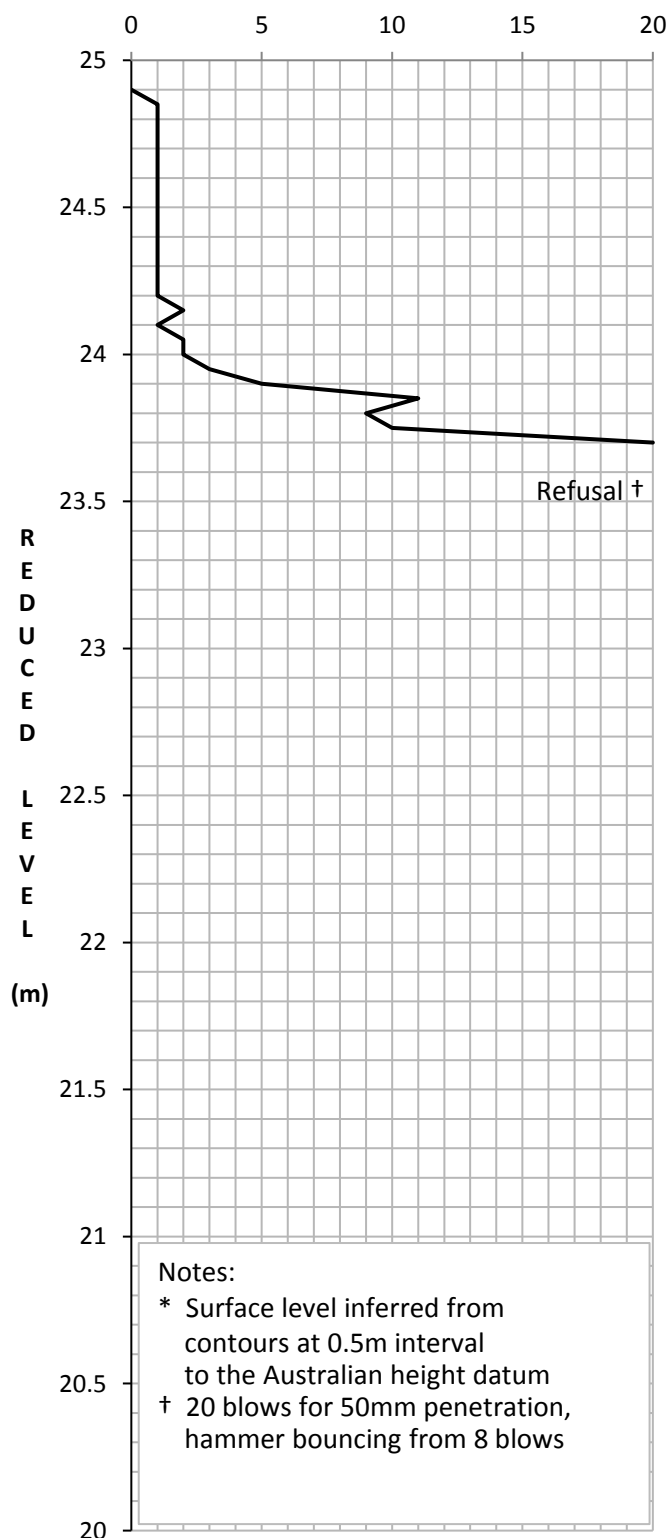
The DCP probe was driven to refusal at depths ranging from 1.2 m at test location DCP1 to 2.4 m at test location DCP3.

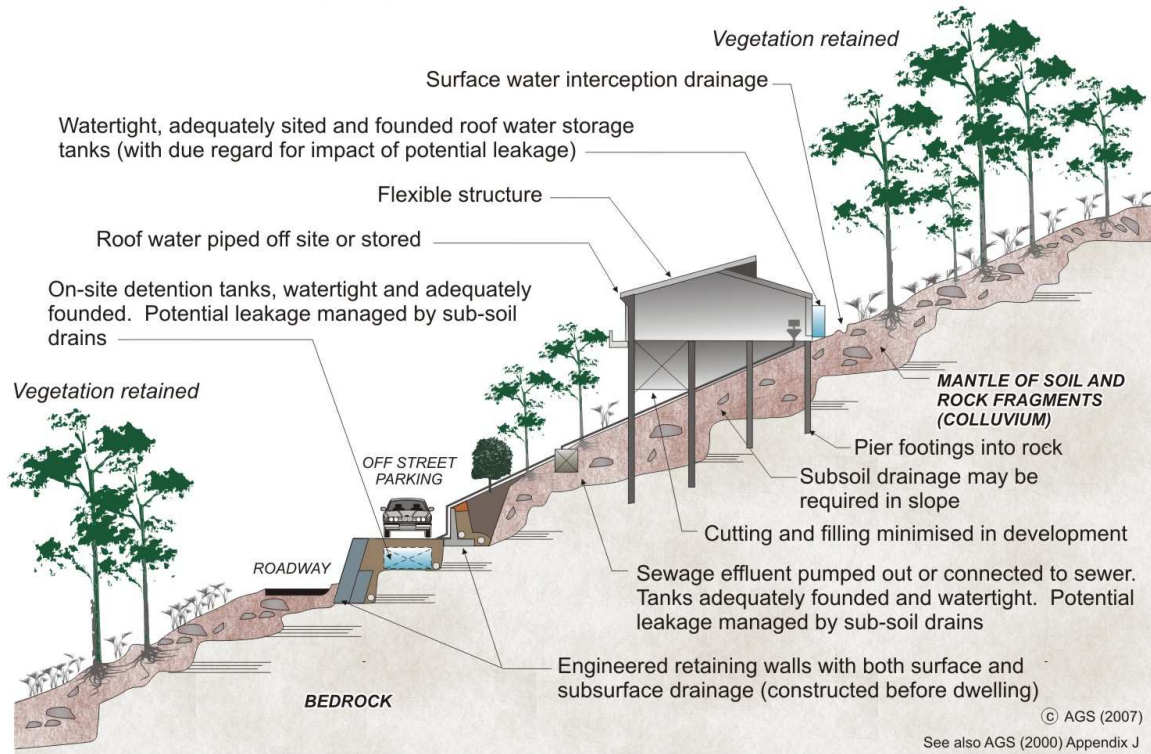
EXAMPLES OF GOOD HILLSIDE CONSTRUCTION PRACTICE

Roadways and parking areas - are paved and incorporate kerbs which prevent water discharging straight into the hillside (GeoGuide LR5).

Sewage - whether treated or not is either taken away in pipes or contained in properly founded tanks so it cannot soak into the ground.

Surface water - from roofs and other hard surfaces is piped away to a suitable discharge point rather than being allowed to infiltrate into the ground. Preferably, the discharge point will be in a natural creek where ground water exits, rather than enters, the ground. Shallow, lined, drains on the surface can fulfil the same purpose (GeoGuide LR5).

Surface loads - are minimised. No fill embankments have been built. The house is a lightweight structure. Foundation loads have been taken down below the level at which a landslide is likely to occur and, preferably, to rock. This sort of construction is probably not applicable to soil slopes (GeoGuide LR3). If you are uncertain whether your site has rock near the surface, or is essentially a soil slope, you should engage a geotechnical practitioner to find out.

Vegetation clearance - on soil slopes has been kept to a reasonable minimum. Trees, and to a lesser extent smaller vegetation, take large quantities of water out of the ground every day. This lowers the ground water table, which in turn helps to maintain the stability of the slope. Large scale clearing can result in a rise in water table with a consequent increase in the likelihood of a landslide (GeoGuide LR5). An exception may have to be made to this rule on steep rock slopes where trees have little effect on the water table, but their roots pose a landslide hazard by dislodging boulders.

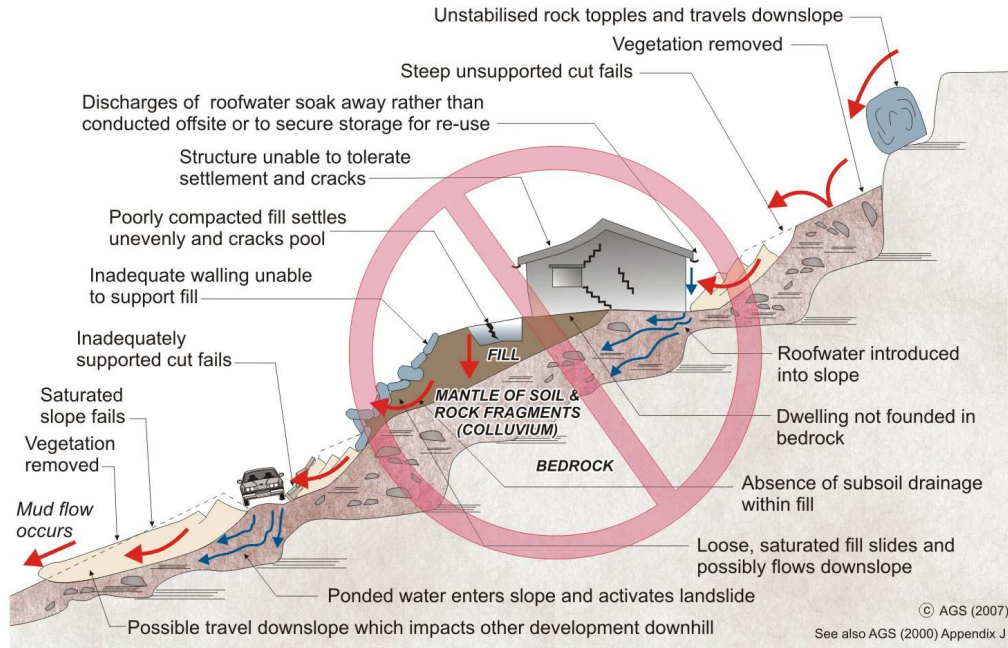
EXAMPLES OF **POOR** HILLSIDE CONSTRUCTION PRACTICE

Roadways and parking areas - are unsurfaced and lack proper table drains (gutters) causing surface water to pond and soak into the ground.

Cut and fill - has been used to balance earthworks quantities and level the site leaving unstable cut faces and added large surface loads to the ground. Failure to compact the fill properly has led to settlement, which will probably continue for several years after completion. The house and pool have been built on the fill and have settled with it and cracked. Leakage from the cracked pool and the applied surface loads from the fill have combined to cause landslides.

Retaining walls - have been avoided, to minimise cost, and hand placed rock walls used instead. Without applying engineering design principles, the walls have failed to provide the required support to the ground and have failed, creating a very dangerous situation.

A heavy, rigid, house - has been built on shallow, conventional, footings. Not only has the brickwork cracked because of the resulting ground movements, but it has also become involved in a man-made landslide.

Rock debris - from landslides higher up on the slope seems likely to pass through the site. Such locations are often referred to by geotechnical practitioners as "debris flow paths". Rock is normally even denser than ordinary fill, so even quite modest boulders are likely to weigh many tonnes and do a lot of damage once they start to roll. Boulders have been known to travel hundreds of metres downhill leaving behind a trail of destruction.
