# Arboricultural Impact Assessment

25-27 Kevin Avenue  
AVALON BEACH NSW 2107

REVISION 2 - AMENDED MARCH 2024

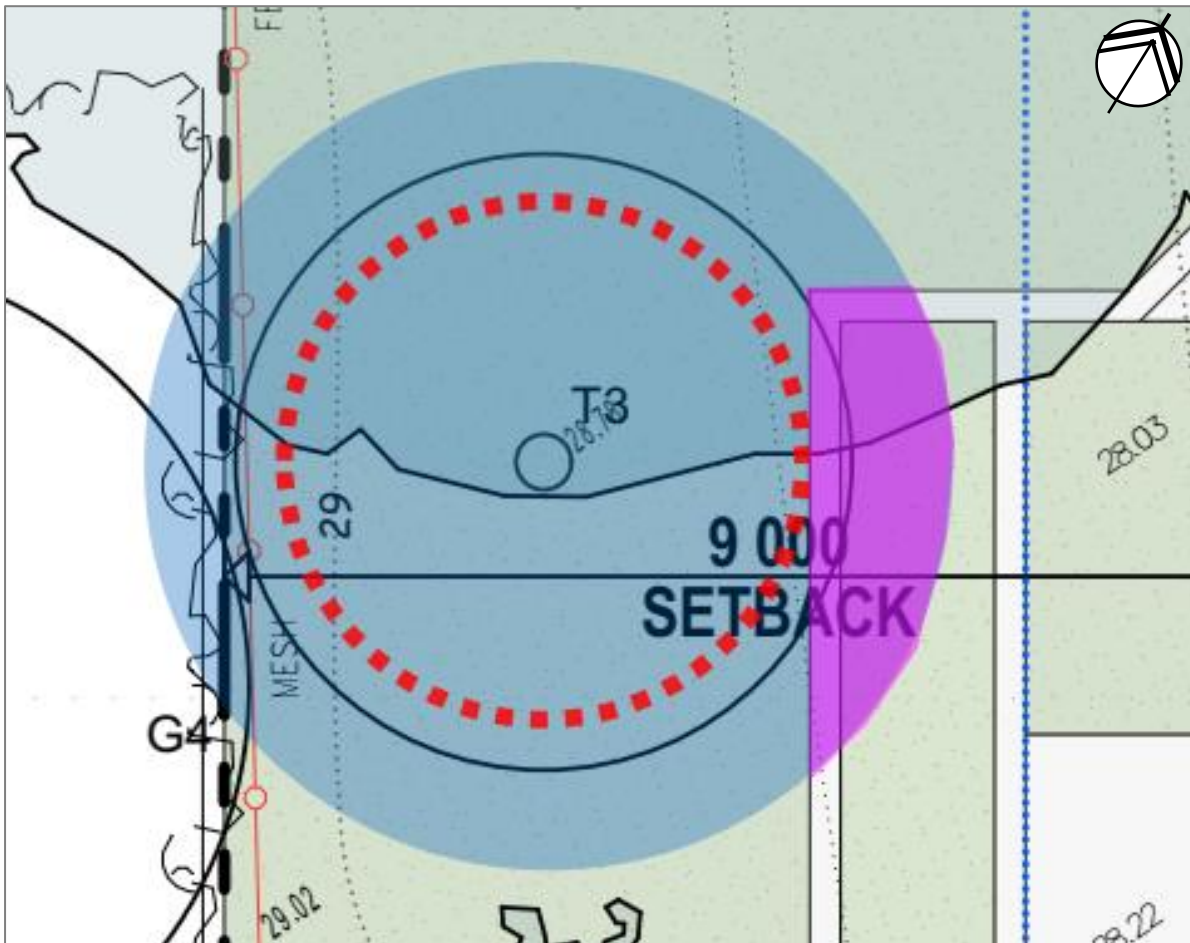
Figure 1 – Tree 3 encroachment calculation – Excerpt of Site Plan, Project 2306, dwg no. A.03, 30/10/23 authored by Gartner Trovato Architects. Red hashed circle indicates SRZ, blue shaded circle denotes the TPZ. Pink shading indicates encroachment. NOT TO SCALE. Marked up by C Hughes.

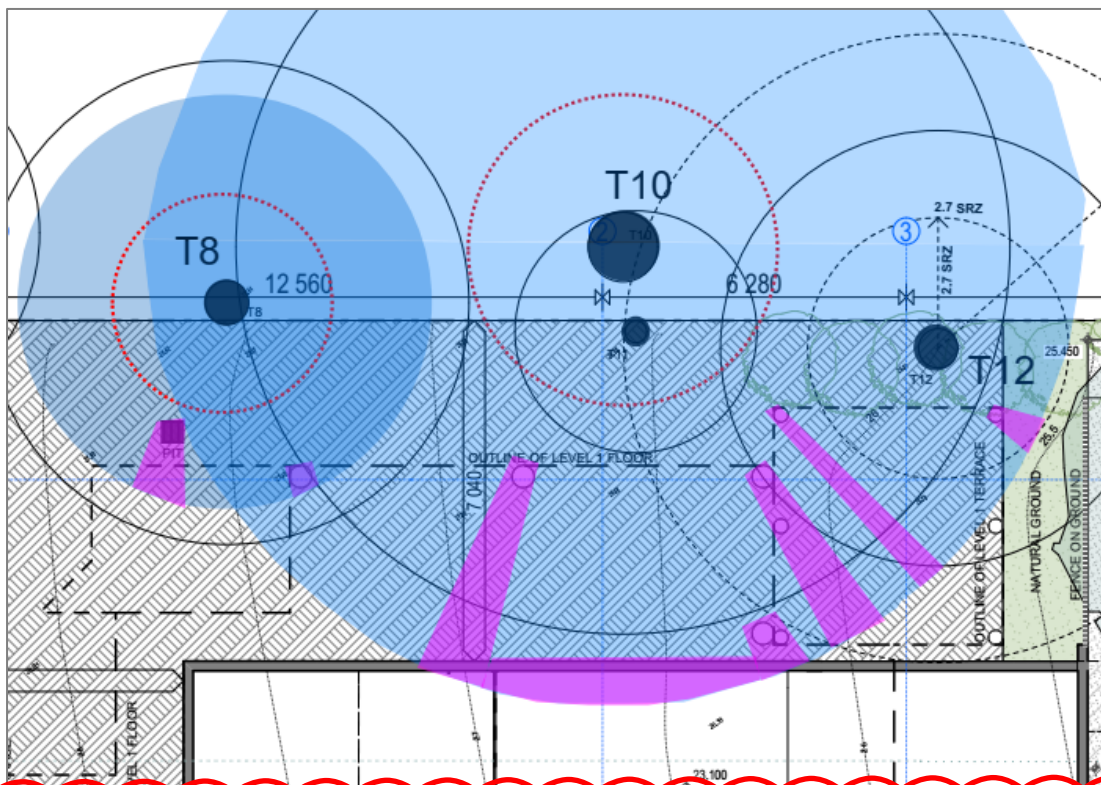
- An encroachment of 2.6% has been estimated (see Figure 2 below) for the proposed pit and one (1) pier for Level 1 Floor of the build. This places it within *minor* encroachment under AS4970.
- This level of impact is not foreseen to impact tree health or condition.

- An encroachment of 5.6% has been estimated (see Figure 2 below) for the proposed piers for Level 1 Floor of the build and basement. This places it within *minor* encroachment under AS4970.
- This level of impact is not foreseen to impact tree health/condition in relation to root disturbance. However, consideration into irrigation to offset the inevitable rain shadow is recommended.

Figure 2 – Tree 8 & 10 encroachment calculation – Excerpt of Ground Floor Plan, Project 2306, dwg no. A.05, authored by Gartner Trovato Architects. Red dotted circle indicates SRZ, blue shaded circle denotes the TPZ. Pink shading indicates encroachment. NOT TO SCALE. Marked up by C Hughes.

- Moderate pruning (two (2) 100-200mm in diameter low east branches) will be required. This pruning work could be carried out in compliance with AS4373.

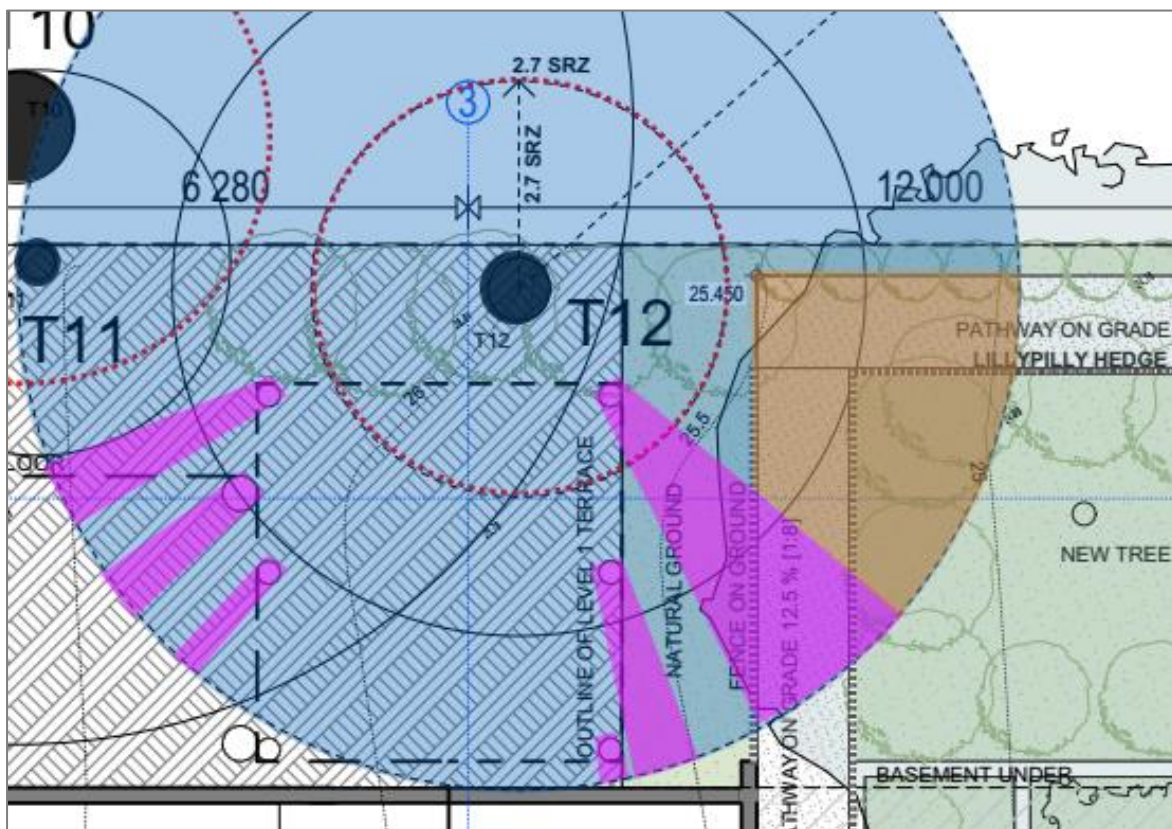
Figure 3 – Tree 12 encroachment calculation – Excerpt of Ground Floor Plan, Project 2306, dwg no. A.05, authored by Gartner Trovato Architects. Red dotted circle indicates SRZ, blue shaded circle denotes the TPZ. Pink shading indicates encroachment for piers and orange shading ‘temporary’ encroachment. NOT TO SCALE. Marked up by C Hughes.

- Significant and heavy pruning will be required to provide clearances for both the terrace/Level 1 building footprint and scaffolding during works.

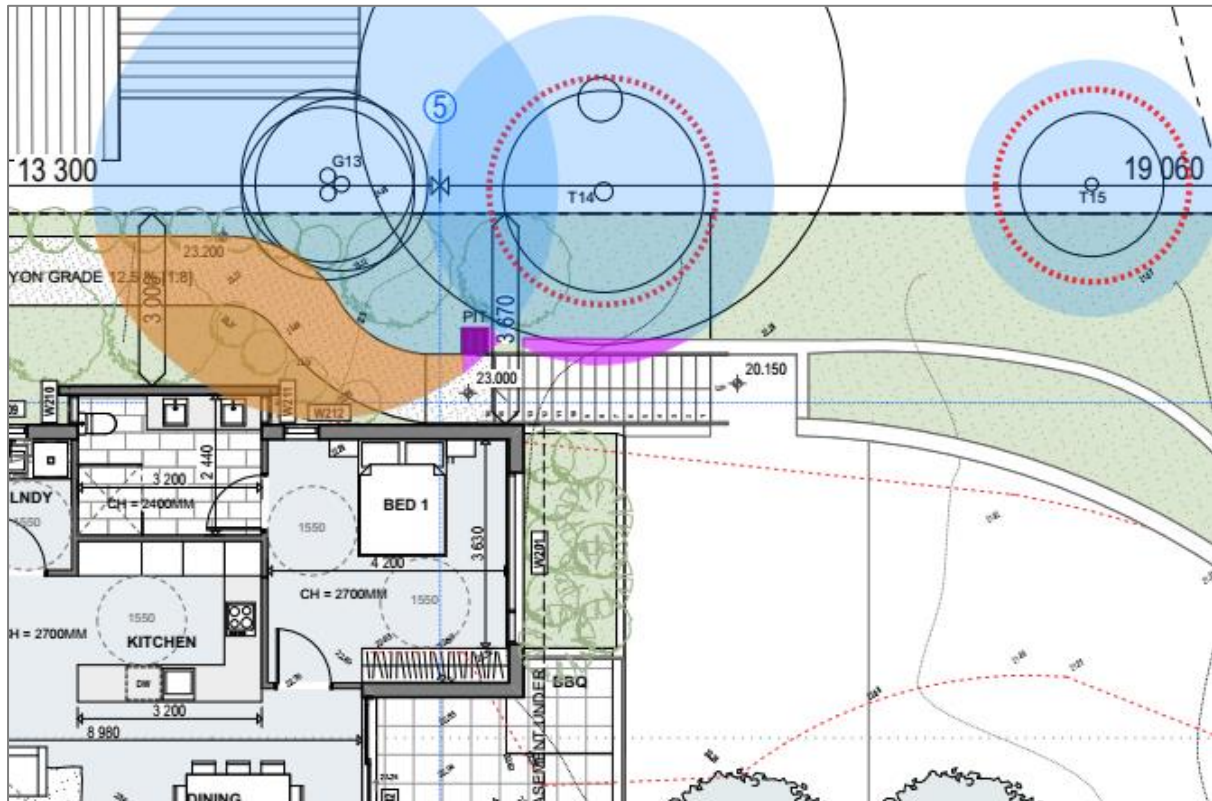
- An encroachment of 3.3% has been estimated (see Figure 4 below/next page) for the proposed retaining wall beside entry stairs. This places it within *minor* encroachment under AS4970.
- This level of impact is not foreseen to impact tree health or condition.

Figure 3 – Group 13, Tree 14 & 15 encroachment calculation – Excerpt of Ground Floor Plan, Project 2306, dwg no. A.05, 23/10/23 authored by Gartner Trovato Architects. Red hashed circle indicates SRZ, blue shaded circle denotes the TPZ. Pink shading indicates permanent encroachment, orange shading 'temporary' encroachment. NOT TO SCALE. Marked up by C Hughes.

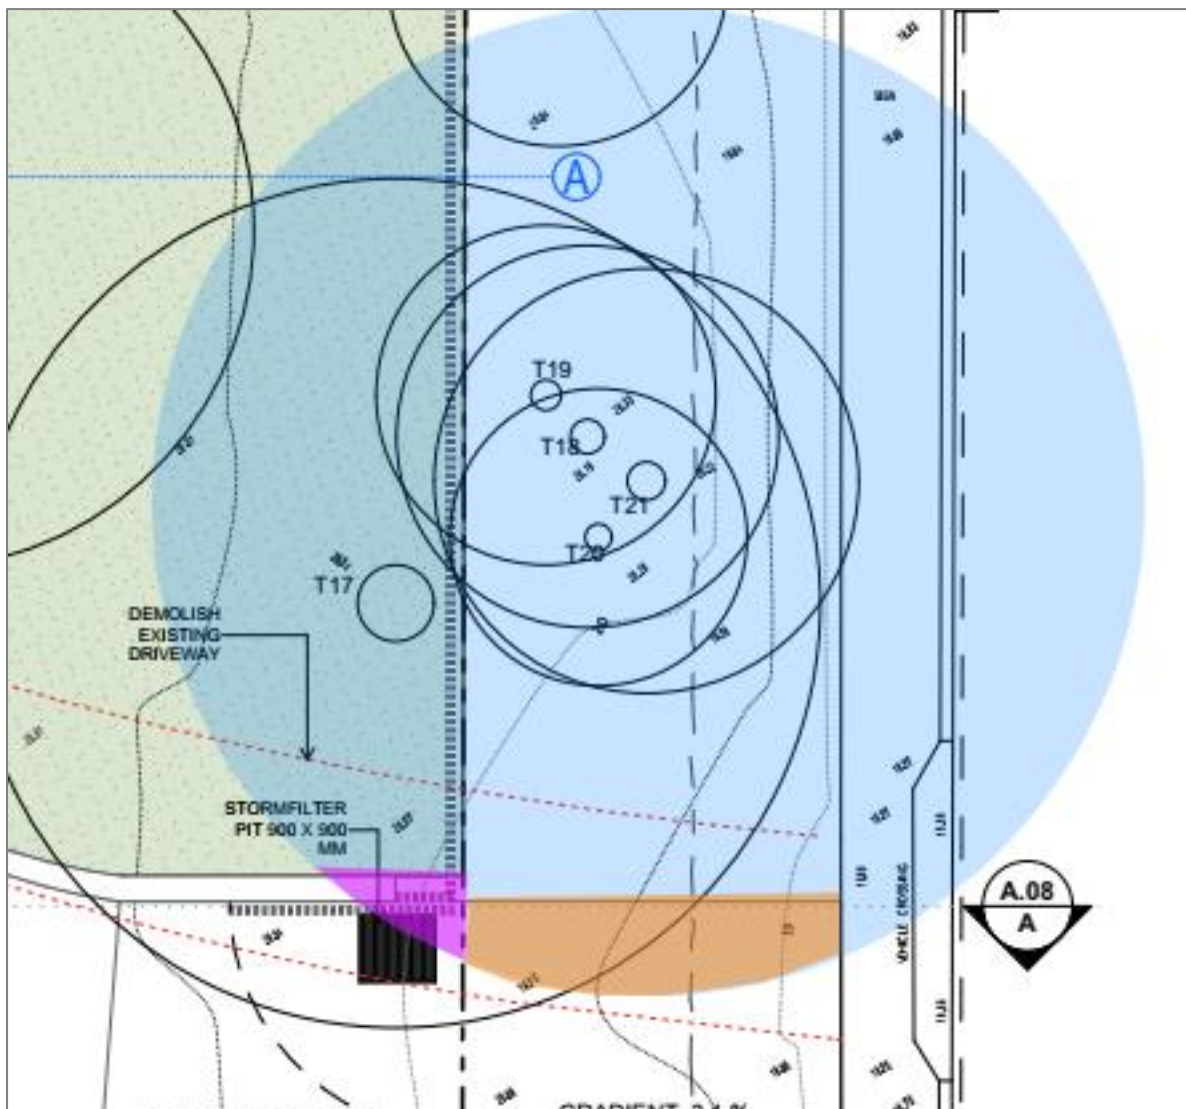
- An encroachment of 5.2% has been estimated (see Figure 6 below) for the proposed retaining wall beside the driveway and driveway cross-over. This places it within *minor* encroachment under AS4970.
- This level of impact is not foreseen to impact tree health or condition. Additionally existing cross-over encroachment sits closer to the tree stem.

Figure 6 –Tree 21 encroachment calculation – Excerpt of Basement Plan, Project 2306, dwg no. A.04, 23/10/23 authored by Gartner Trovato Architects. Red hashed circle indicates SRZ, blue shaded circle denotes the TPZ. Pink shading indicates permanent encroachment, orange shading indicates existing concrete encroachment. NOT TO SCALE. Marked up by C Hughes.

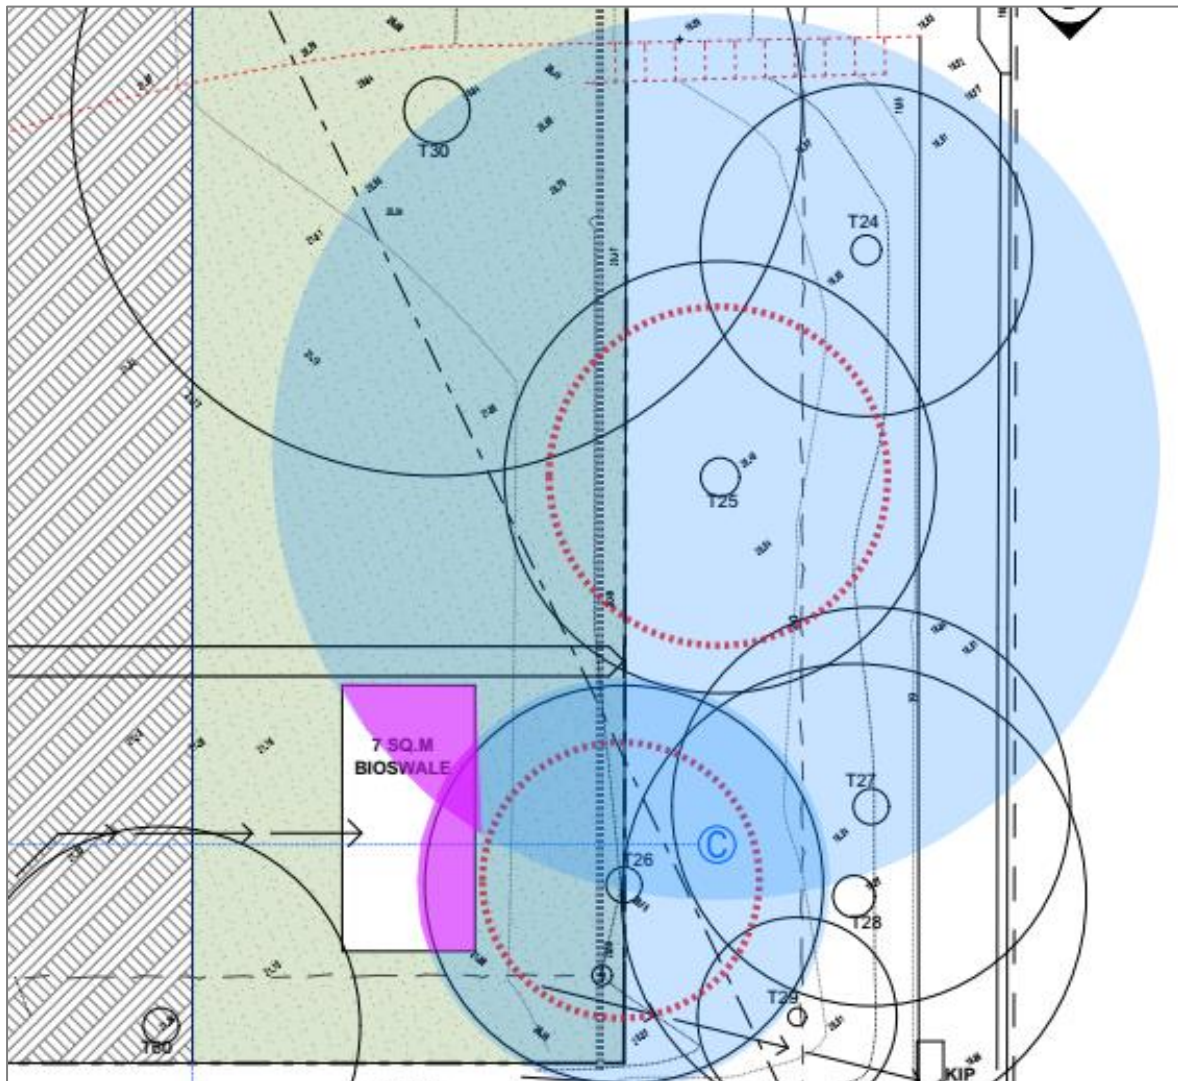
- An encroachment of 1.9% has been estimated (see Figure 7 below/next page) for the proposed bioswale. This places it within *minor* encroachment under AS4970.
- This level of impact is not foreseen to impact tree health or condition.

- An encroachment of 6.3% has been estimated (see Figure 7 below/next page) for the proposed bioswale. This places it within *minor* encroachment under AS4970.
- This level of impact is unlikely to negatively impact tree health/condition.

Figure 7 –Tree 25 & 26 encroachment calculation – Excerpt of Basement Plan, Project 2306, dwg no. A.04, 23/10/23 authored by Gartner Trovato Architects. Red hashed circle indicates SRZ, blue shaded circle denotes the TPZ. Pink shading indicates encroachment. NOT TO SCALE. Marked up by C Hughes.

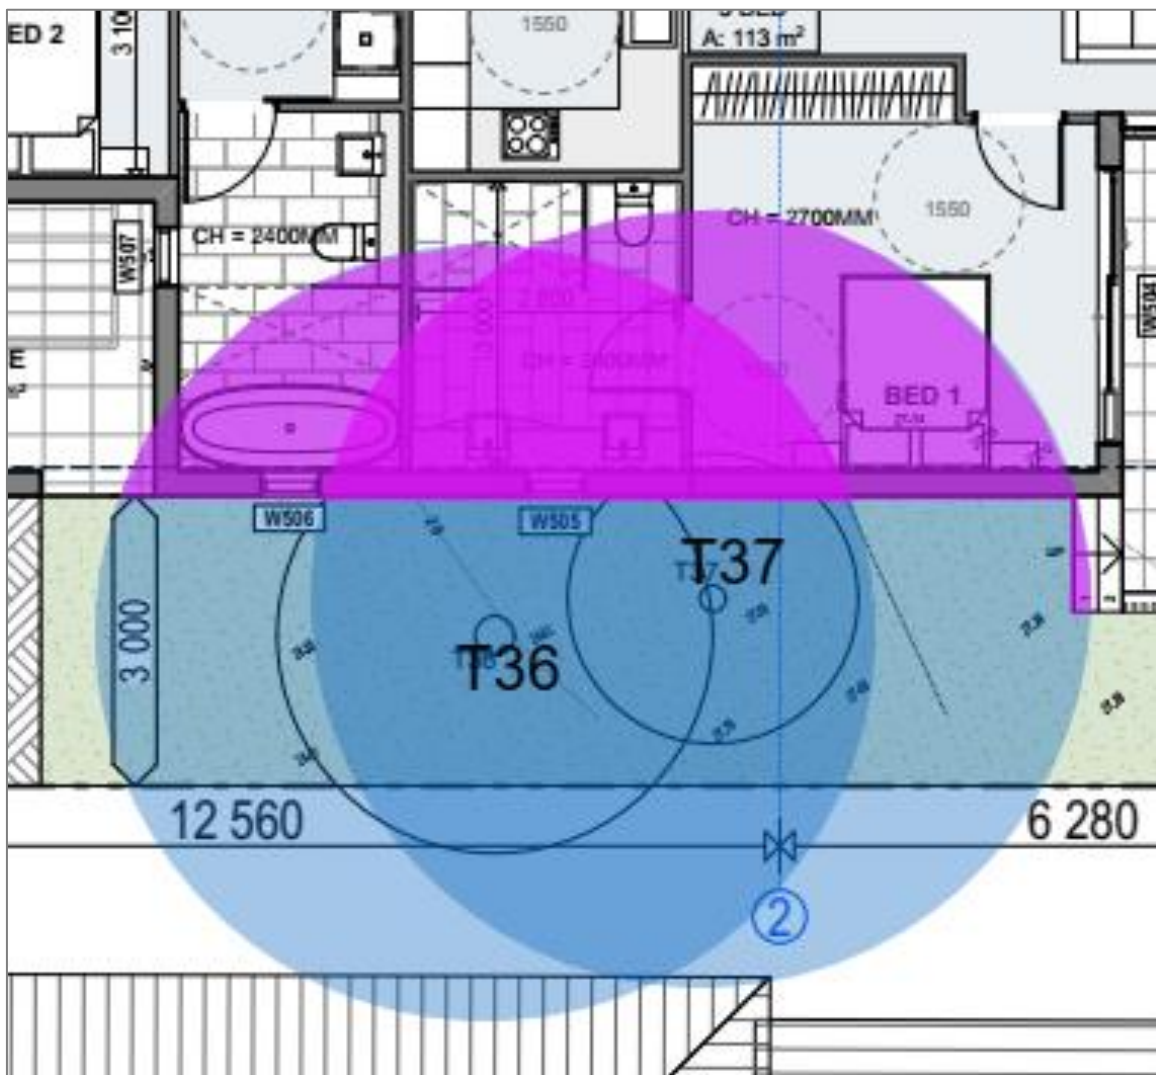
Figure 9 –Tree 36 & 37 encroachment calculation – Excerpt of Level 01 Plan, Project 2306, dwg no. A.06, 23/10/23 authored by Gartner Trovato Architects. Red hashed circle indicates SRZ, blue shaded circle denotes the TPZ. Pink shading indicates encroachment. NOT TO SCALE. Marked up by C Hughes.

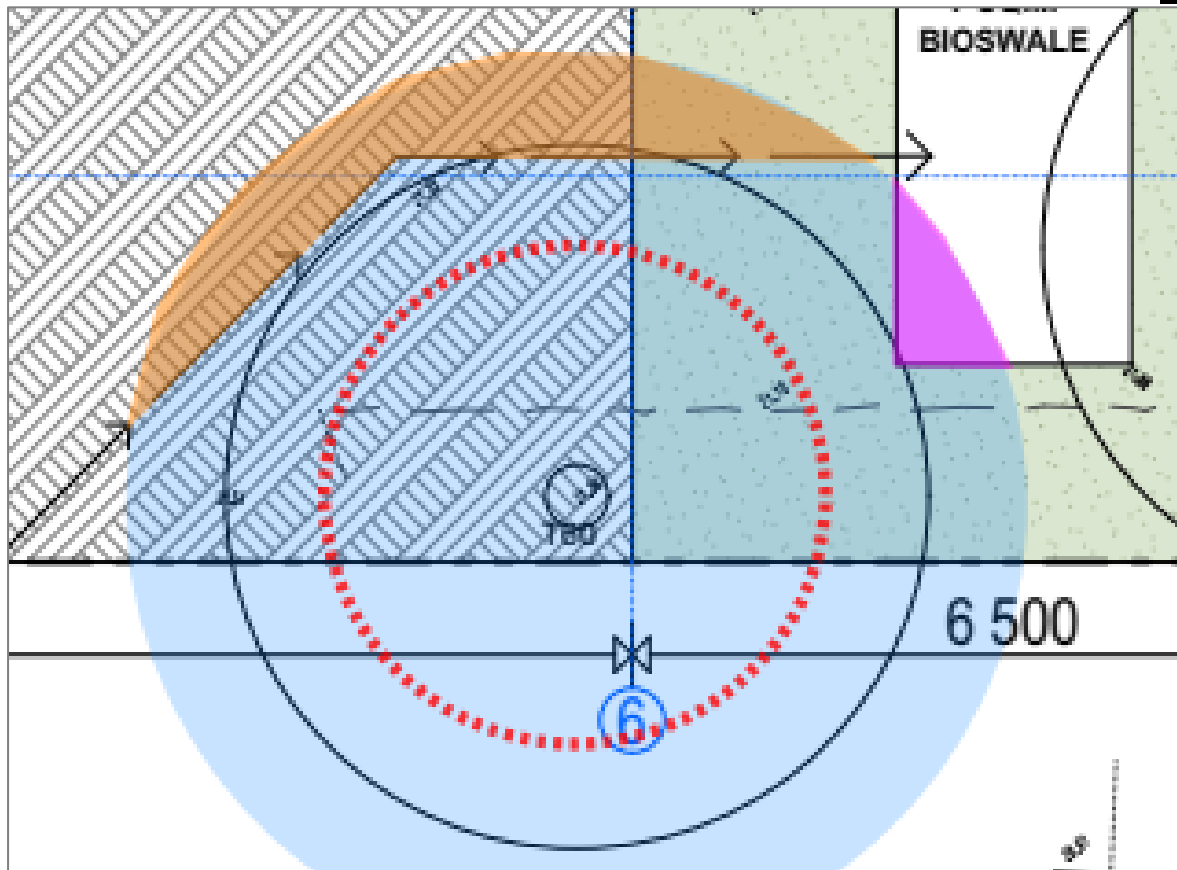
Figure 10 –Tree 60 encroachment calculation – Excerpt of Basement Plan, Project 2306, dwg no. A.04, 23/10/23 authored by Gartner Trovato Architects. Red hashed circle indicates SRZ, blue shaded circle denotes the TPZ. Pink shading indicates ‘permanent’ encroachment and orange ‘temporary’ encroachment. NOT TO SCALE. Marked up by C Hughes.

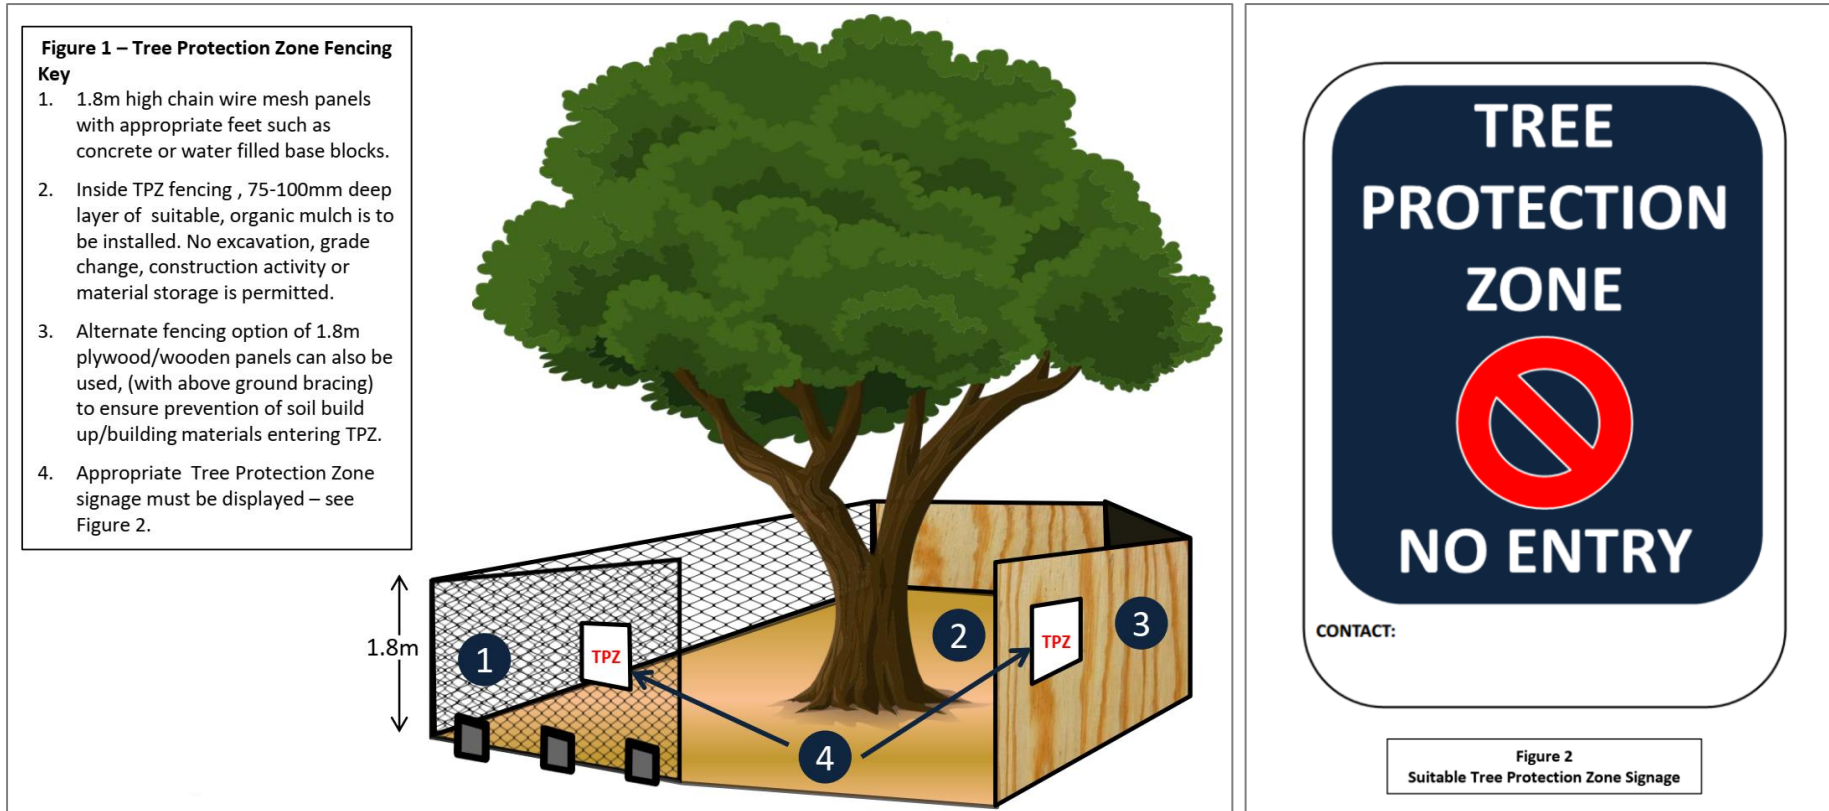
Figures 1 & 2 – Tree Protection Fencing and appropriate signage.

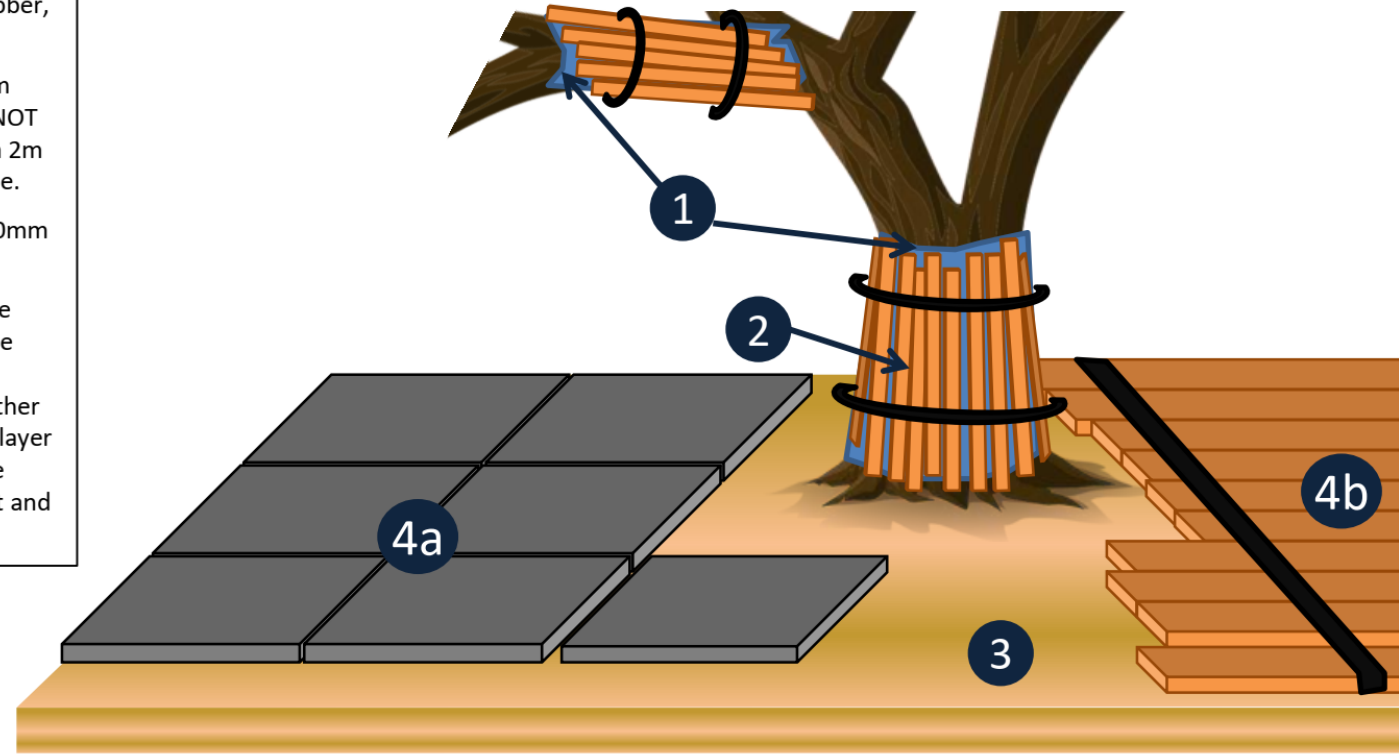
**Figure 3 - Stem, Branch & Ground protection measures**

1. Padding (such as geotextile membrane, natural hessian, rubber, or carpet to protect bark).
2. Battens/boards for branch/stem protection, strapped together NOT nailed into bark/tree. Minimum 2m in height on stem where feasible.
3. Ground protection base 75-100mm of fit for purpose mulch.
4. If machinery is required to move within the TPZ then steel rumble boards (4a) or wide, timber sheeting/boards thrashed together (4b) is to be placed over mulch layer (preferably with geotextile base layer), this to spread the weight and minimise soil compaction

Figure 3 – Stem and ground protection measures.

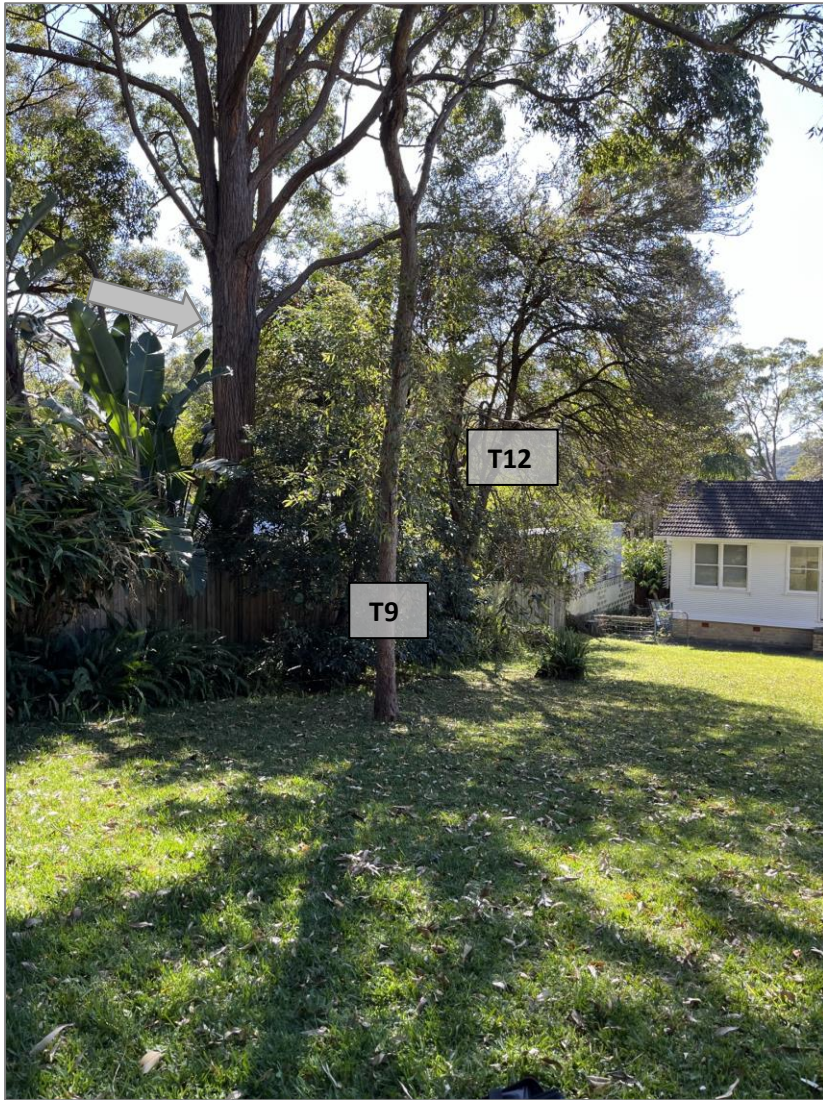
Plate 1 – Tree 10 noted with arrow – Tree is located within neighbouring property. Branches overhang the site and will require pruning prior to works commencing. Tree 9 is proposed for removal. Tree 12 will require heavy pruning for Level 1.

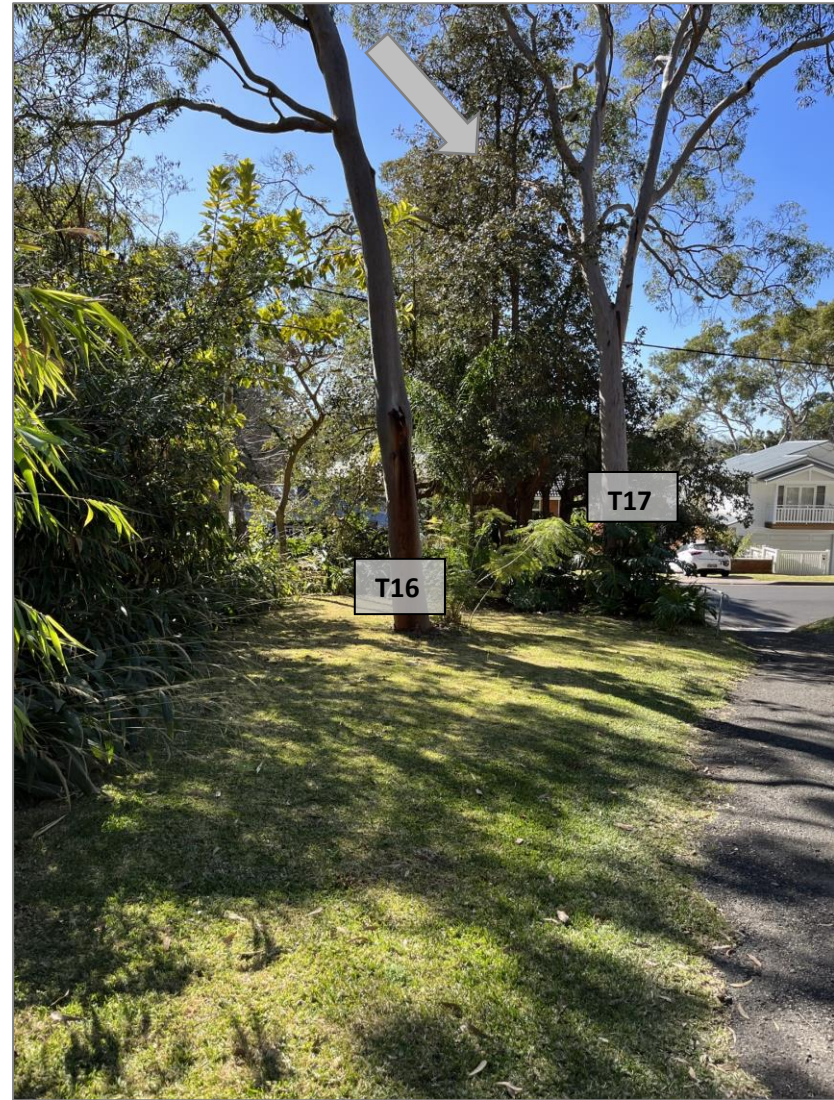
Plate 2 – Tree 16-21 – Arrow notes trees on Council managed land Tree 18-21, Tree 16 and 17 on subject site labelled. All trees are proposed for retention.

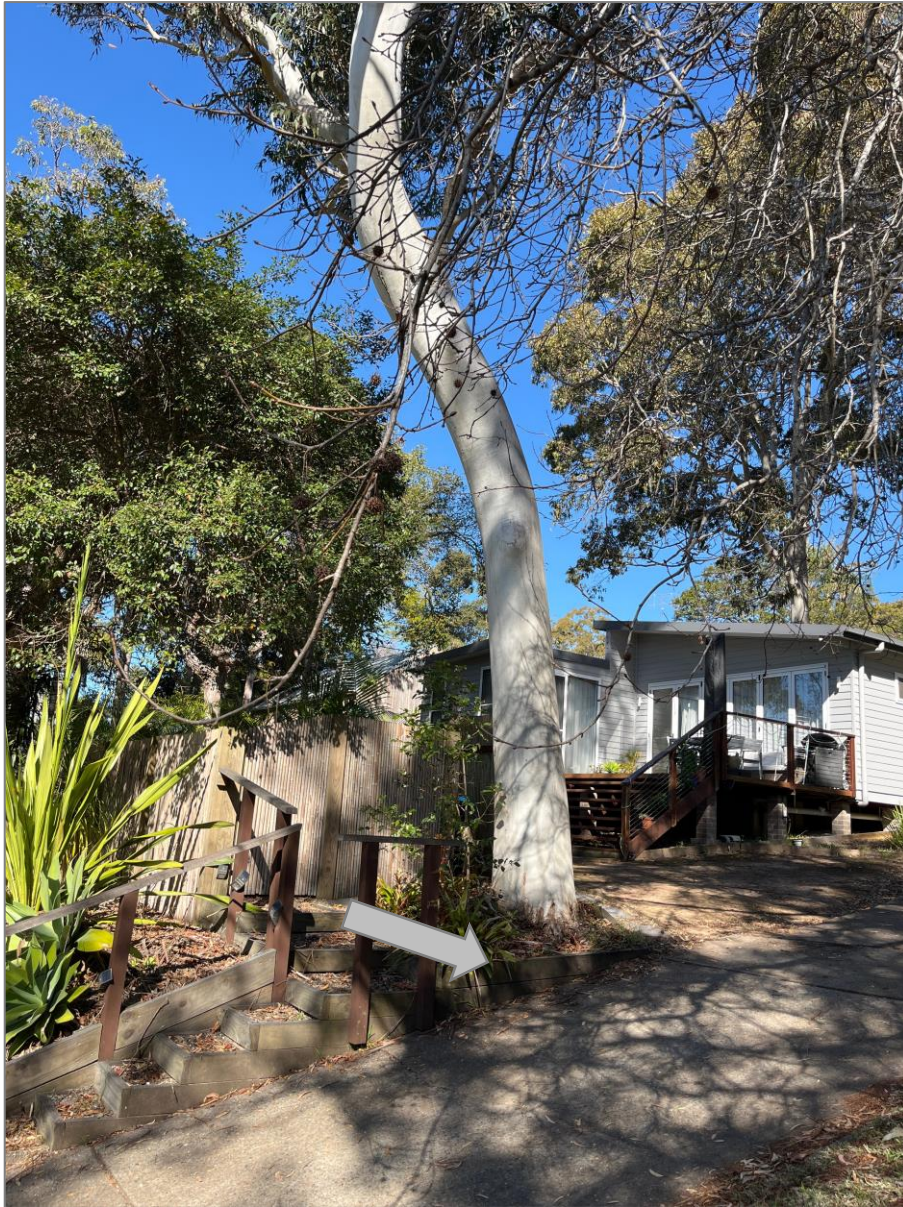
Plate 3 – Tree 30 – Arrow notes existing driveway and timber stairs/garden. This tree is proposed for retention.

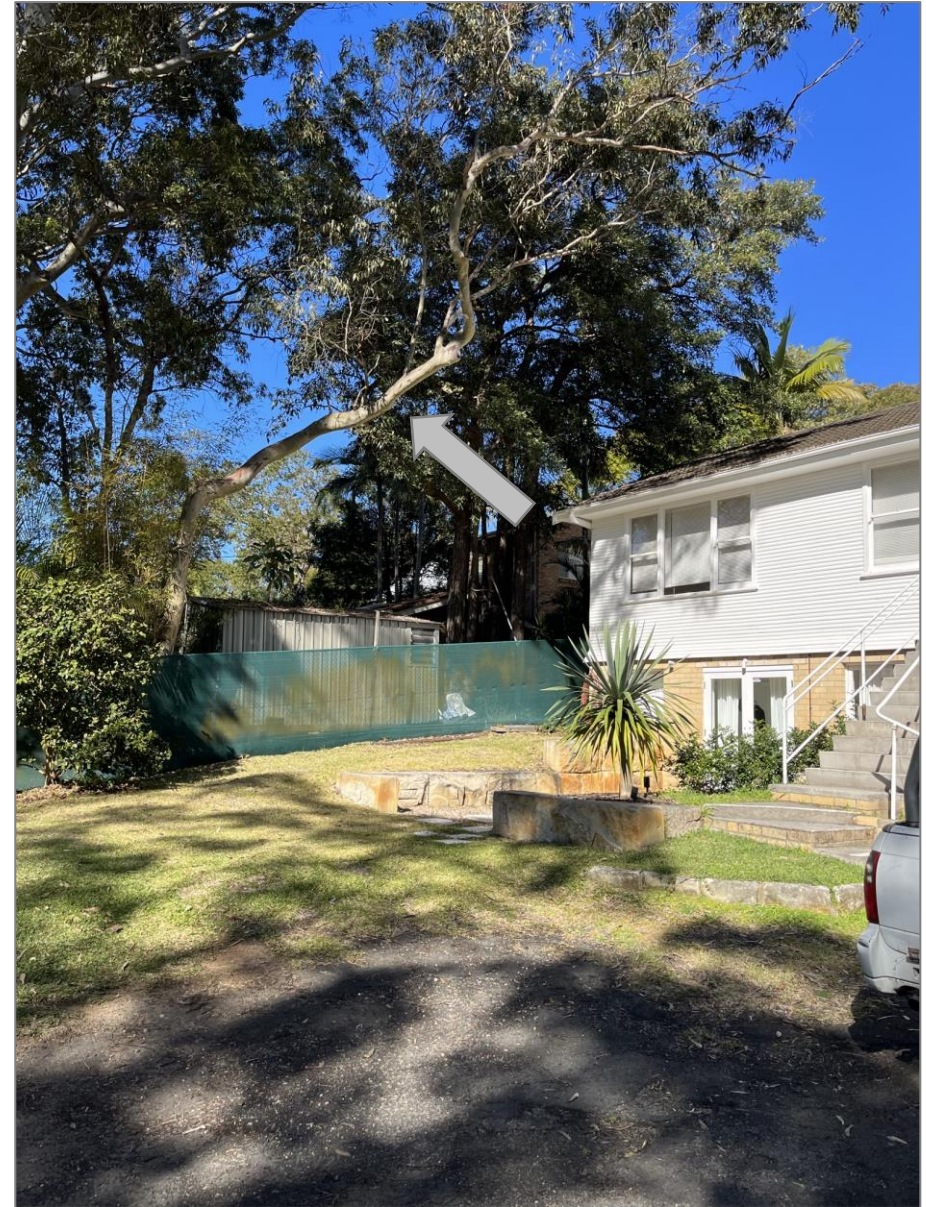
Plate 4 – Tree 51 – This tree will require removal, canopy over proposed build and encroachment into TPZ excessive.

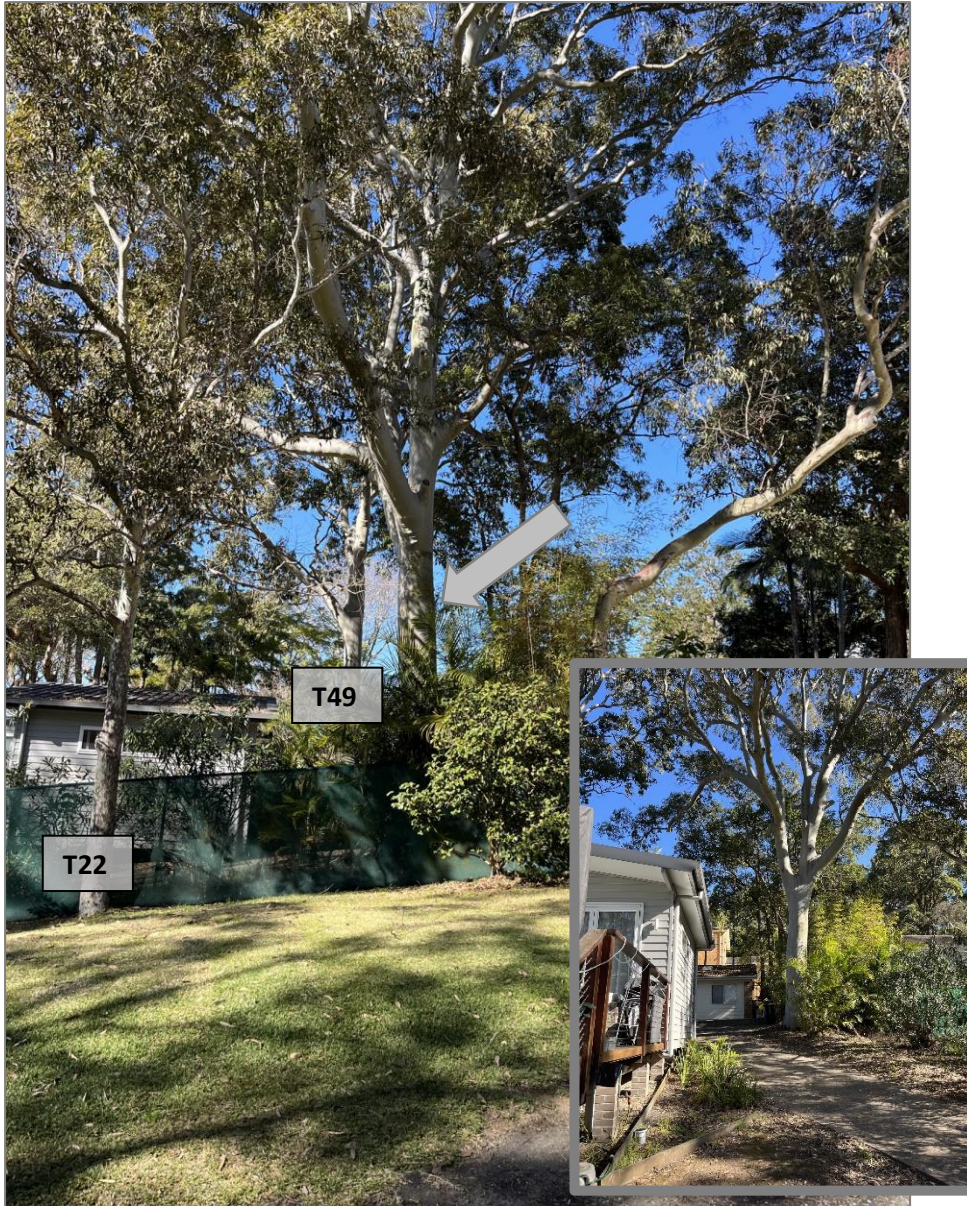
Plate 5 – Tree 50 – Arrow (and INSET) note Tree 50. Extraordinary effort has gone into the site design and is required during build to protect and retain this tree.

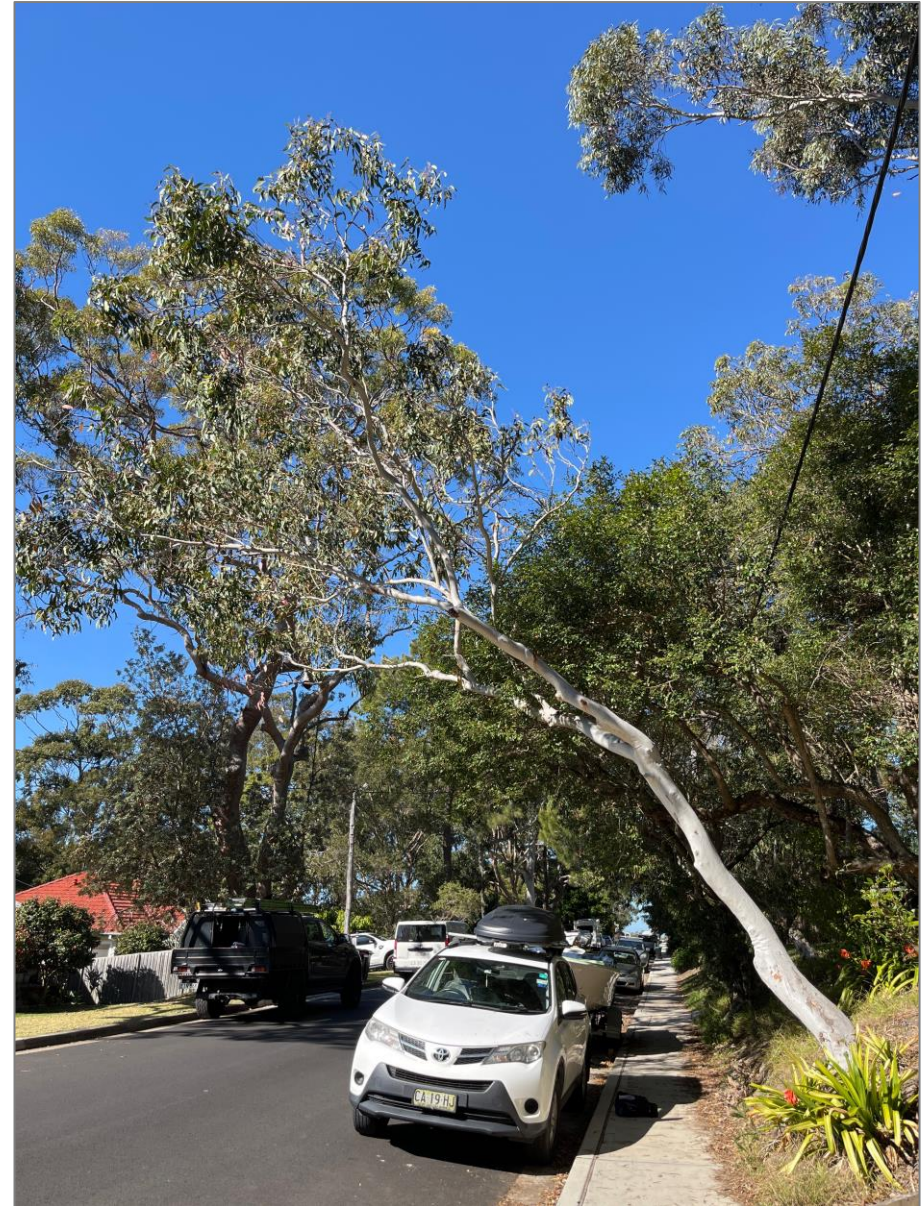
Plate 6 – Tree 24 – Tree located on Council managed land. Leans over roadway and may impact truck movement.

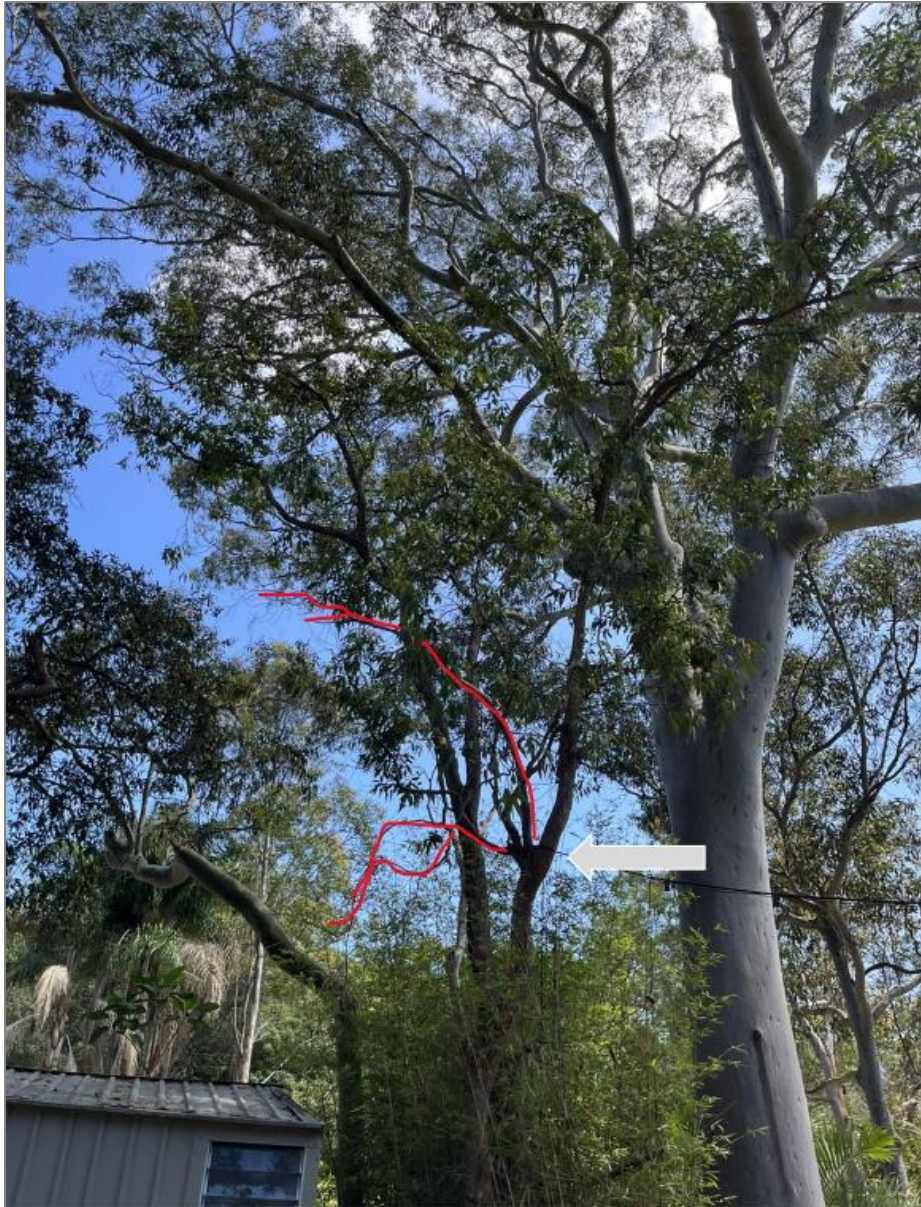
Plate 7 – Tree 52 – Remove deadwood as marked red to clear for scaffolding/built form.

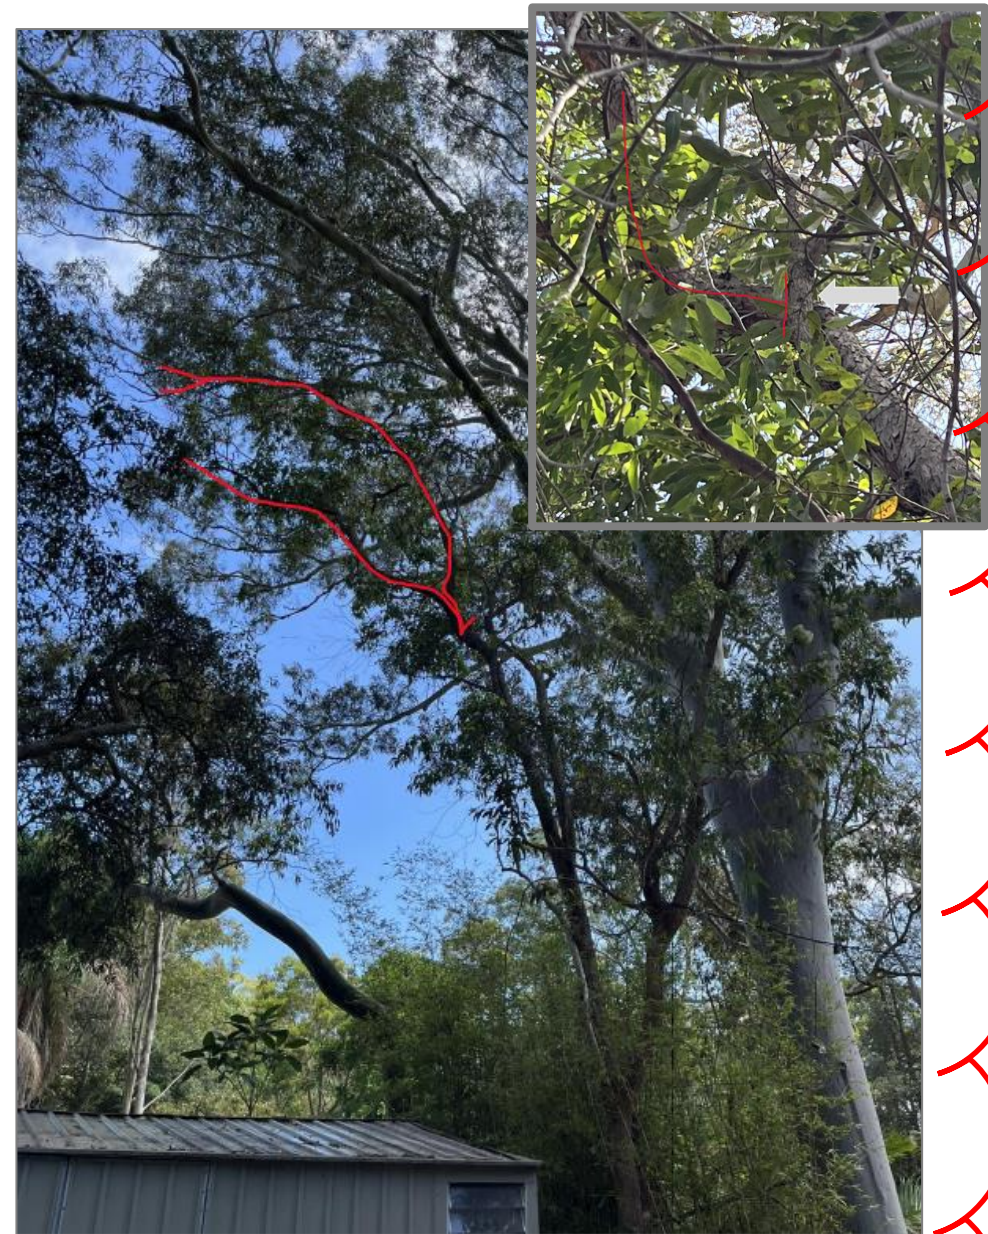
Plate 8 – Tree 53 – (and INSET) Red lines note branches requiring removal. Inset notes point of junction back to an upright epicormic branch most likely needing pruning to for clearances.
