# *Arboriculture Impact Assessment & Management Report for DA2022/0084*

November 2021, Updated June 2022

**Site:** Lot 114 in DP 8394  
73 Marine Parade  
AVALON BEACH, NSW

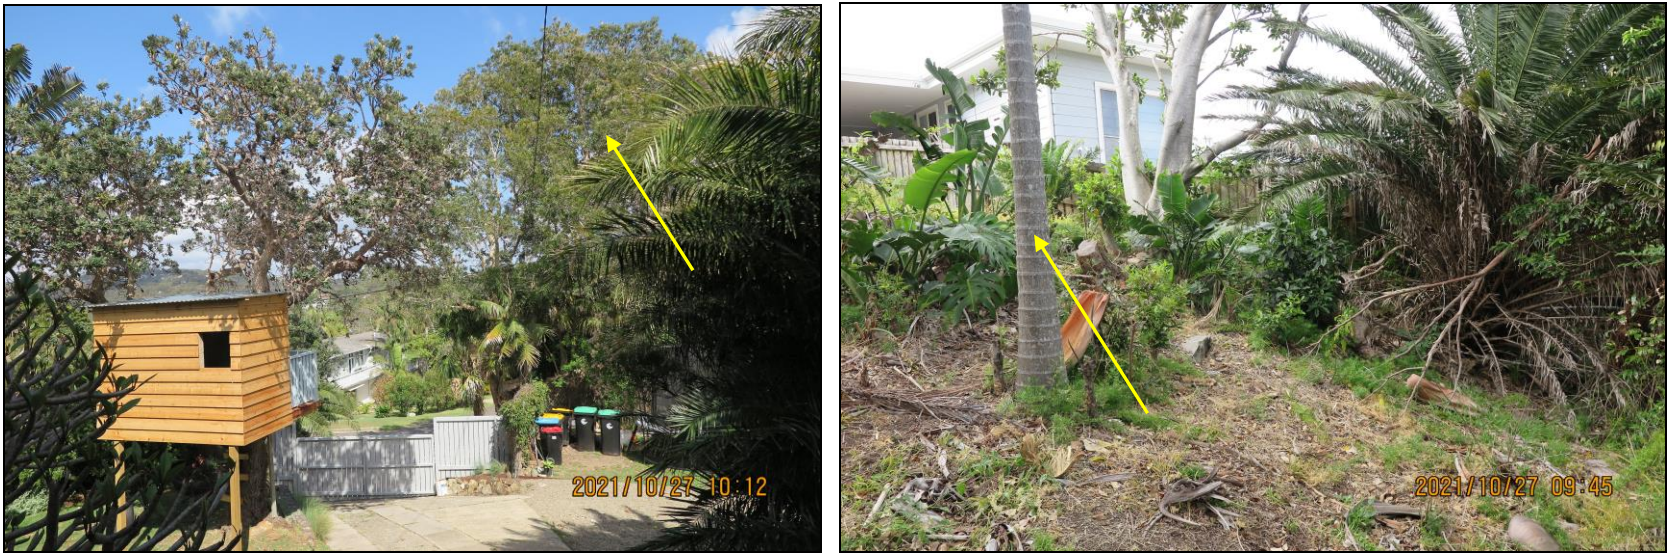
Figure 3: Above illustrates the road reserve discussed trees (Red Arrow trees are proposed to be replaced). Below illustrates front & rear yard high value trees proposed to be retained.

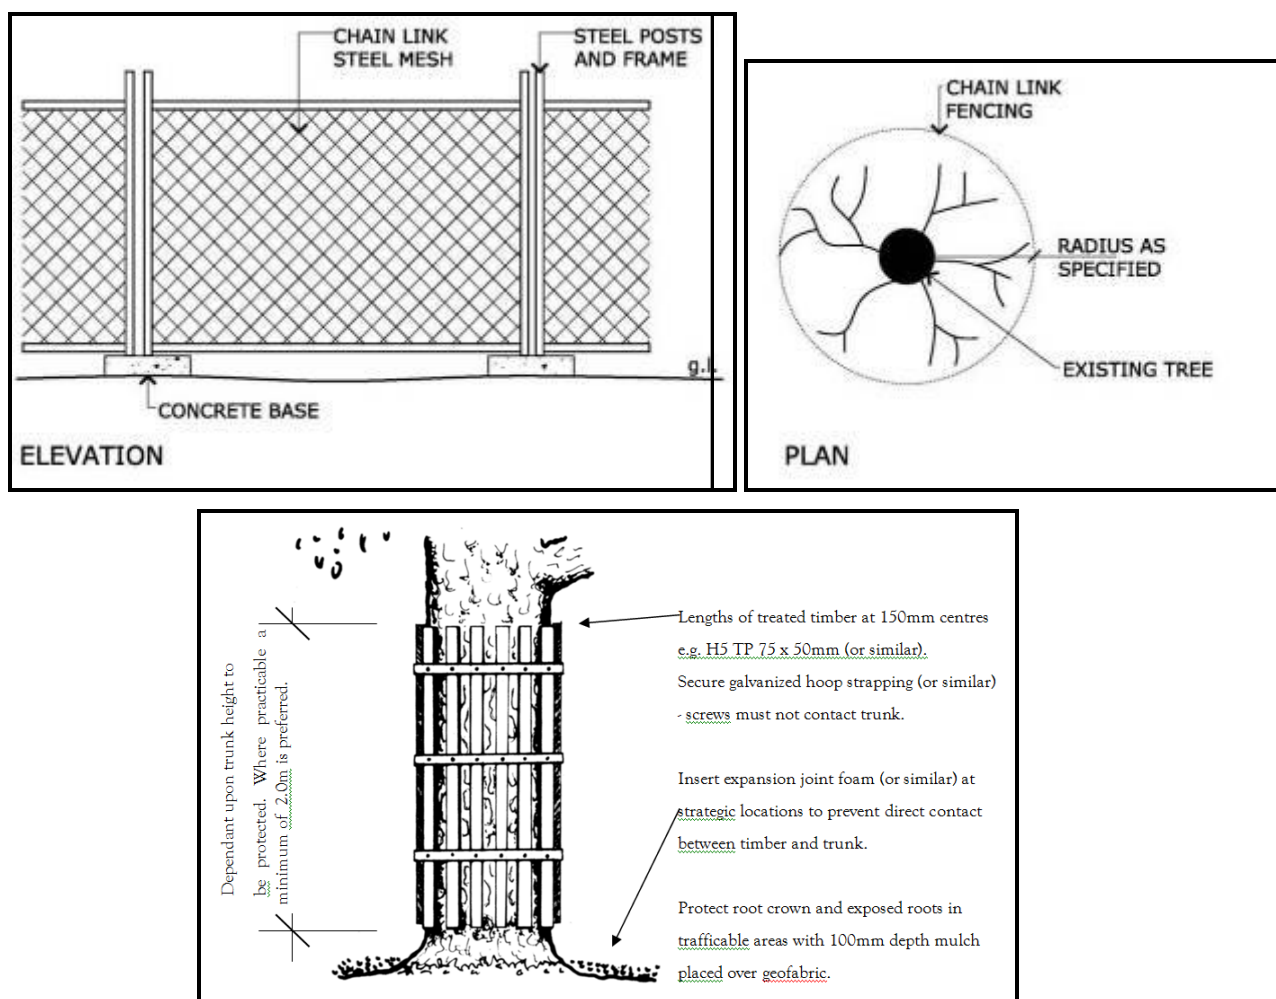
The installation of Tree Protection Zone (TPZ) fencing is to be carried out prior to commencement of all works. The most suitable fencing material is 1.8m tall chain link mesh with 50mm metal pole supports, see **detail 1: tree protection fencing**.

Trunk protection “Tree Guards” are detailed (below) by generic diagram.
