Development Application for _____	Avalon Central Pty Ltd
	Name of Applicant
Address of site _____	3 Central Road, Avalon, NSW

**REPORT TO
AVALON CENTRAL PTY LTD**

**ON
GEOTECHNICAL INVESTIGATION AND
ASSESSMENT
(In Accordance with Pittwater Council Risk
Management Policy)**

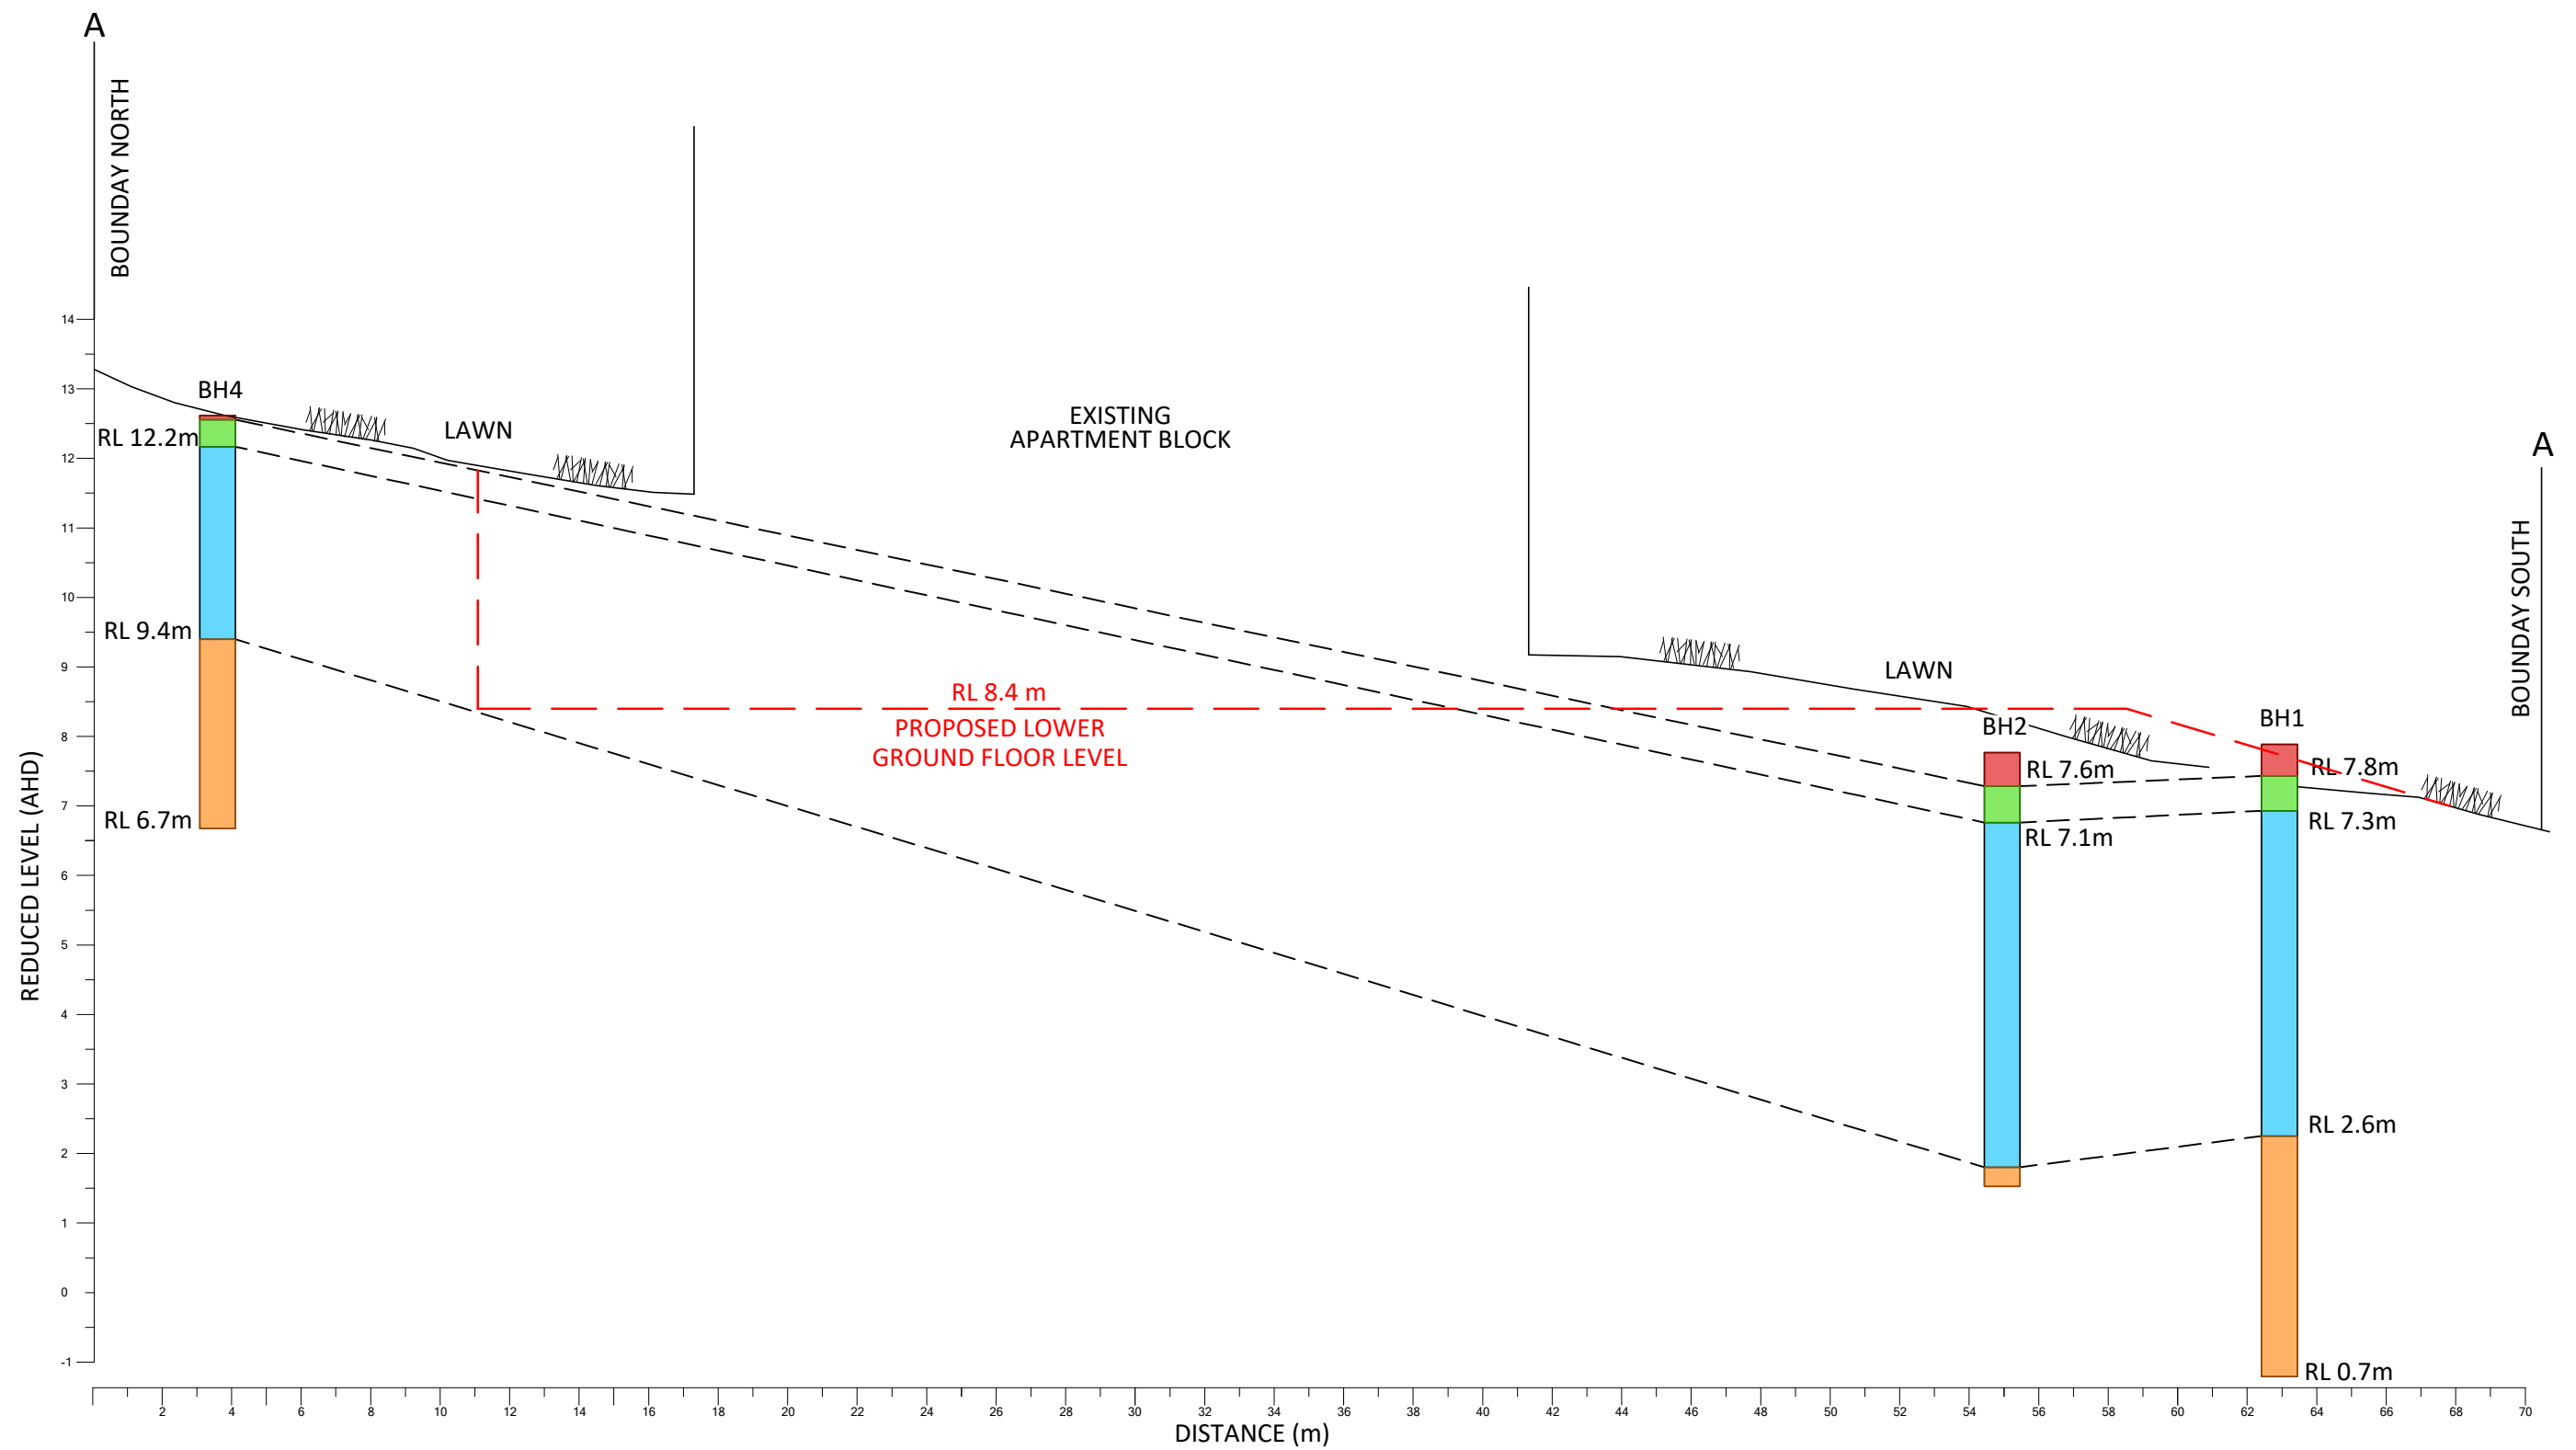
- FILL
- ALLUVIAL SOILS
- RESIDUAL SOILS
- EXTREMELY WEATHERED SILTSTONE/SANDSTONE

Reference to the Sydney 1:100,000 Geological Series Sheet indicates that the site is located within an area mapped to be underlain by the Newport Formation of the Narrabeen Group. The boreholes disclosed a subsurface profile of shallow fill, underlain by alluvial sands over residual clays grading into siltstone bedrock of generally poor quality. Further comments on the subsurface conditions encountered are provided below. Reference should be made to the borehole logs for detailed descriptions of the subsurface conditions encountered. The results are also summarised within the section given as Figure 3.

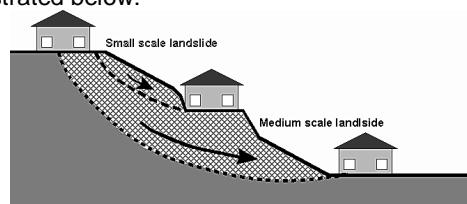
Figure 1

Rotational or circular slip failures (Figure 1) - can occur on moderate to very steep soil and weathered rock slopes (Table 1). The sliding surface of the moving mass tends to be deep seated. Tension cracks may open at the top of the slope and bulging may occur at the toe. The ground may move in discrete "steps" separated by long periods without movement. More rapid movement may occur after heavy rain.

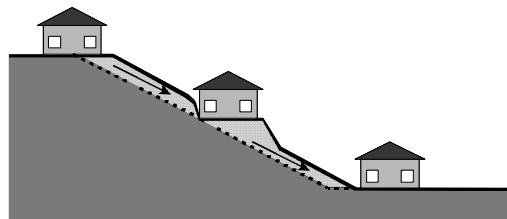
Figure 2

Translational slip failures (Figure 2) - tend to occur on moderate to very steep slopes (Table 1) where soil, or weak rock, overlies stronger strata. The sliding mass is often relatively shallow. It can move, or deform slowly (creep) over long periods of time. Extensive linear cracks and hummocks sometimes form along the contours. The sliding mass may accelerate after heavy rain.

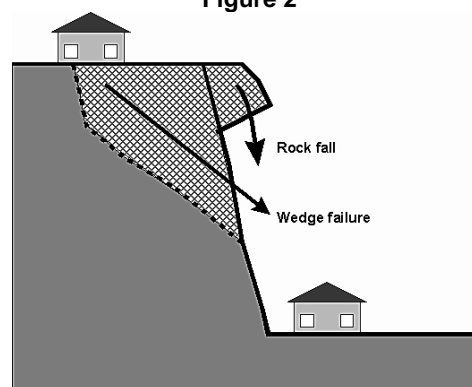
Figure 3

Wedge failures (Figure 3) - normally only occur on extreme slopes, or cliffs (Table 1), where discontinuities in the rock are inclined steeply downwards out of the face.

Rock falls (Figure 3) - tend to occur from cliffs and overhangs (Table 1).

Cliffs may remain, apparently unchanged, for hundreds of years. Collections of boulders at the foot of a cliff may indicate that rock falls are ongoing. Wedge failures and rock falls do not "creep". Familiarity with a particular local situation can instil a false sense of security since failure, when it occurs, is usually sudden and catastrophic.

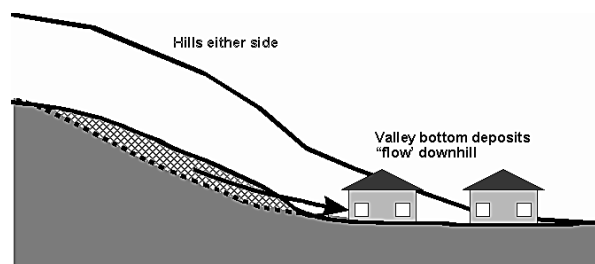
Figure 4

Debris flows and mud slides (Figure 4) - may occur in the foothills of ranges, where erosion has formed valleys which slope down to the plains below. The valley bottoms are often lined with loose eroded material (debris) which can "flow" if it becomes saturated during and after heavy rain. Debris flows are likely to occur with little warning; they travel a long way and often involve large volumes of soil. The consequences can be devastating.

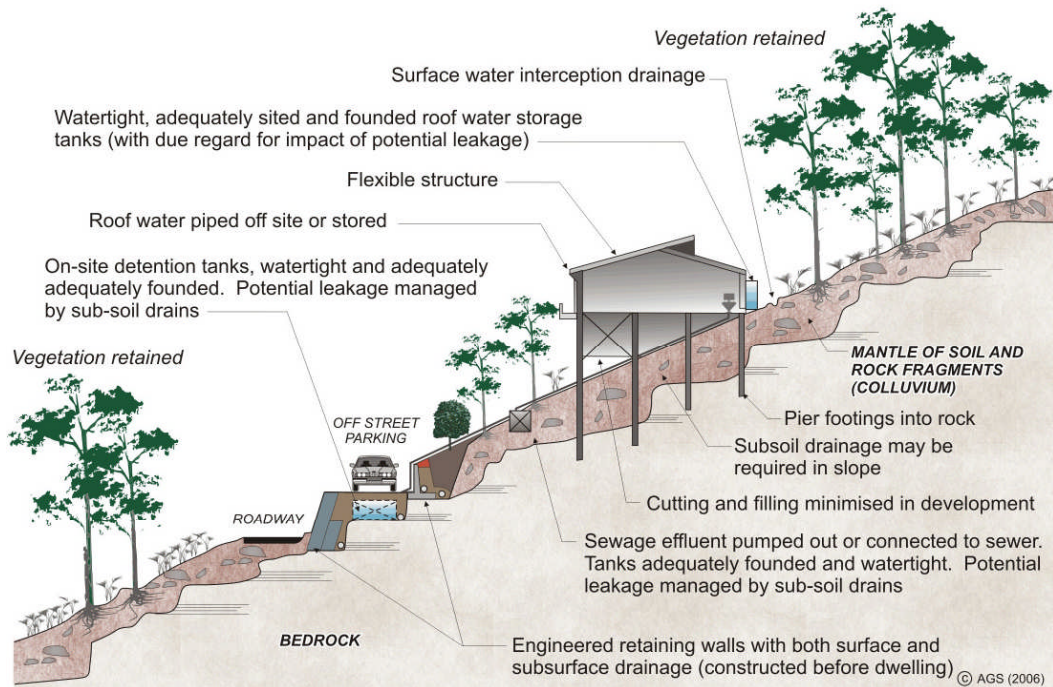
EXAMPLES FOR **GOOD** HILLSIDE CONSTRUCTION PRACTICE

Roadways and parking areas - are paved and incorporate kerbs which prevent water discharging straight into the hillside (GeoGuide LR5).

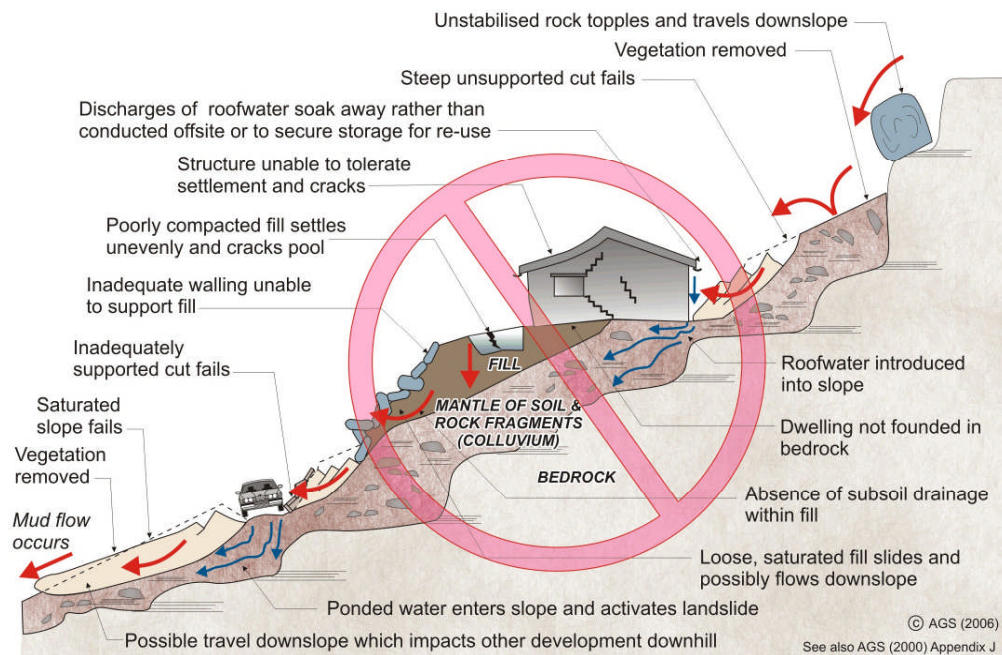
EXAMPLES FOR **POOR** HILLSIDE CONSTRUCTION PRACTICE

Roadways and parking areas - are unsurfaced and lack proper table drains (gutters) causing surface water to pond and soaks into the ground.
