Report Title: Geotechnical Report 56 Crescent Road, Newport
Report Date: 30/9/24

GEOTECHNICAL INVESTIGATION:

Proposed Secondary Dwelling at **56 Crescent Road, Newport**

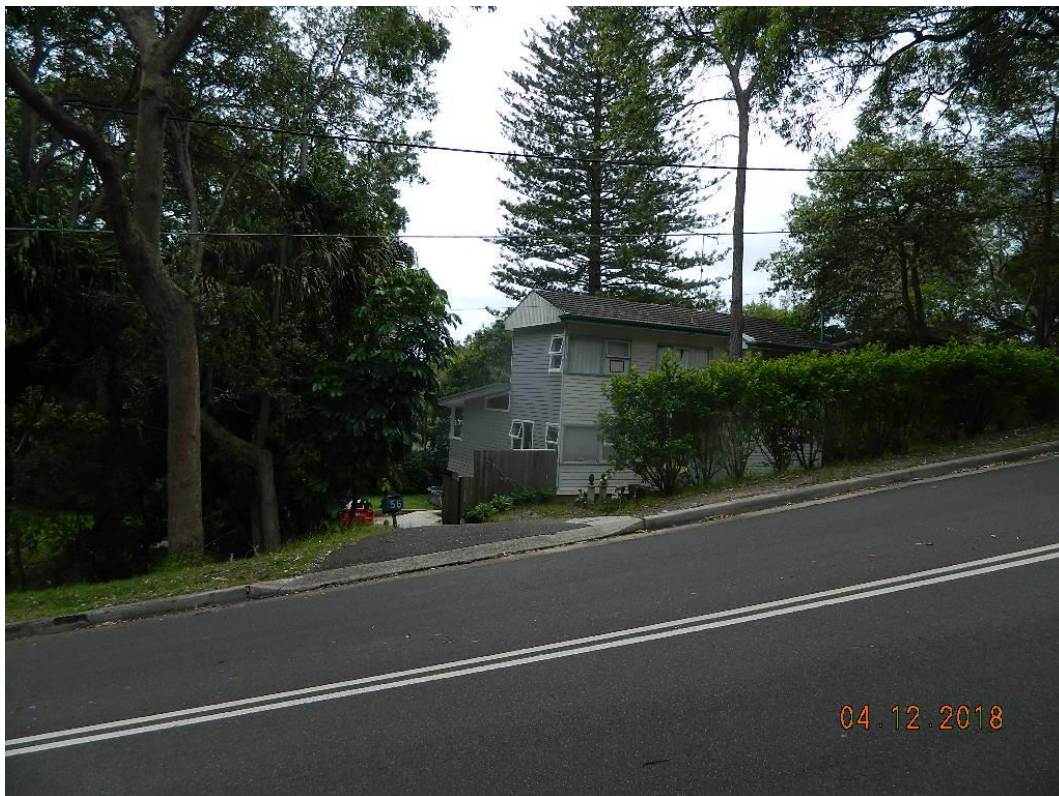
Photo 1

- 2.3** At the road frontage, a concrete driveway runs down the S side of the property to a garage under the downhill side of the house (Photos 1 & 2). A gently sloping lawn falls from the road frontage (Photo 3). An excavation has been made in the slope to create a level platform for the uphill side of the house. The cut is supported by a stable sandstone flagging retaining wall (Photo 4). A portion of the wall will be demolished as part of the proposed works. The wall continues down the N side of the house as a stable treated pine retaining wall (Photo 5). The part two-storey timber framed and clad house is supported on brick walls and brick piers (Photo 6). A large vertical crack

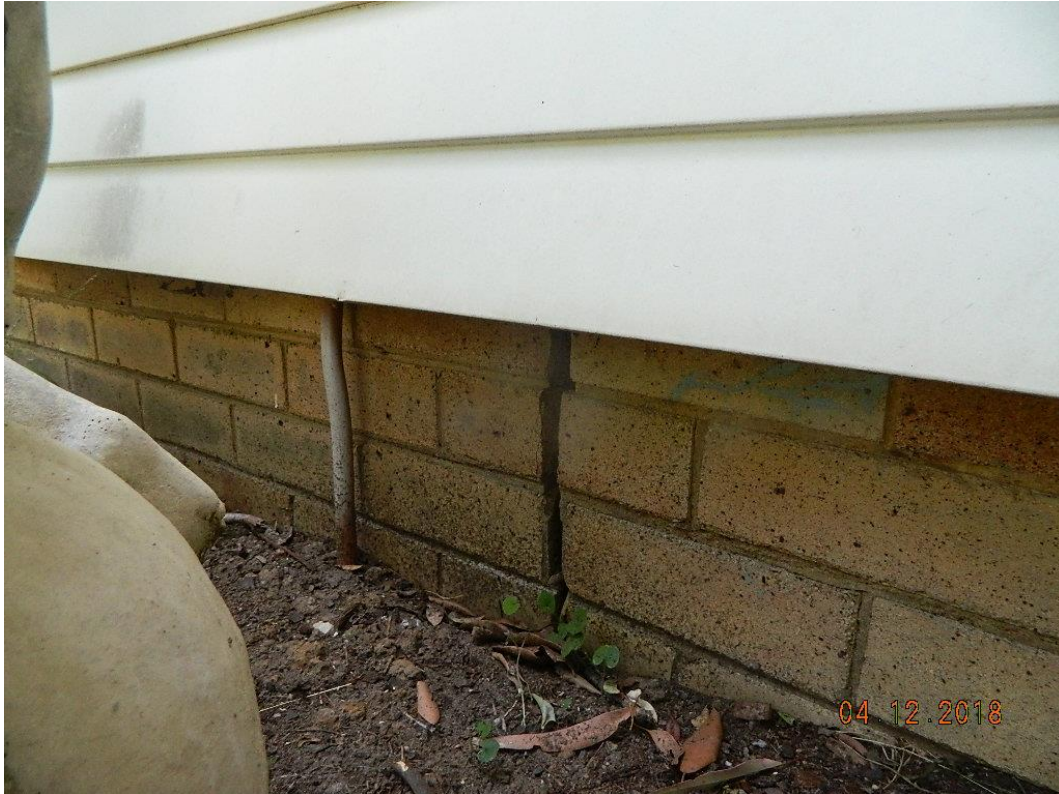
Photo 7

observed in the uphill supporting brick wall of the house (Photo 7). We are not sure why the cracking has occurred but it is not considered the result of settlement or an indication of slope instability. The brick piers stand vertical (Photo 8). A stable timber crib wall reaching a maximum height of ~1.5m runs along a portion of the N common boundary below the house. The wall continues on the N neighbouring property and supports a cut and fill for a level lawn area on the N neighbouring property (Photo 9). The slope that falls from the downhill side of the house to the lower boundary has been terraced. The terraces are supported by stable treated timber retaining walls that reach a maximum height of ~1.6m (Photos 10 & 11).

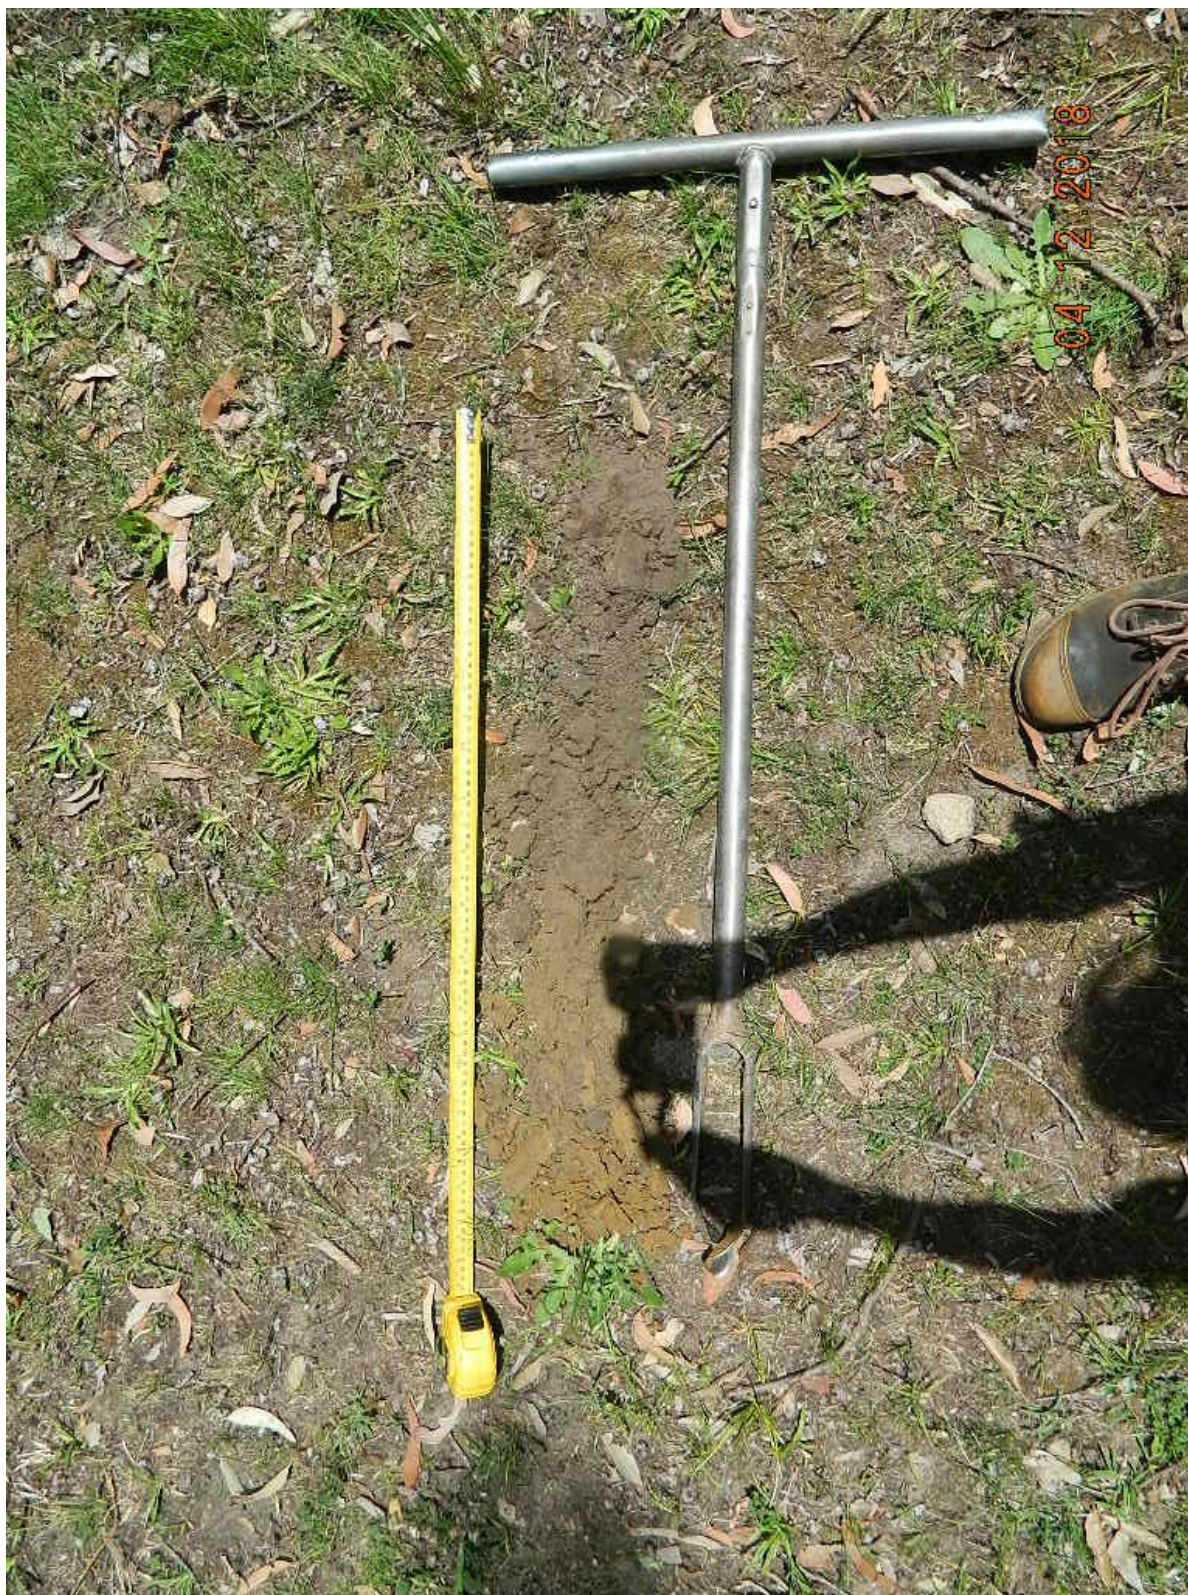
Photo 12 - End of the auger is at the bottom of the image

AUGER HOLE 1 (~RL14.4) – AH1 (Photo 12)

Depth (m)	Material Encountered
0.0 to 0.4	SANDY SOIL , light brown/brown, loose, fine to medium grained, organic matter, dry.
0.4 to 0.6	SANDY CLAY , orange/brown, firm, rock fragments, fine to medium grained, dry.
0.6 to 0.8	SANDY CLAY , orange/brown, stiff, fine to medium grained, dry.

End of hole @ 0.8m in sandy clay. No water table encountered.
