Anthony Protas Consulting Pty Ltd
BUILDING REGULATIONS CONSULTANTS

**Re: 1174 Barrenjoey Road, Palm Beach
Construction Certificate**

Construction Certificate – 1174 Barrenjoey Road, Palm Beach - Demolition of the existing garage & shed and construction of a new garage, driveway, retaining walls & associated landscaping
BCA Class: 10a & 10b

Report on Internal and External
aspects at
1176 Barrenjoey Road,
Palm Beach, NSW 2108
Thursday 13th September 2012.

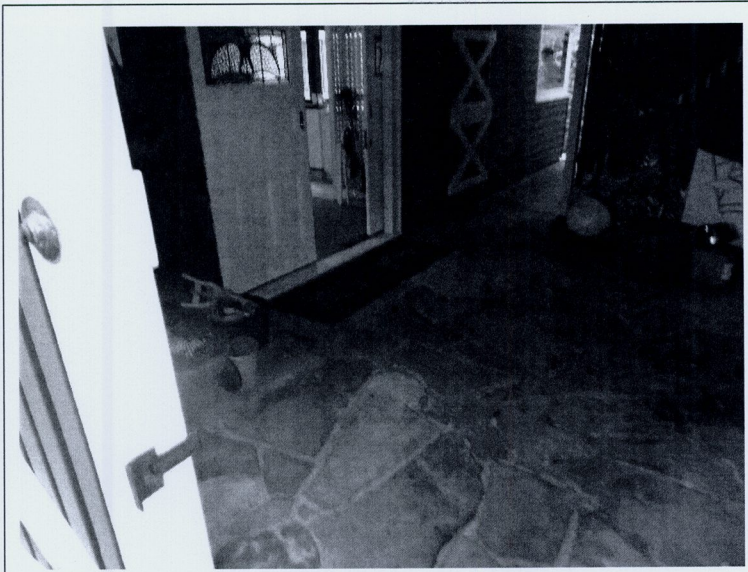
Photograph 1
Western Entrance
This photograph represents the general condition of the Western entrance of the dwelling.

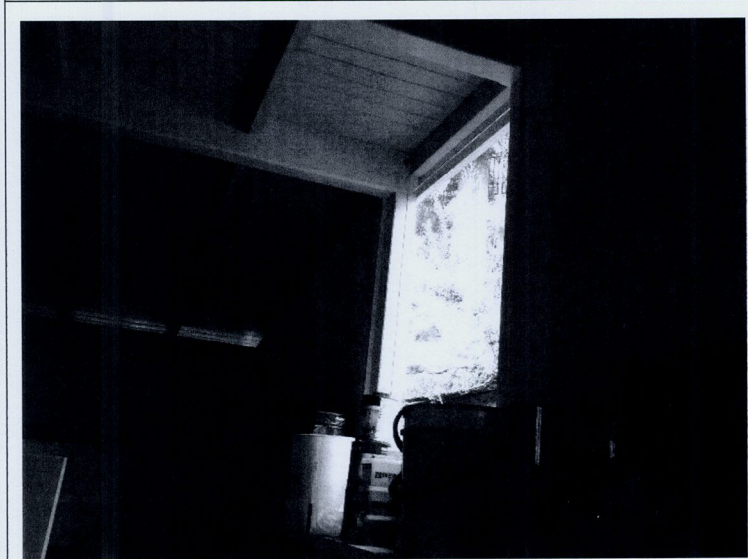
Photograph 2
Storage Area
This photograph represents the general condition of the Western storage area.

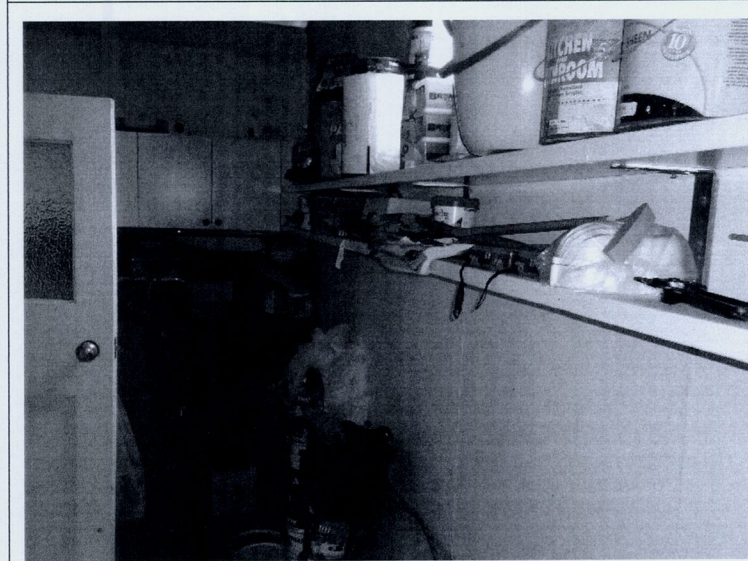
Photograph 3
Storage Area
This photograph represents the general condition of the Western storage area.

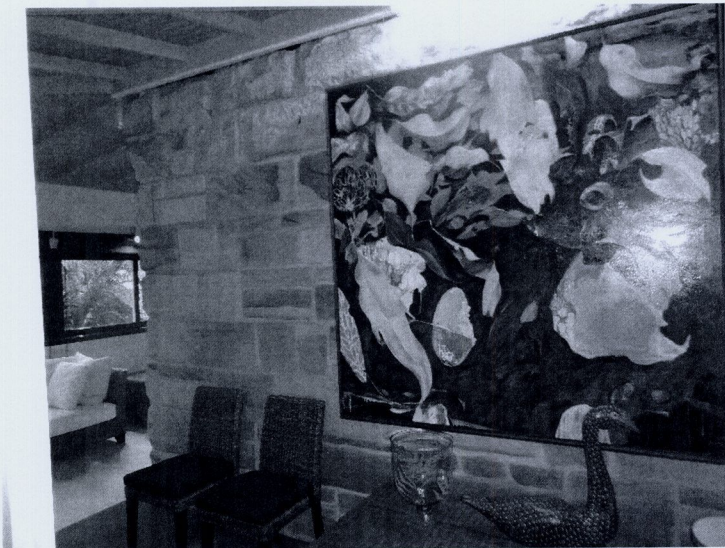
<p>Photograph 4</p> <p><u>Entrance</u></p> <p>This photograph represents the general condition of the Western façade of the internal cottage.</p>

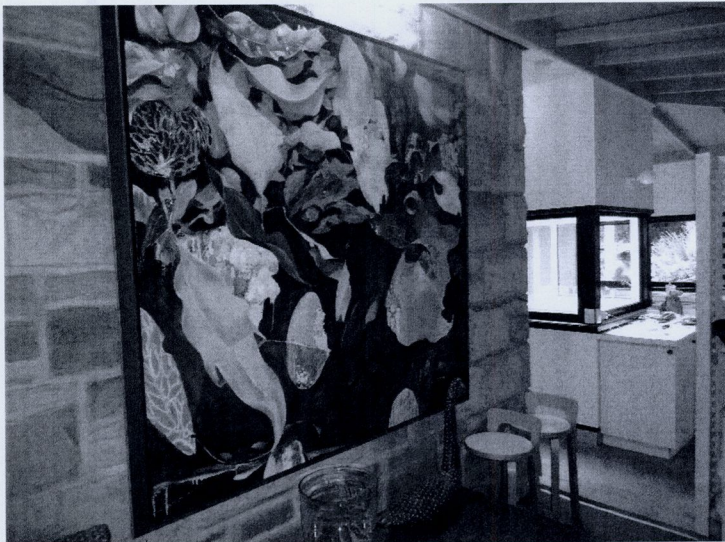
<p>Photograph 5</p> <p><u>Entrance</u></p> <p>This photograph represents the general condition of the Western façade of the internal cottage.</p>

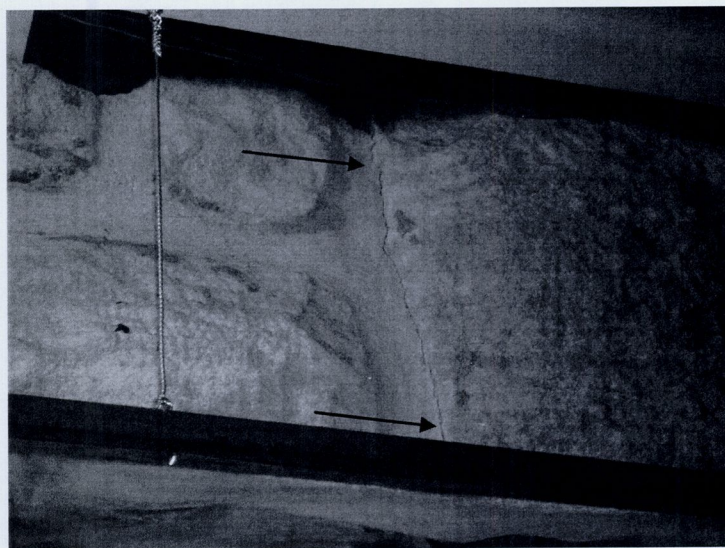
<p>Photograph 6</p> <p><u>Entrance</u></p> <p>A hairline crack is evident to the mortar joint adjacent to the sandstone block above the RHS of the art piece.</p>

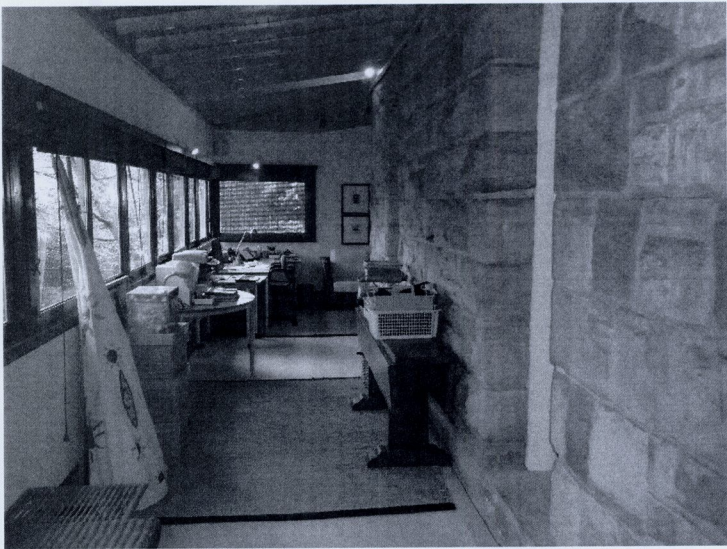
Photograph 10
Northern Passage
 This photograph represents the general condition of the Northern passage from the NW corner.

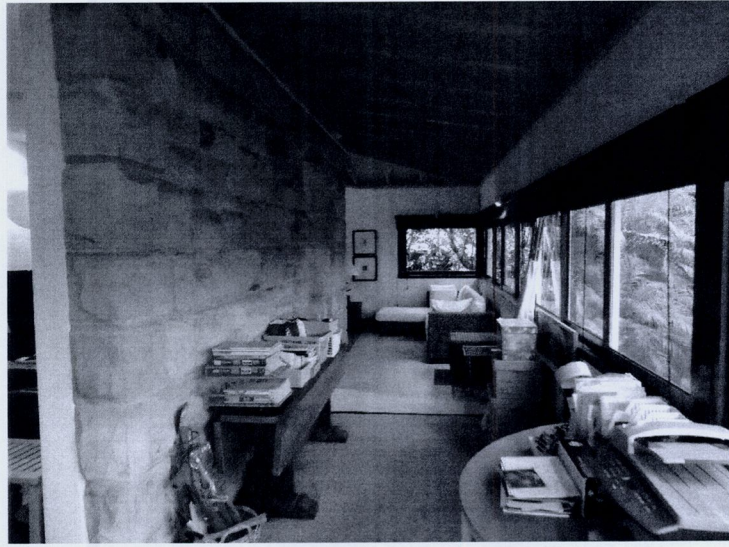
Photograph 15
Northern Passage
 This photograph represents the general condition of the Northern passage from the NE corner.

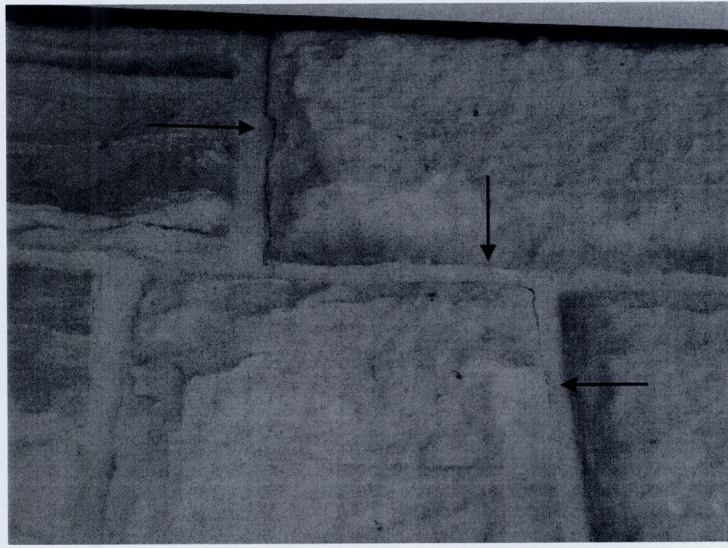
<p>Photograph 17</p> <p><u>Eastern Passage</u></p> <p>A stepped crack is evident to the mortar joint to the top course of sandstone blocks to the interior cottage.</p>

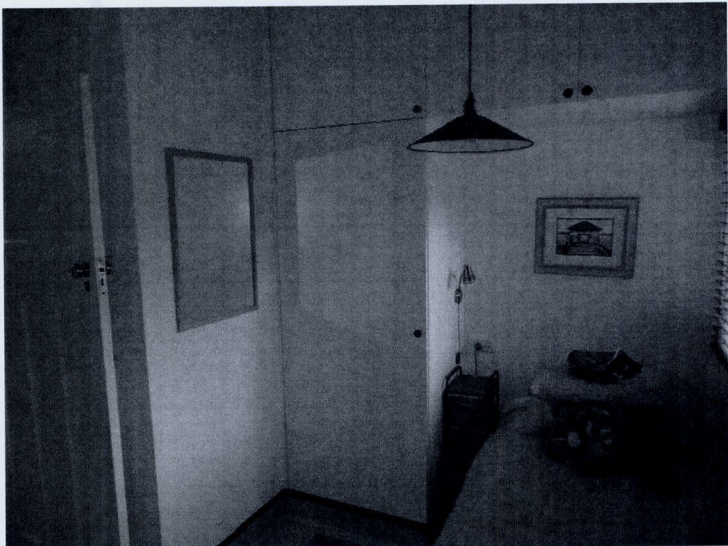
<p>Photograph 19 <u>Second Guestroom</u> This photograph represents the general condition of the SE ground floor guest bedroom.</p>

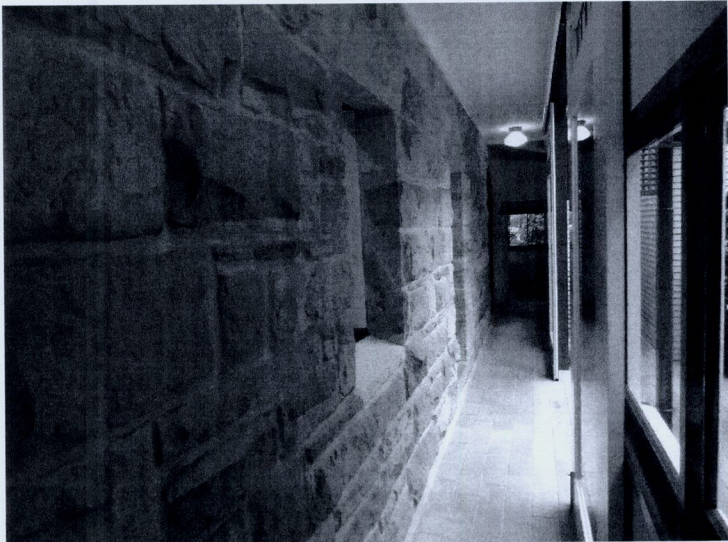
<p>Photograph 20 <u>Southern Passage</u> This photograph represents the general condition of the Southern passage from the SW corner.</p>

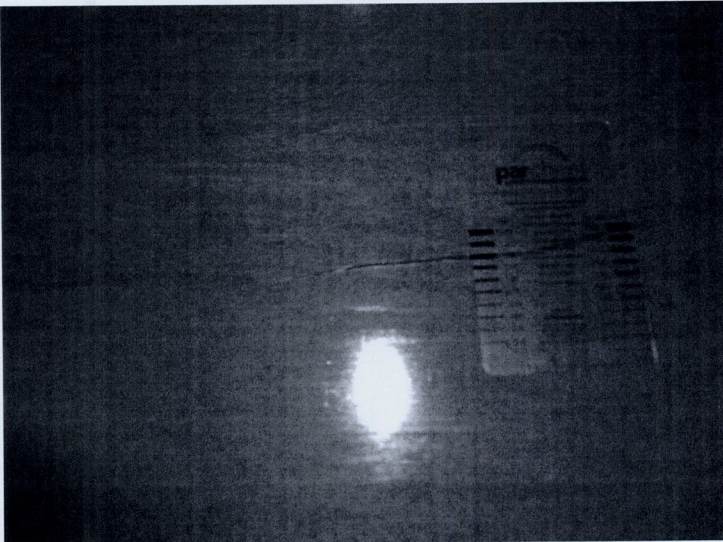
<p>Photograph 23 <u>Staircase</u></p> <p>A 1.5mm wide crack is evident on the eighth stair tread.</p>

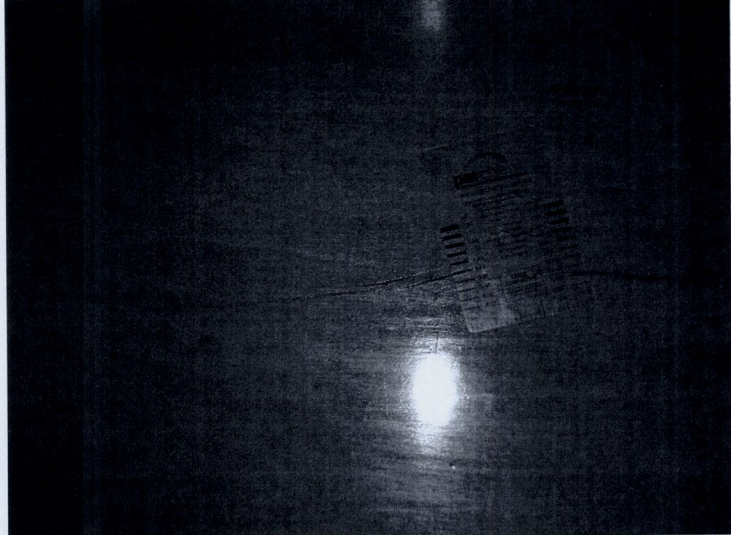
<p>Photograph 24 <u>Staircase</u></p> <p>A 0.75mm wide crack is evident on the eighth stair tread.</p>

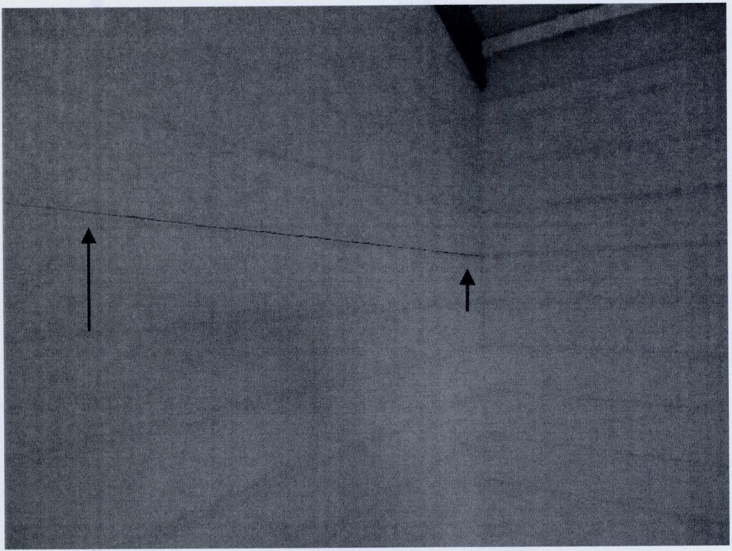
<p>Photograph 31 <u>Master Bedroom</u> Cracks to the paintwork are evident to the RHS of the ensuite door.</p>

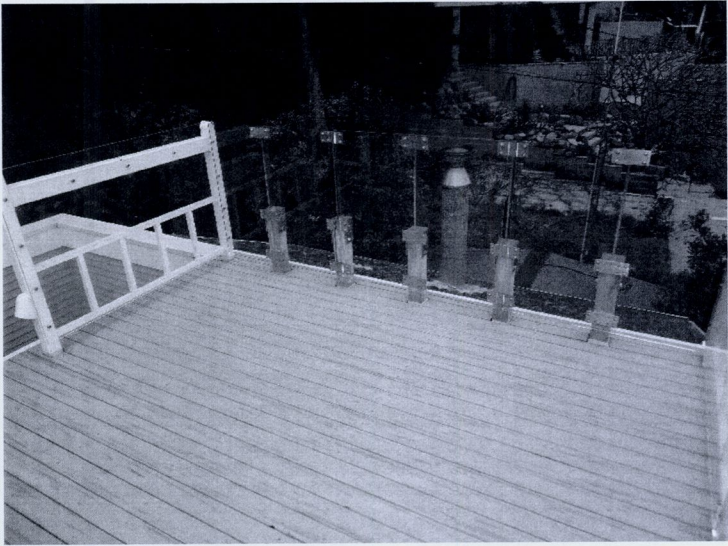
<p>Photograph 33 <u>Rooftop Landing</u> This photograph represents the general condition of the lookout.</p>

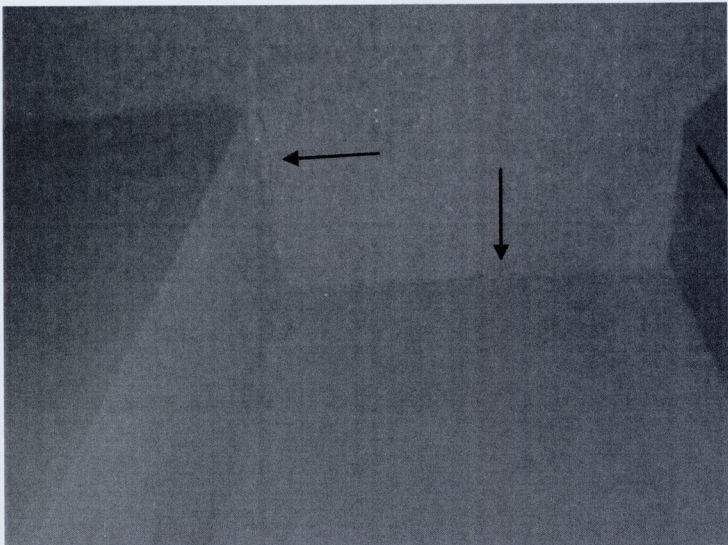
<p>Photograph 34 <u>Internal Cottage</u> Hairline cracks are evident at the ceiling – wall junction adjacent to the fireplace.</p>

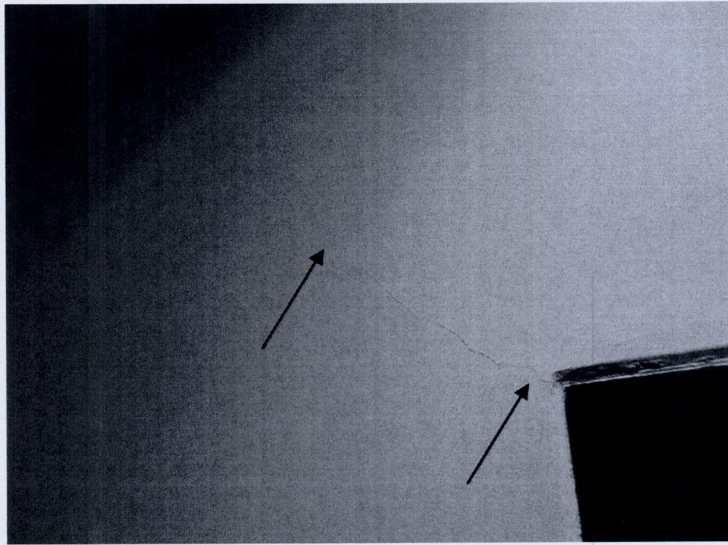
<p>Photograph 35 <u>Internal Cottage</u> A paint defect is evident to the top LHS of the Southern door opening.</p>

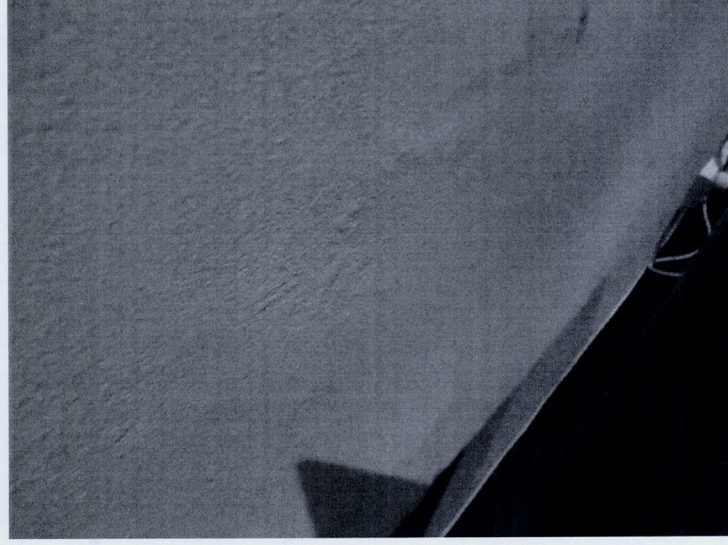
<p>Photograph 36 <u>Internal Cottage</u> Bubbling paint is evident to the lower LHS of the SW opening timber sill.</p>

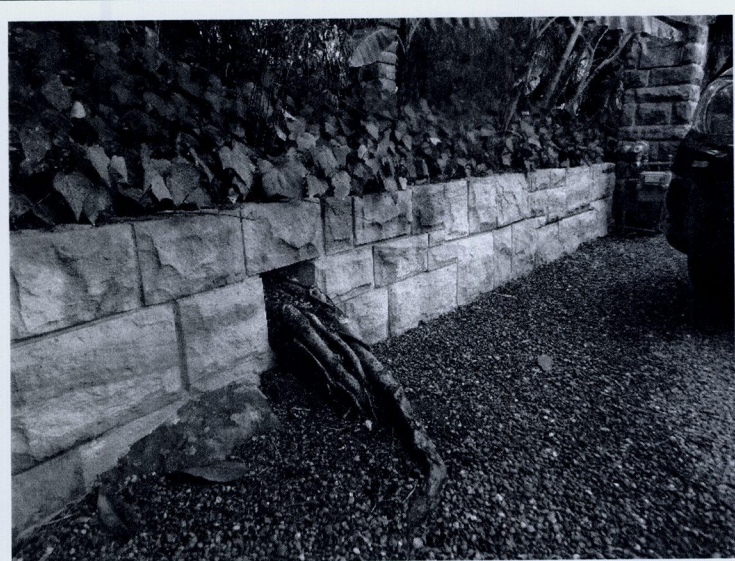
Photograph 37
Northern Elevation
This photograph represents the general condition of the driveway sandstone retaining wall.

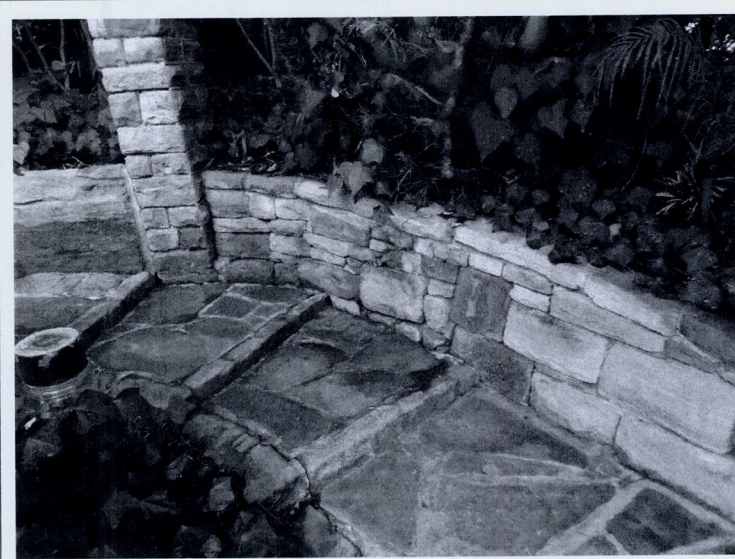
Photograph 38
Northern Elevation
This photograph represents the general condition of the garden retaining wall and entrance pathway.

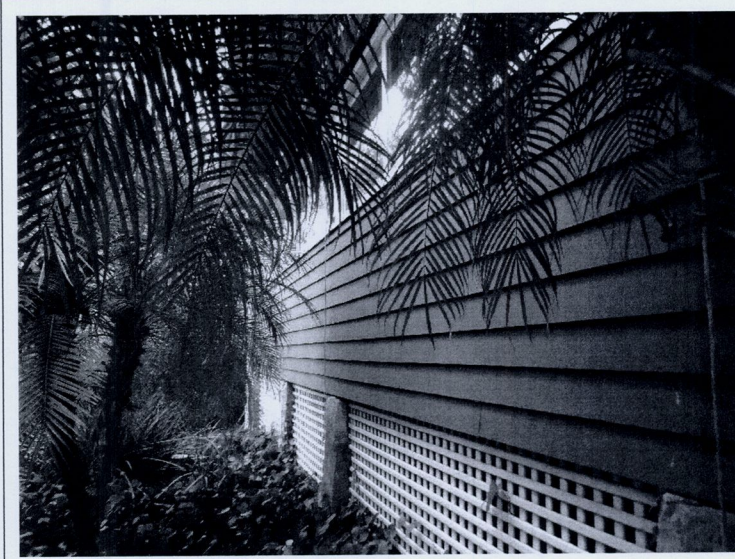
Photograph 39
Northern Elevation
This photograph represents the general condition of the Northern façade of the dwelling, from the NW corner.

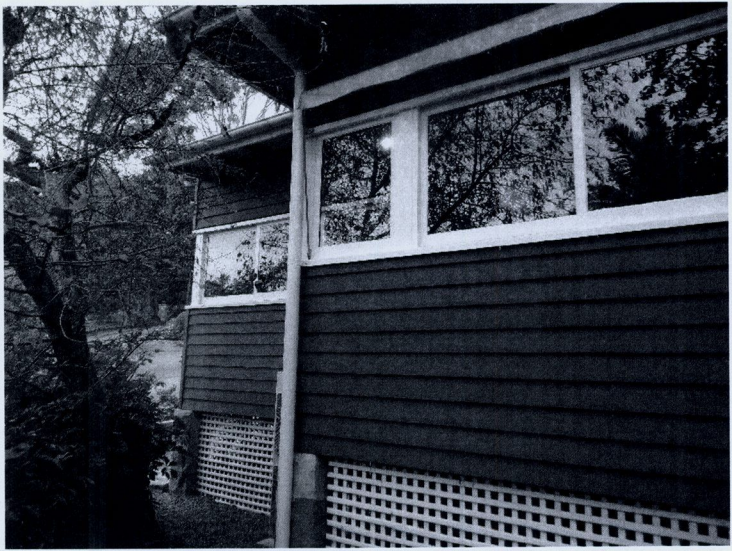
Photograph 40
Northern Elevation
This photograph represents the general condition of the Northern façade of the dwelling, from the NE corner.

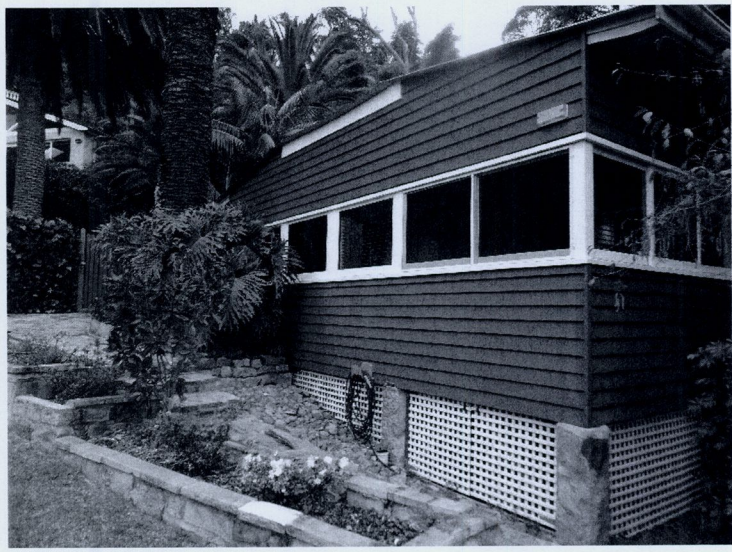
Photograph 41
Eastern Elevation
This photograph represents the general condition of the Eastern façade of the dwelling, from the NE corner.

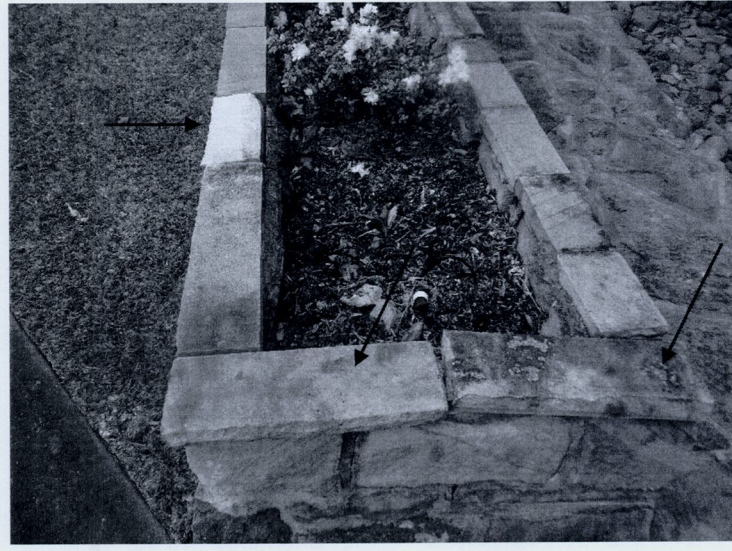
Photograph 42
Eastern Elevation
Loose sandstone cappings were evident to the Eastern planterbox.

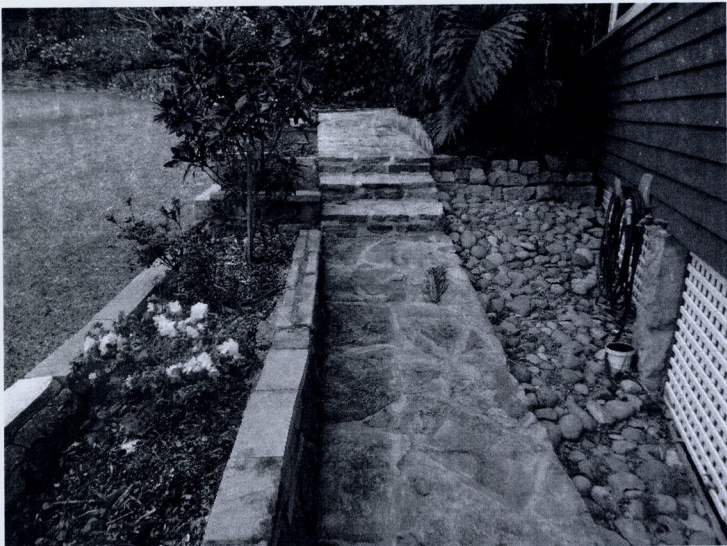
Photograph 43
Eastern Elevation

This photograph represents the general condition of the Eastern pathway.

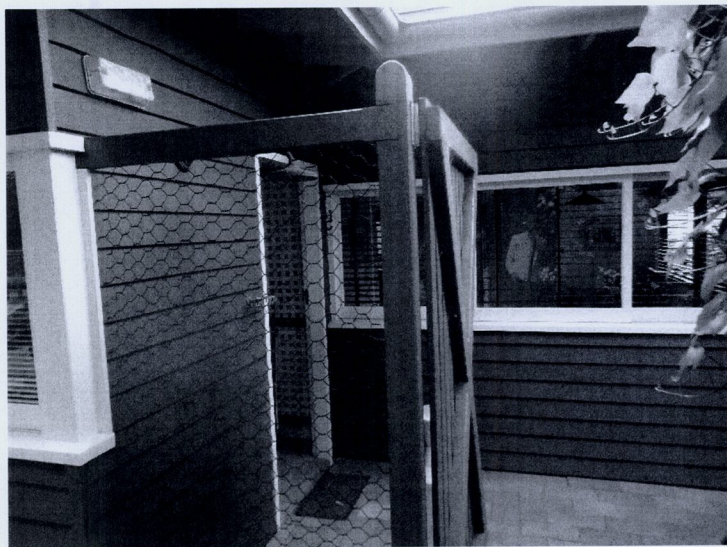
Photograph 44
Southern Elevation

This photograph represents the general condition of the Southern façade of the dwelling, from the SE corner.

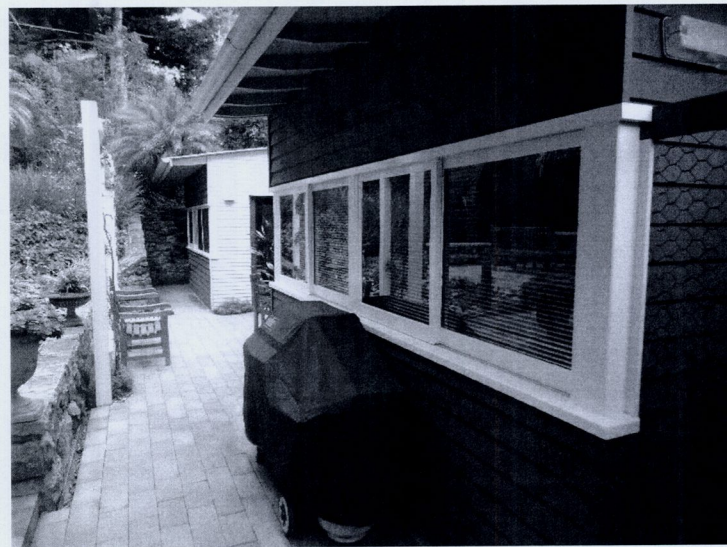
Photograph 45
Southern Elevation

This photograph represents the general condition of the Southern façade of the dwelling, from the SE corner.

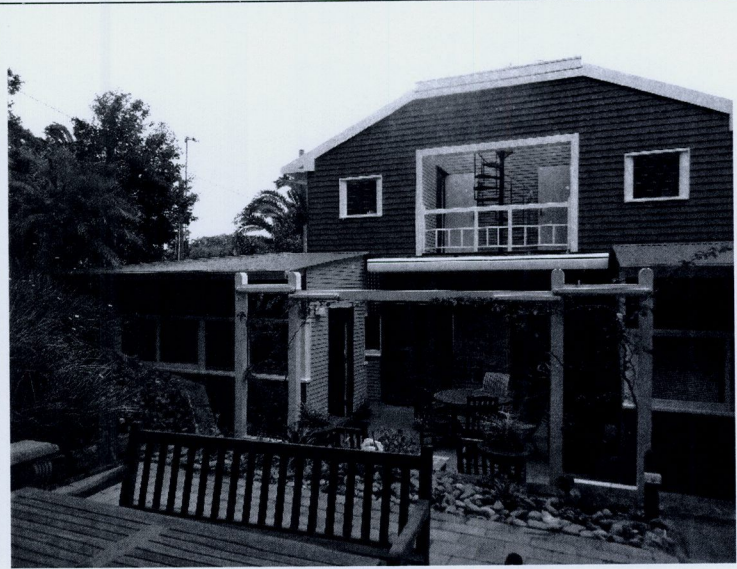
Photograph 46
Southern Elevation
This photograph represents the general condition of the Southern façade.

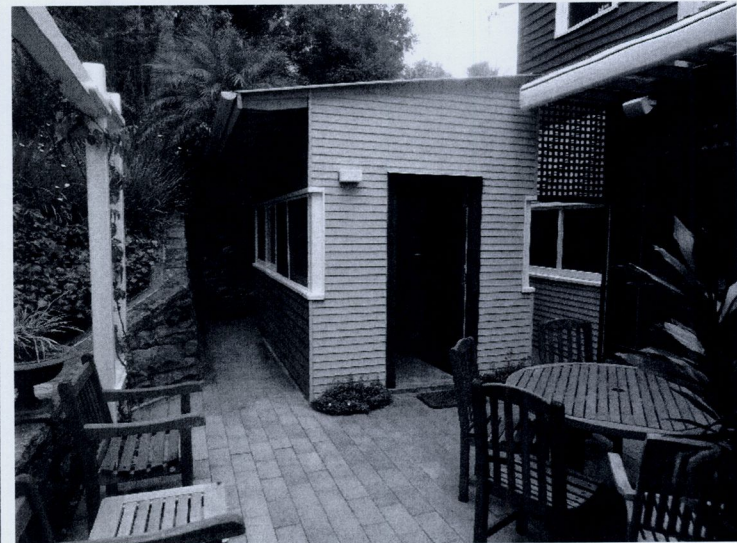
Photograph 47
Southern Elevation
This photograph represents the general condition of the rear courtyard.

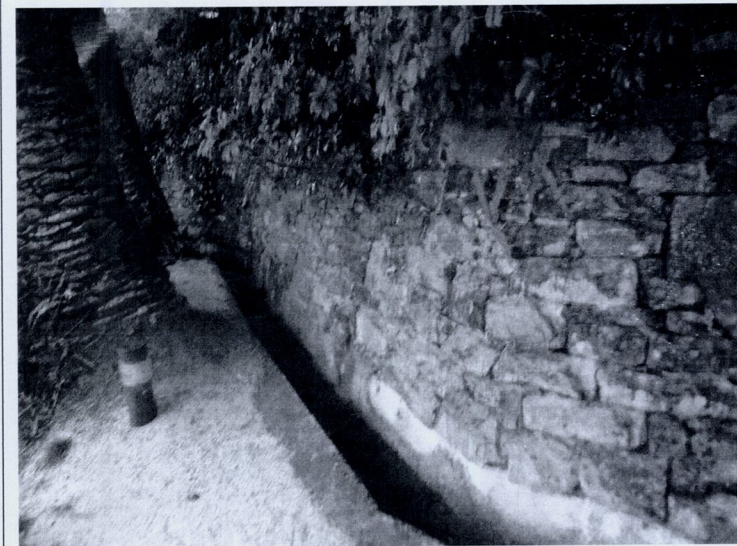
Photograph 48
Southern Elevation
This photograph represents the general condition of the rear stone retaining wall.

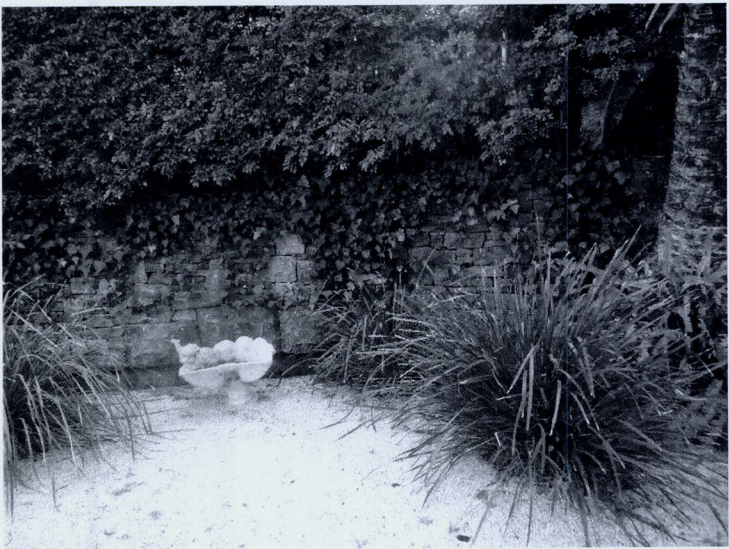
Photograph 49
Southern Elevation

This photograph represents the general condition of the rear stone retaining wall.

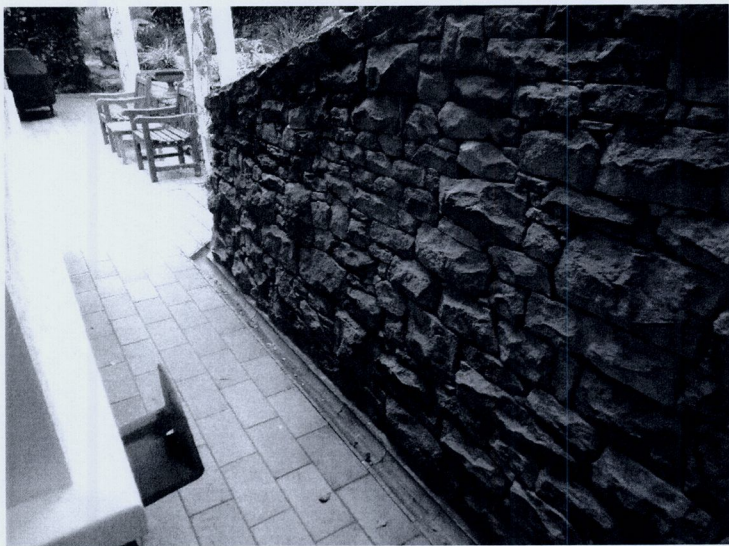
Photograph 50
Southern Elevation

This photograph represents the general condition of the unbound stone retaining wall to the rear pathway.

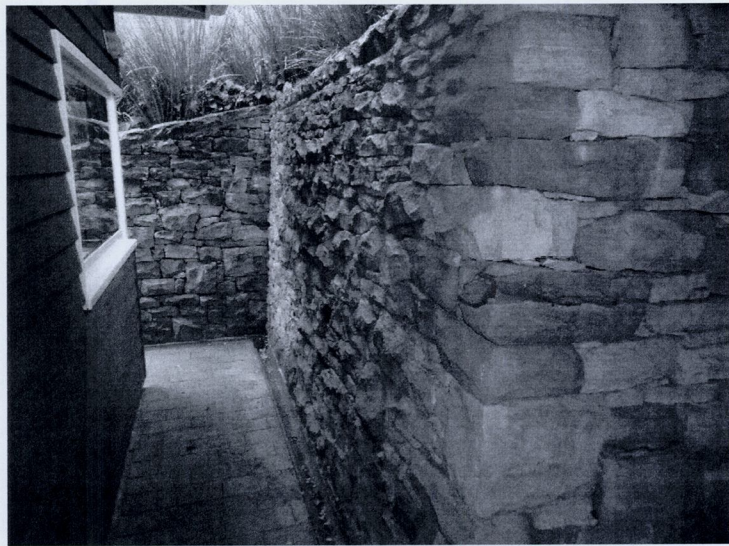
Photograph 51
Western Elevation

This photograph represents the general condition of the unbound stone retaining wall to the SW rear pathway.

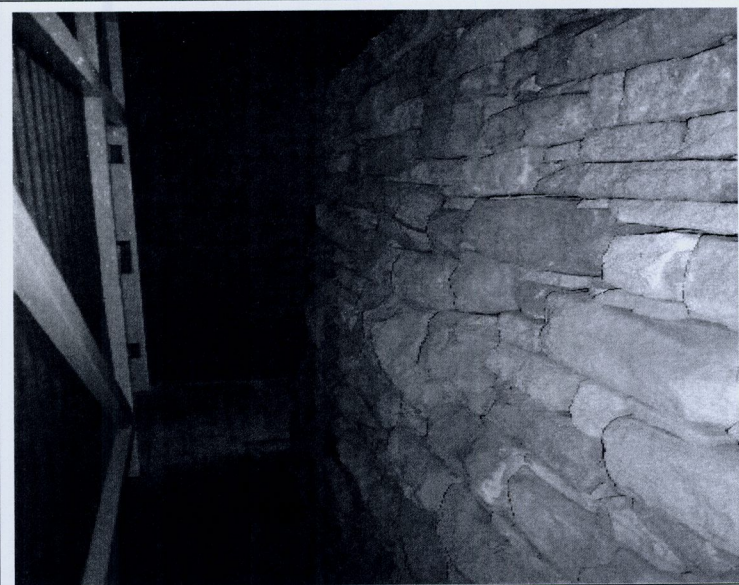
Photograph 52

This photograph represents the general condition of the unbound stone retaining wall to the SW rear pathway.

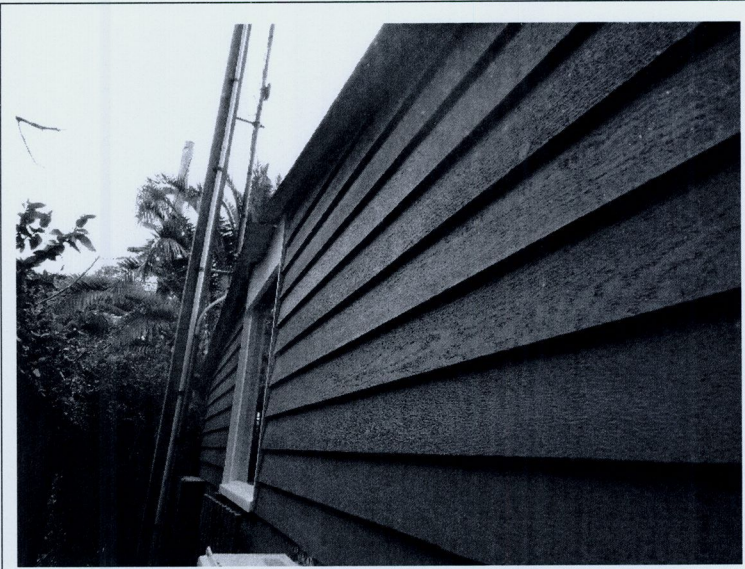
Photograph 58
Western Elevation

This photograph represents the general condition of the Western façade.

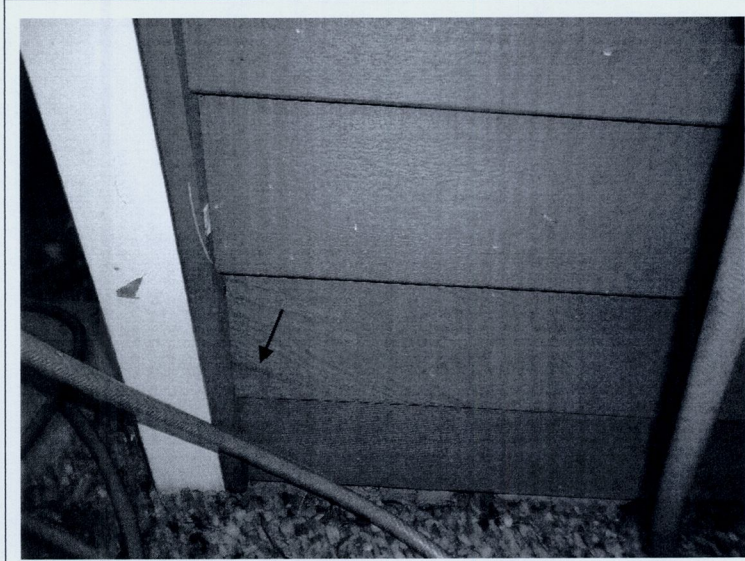
Photograph 60
Western Elevation

A diagonal crack was noted in the weatherboard adjacent to the external tap, to the NW corner of the dwelling.

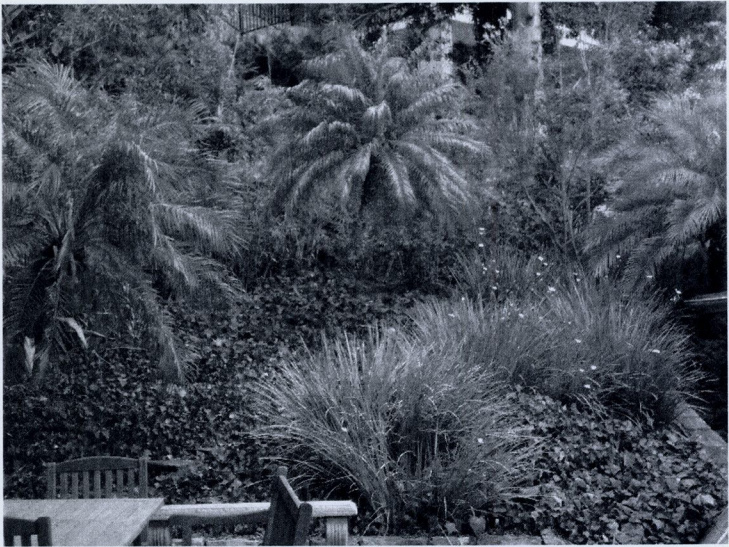
Photograph 61
Western Boundary
This photograph represents the general condition of the Western garden and boundary.

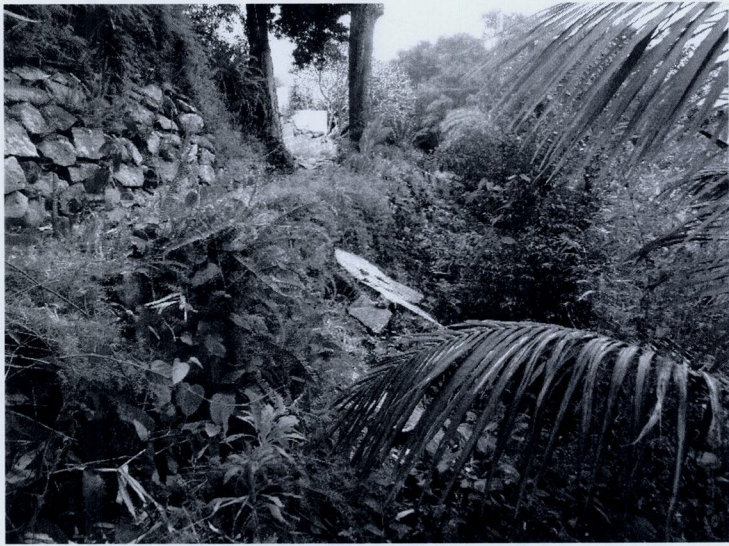
Photograph 62
Western Boundary
This photograph represents the general condition of the unbound stone retaining wall and walkway.

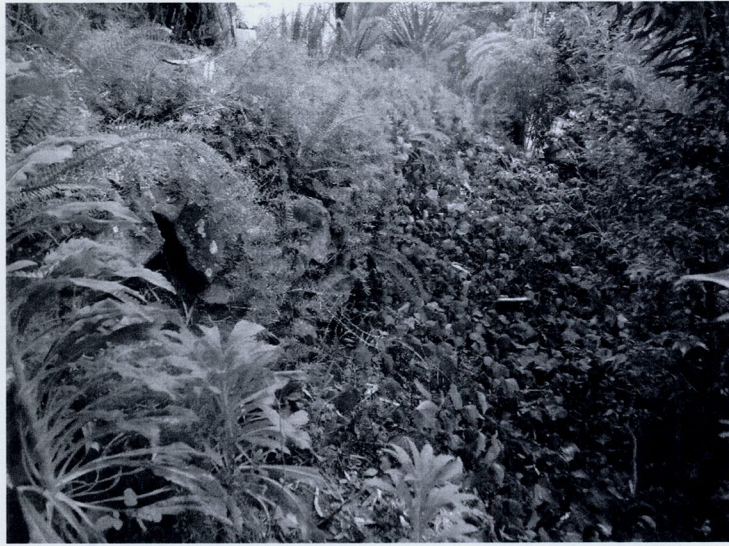
Photograph 63
Western Boundary
This photograph represents the general condition of the garden.

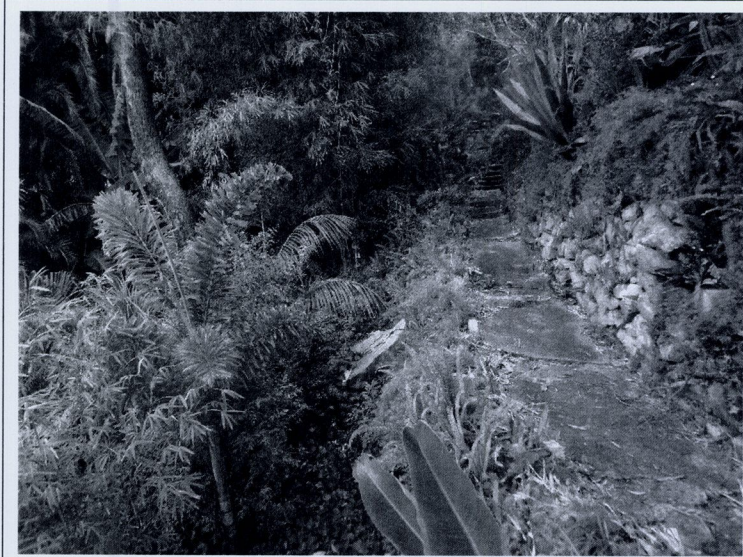
Photograph 64
Western Boundary
This photograph represents the general condition of the garden.

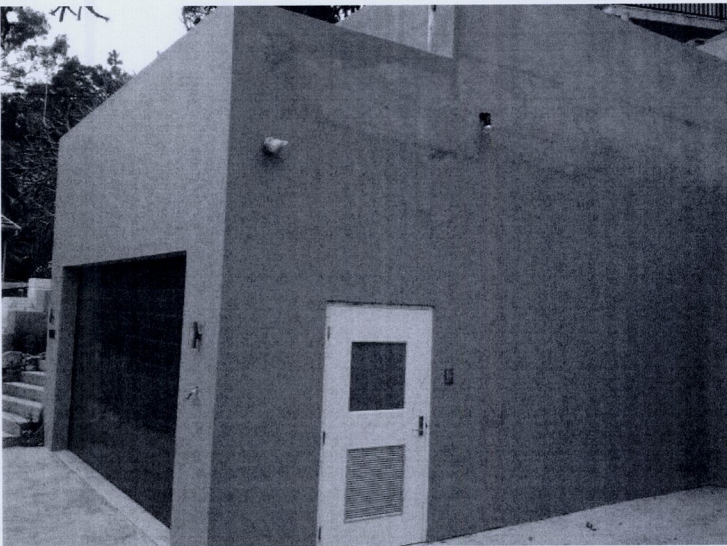
Photograph 2
Garage
 This photograph represents the general condition of the Western façade of the garage from ground level.

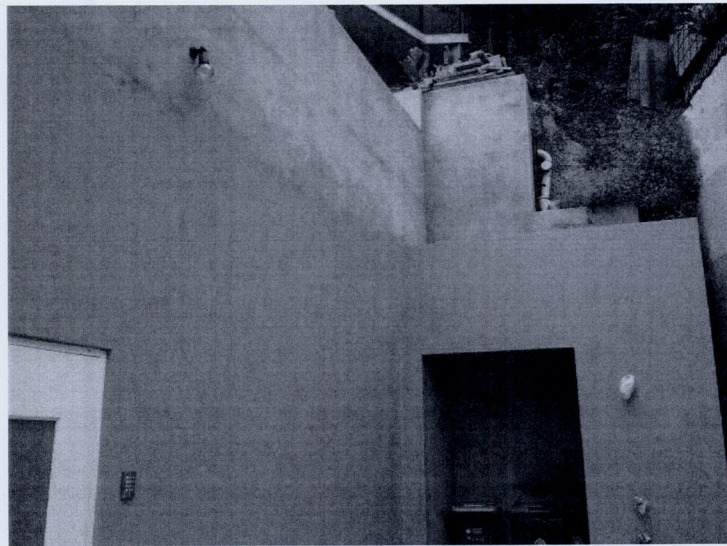
Photograph 3
Garage
 This photograph represents the general condition of the Western façade and bin storage area from ground level.

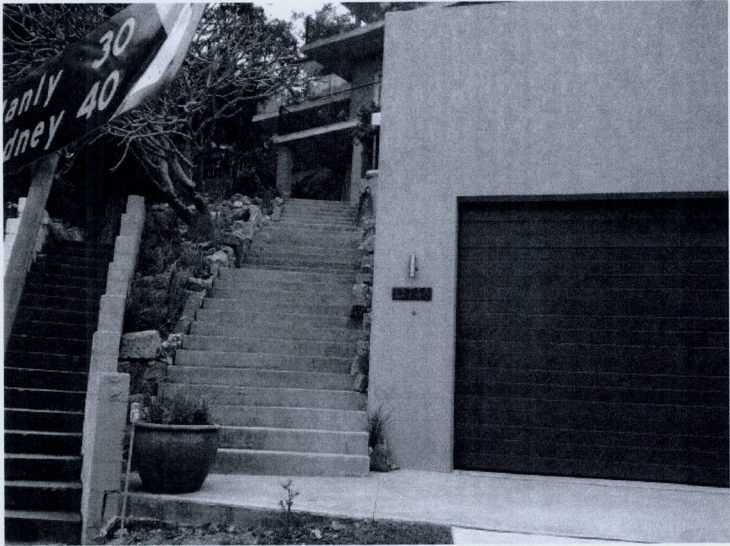
Photograph 7
Northern Elevation
This photograph represents the general condition of the entrance staircase from street level.

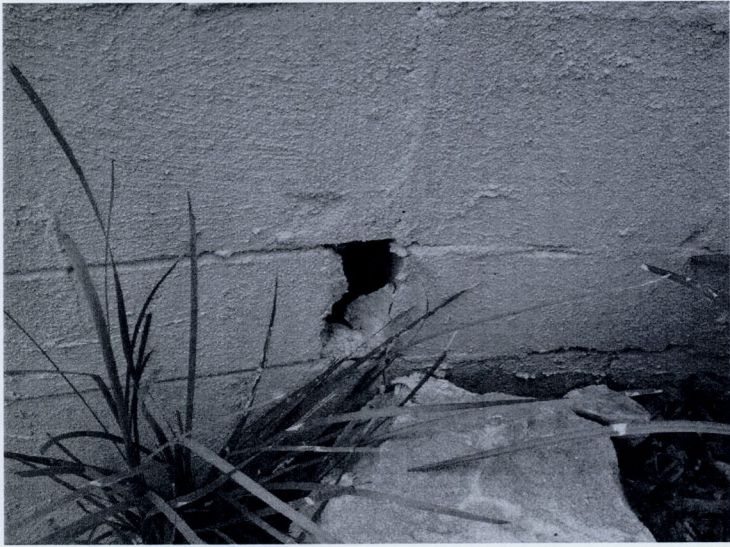
Photograph 9
Northern Elevation
A hole is evident in the concrete blockwork above the second tread of the entrance staircase.

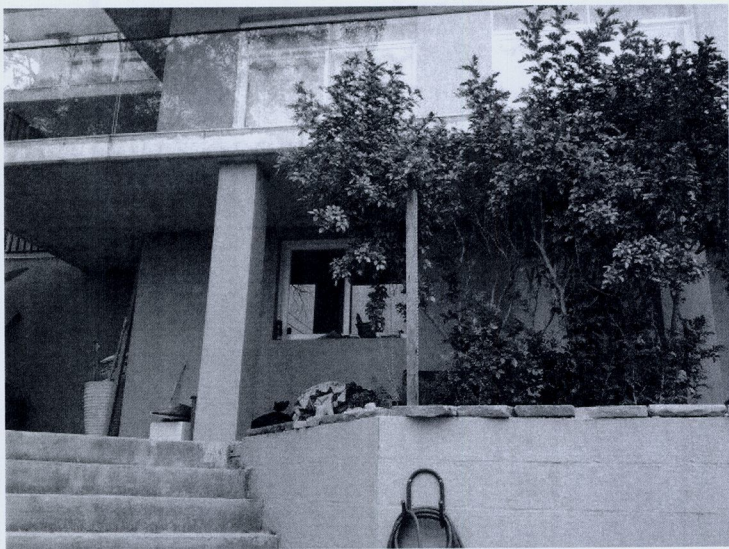
Photograph 10
Northern Elevation
 This photograph represents the general condition of the Northern façade from the entrance staircase on ground level.

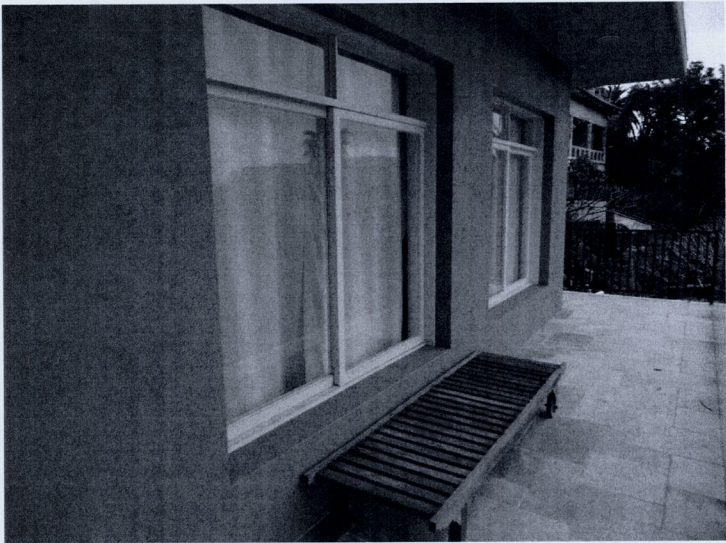
Photograph 11
Northern Elevation
 This photograph represents the general condition of the Northern façade from the first level balcony deck.

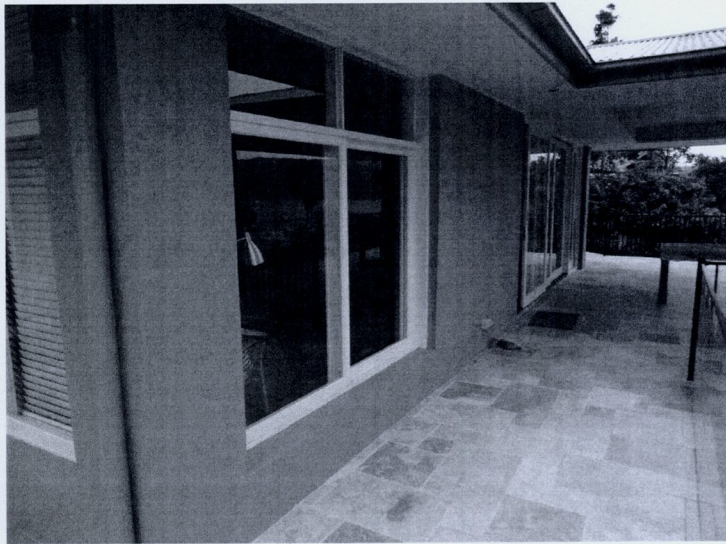
Photograph 12
Northern Elevation
 This photograph represents the general condition of the Northern façade from the second level balcony deck.

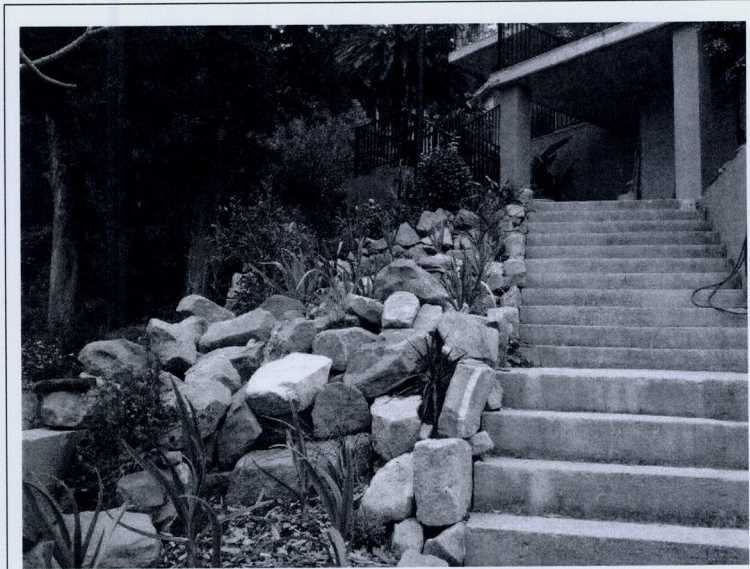
Photograph 13
Eastern Elevation

This photograph represents the general condition of the entrance staircase and garden along the Eastern boundary.

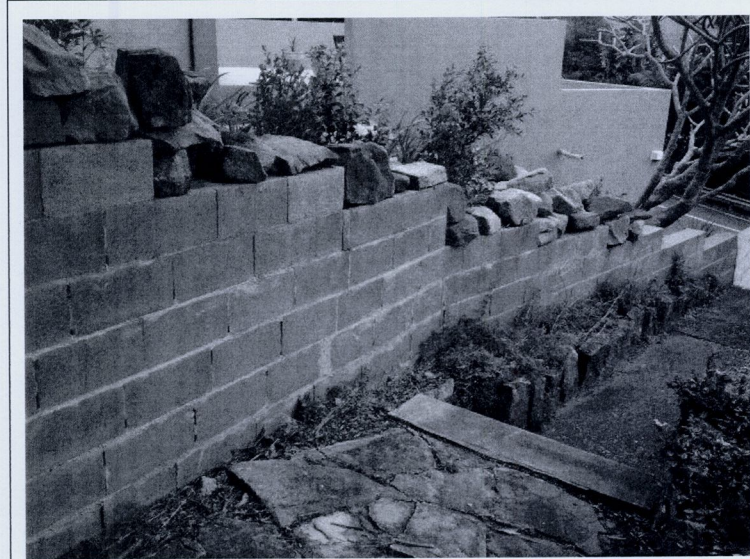
Photograph 14
Eastern Elevation

This photograph represents the general condition of the concrete block retaining wall extending to street level along the Eastern boundary.

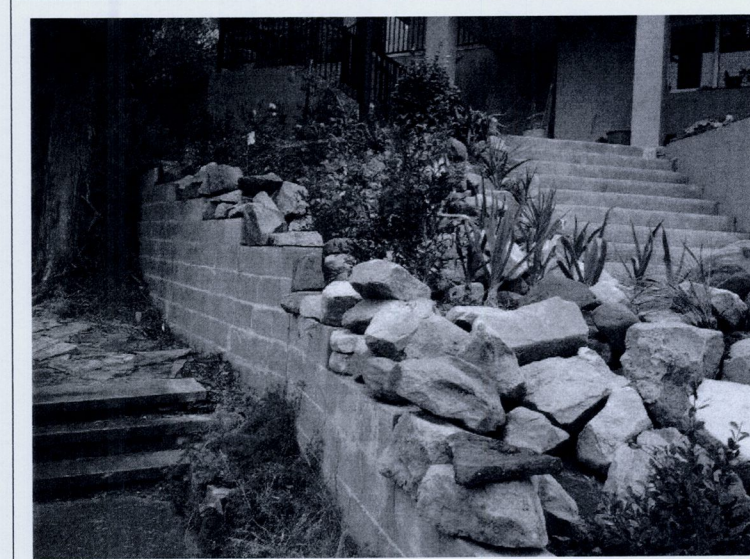
Photograph 15
Eastern Elevation

This photograph represents the general condition of the concrete block retaining wall extending to the rear of the property along the Eastern boundary.

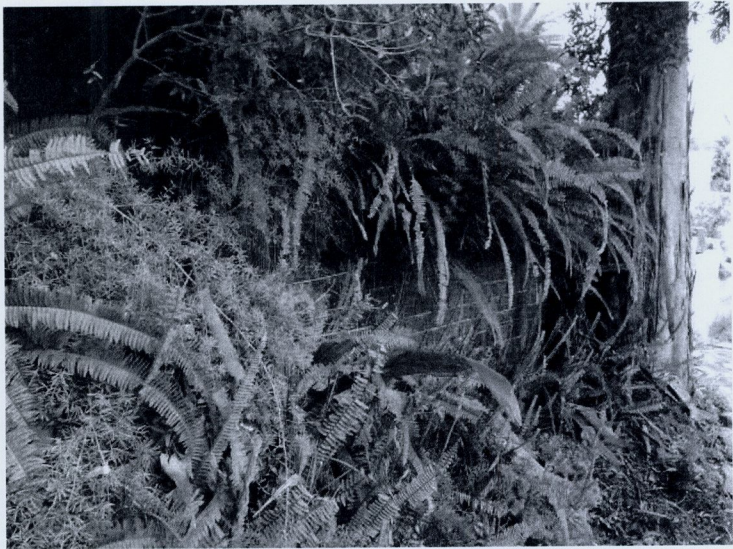
Photograph 16
Eastern Elevation

This photograph represents the general condition of the red brick masonry retaining wall.

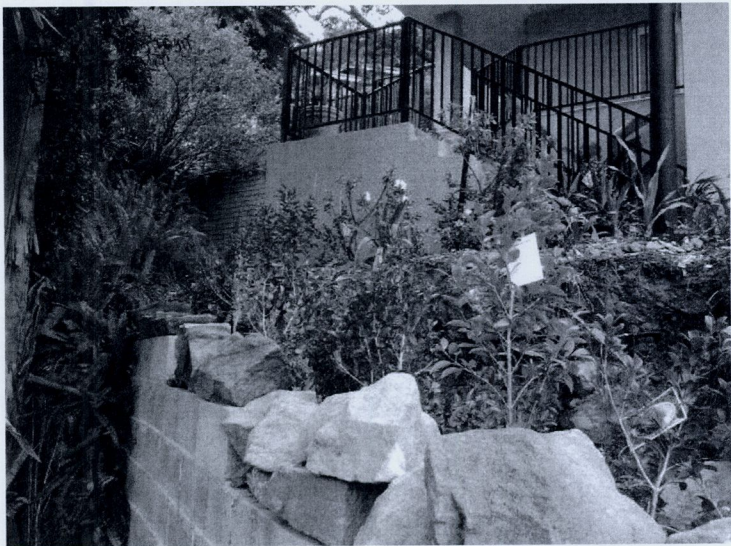
Photograph 17
Eastern Elevation

This photograph represents the general condition of the staircase and garden along the Eastern boundary.
