Anthony Protas Consulting Pty Ltd
BUILDING REGULATIONS CONSULTANTS

**Re: 1174 Barrenjoey Road, Palm Beach
Construction Certificate**

Construction Certificate – 1174 Barrenjoey Road, Palm Beach - Demolition of the existing garage & shed and construction of a new garage, driveway, retaining walls & associated landscaping
BCA Class: 10a & 10b

Report on Internal and External
aspects at
1176 Barrenjoey Road,
Palm Beach, NSW 2108
Thursday 13th September 2012.

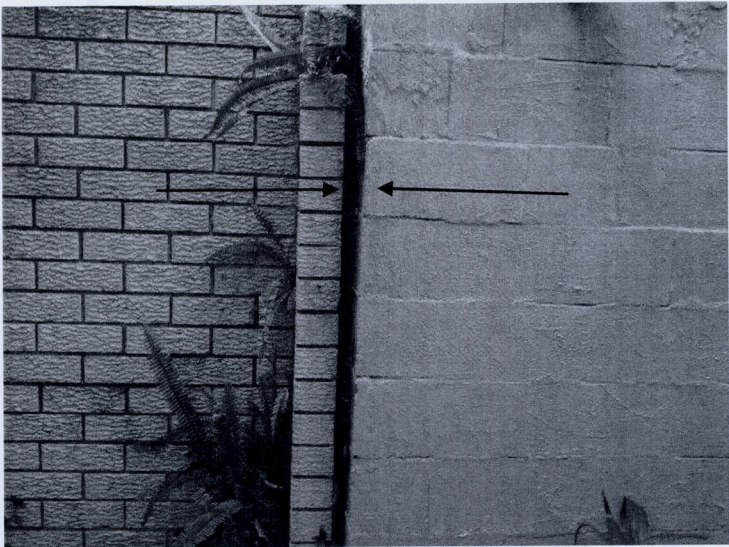
Photograph 19
Eastern Elevation

A gap approximately 70mm wide is evident between the masonry and block walls.

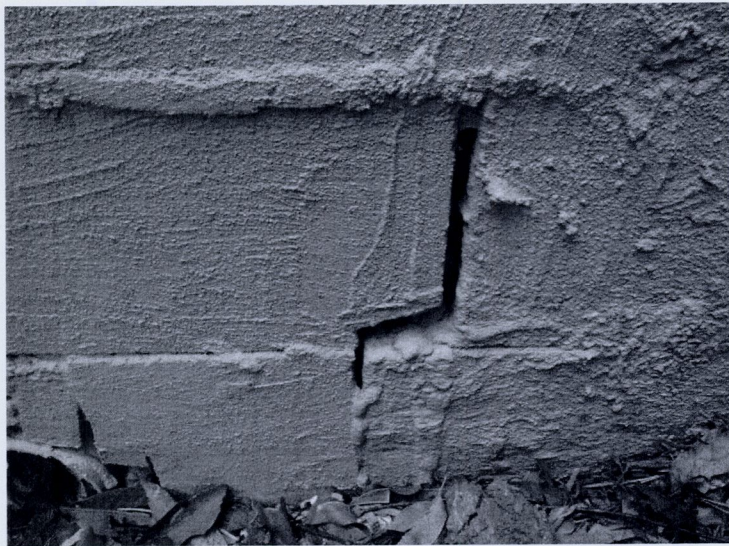
Photograph 20
Eastern Elevation

A gap approximately 10mm is evident to the base of the blockwall supporting the entrance landing.

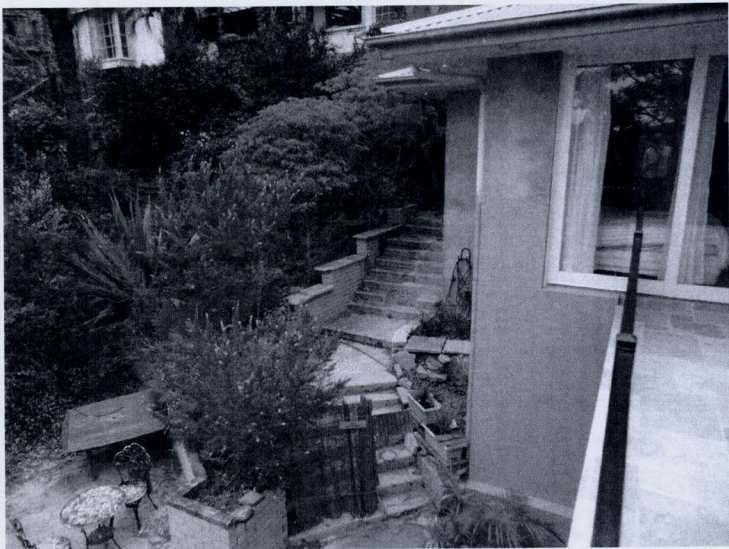
Photograph 22
Eastern Elevation
 This photograph represents the general condition of the Eastern terrace and garden along the Eastern boundary.

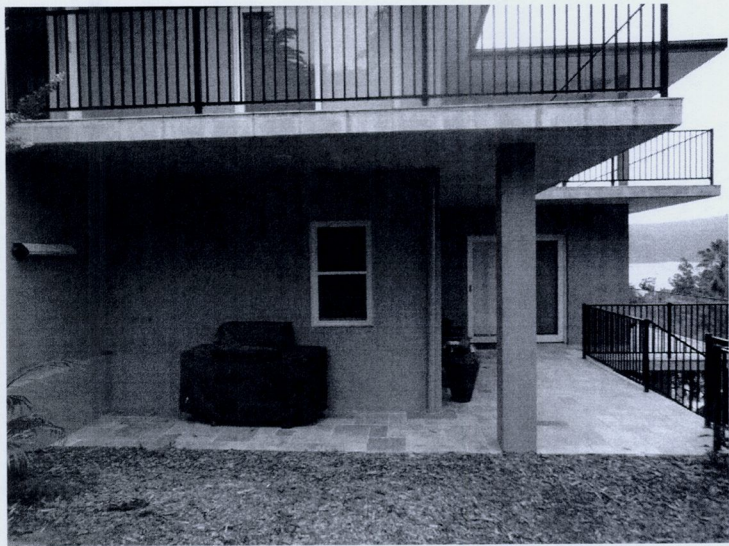
Photograph 24
Eastern Elevation
 This photograph represents the general condition of the Eastern façade from ground floor level.

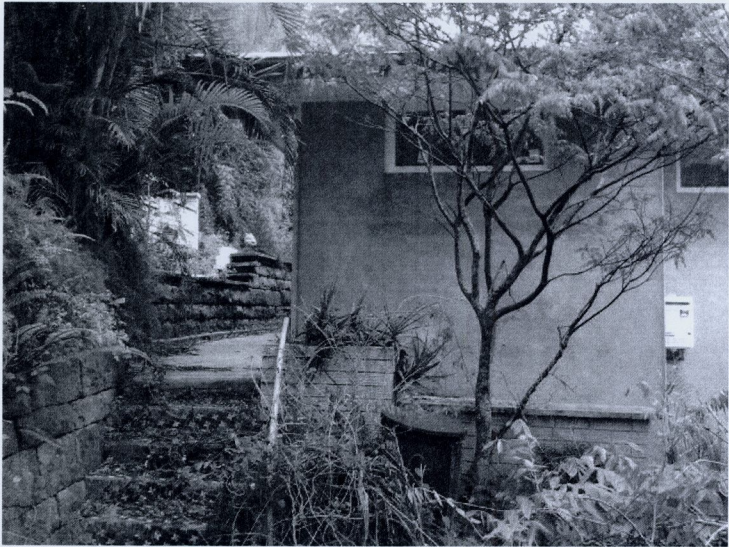
Photograph 25
Eastern Elevation
 This photograph represents the general condition of the rear Eastern façade from ground floor level.

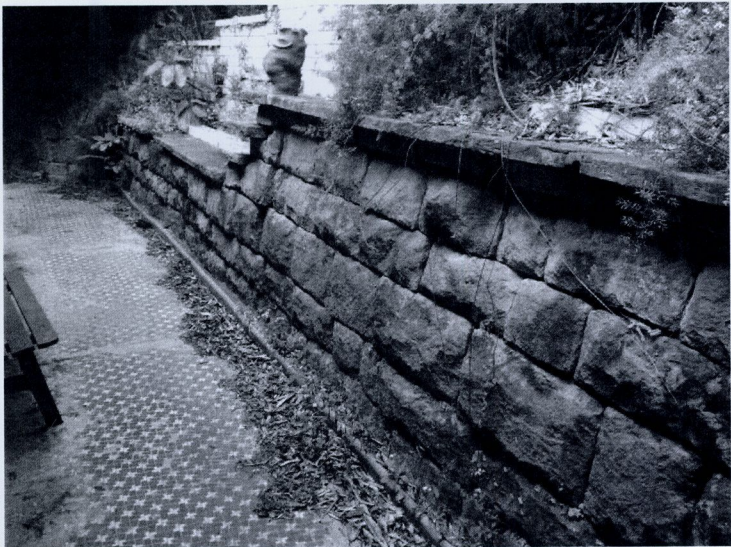
Photograph 28
Southern Elevation
 This photograph represents the general condition of the stone retaining wall to the rear of the property.

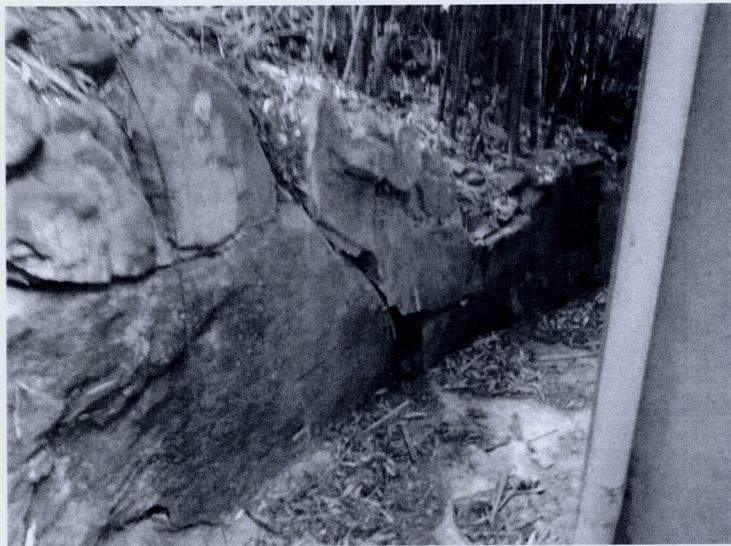
Photograph 29
Southern Elevation
 This photograph represents the general condition of the stone retaining wall in the SW corner.

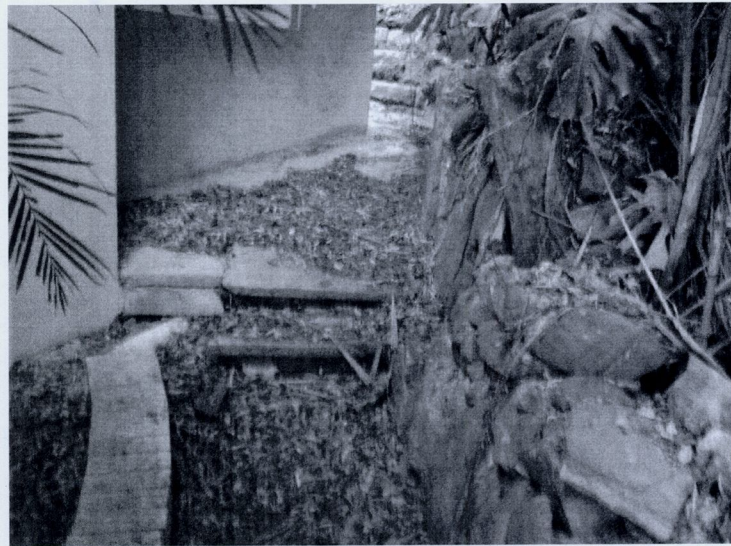
Photograph 30
Western Elevation
 This photograph represents the general condition of the rear stone retaining wall and pathway along the Western boundary.

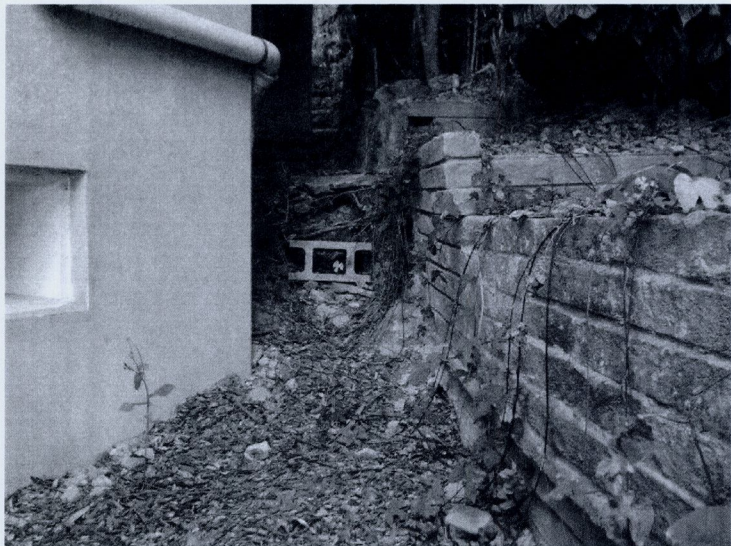
Photograph 31
Western Elevation

This photograph represents the general condition of the stone retaining wall and pathway along the Western boundary.

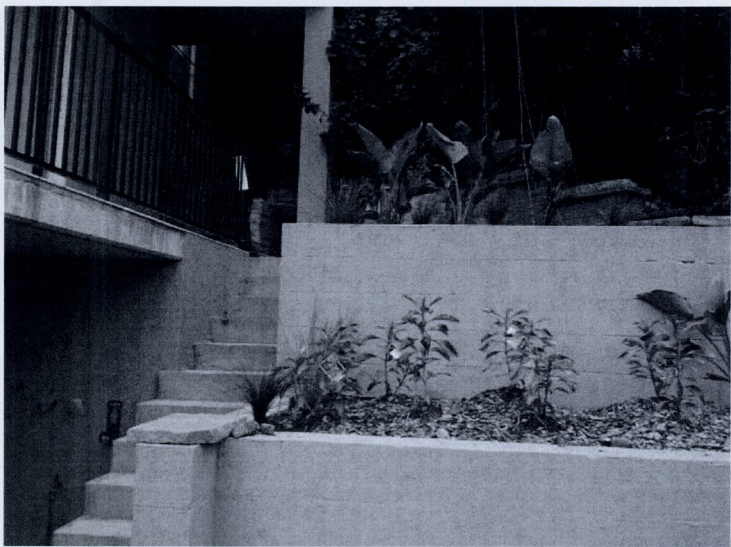
Photograph 32
Western Elevation

This photograph represents the general condition of the blockwork retaining walls.

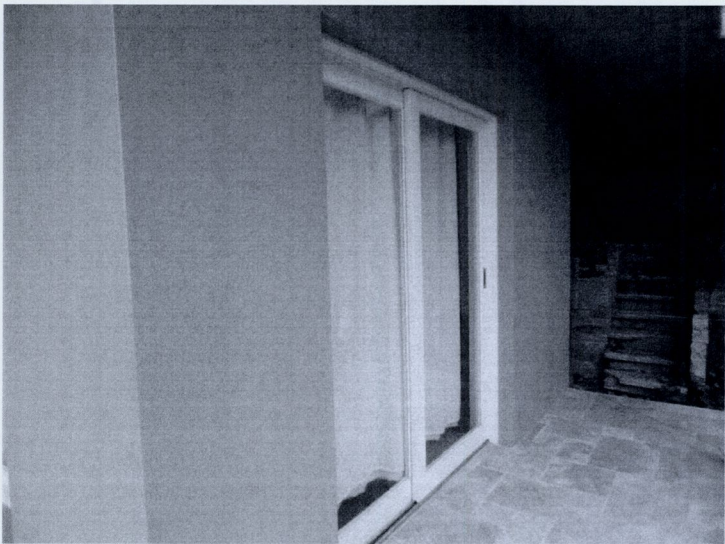
Photograph 33
Western Elevation

This photograph represents the general condition of the Western façade from the first level balcony deck.

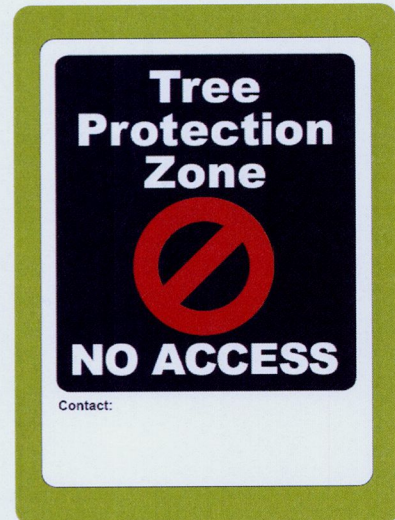
1. Chain wire mesh panels with shade cloth (if required) attached, held in place with concrete feet.
2. Alternative plywood or wooden paling fence panels. This fencing material also prevents building materials or soil entering the TPZ.
3. Mulch installation across surface of TPZ (at the discretion of the project arborist). No excavation, construction activity, grade changes, surface treatment or storage of materials of any kind is permitted within the TPZ.
4. Bracing is permissible within the TPZ. Installation of supports should avoid damaging roots.
