Arboriculture Assessment & Management Report

September 2021

Site: Lot 4 in DP 567442
23 Barooka Road
CHURCH POINT, NSW

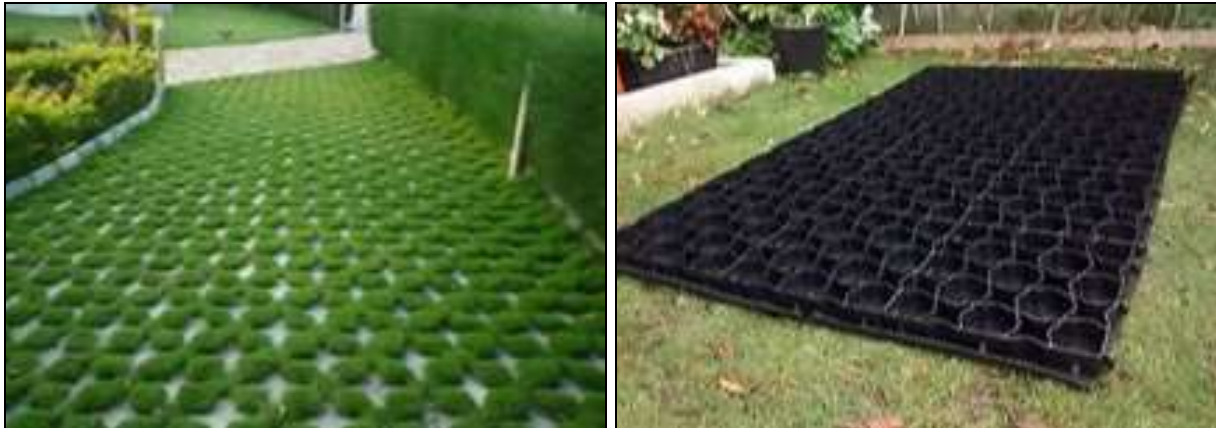
Figure 5: Examples of 'cell style' hardstand parking space/driveway solutions.

Tree #1 is proposed to have a hardstand car space created at least partially within its TPZ total surface area. Our requirements are that the finished level for the hard stand parking space does not involve any excavation into natural soil levels (our opinion is existing soil levels are not truly natural) & is constructed using 'live tree root friendly' materials. This simply mean permeable or pervious finished surfaces. In this situ, we suggest investigating s 'cell type' solution. See below photographs of potentially suitable commercially available products.

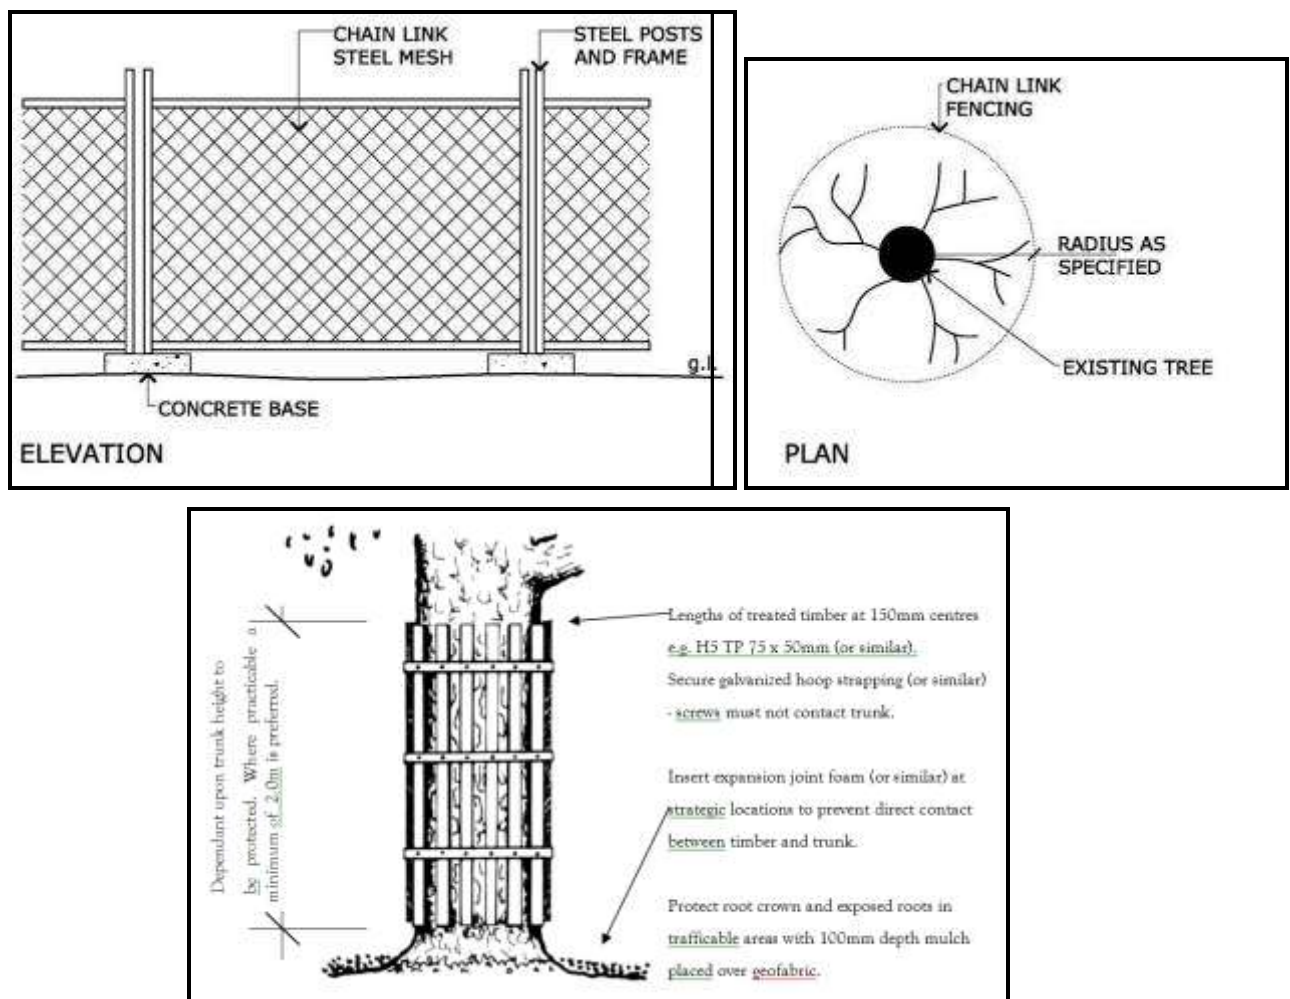
The installation of Tree Protection Zone (TPZ) fencing is to be carried out prior to commencement of all works. The most suitable fencing material is 1.8m tall chain link mesh with 50mm metal pole supports, see **detail 1: tree protection fencing**.

Trunk protection “Tree Guards” are detailed (below) by generic diagram.
