Acid Sulfate Soils Management Plan

351-353 Barrenjoey Road, Newport NSW

Atlen Construction Pty Ltd

14429-ER-1-2

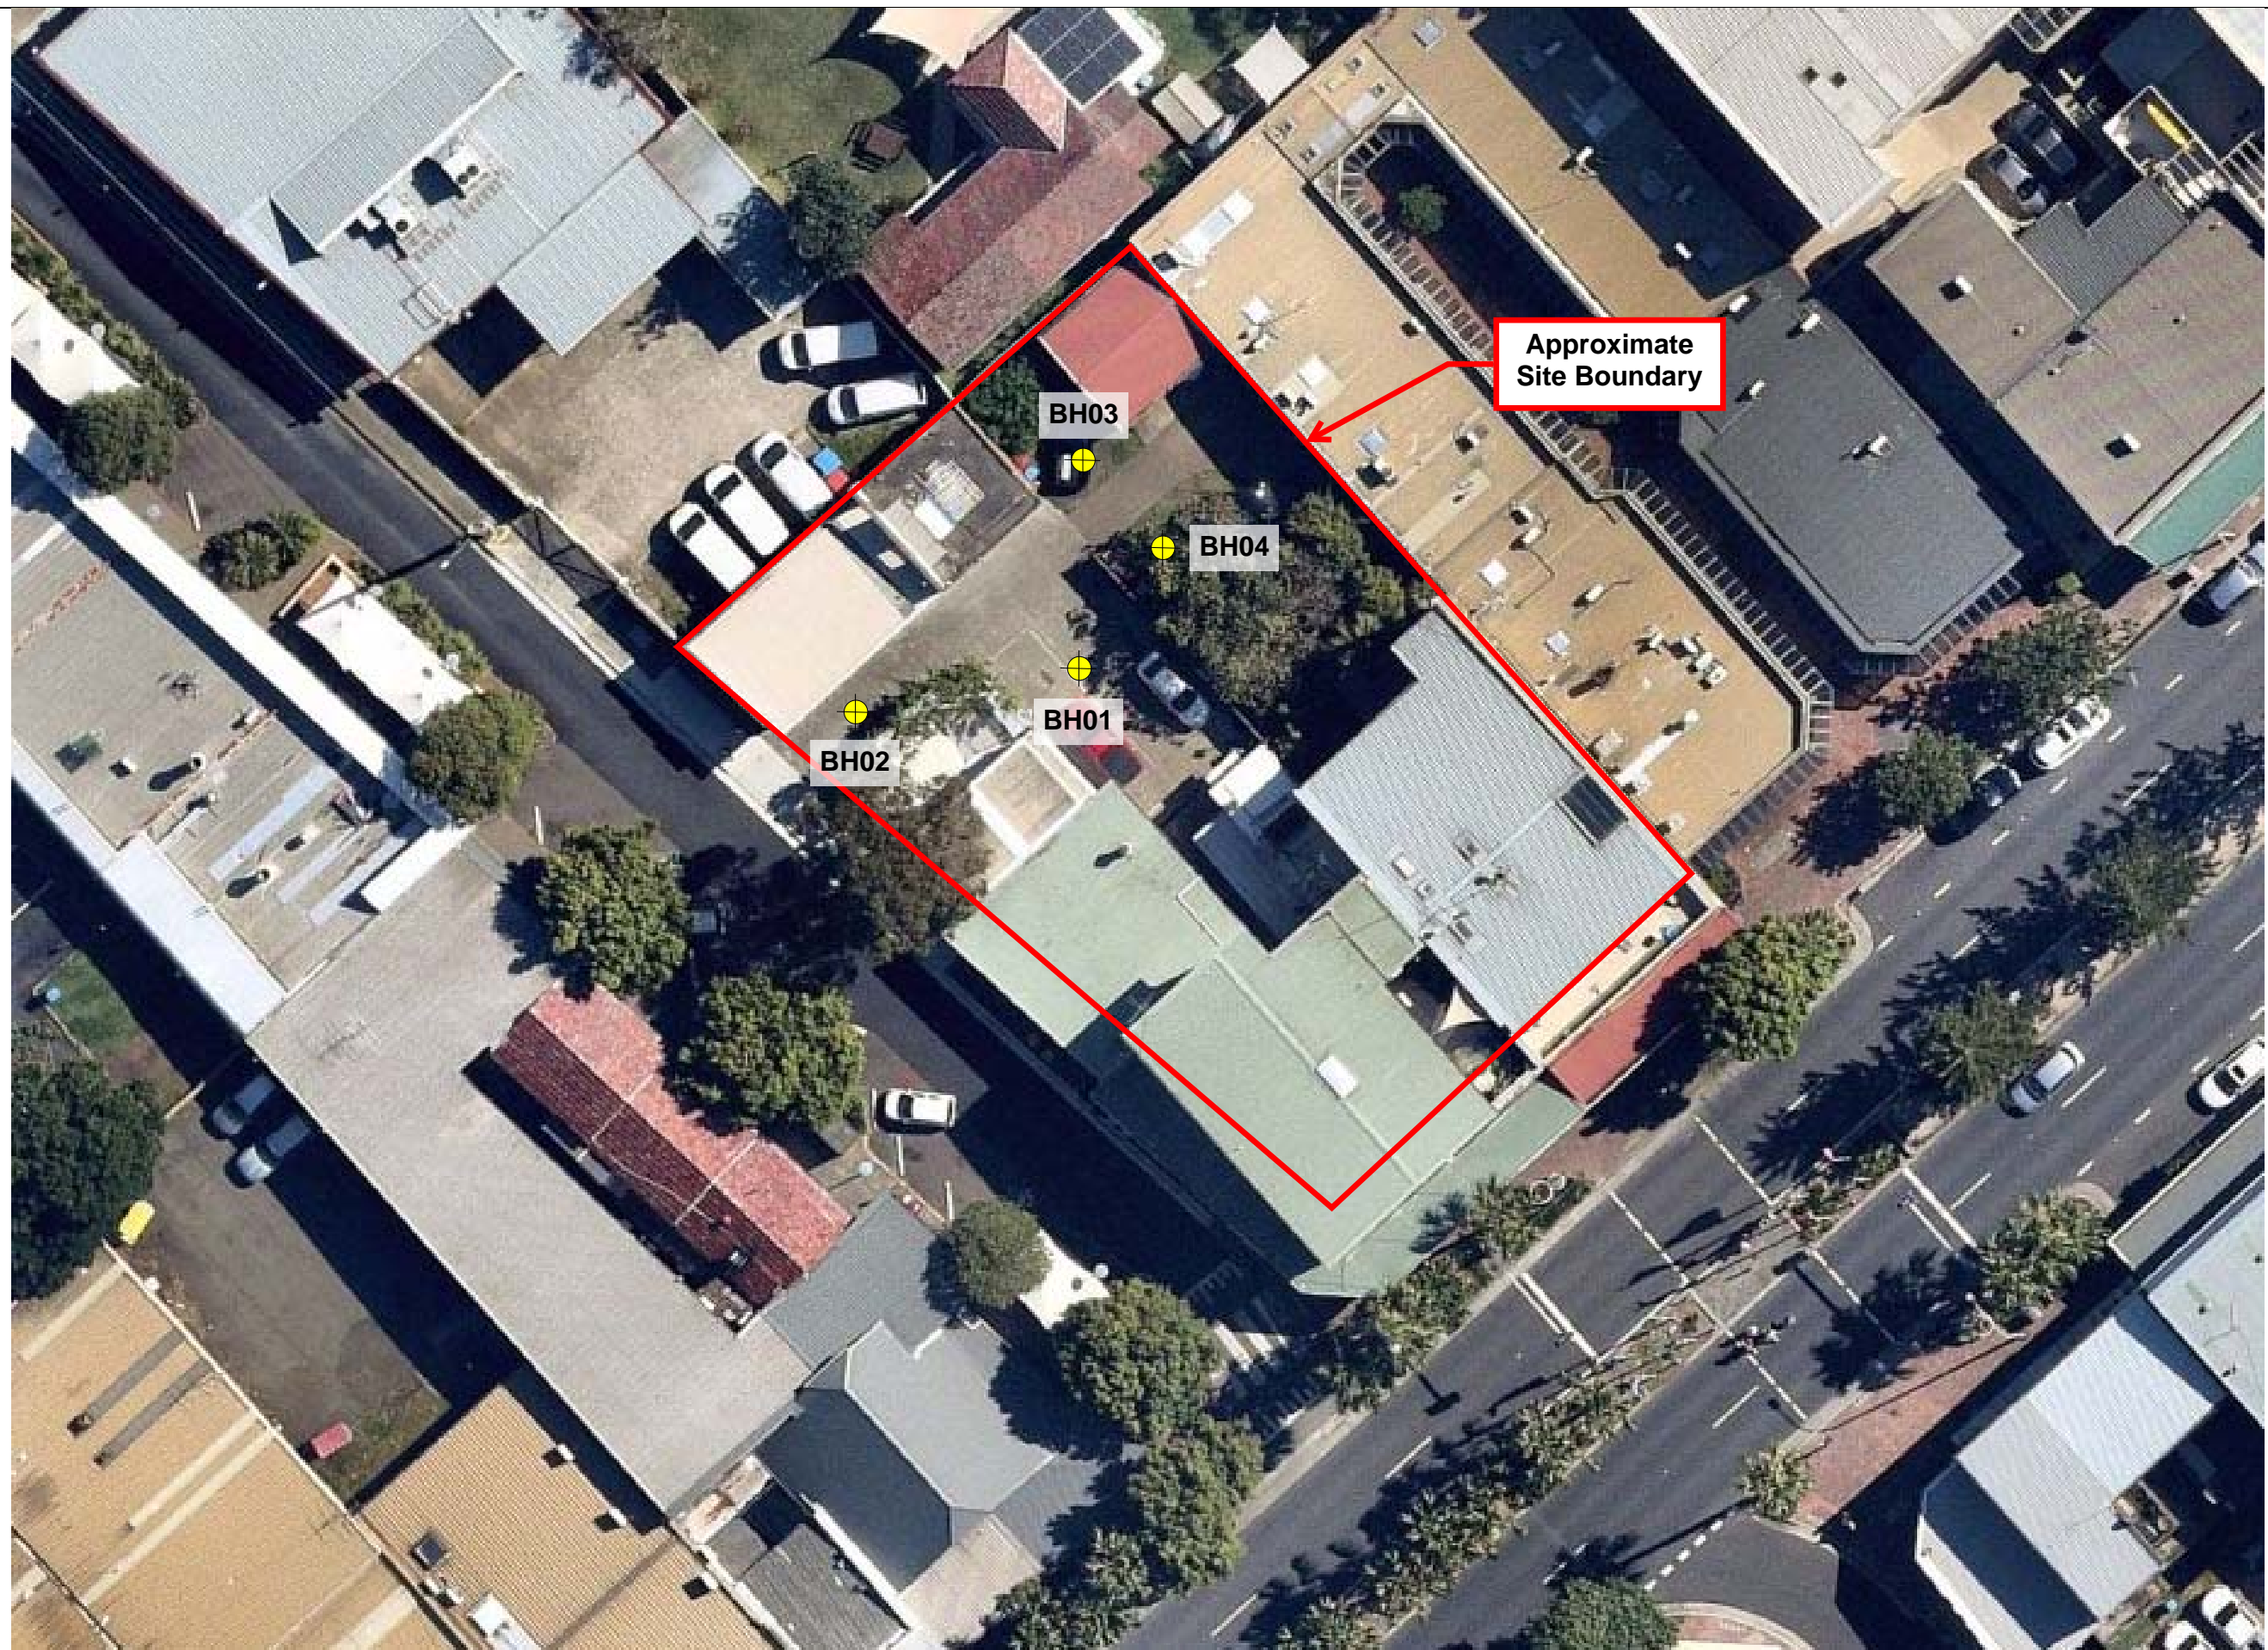
Borehole Locations

The layout of the site is present in **Figure 2**. The layout plan also includes locations on site of:

- Site access points;
- Current buildings / structures; and
- Surface water bodies on site and immediately adjacent to the site.

Intrusive investigation was performed at four (4) borehole locations to a maximum depth of 6.0 mbgl. Soil samples were collected at 0.5m intervals during auger advancement at each borehole location for subsequent laboratory analysis.
