# **MARINE POLLUTION RESEARCH** PTY LTD

**13 August 2021**

## **AQUATIC ECOLOGY ASSESSMENT**

### **PROPOSED EXTENSION OF JETTY, RAMP AND PONTOON AT 967 BARRENJOEY ROAD, PALM BEACH.**

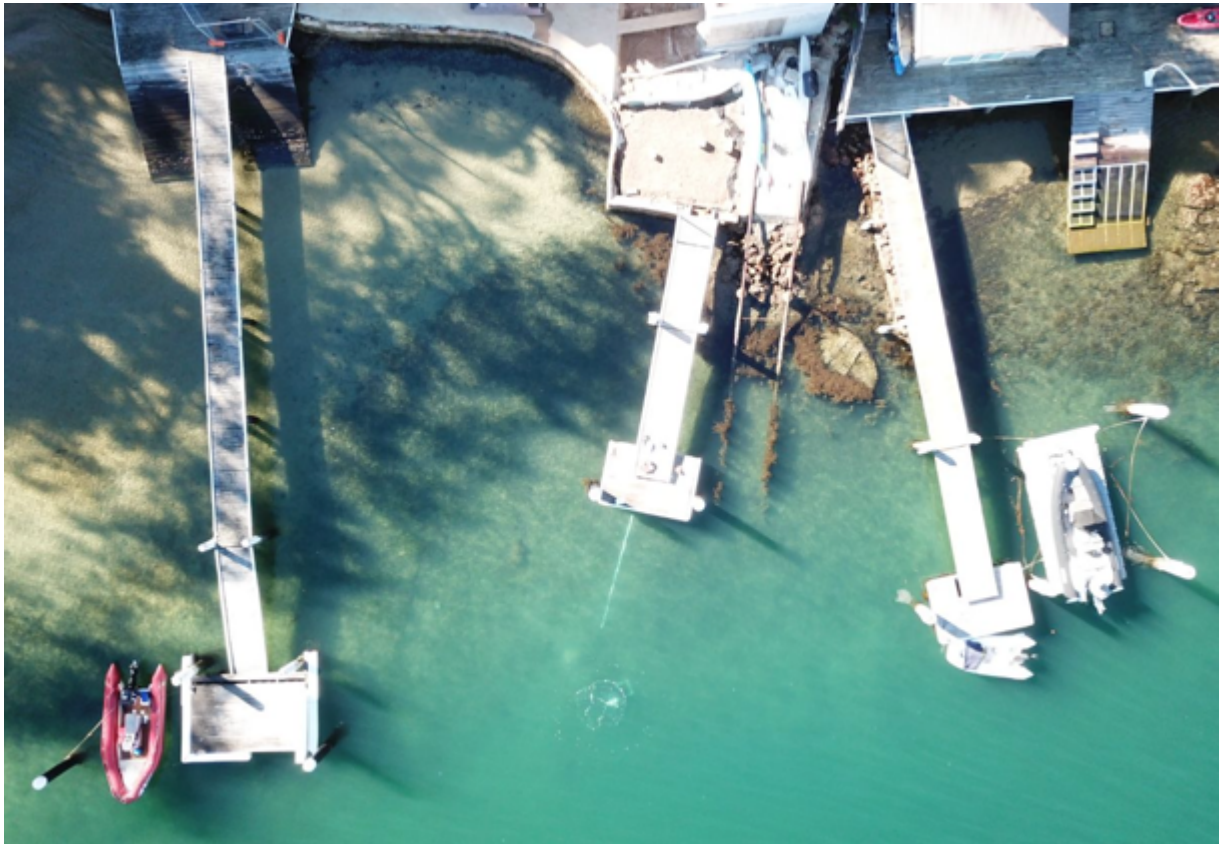
**Figure 1** Drone view of 967 Barrenjoey Rd, Palm Beach existing facility (middle jetty).

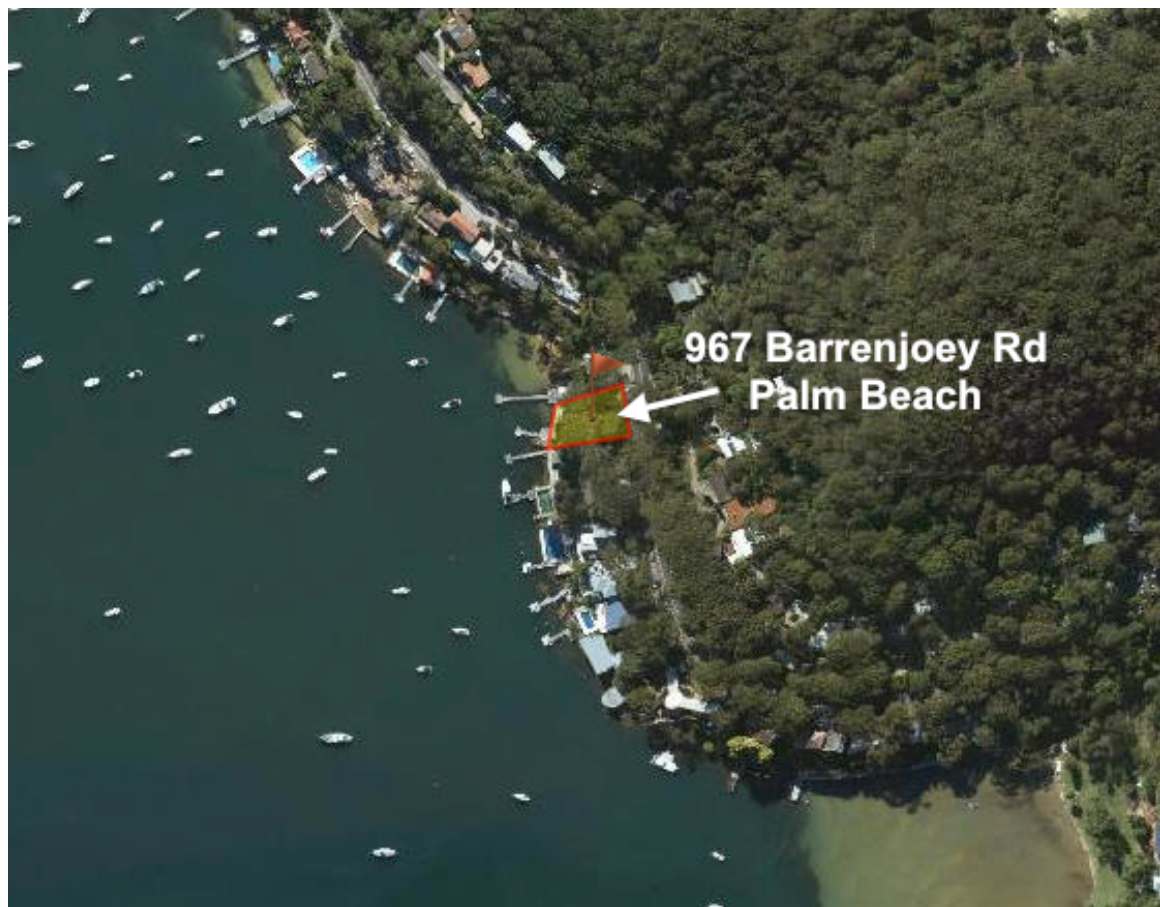
**Figure 2** Aerial view showing the existing jetty and similar facilities in the locality

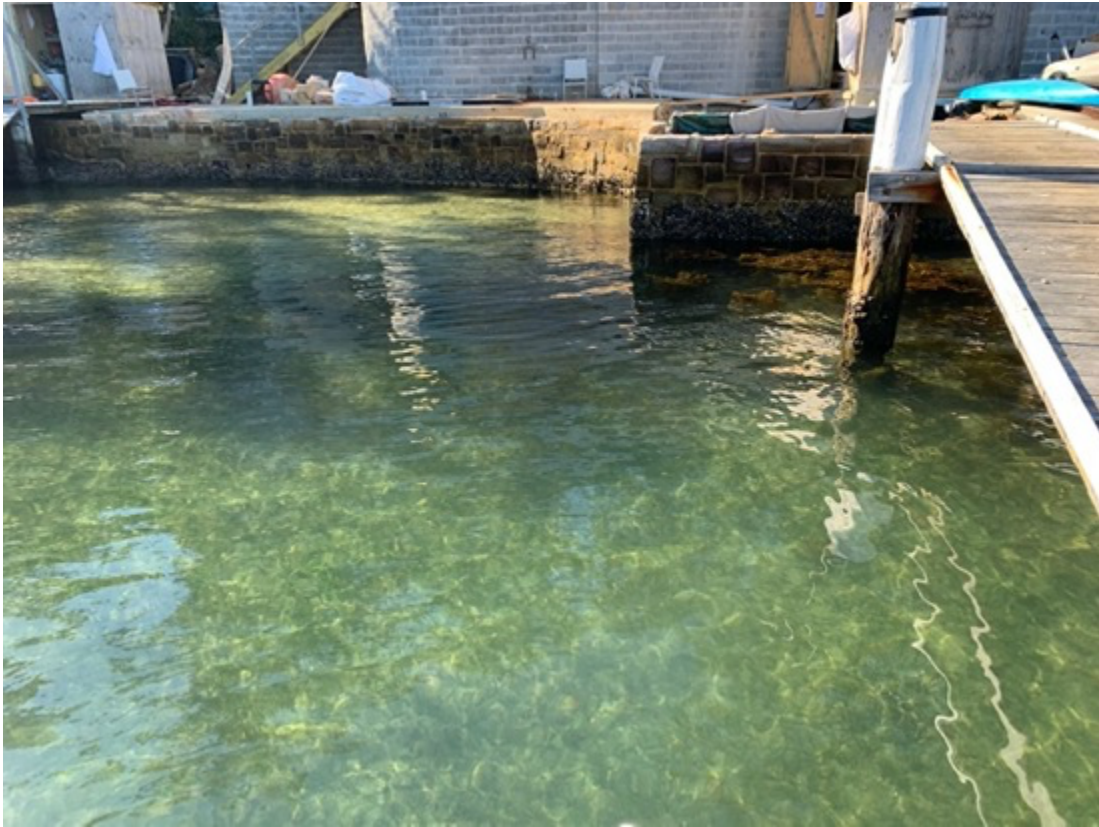
- The intertidal sand beach inshore is comprised of clean marine sands plus sections with an overlaying rock rubble toe at the sandstone seawall (**Figure 5**).

**Figure 5** Sand beach plus rock rubble toe at the sandstone seawall.

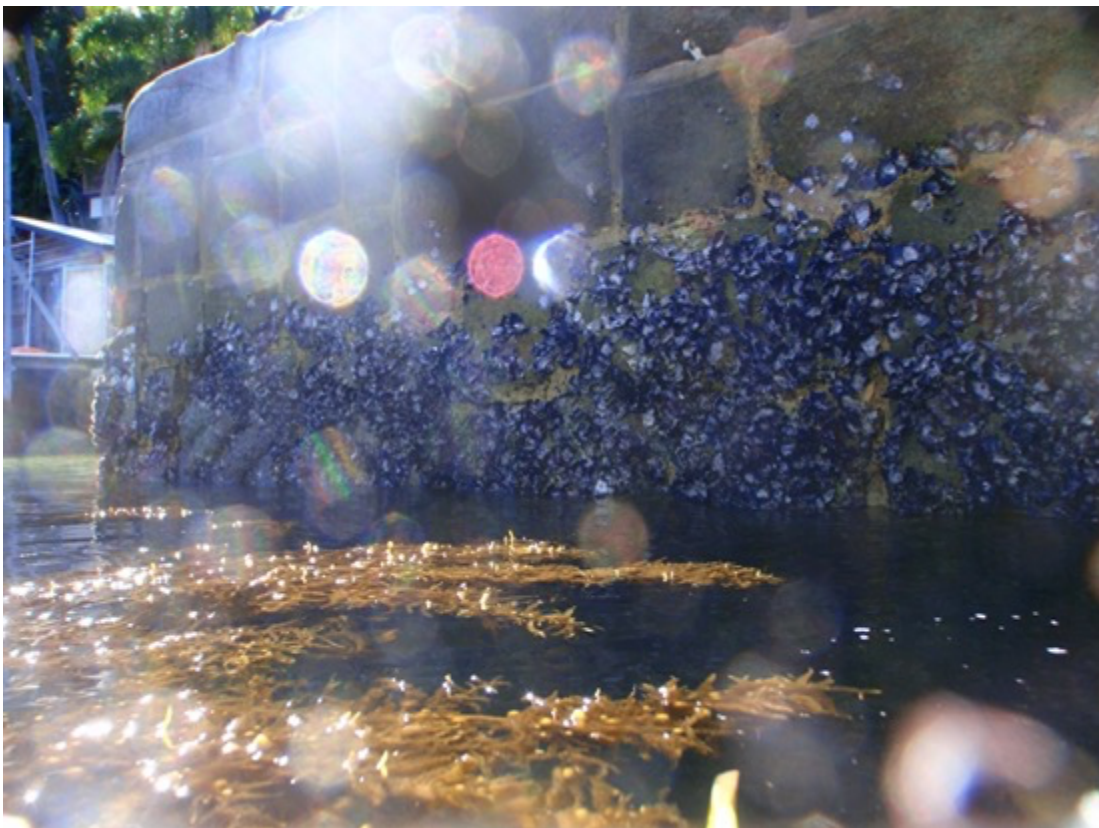
- The lower intertidal portion of the seawall plus the intertidal rock rubble supports an oyster-base assemblage (*Saccostrea commercialis*) plus grazing molluscs (mainly *Bembicium*) (**Figure 6**).

**Figure 6** Oyster-based assemblage on intertidal section of the seawall, with *Sargassum* algae on the subtidal rock rubble.

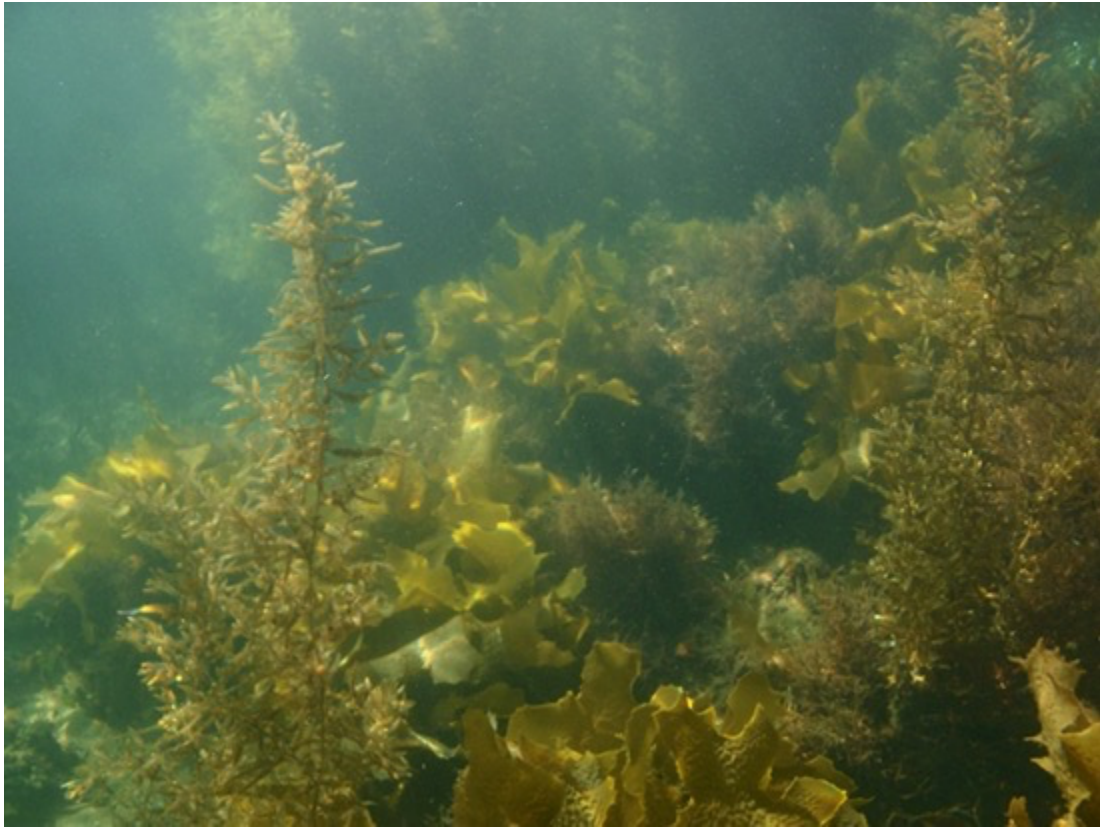
- The subtidal rock rubble reef inshore under the existing jetty and around the front of the property rock and concrete slipway supports a fringe of tufted algae (*Padina* and *Dictyota*) with coralline algae and small amounts of *Colpomenia*. Larger macro algae (*Sargassum* and kelp, *Ecklonia radiata*) species were present on the deeper sections of the subtidal rock rubble (**Figure 7**), with high *Sargassum* algae cover on the slip rails extending offshore from the concrete ramp (**Figure 8**).

**Figure 7** Shallow sub-tidal rock rubble with *Ecklonia* and *Sargassum*

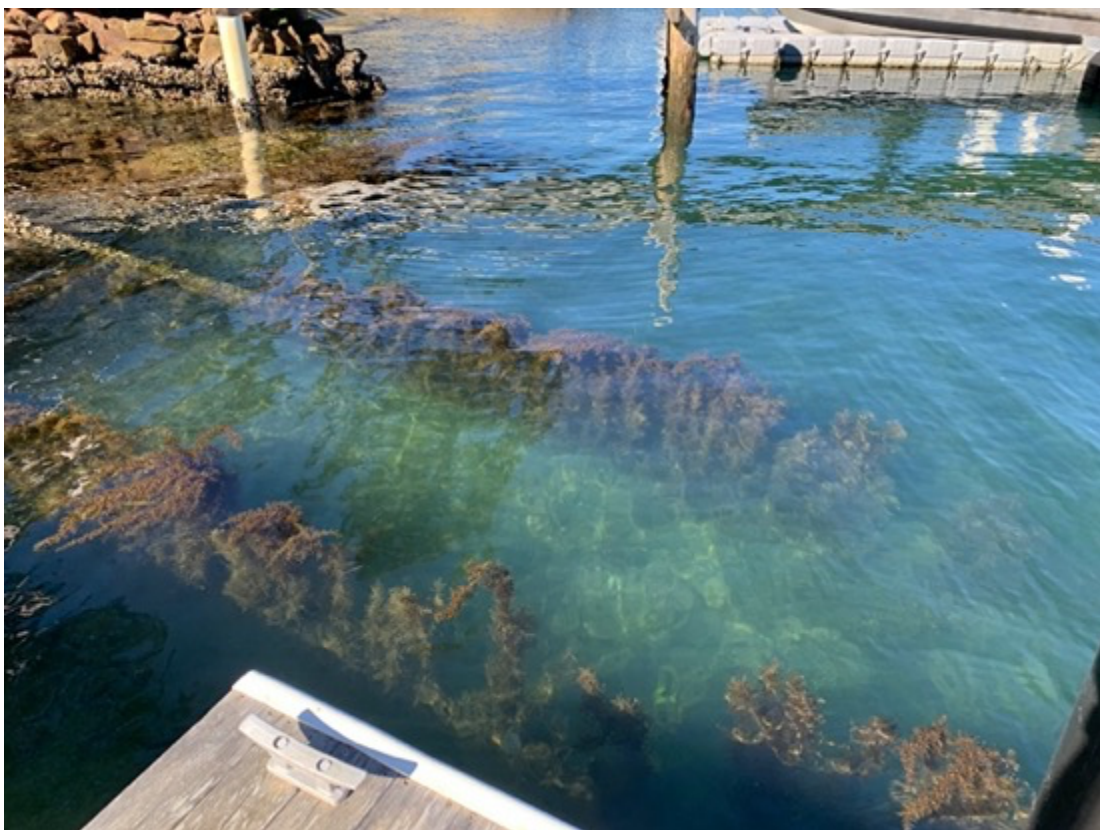
**Figure 8** *Sargassum* on sliprails.

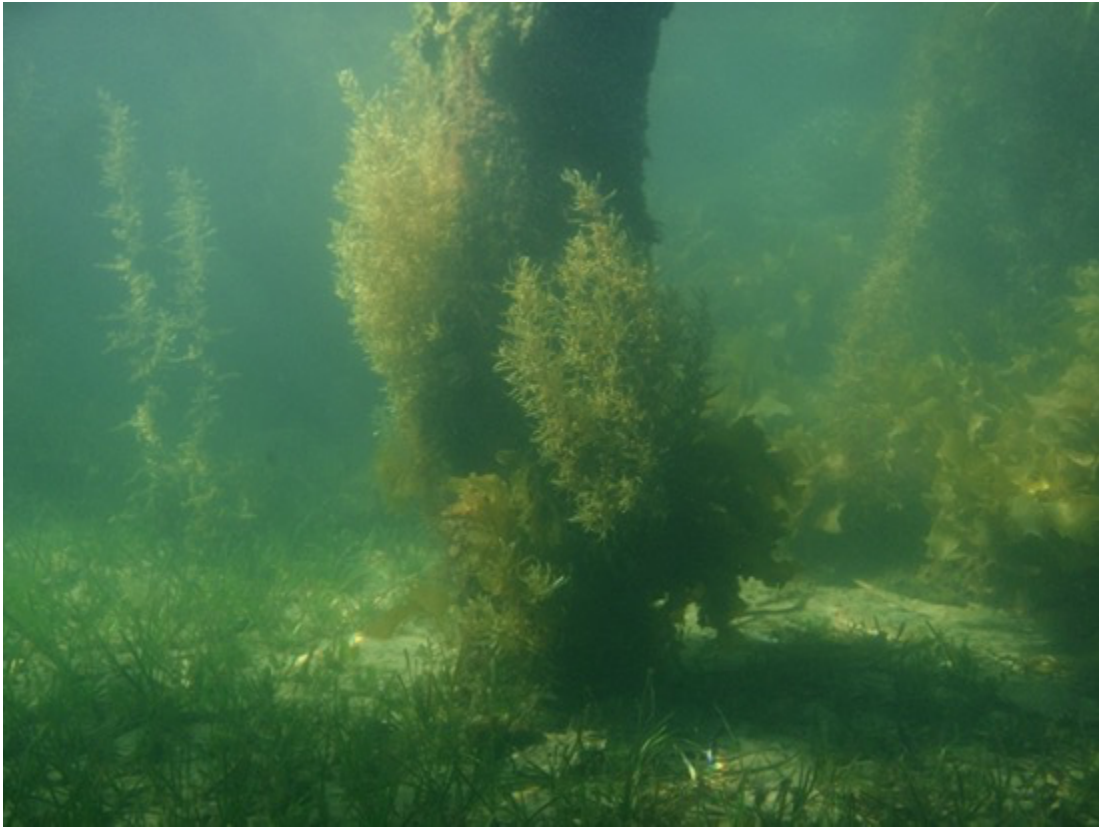
- The wetted surface areas of the deck and jetty support piles provided habitat for intertidal assemblages comprising oysters and associated molluscs, barnacles and tubeworms and the sub-tidal portions of the piles supported small amounts of kelp with *Sargassum*, plus an assemblage of encrusting fauna (mostly tunicates and bryozoans) (**Figures 9 & 10**).

- The low gradient sediment habitat supports a mixed *Zostera* and *Halophila* seagrass bed. The *Halophila* occurs scattered throughout the *Zostera* bed. Whilst the *Zostera* cover is even, it occurs at relatively low density (**Figure 9 & 12**).

**Figure 9** *Kelp* and *Sargassum* growth on inshore jetty piles. Note also *Zostera* seagrass growth around the pile.

- The two new locator piles will provide an additional minimum of 2m depth wetted surfaces for colonisation by marine algae and encrusting fauna as indicated in **Figures 9 and 10** above with the potential for an additional  $2.5\text{m}^2$  of good quality macroalgae habitat, and the wetted surfaces of the pontoon will provide good

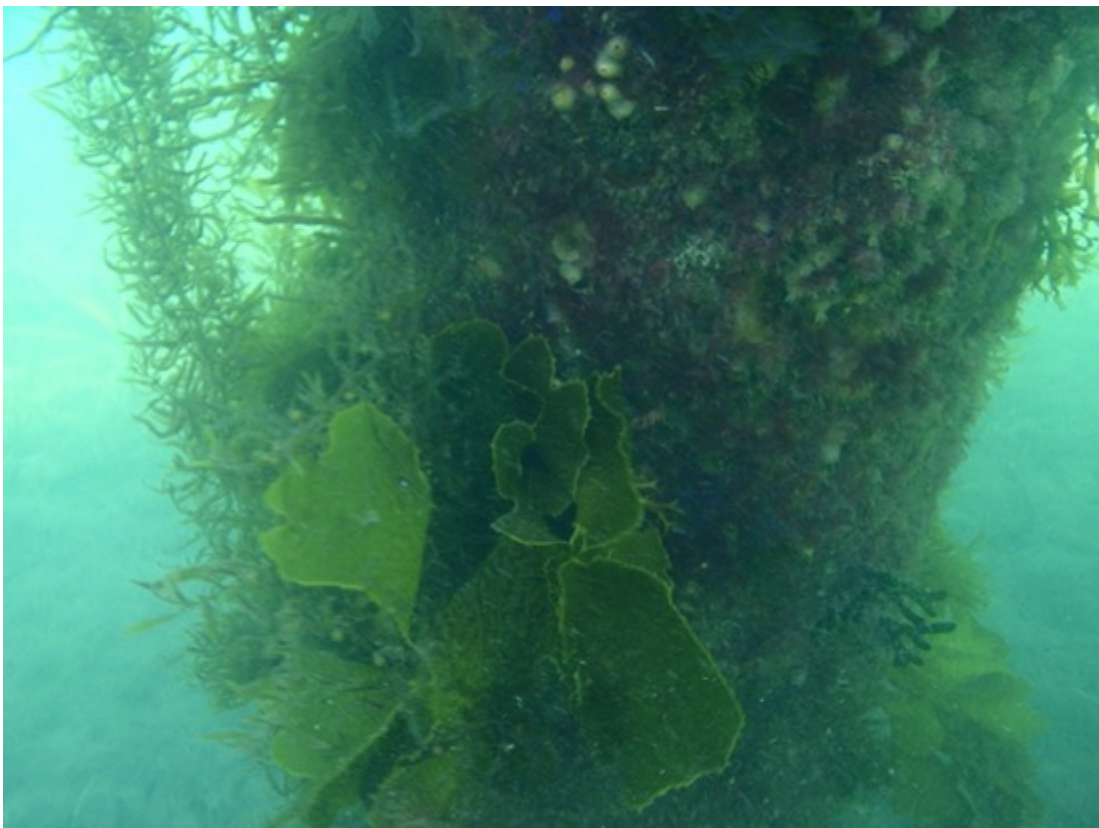
**Figure 10** *Kelp* and *Sargassum* plus encrusting fauna attached to existing piles.

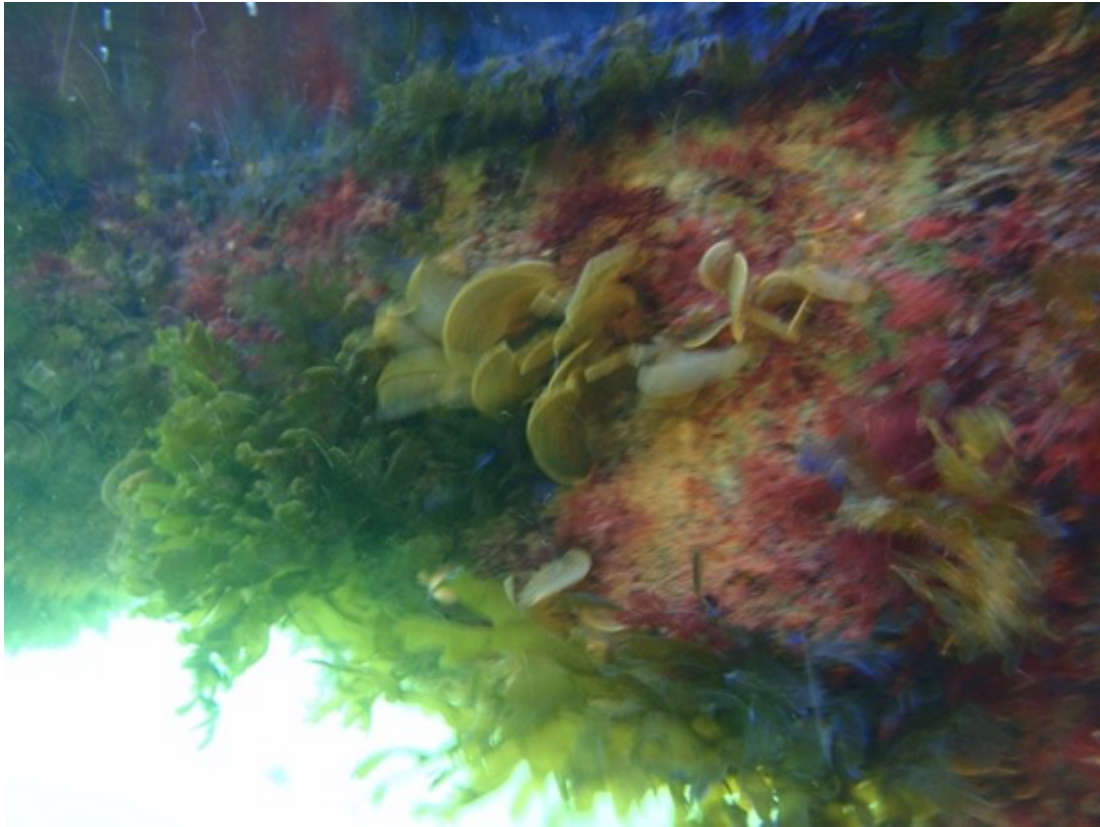
- The wetted surfaces of the pontoon supported a dense assemblage of tufted and frondose algae, tunicates and a suite of molluscs and encrusting fauna (**Figure 11**).

**Figure 11** Attached frondose algae and encrusting fauna upon existing pontoon.

replacement habitat for marine algae and attached biota similar to the existing pontoon as indicated in **Figure 11** above. As the pontoons are the same size this represents no net change in pontoon wetted surface habitat.

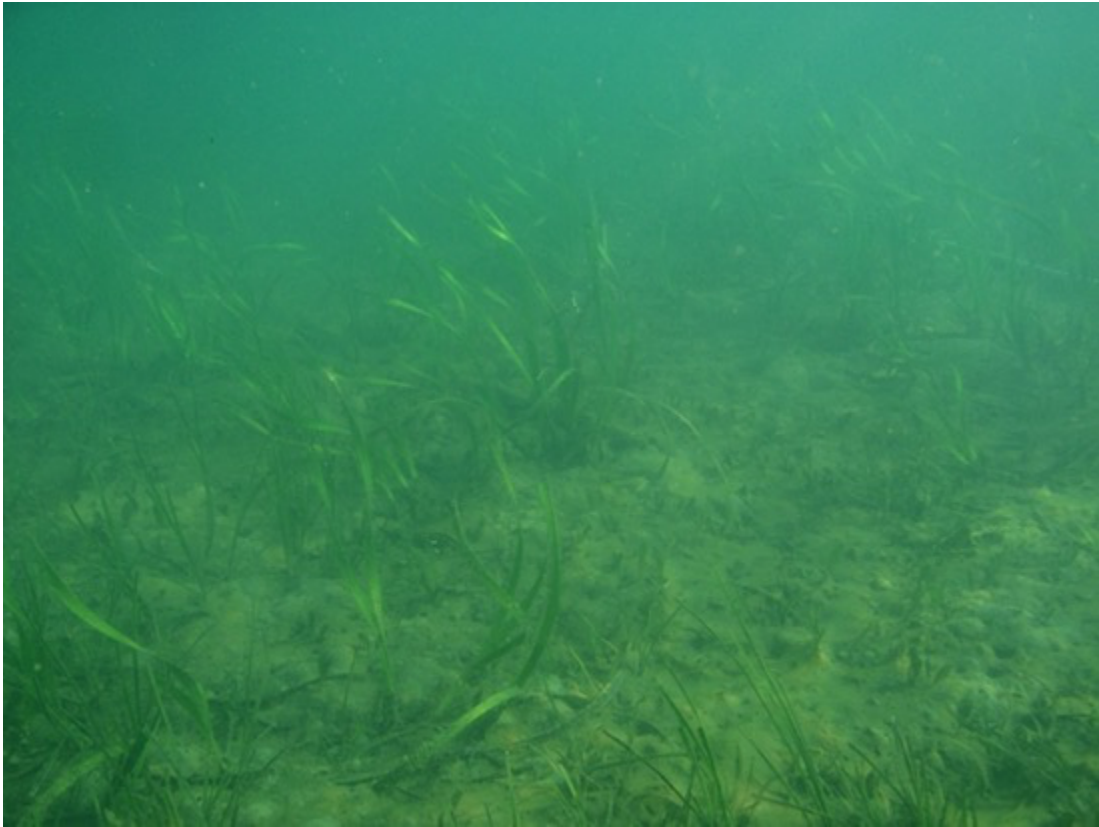
- There is an overlap of *Zostera* and *Posidonia* at the deeper end at the alignment of the existing pontoon (see **Figures 4 & 13**).
- The scattered and fragmented patches of *Posidonia* shoots continue down-slope offshore from the *Zostera* distribution, with the deepest *Posidonia* shoots offshore from the proposed pontoon occurring a depth of approximately -3.4m (AHD) - which is -2.5m (ISLW) (**Figure 14**). The seabed is bare sandy habitat offshore from the *Posidonia* limits as indicated on **Figure 4**.

**Figure 13** Sparse *Posidonia*, *Zostera* and *Halophila* seagrass.

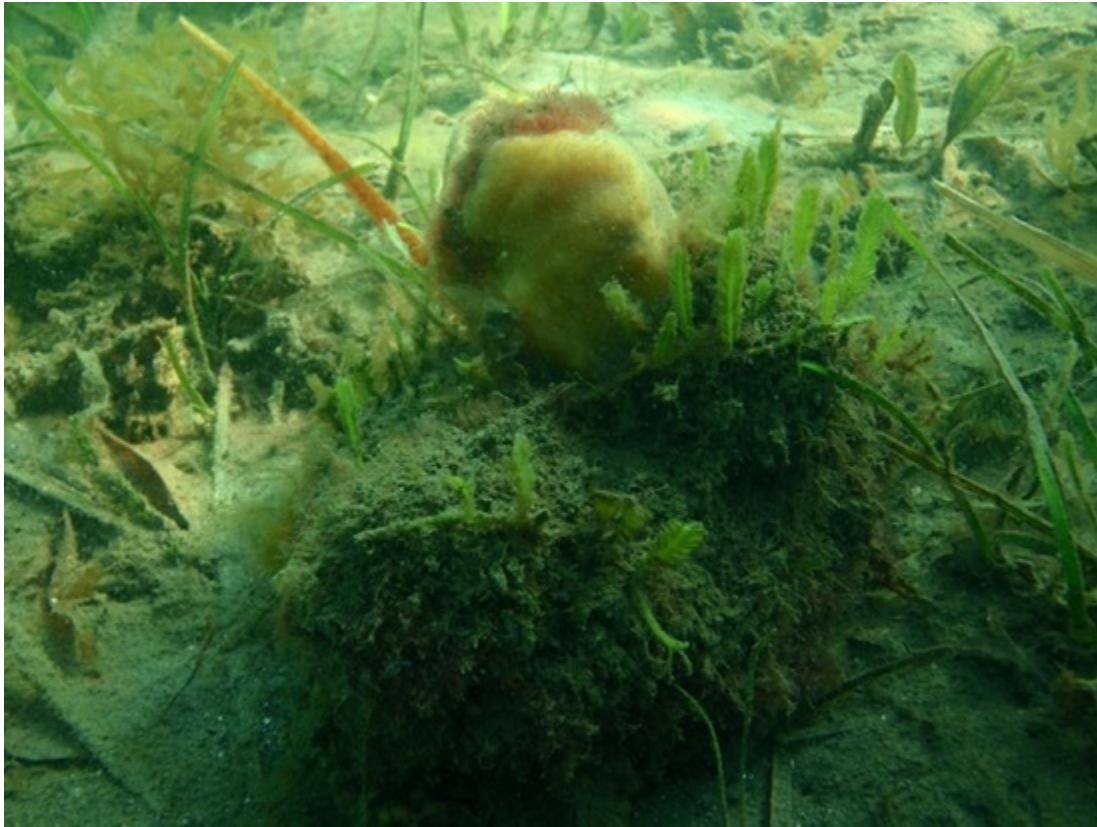
- Specific searches were made throughout the survey area for *Caulerpa taxifolia* (a pest algae species listed under NSW Fisheries Management Act 1994 (FMA) and known from Pittwater. Whilst there was no *C. taxifolia* observed within the seagrasses, there was a very small amount found on an isolated rock just off from the existing pontoon (**Figure 15**).

**Figure 15** Small amount of *Caulerpa taxifolia* on isolated rock offshore from pontoon.

- Any moorings or anchors that are used or piles/structures that are removed, should be inspected for the pest algae *Caulerpa taxifolia* once on the barge deck. If the alga is present, it should not be returned to the water and should be disposed of as normal construction waste into bins for appropriate shore disposal.
