GEOTECHNICAL INVESTIGATION:

New House, Pool, and Horse Arena at **113 Orchard Street, Warriewood**

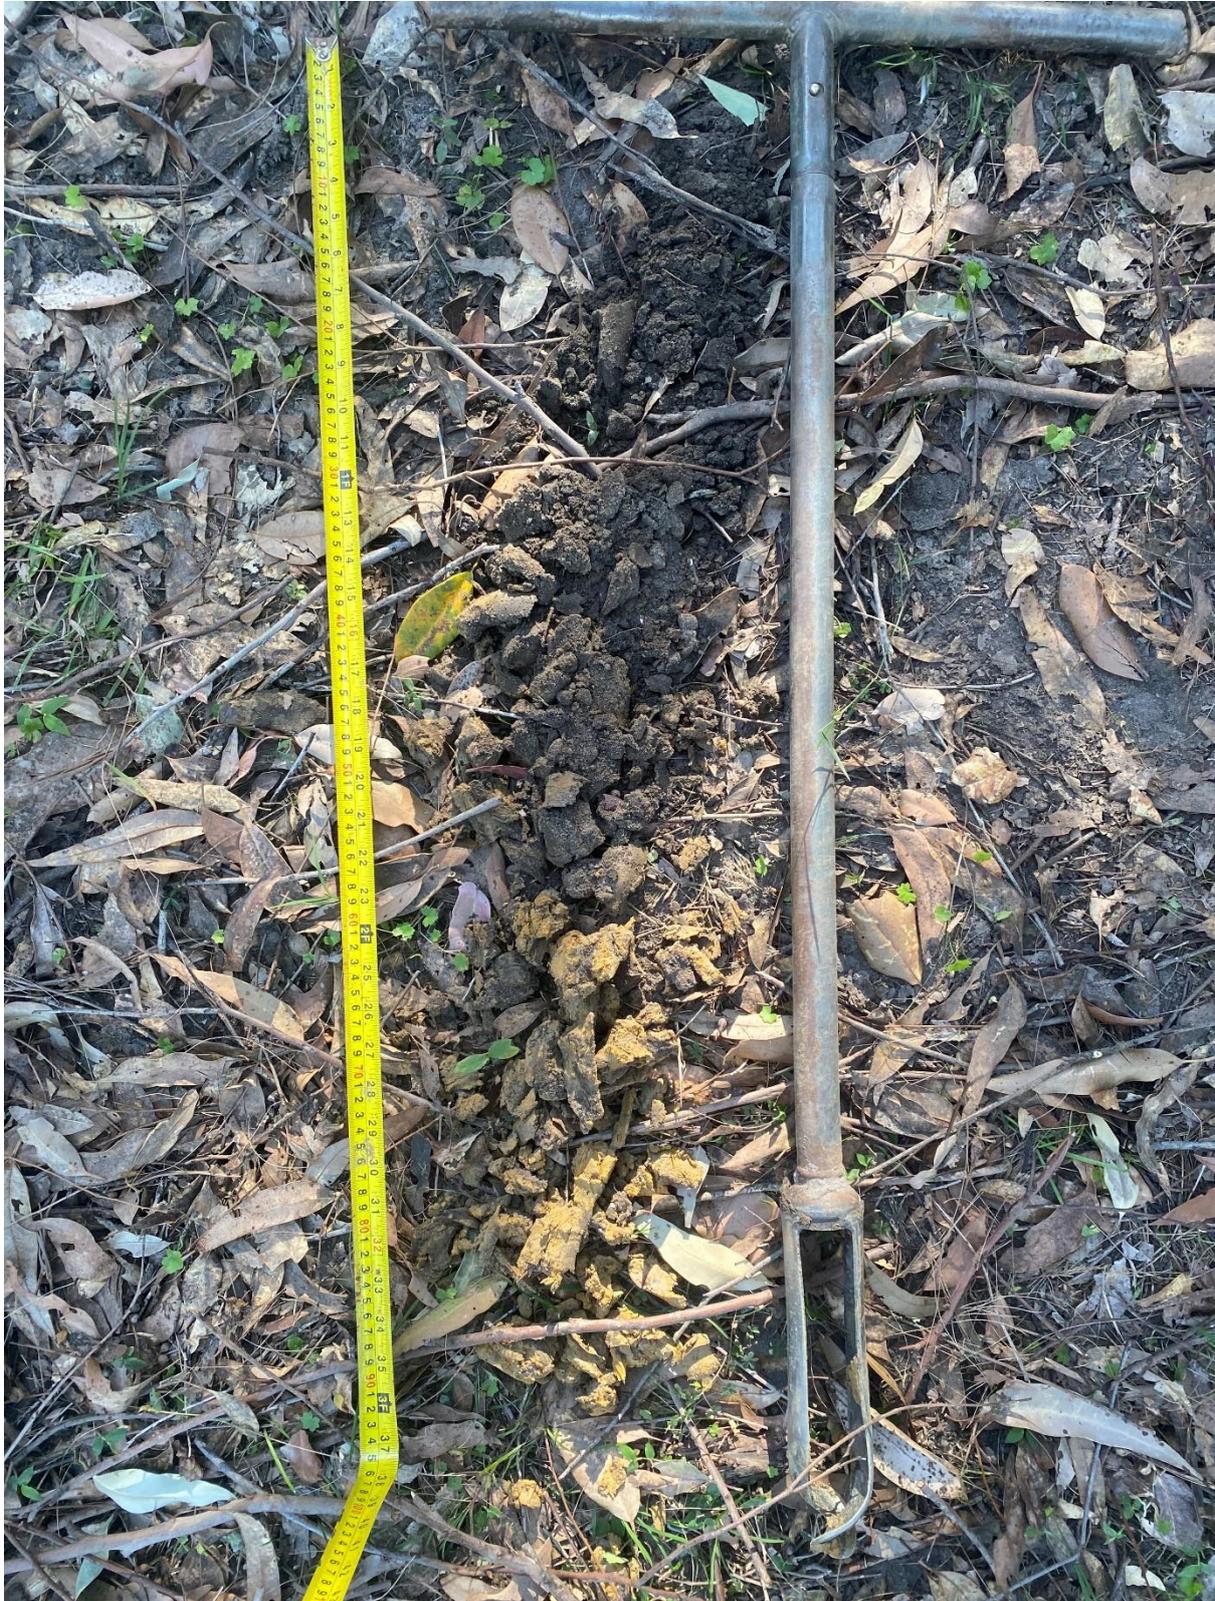
Photo 7 (Top to Bottom)

AUGER HOLE 1 (~RL40.0) – AH1 (Photo 7)

Depth (m)	Material Encountered
0.0 to 0.3	SANDY TOPSOIL , dark brown, Soft, dry, fine to medium grained.
0.3 to 0.7	CLAY , brown, Firm, dry
0.7 to 0.9	CLAY , yellowy brown, Firm, dry.

End of test @ 0.9m in clay. No water table encountered.

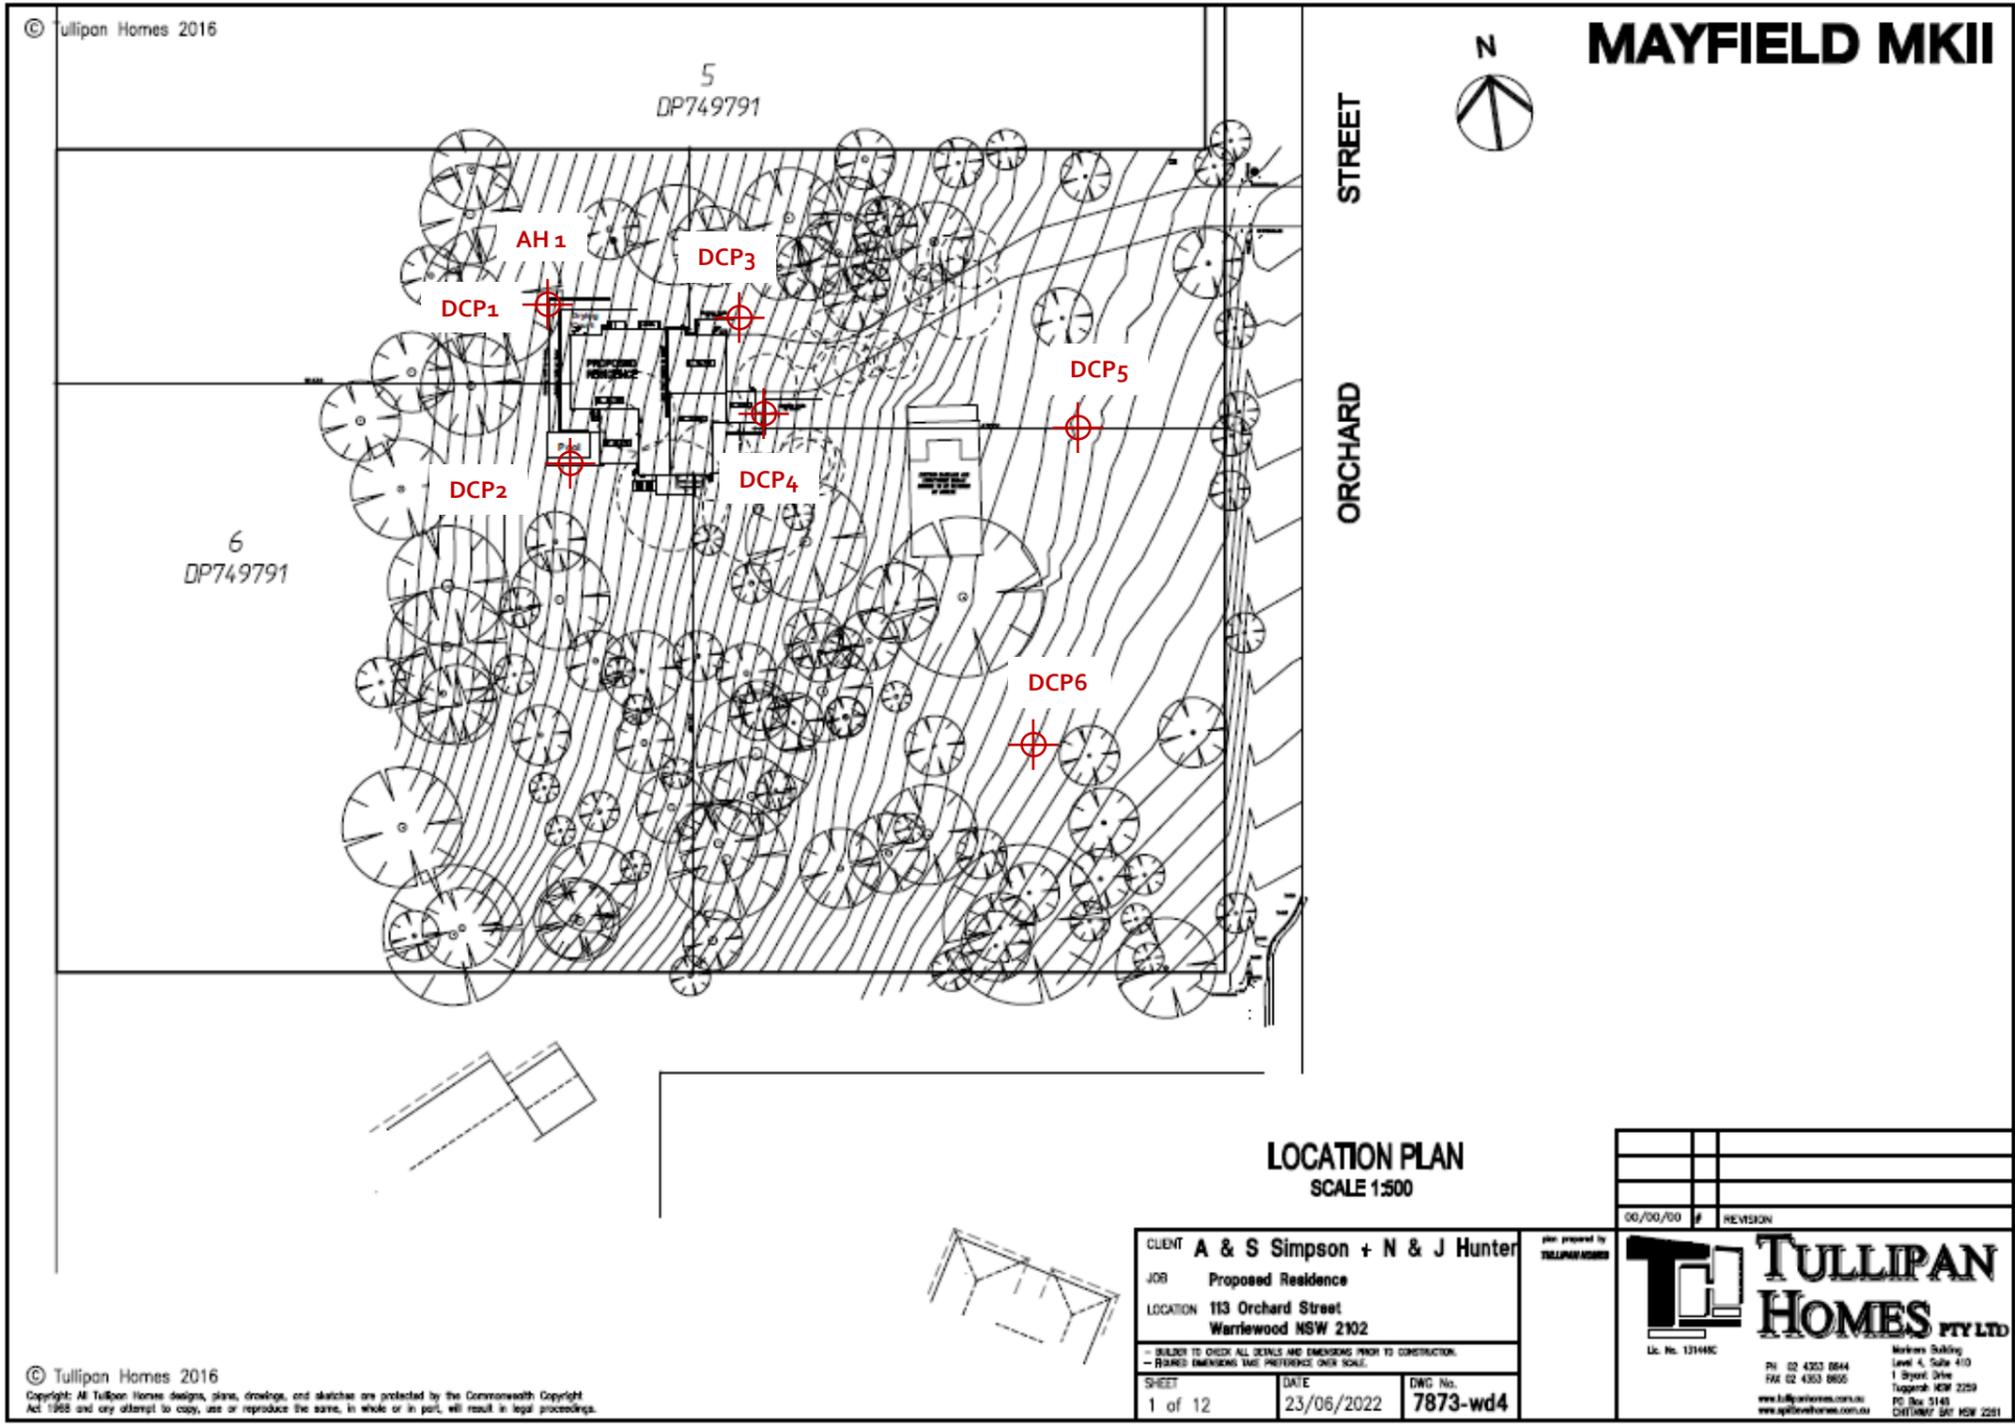
SITE PLAN – showing test locations

One hand Auger Hole (AH) was put down to identify soil materials. Six Dynamic Cone Penetrometer (DCP) tests were put down to determine the relative density of the overlying soil and the depth to weathered rock. The locations of the tests are shown on the site plan attached. It should be noted that a level of caution should be applied when interpreting DCP test results. The test will not pass through hard buried objects so in some instances it can be difficult to determine whether refusal has occurred on an obstruction in the profile or on the natural rock surface. This is not expected to be an issue for the testing on this site. However, excavation and foundation budgets should always allow for the possibility that the interpreted ground conditions in this report vary from those encountered during excavations.

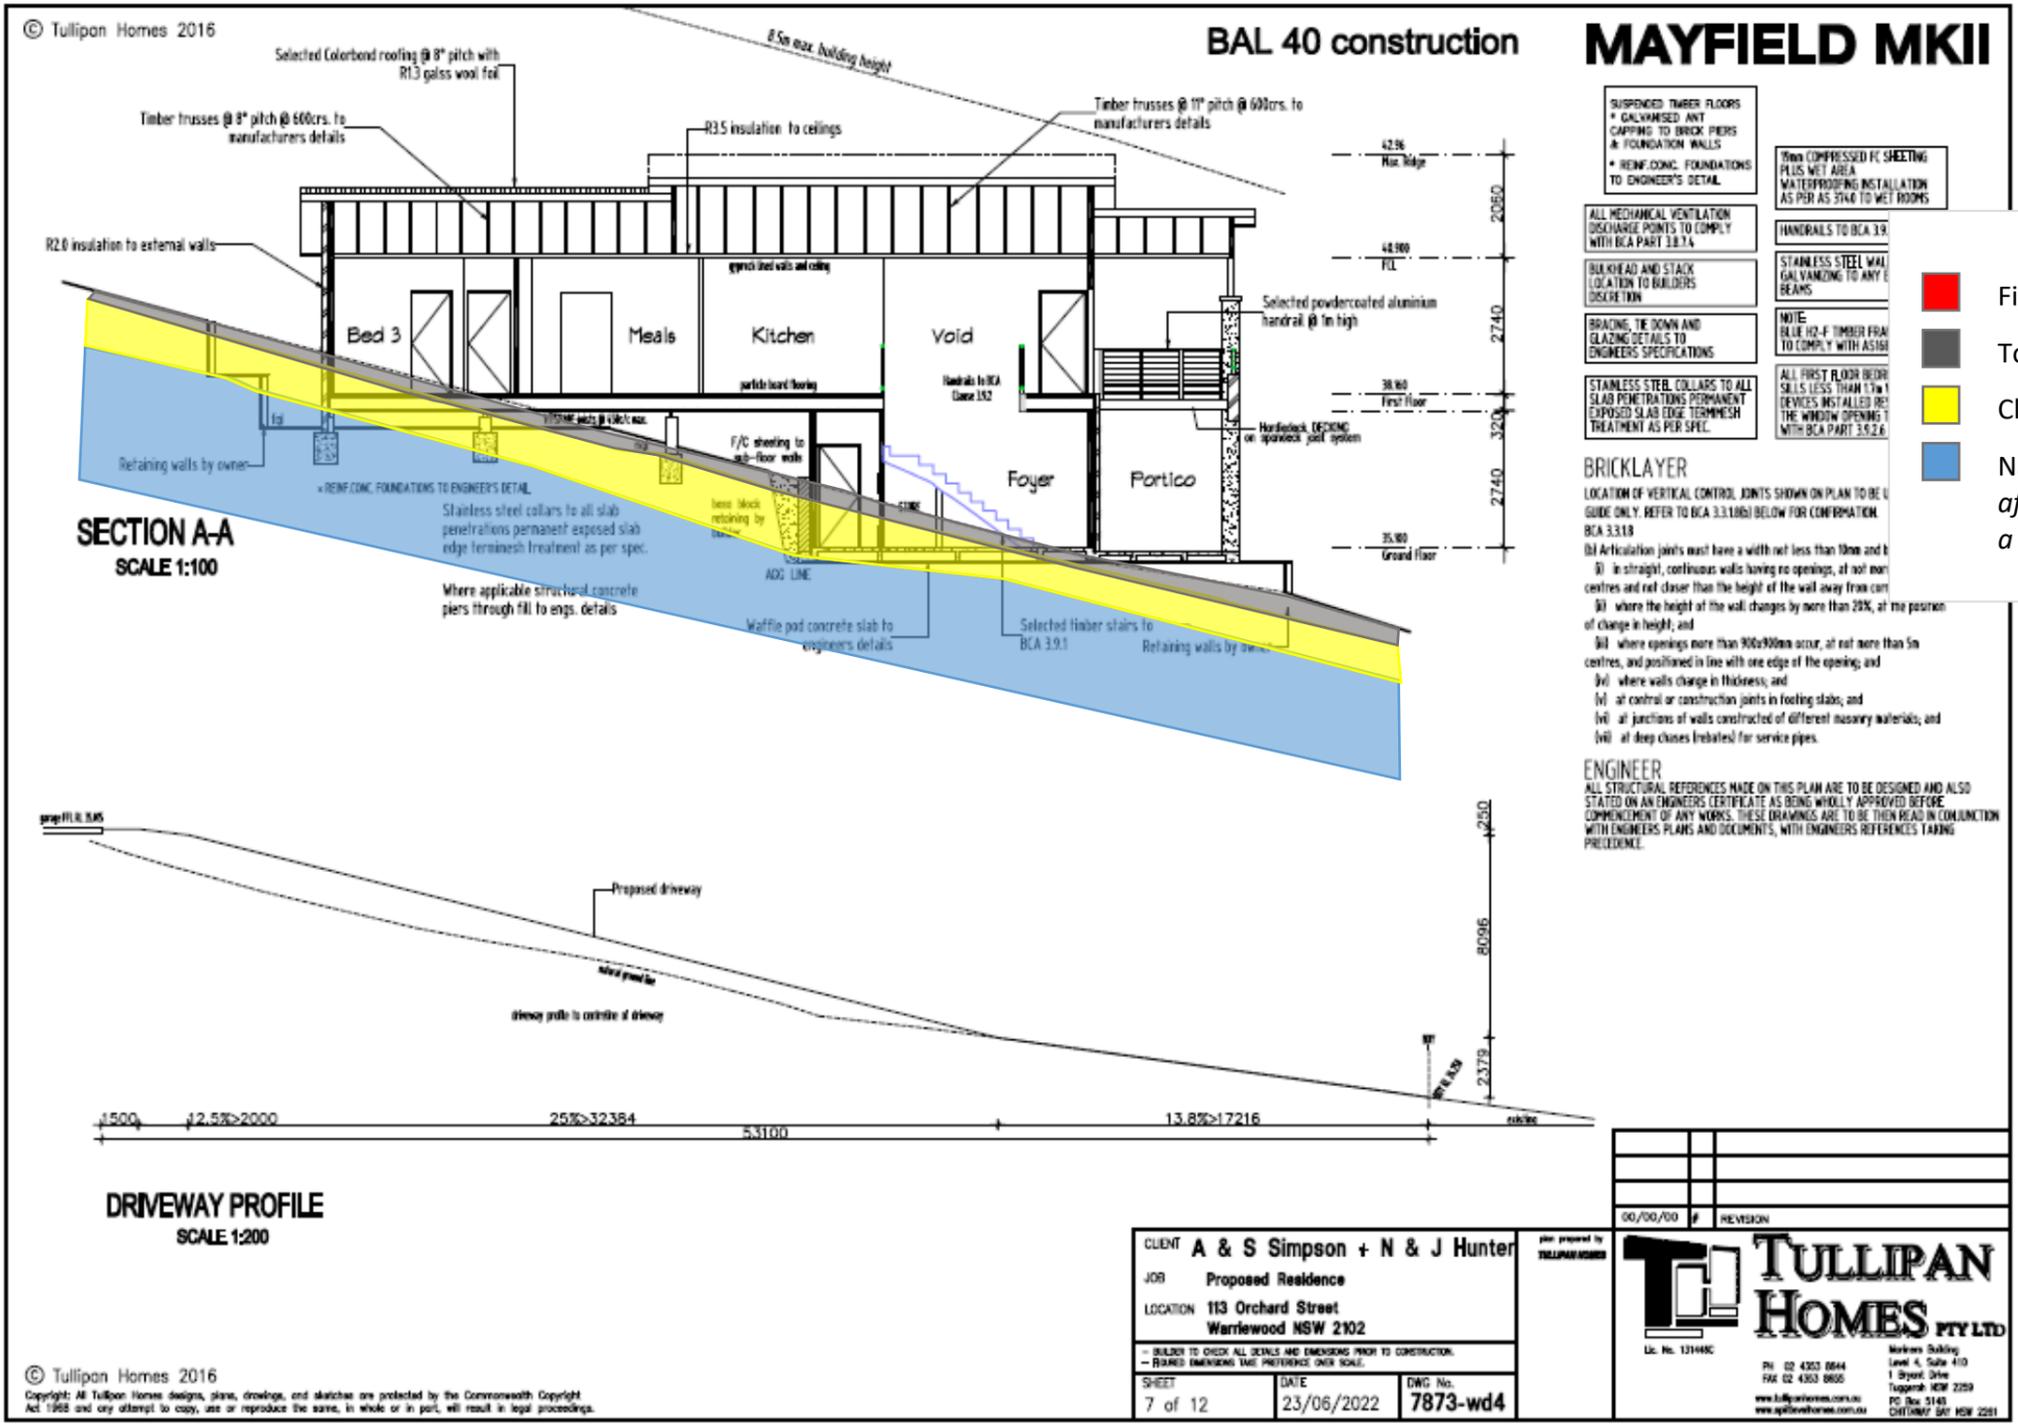
TYPE SECTION – Diagrammatical Interpretation of expected Ground Materials

The slope materials are colluvial at the near surface and residual at depth. In the test locations, the ground materials consist of shallow soils over clays. The clay merges into the underlying weathered rock at depths of between ~1.2m to ~1.5m below the current surface. The weathered zone is interpreted to be Extremely Low Strength Shale. See Type Section attached for a diagrammatical representation of the expected ground materials.

Expected Ground Materials

- Fill
- Topsoil
- Clay – Firm to Stiff
- Narrabeen Group Rocks – Extremely Low Strength Shale - after being cut up by excavation equipment can resemble a stiff to hard clay.
